| Location Plan: | <b>Mostyn Sea Wall</b><br>Assessment Date: 16/03/2023 | |
| | CARRS Exam ID: | <b>15614043</b> |
| | Structure Reference: | <b>W1990286</b> |

# COASTAL ASSET CONDITION SURVEY REPORT

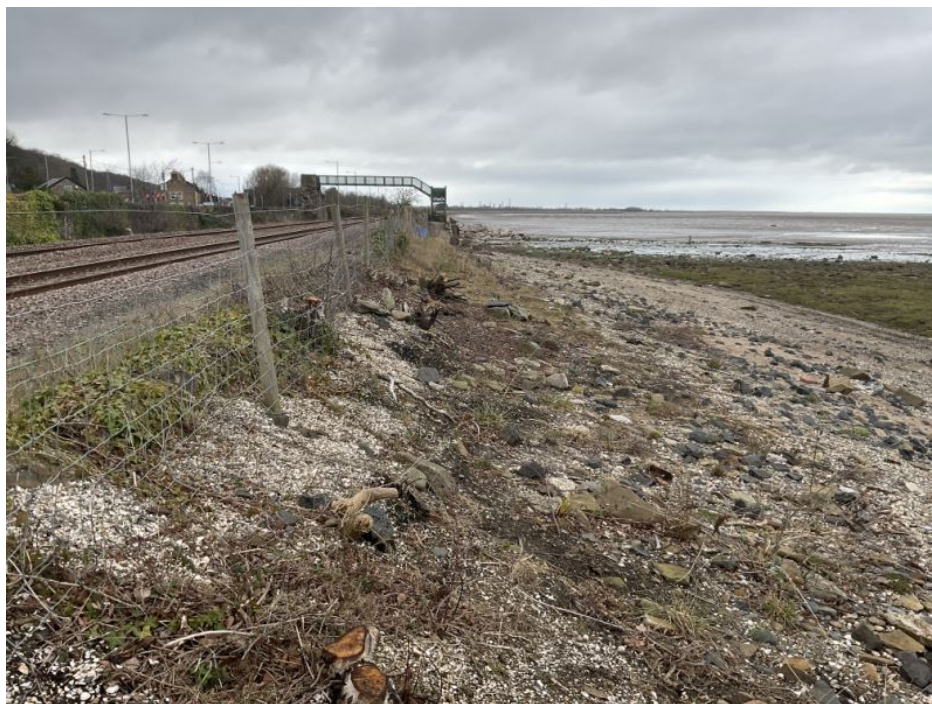
**Section A**  
**Wall section**  
**Defect Ref: D38**  
**Description:** Tree growth present against the wall. In the 2023 inspections it was observed that large vegetation had been removed.  
**Photo number: 64**

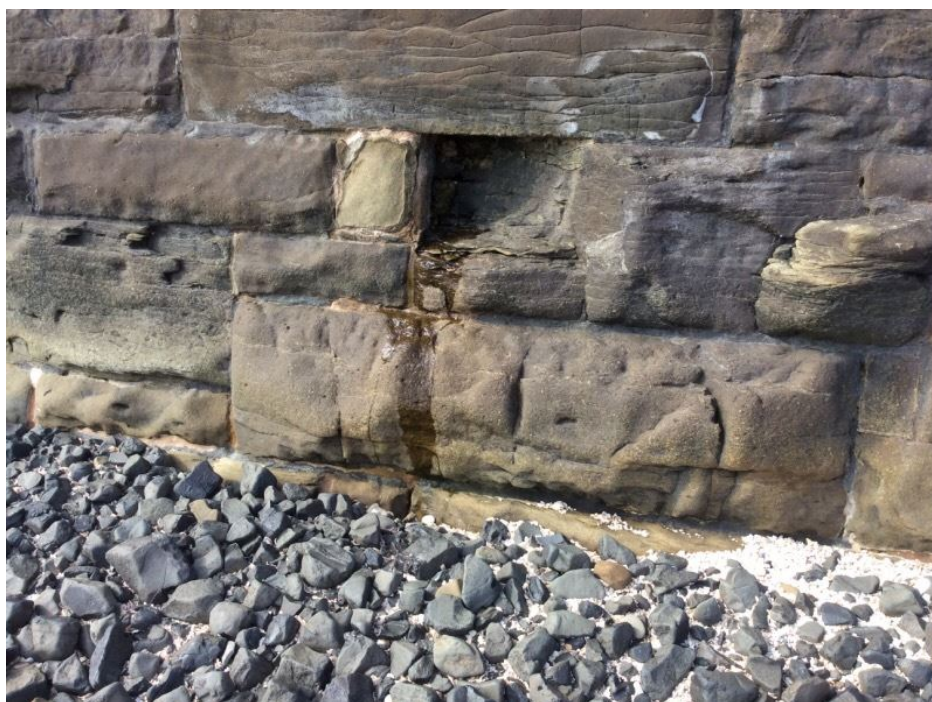
**Section A**  
**Wall section**  
**Defect Ref: D39**  
**Description:** Seepage through wall. Defect observed in 2023 inspections, no significant deterioration was observed.  
**Photo number: 12**

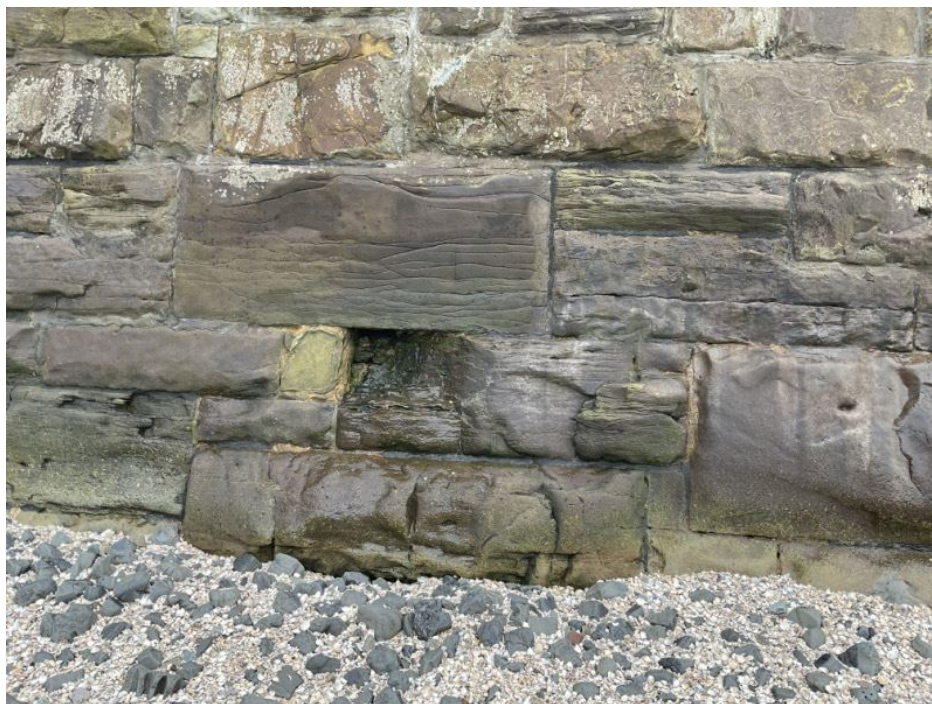
**Section A**  
**Wall section**  
**Defect Ref: D39**  
**Description:**  
Seepage through wall. Defect observed in 2023 inspections, no significant deterioration was observed.  
**Photo number: 48**

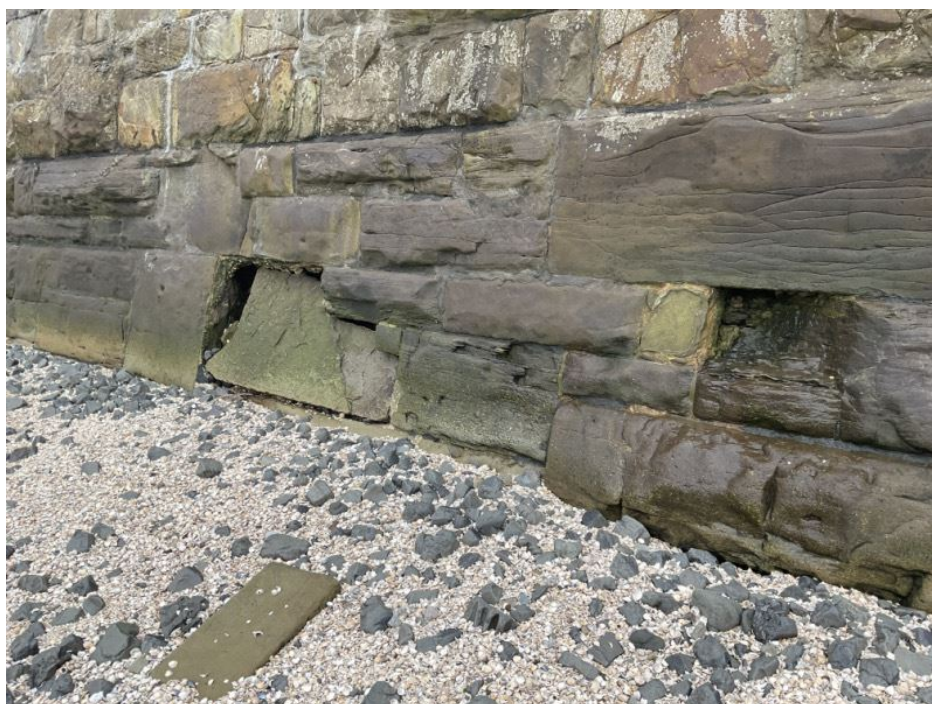
**Section A**  
**Wall section**  
**Defect Ref: D40**  
**Description:** Void in wall of at least 300mm deep. Further deterioration observed in the 2023 examination.  
**Photo number: 46**

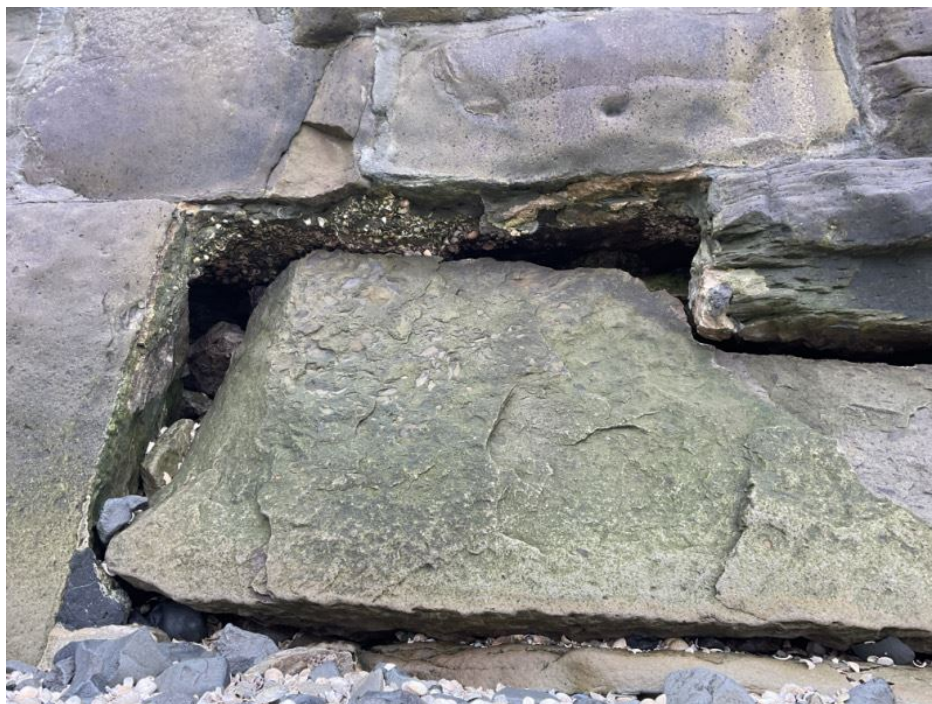
**Section A**  
**Wall section**  
**Defect Ref: D40**  
**Description:** Void in wall of at least 300mm deep. Further deterioration observed in the 2023 examination.  
**Photo number: 47**

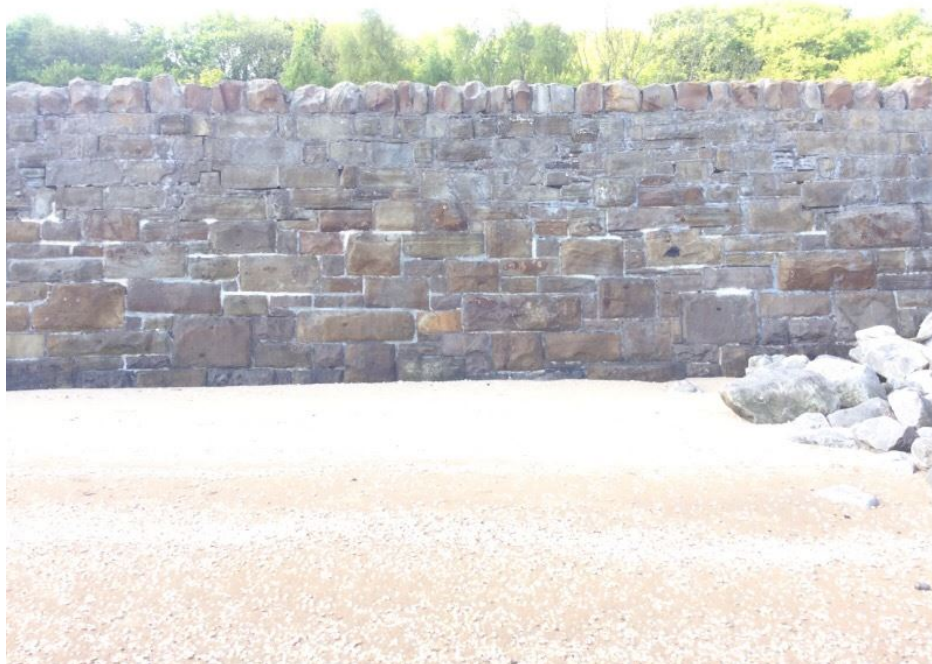
**Section A**  
**Wall section**  
**Defect Ref: D41**  
**Description:** Open joints in wall face. Significant repointing was observed in the 2023 inspections.  
**Photo number: 19**

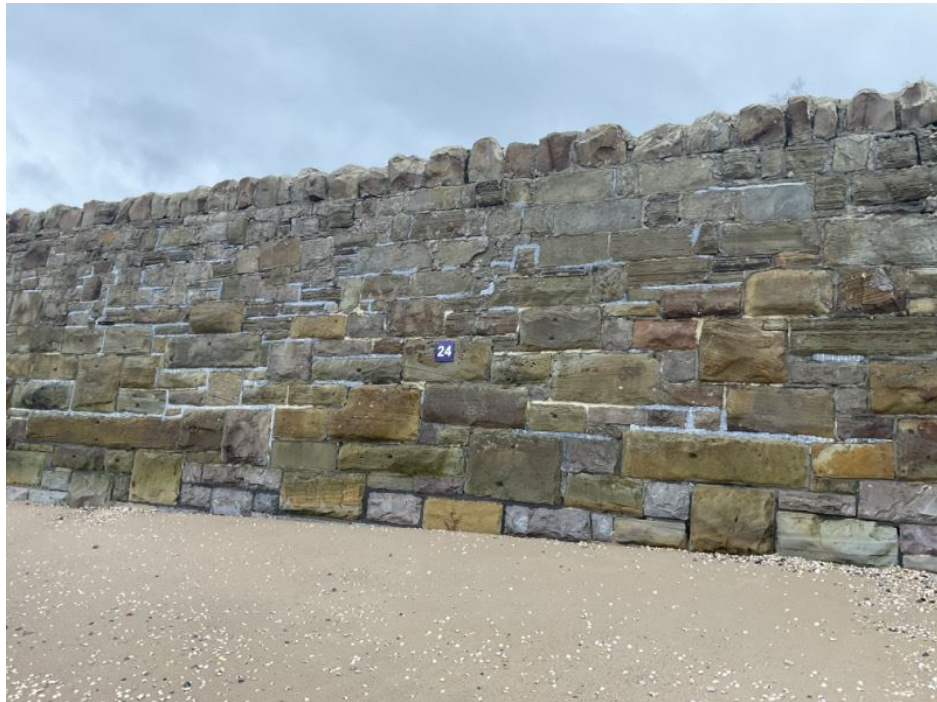
**Section A**  
**Wall section**  
**Defect Ref: D41**  
**Description:** Open joints in wall face. Significant repointing was observed in the 2023 inspections.  
**Photo number: 72**

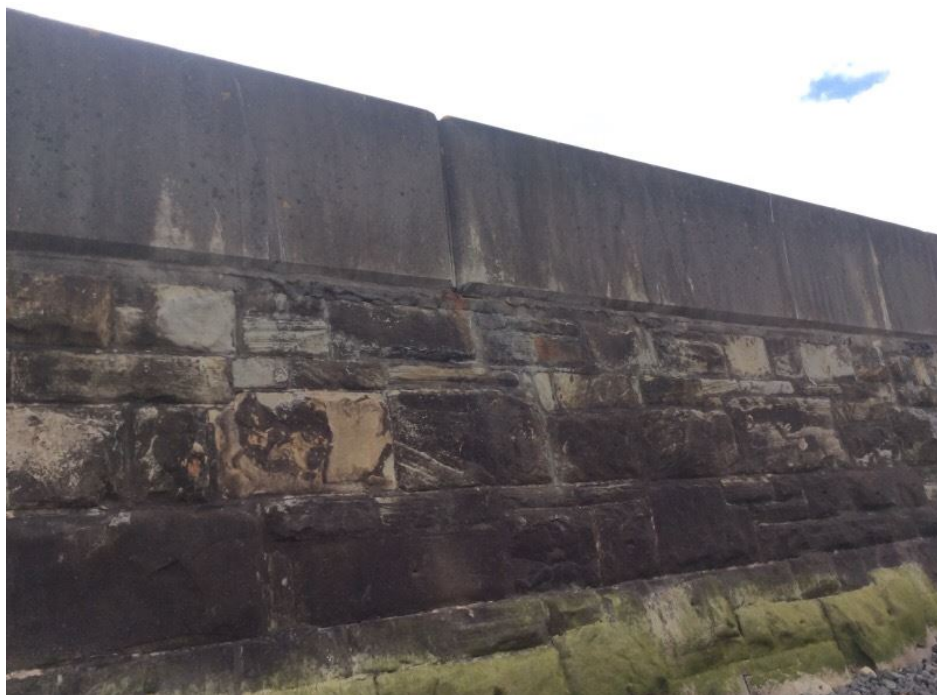
**Section A**  
**Wall section**  
**Defect Ref: D42**  
**Description:** Missing mortar at joints between the concrete units. Minor defect, no change observed in 2023 inspections.  
**Photo number: 28**

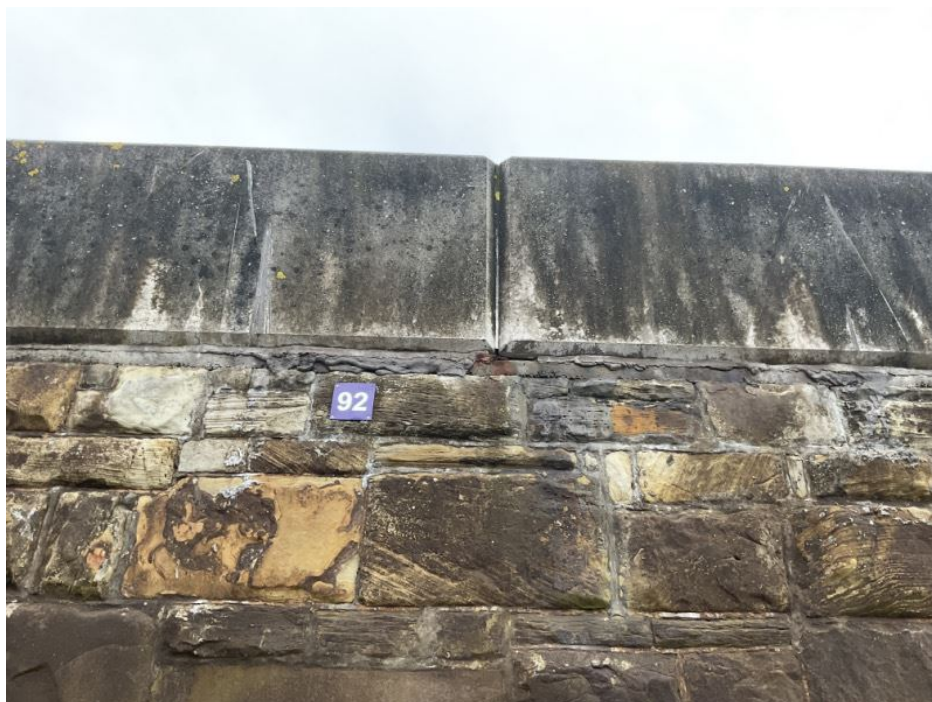
**Section A**  
**Wall section**  
**Defect Ref: D42**  
**Description:** Missing mortar at joints between the concrete units. Minor defect, no change observed in 2023 inspections.  
**Photo number: 49**

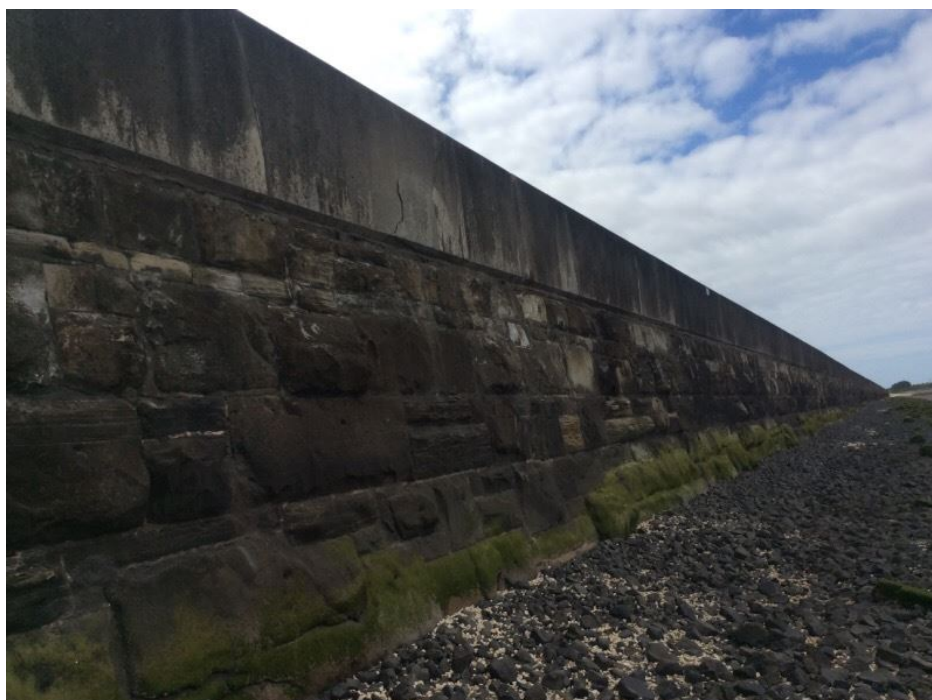
**Section A**  
**Wall section**  
**Defect Ref: D43**  
**Description:** Delamination of concrete unit. Significant deterioration observed in 2023 inspection.  
**Photo number: 29**

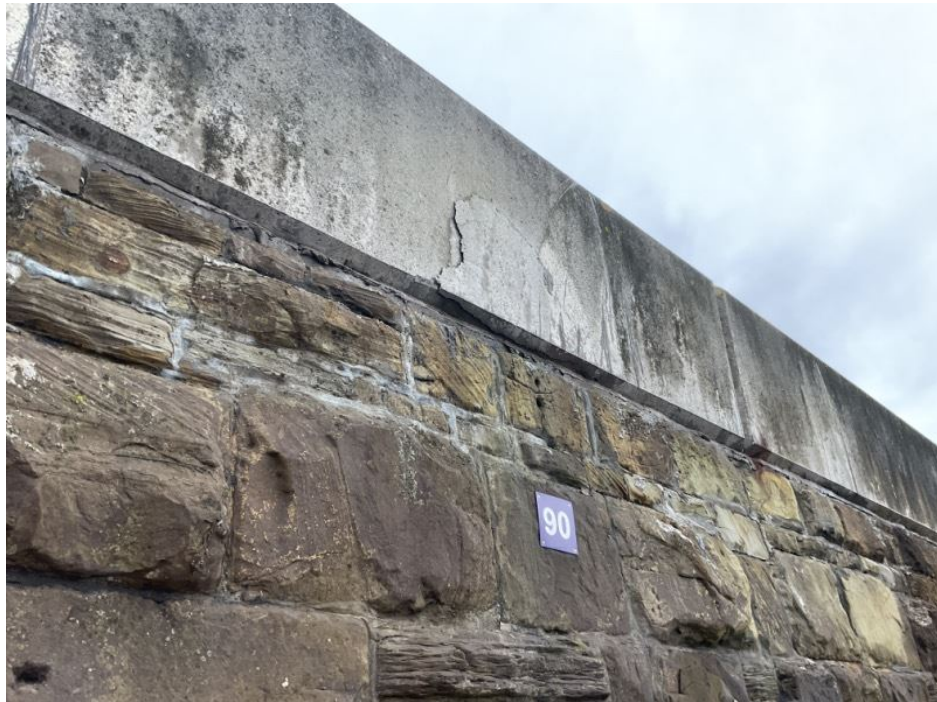
**Section A**  
**Wall section**  
**Defect Ref: D43**  
**Description:**  
Delamination of  
concrete unit.  
Significant  
deterioration  
observed in 2023  
inspection.  
**Photo number: 50**

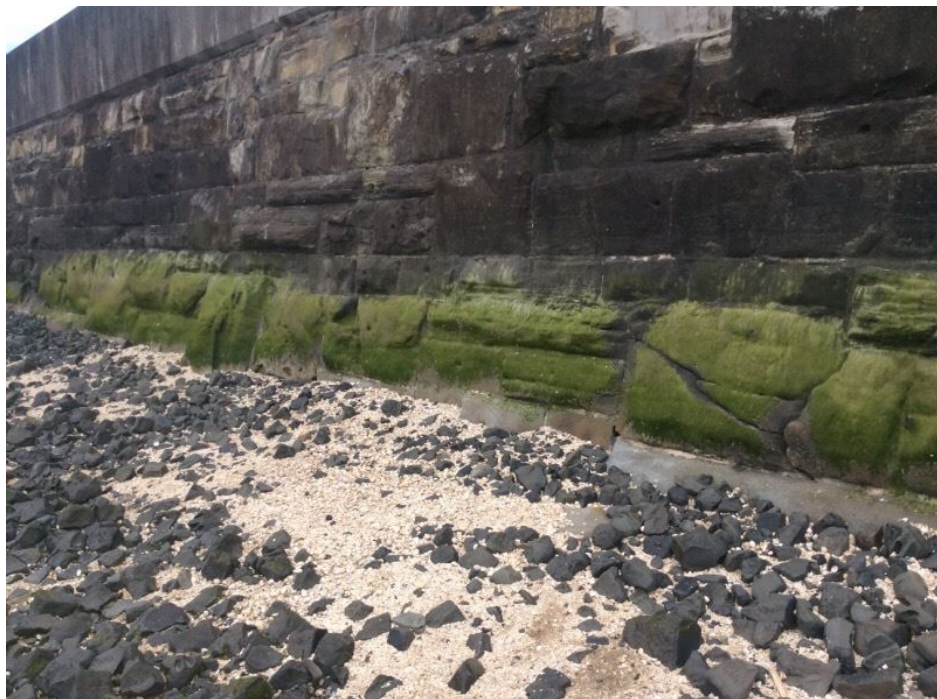
**Section A**  
**Wall section**  
**Defect Ref: D44**  
**Description:**  
Fractured and broken  
blockwork in wall.  
Slight deterioration  
observed in 2023  
inspections.  
**Photo number: 30**

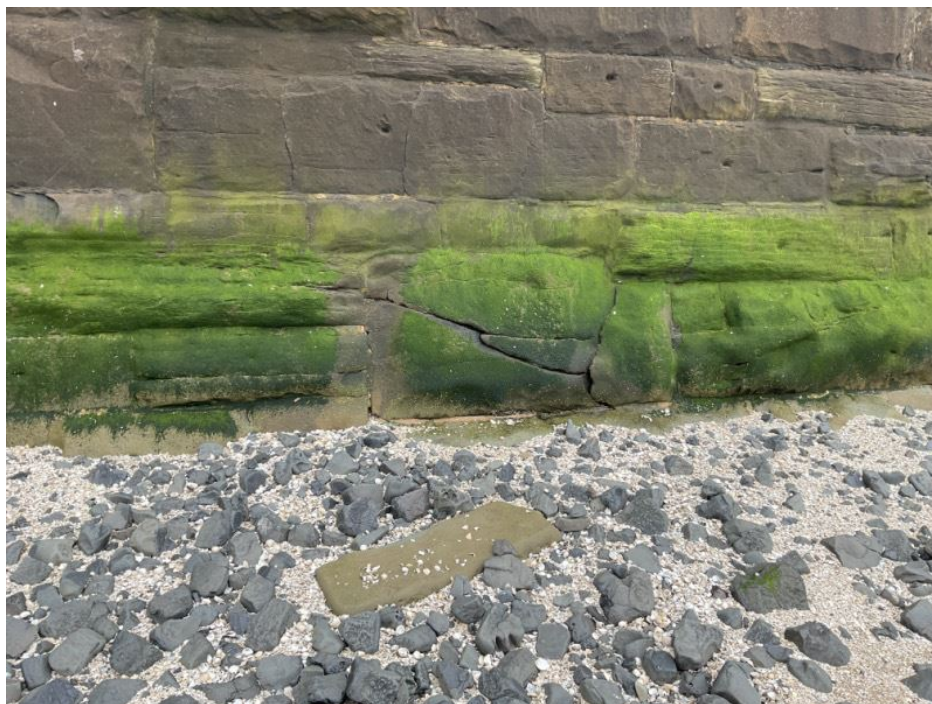
**Section A**  
**Wall section**  
**Defect Ref: D44**  
**Description:**  
Fractured and broken  
blockwork in wall.  
Slight deterioration  
observed in 2023  
inspections.  
**Photo number: 52**

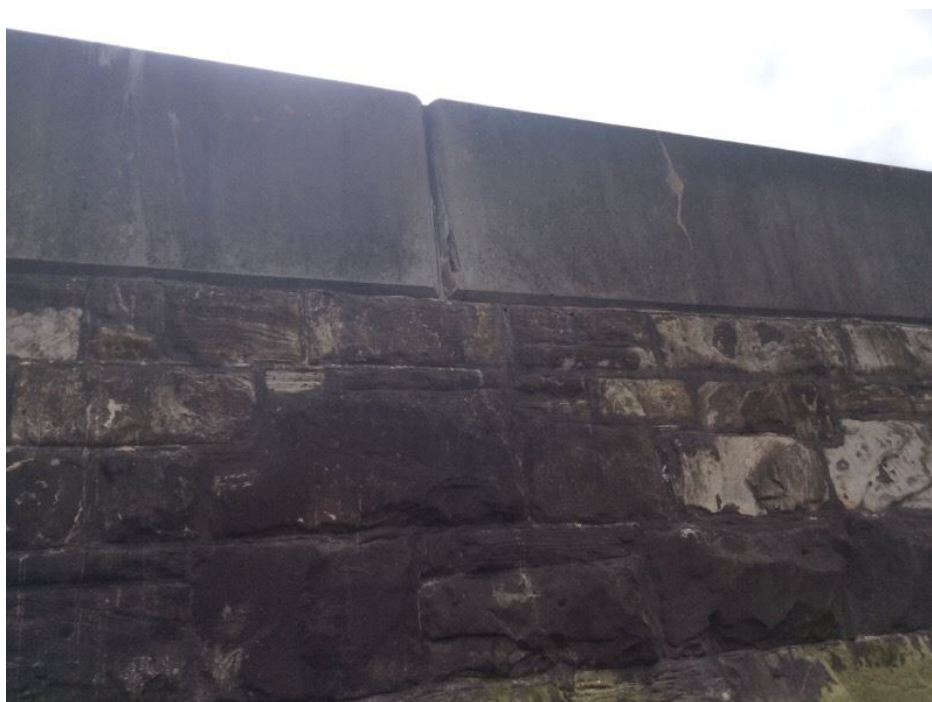
**Section A**  
**Wall section**  
**Defect Ref: D45**  
**Description:**  
Fracture in corroded  
section of concrete  
capping block. No  
significant change  
observed in 2023  
inspections.  
**Photo number: 32**

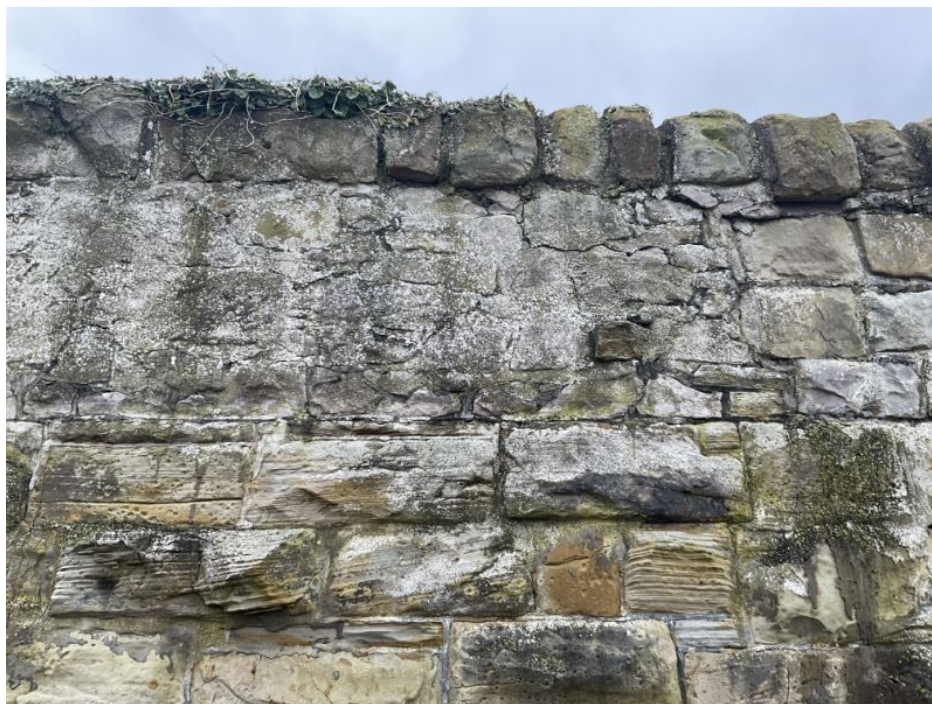
**Section A**  
**Wall section**  
**Defect Ref: D47**  
**Description:**  
Fractures and open joints in wall area near to pedestrian crossing. No significant change observed 2023 in inspections.  
**Photo number: 61**

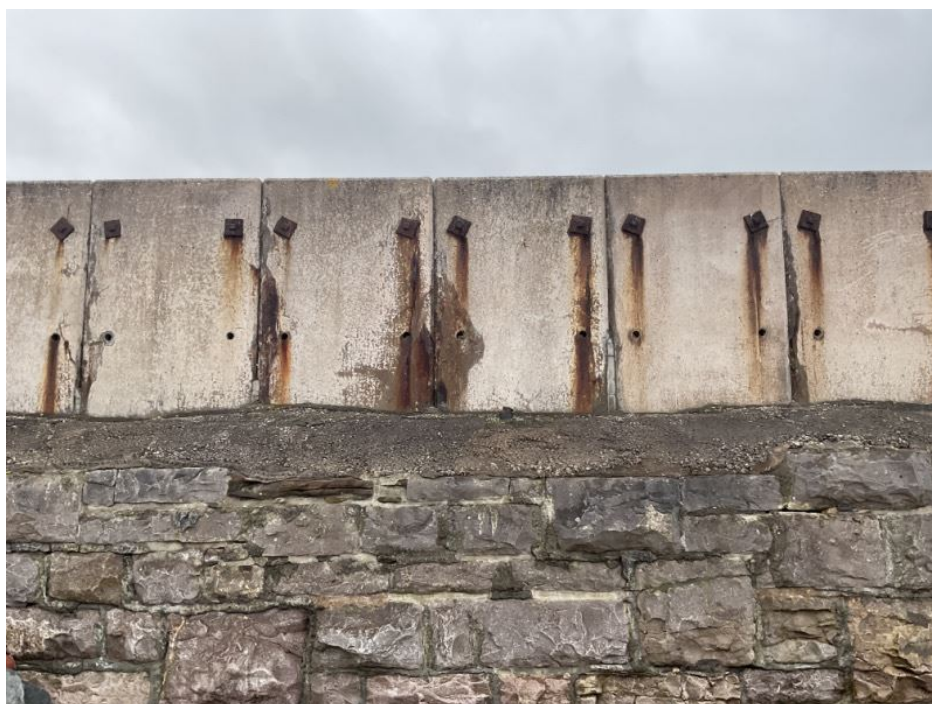
**Section A**  
**Parapet/Capping**  
**Defect Ref: D48**  
**Description:** Cracks and corrosion seepage in concrete units.  
**Photo number: 80**

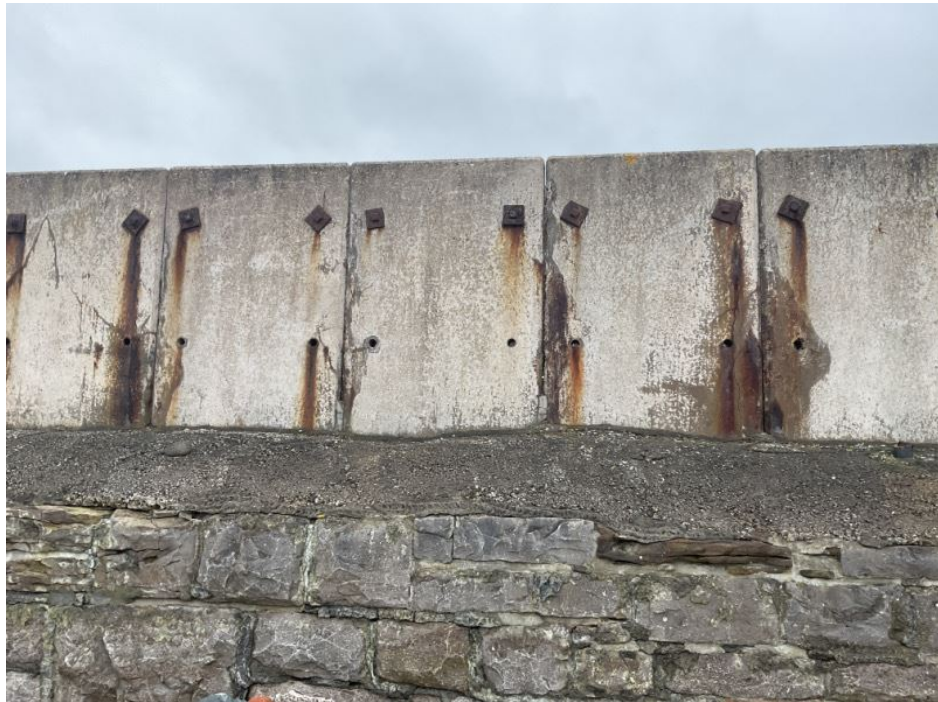
**Section A**  
**Parapet/Capping**  
**Defect Ref: D48**  
**Description:** Cracks and corrosion seepage in concrete units.  
**Photo number: 81**

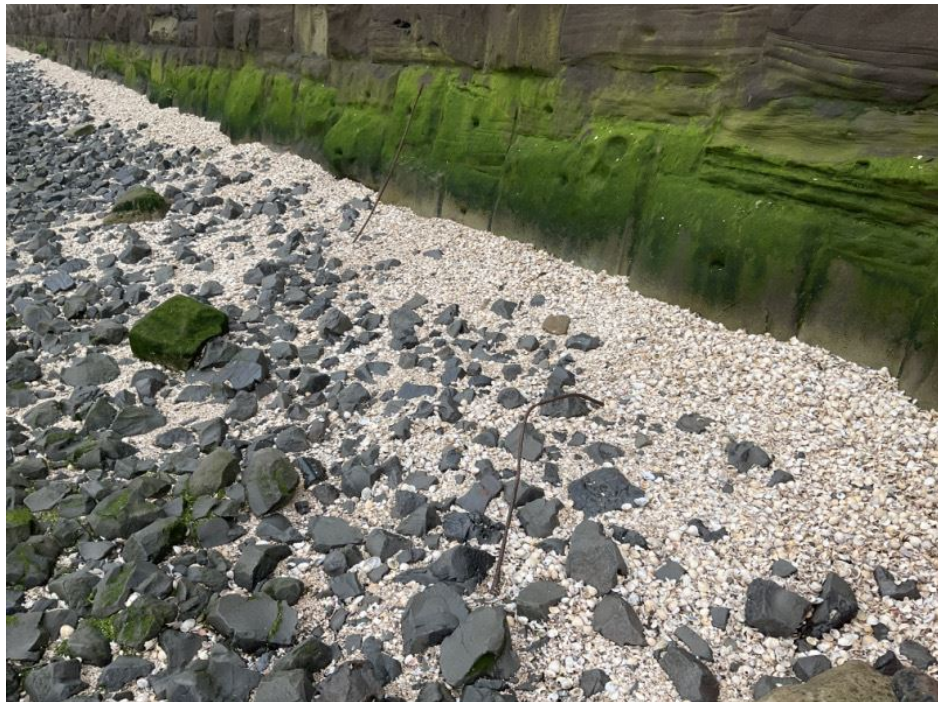
**Section A**  
**Wall Armour**  
**Defect Ref: D49**  
**Description:** Rebar extruding from rock armour/ base of wall, observed in 2023 examinations.  
**Photo number: 43**

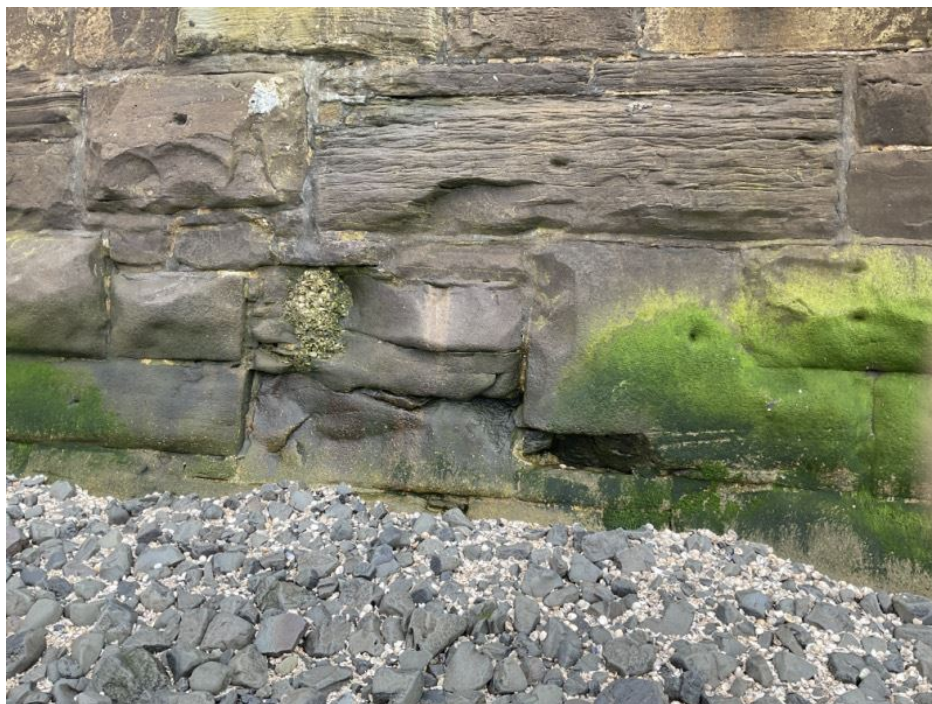
**Section A**  
**Wall section**  
**Defect Ref: D50**  
**Description:**  
Weathered block  
work leading to void,  
observed in 2023  
inspections.  
**Photo number: 51**

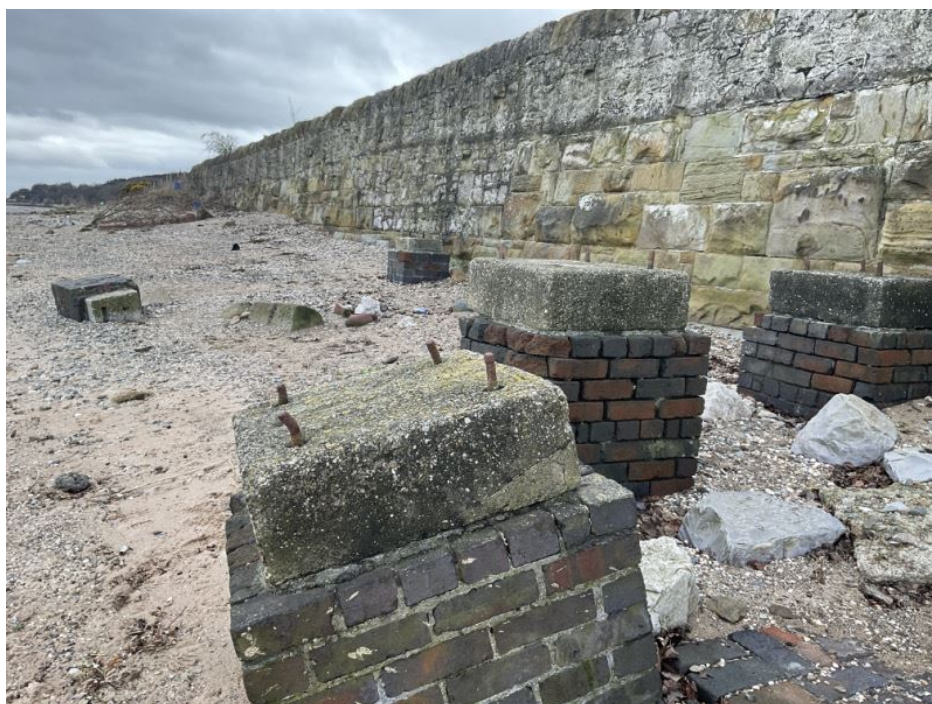
**Section A**  
**Wall section**  
**Defect Ref: D51**  
**Description:**  
Exposed rebar  
presents H&S risk, in  
the 2023  
examinations this  
defect was observed  
in multiple locations  
across extent of  
asset.  
**Photo number: 62**
