Our Ref: EPR/CB3396FF  
Your Ref:

John Jones Civil Engineering and  
Groundworks Ltd.,  
Cwetgwenddw'r Wood  
Builth Wells  
LD2 3YR

29 August 2024

## Response to Letter regarding Permit Compliance

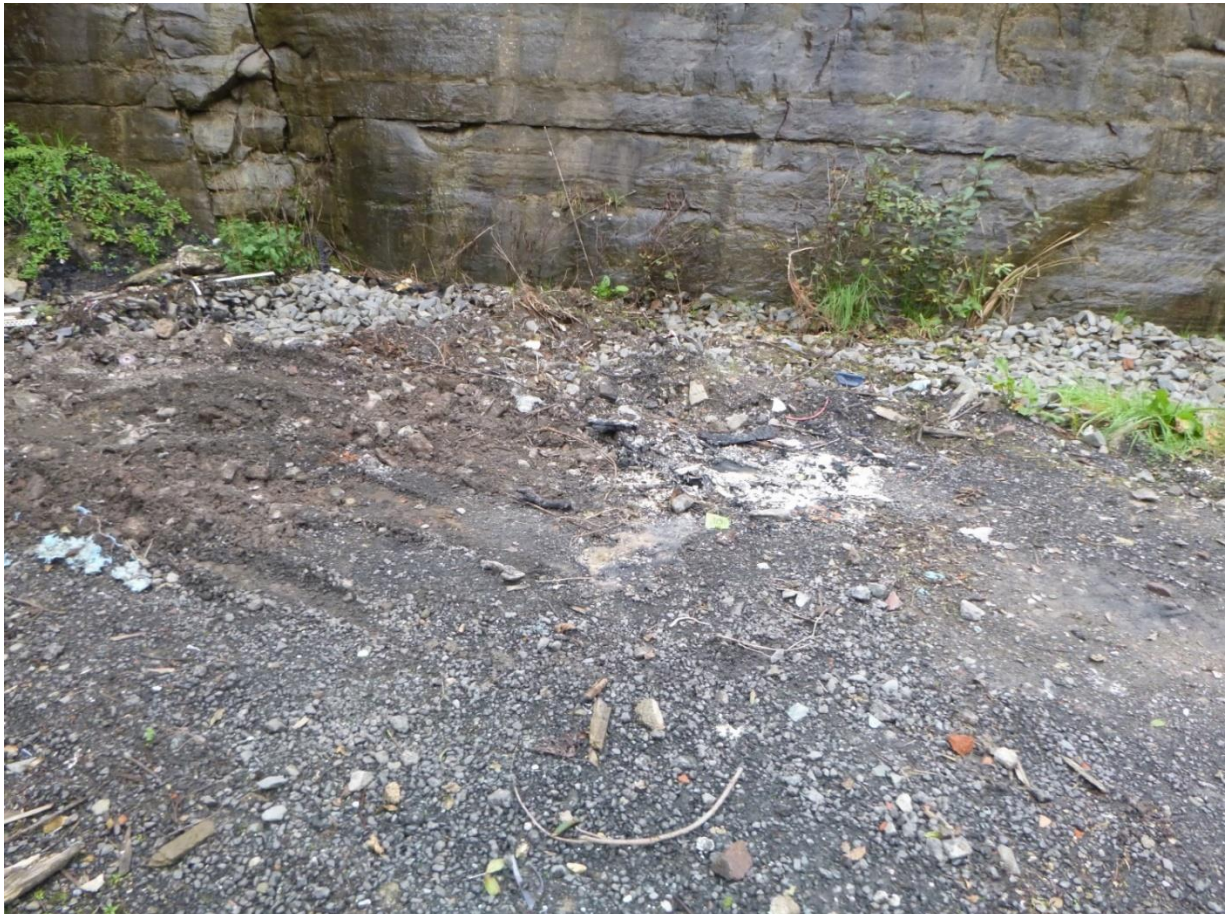
During the compliance visit on 12 October 2023, where both yourself and Mr. Bridges were present, it was observed by officers that, as shown in the photograph below, there had been a fire between the workshop and the quarry wall at the rear of the site. This is within the permit boundary and your permit does not authorise the burning of wastes.

Shortly after this compliance visit, Natural Resources Wales received information regarding burning at the site and as such have a statutory duty to respond to such reports. As noted above and shown in the earlier photograph, officers had previously observed that fires have occurred at the site and therefore we considered that the best response was to treat this as a permit compliance matter rather than as an illegal waste activity and so it was included in the Compliance Report. However, as the alleged burning was not substantiated, and as this Compliance Report is going to be re-issued for another matter, we will also change this issue from an "Action Only" Permit Breach to being Advice and Guidance in "Other Matters".

We thank you for raising staff awareness that burning is not allowed on site and hopefully this will prevent future fires.
