**EAST WASTE  
MANAGEMENT SITE,  
LLANWERN STEELWORKS**

**PERMIT EAWML/30003**

**2022 Annual Review of  
Environmental  
Monitoring**

*Report Number 2215r1v1d0123*

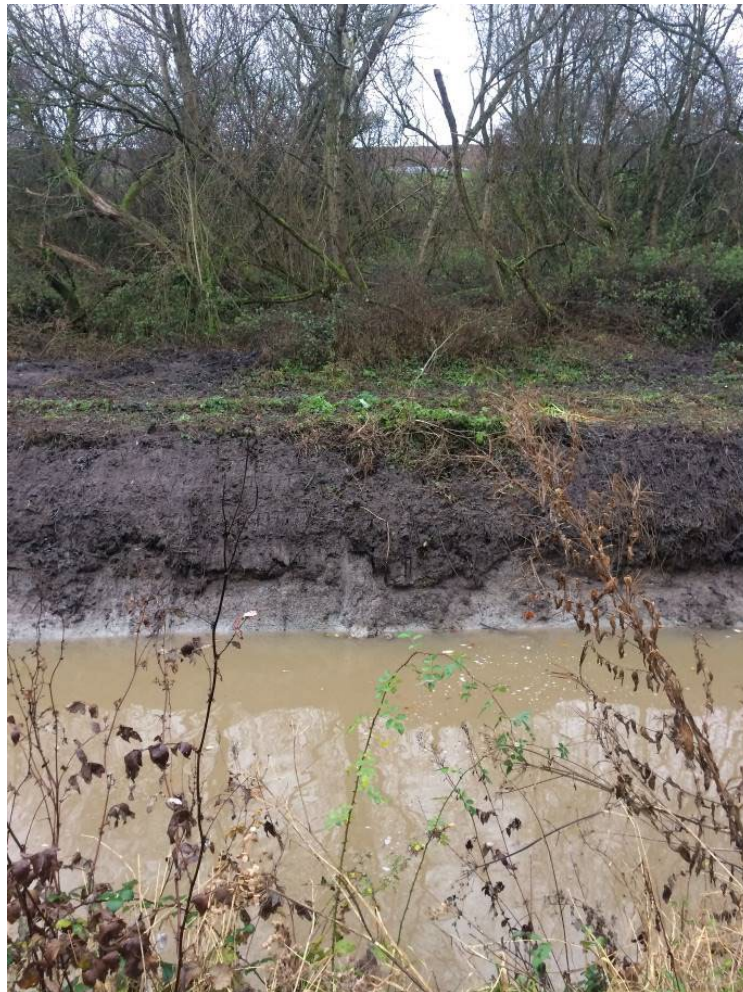
The latest monitoring data continues to indicate that upgradient and downgradient surface water chemistry is generally very similar. However, there are times when there are abrupt changes in several parameters including pH and alkalinity. Subtle differences in the concentration of sodium, potassium, chloride, sulphate and alkalinity (and other parameters) are also sometimes apparent and as leachate has been observed along this flank and as the waste in the landfill is being exposed during the restoration works, this aspect of the monitoring programme should continue to be closely scrutinised. Recent inspection of the adjacent reen indicates that the reen is cut into low permeability deposits and that there are no obvious visual signs of staining indicative of leachate (see Plate 9-1). At this stage, there is no clear evidence that the reen quality is being impacted by the landfill.

**Plate 9-1 Reen flowing from right to left along eastern side of site. Landfill can be seen in background beyond tree.**

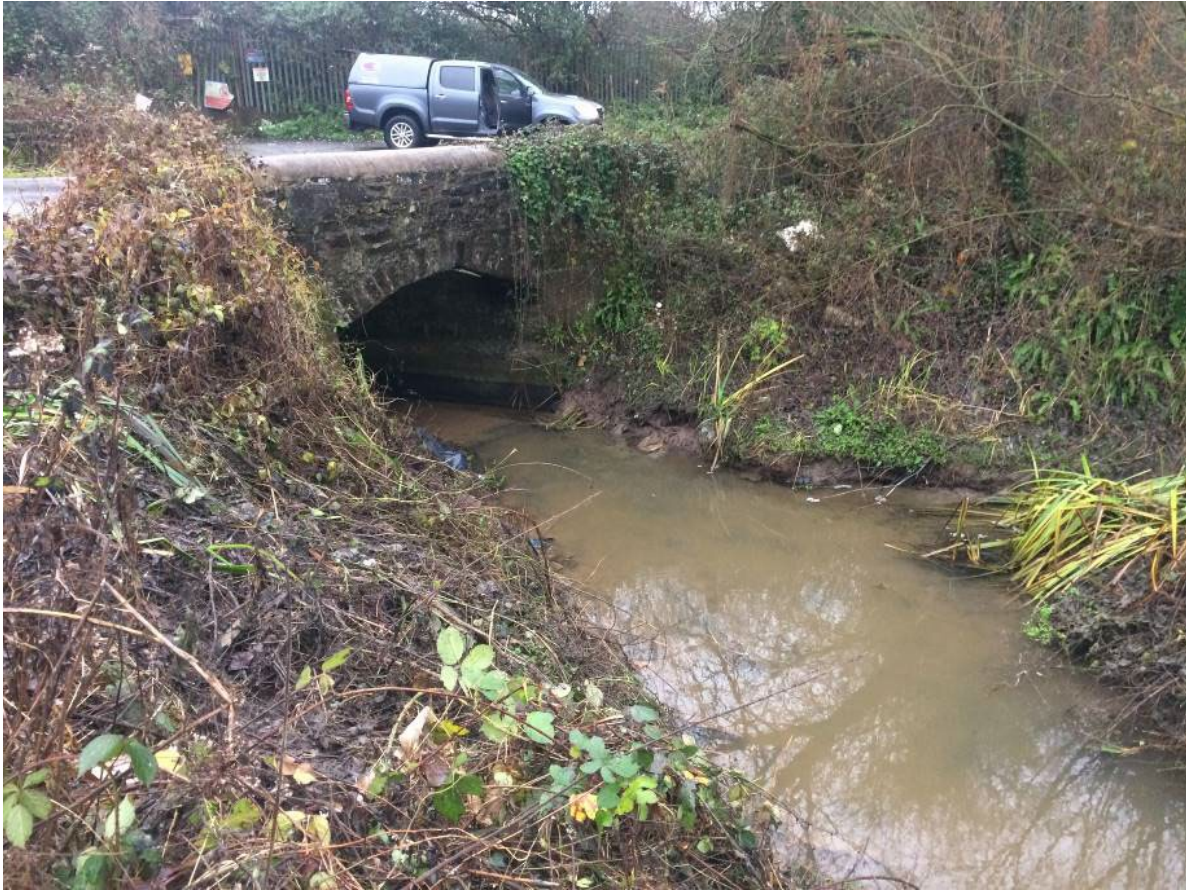
Continued scrutiny of upstream influences is also required as observations on several occasions, as shown in Plate 9-2, suggests that there are upstream sources of suspended solids and other potential pollutants like ammonia. These also influence water chemistry downstream of the landfill.

**Plate 9-2 Suspended solids in surface water upstream of site**
