## Abandoned Anchors Freshwater West

## Greenlink Interconnector Project

JDN document no.:	JDN.6746.SEI.TN.90.98.01
Aconex document no.:	P-021001_EC_12400.A032#GL22&ADD010

The purpose of the document is to provide details regarding the abandonment of 2 3Te Deltaflipper anchors at the Freshwater West landfall.

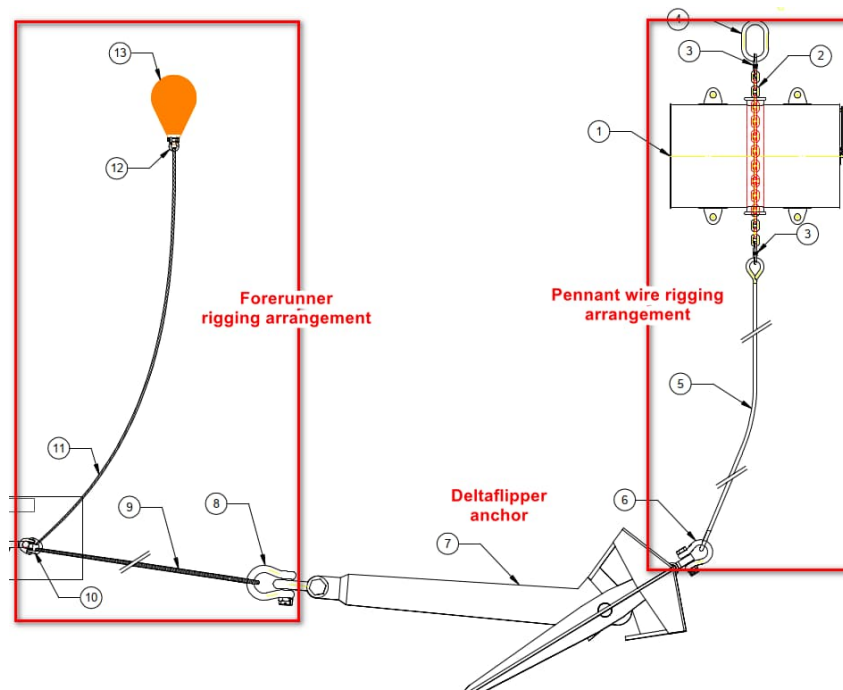
Figure 1-2: anchor rigging arrangement

As can be seen in the above layout, both aft anchors were 3T Delta Flippers. The rigging arrangement is shown Figure 1-2. The steel pennant wire consists of a 30 m 36 mm soft loop steel wire to which a 22 mm chain is connected and guided through the pennant buoy. The forerunner arrangement consists of a 50m 32mm and a 25 m 24 mm steel wire connected to an orange A7 buoy.

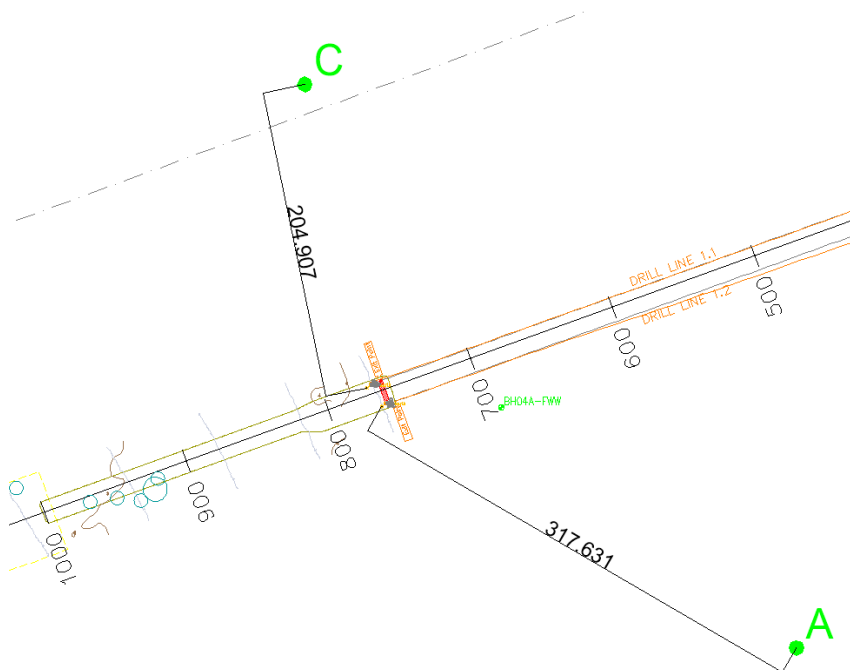
Figure 2-1: Anchor drop positions and bellmouth locations

However due to adverse weather conditions, the buoys parted from the two anchors and whilst numerous attempts were made to locate and recover the anchors as described in section 4 of Annex A these were unsuccessful with the anchors being completely buried beyond a practical depth that can be detected, let alone recovered.

The distance between anchor C, A and the bellmouths is approximately 204 and 317m. The parallel distance between anchor C and the northern HDD route is approximately 200. The distance between anchor A and the southern HDD route is approximately 250m.

The Navigational Risk assessment in Annex A demonstrates that these anchors are not a risk to Navigation and as such no further efforts to either locate or recover these will be made.

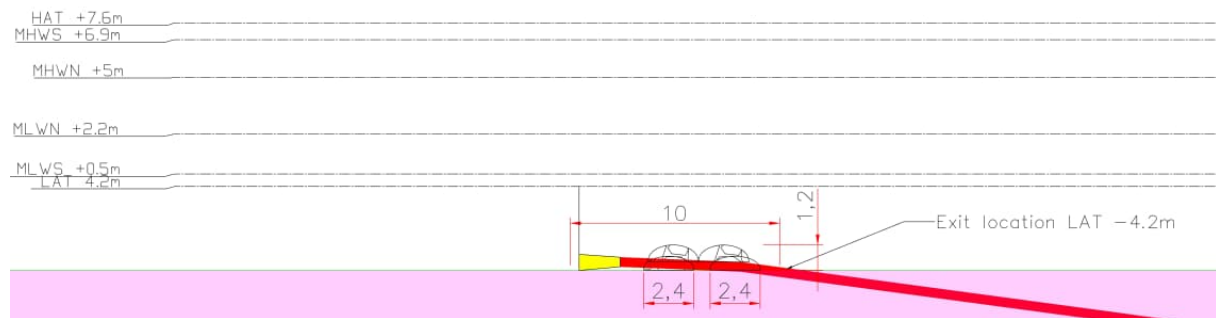
Figure 4 – profile view of the installed asset. Note the rock bags have been removed and the pipe (red) with bellmouth (yellow) has been lowered below seabed in April 2024.

A steel bellmouth structure (yellow) was installed at the end of the HDPE pipe (red). The offshore end of the HDPE pipe was temporarily stabilised with rock bags. In April 2024, the rock bags were removed and the entire bellmouth and pipe structure was buried below seabed (deeper than 4.2m below LAT) using controlled flow excavation method. Below figures show depths and dimensions.

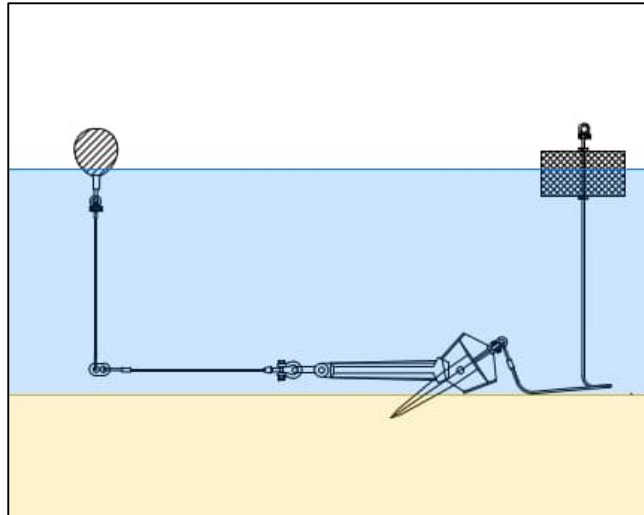
Figure 7: cross section of the pre-deployed anchor with steel wire rigging.

Due to adverse weather conditions, the buoys have parted from the two anchors. Several attempts were undertaken to excavate and retrieve the anchors. However, due to the applied pretension, the anchors had shifted position and had become buried, making all attempts futile. An overview of the timelines is presented below:

From all the above, it is clear that the anchors have become completely buried following their installation in December 2023, beyond a practical depth that can be detected, let alone recovered.

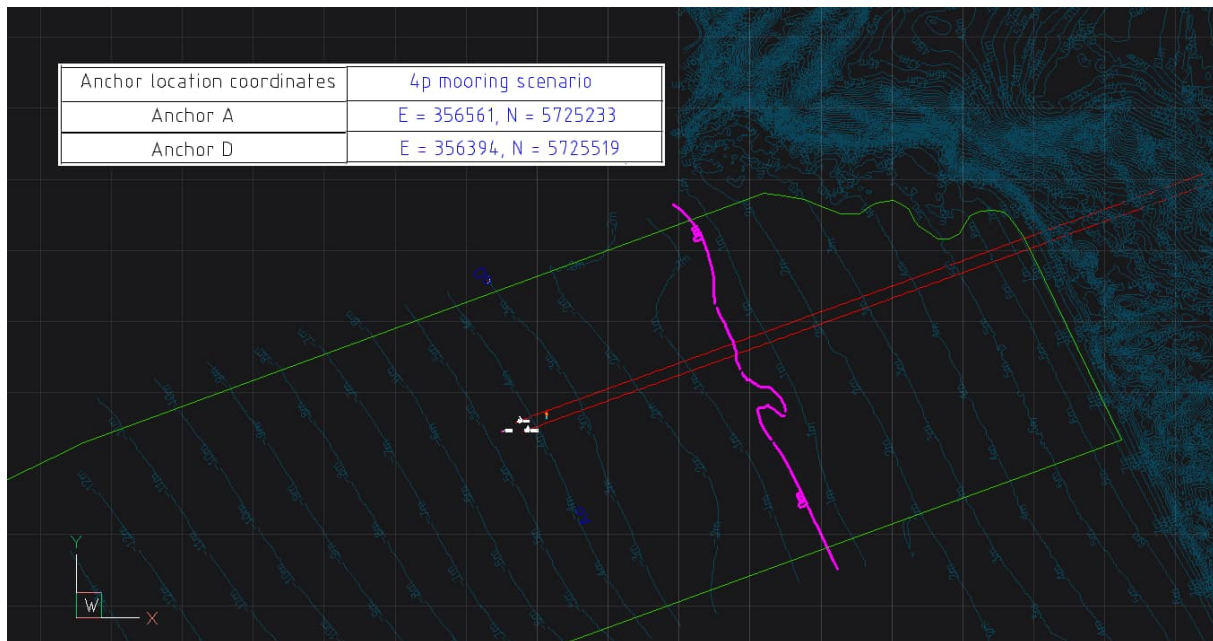
In April 2024, the seabed has been left and restored due to natural sedimentation to the original state, without any local reduction of water depth remaining that could obstruct vessels. The power cables, HDPE pipe and bellmouth structure have all been buried below seabed, as was always foreseen. The rock bags have been recovered to shore. Only the anchors remain in their buried state, due to the pre-tension applied during deployment, beyond detection and recovery.

With regards to a risk of snagging on the installed buried anchors, only recreational and 'pot' fishing takes place in the nearshore area so the seabed is not disturbed to the burial depth of the anchors.
