Compliance Assessment Report CAR_NRW0044817

Permit being assessed: XP3830UR.

For: Haverfordwest Creamery, **held by:** The First Milk Cheese Company Ltd

Type of assessment: Site Inspection,

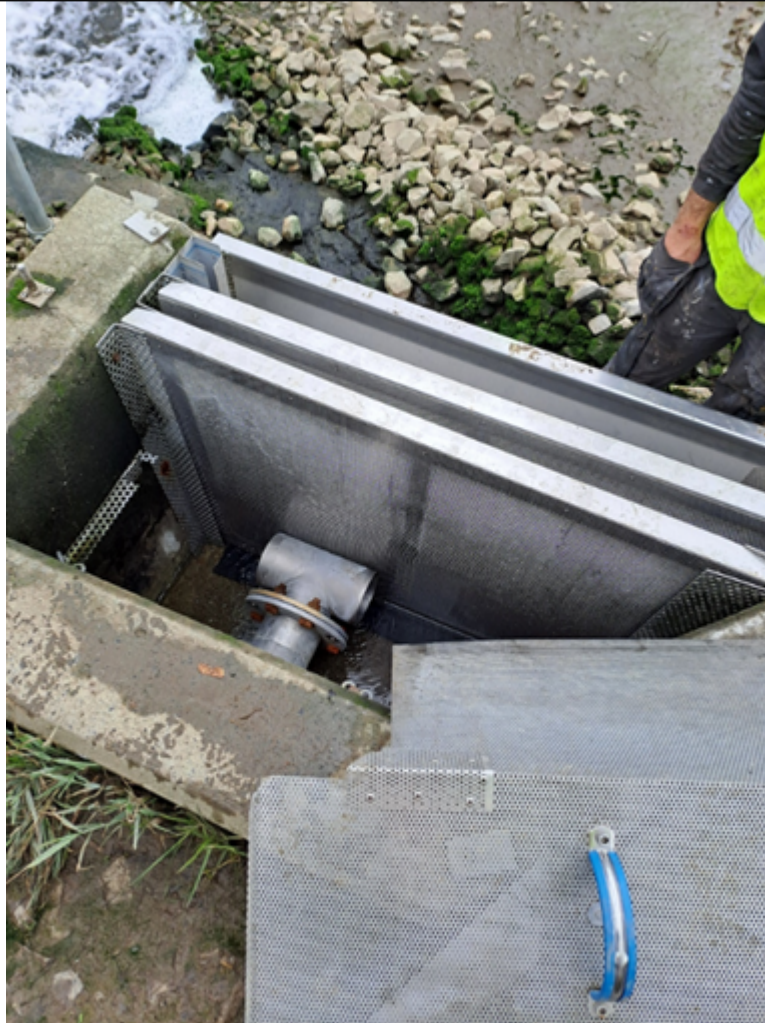
Image 01 – First Milk outfall with the screen removed in preparation for cleaning and inspection.

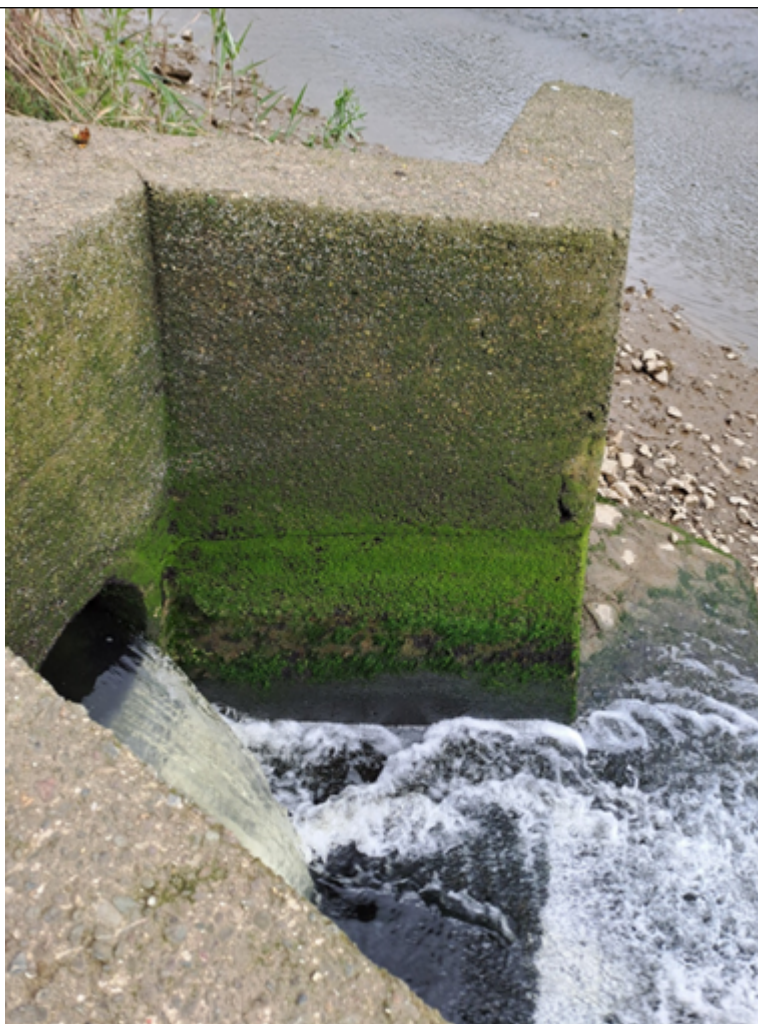
Image 02 – Adjacent DCWW outfall running at full bore.

The First Milk outfall is located directly adjacent to the Dŵr Cymru Welsh Water (DCWW) outfall which discharges from the Merlin's Bridge Sewage Treatment Works (STW). The discharge from the First Milk outfall had been stopped to allow the inspection and cleaning to occur, the DCWW outfall appeared to be discharging at full bore.

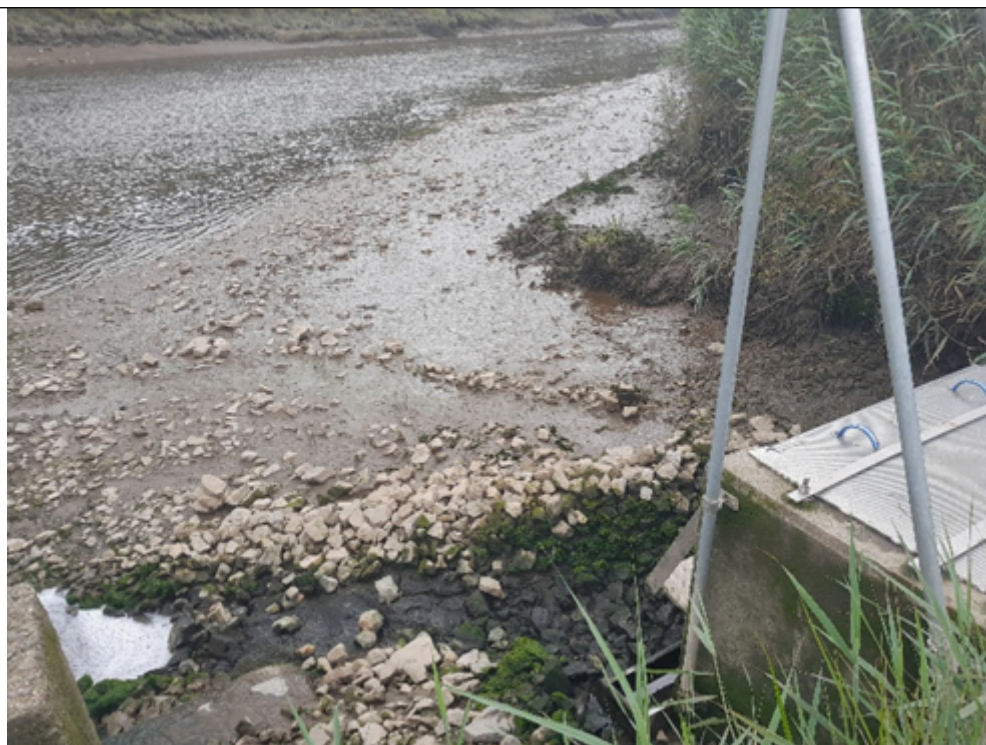
Weather conditions were dry and overcast at the time of the inspection, the tide was low. The banks and intertidal areas surrounding the outfall were observed to be clear with no evidence of any residual deposits or materials that had escaped the screen.

Image 03 – No evidence of any material on the banks in the vicinity of the outfall.

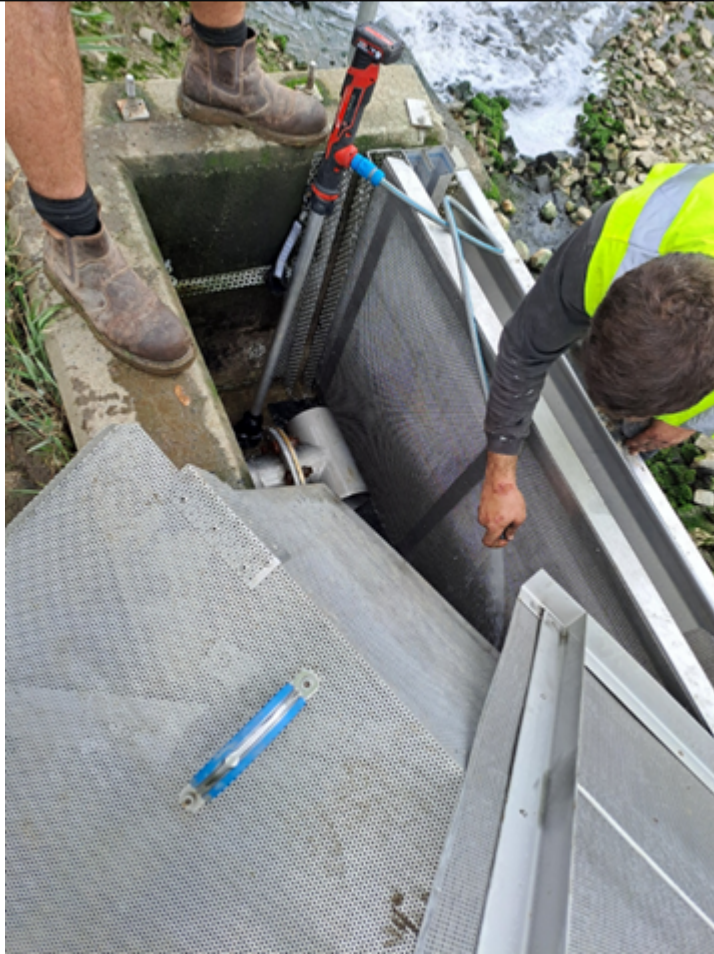
There was some rubbish above the outfall, which could be attributed to members of the public undertaking fishing activities. No odours were detected emanating from the First Milk outfall. NRW officers observed the operatives contracted by First Milk undertaking the routine cleaning/inspection of the screen. The screen appeared to be clean with very minimal material collected, the majority of which appeared to be leaves and other detritus, with an insignificant amount of biofilm. This material was removed from the screen and placed into a bucket to be weighed for the reporting to NRW.

Image 04 – Operators flushing the screen prior to collecting the material.

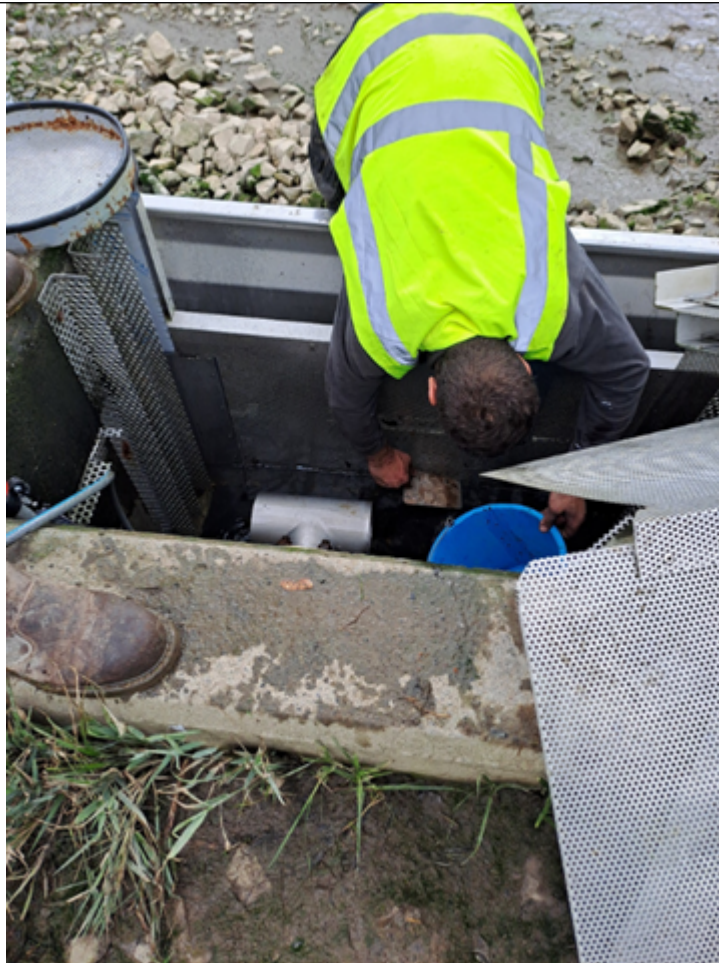
Image 05 – Operators collecting the material accumulated on the screen to be weighed for reporting.

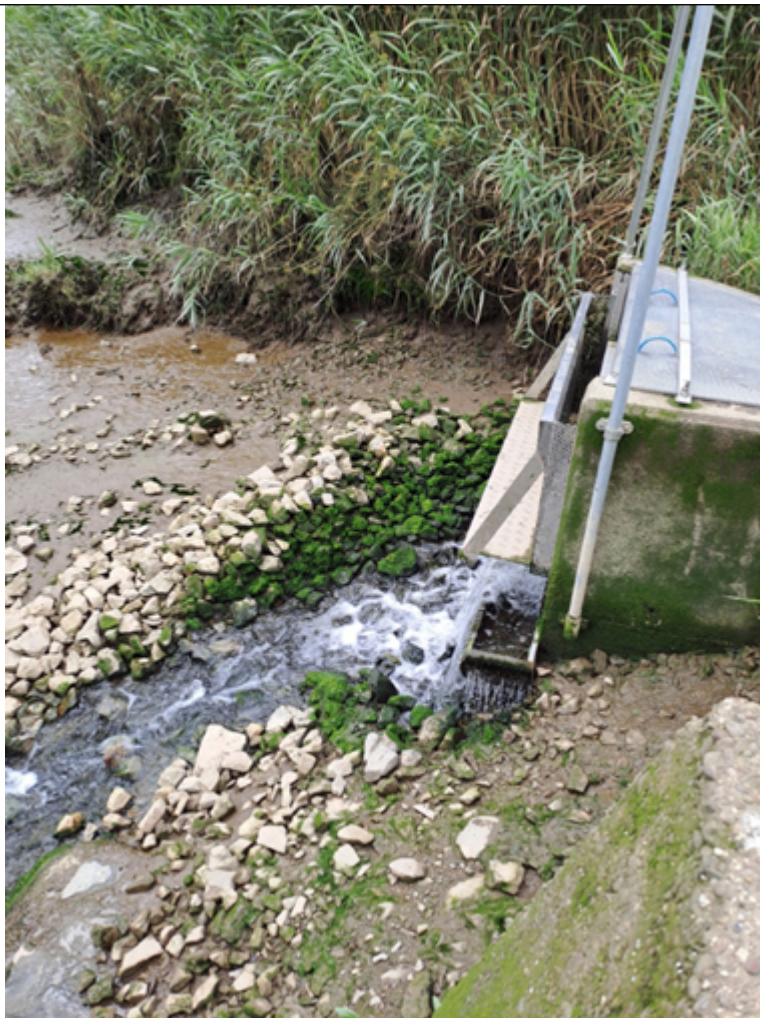
It was evident that much consideration had been given to the design and engineering of the screen and outfall surround, it appeared to be effective at capturing and containing any material from the outfall pipe and withstanding the tough conditions of the intertidal environment. Following the cleaning, the screen was reassembled and securely fastened. First Milk discharge was then ramped back up to full bore. The discharge from the First Milk was observed to be clear with no identifiable odours. First Milk have placed a camera above the outfall to enable monitoring of the discharge 24/7. A live video feed is then able to be observed by the ETP operators and remotely by First Milk staff.

Image 06 – Screen reassembled, and flow returned to normal rate.

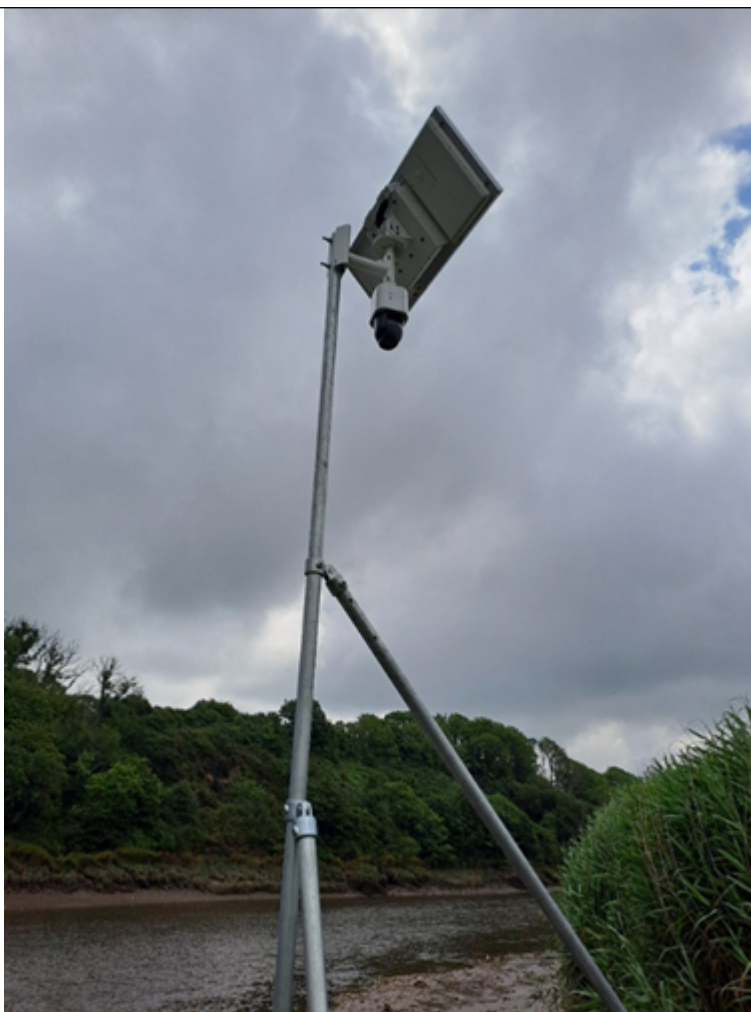
Image 07 – CCTV camera positioned above the First Milk outfall for 24/7 monitoring.

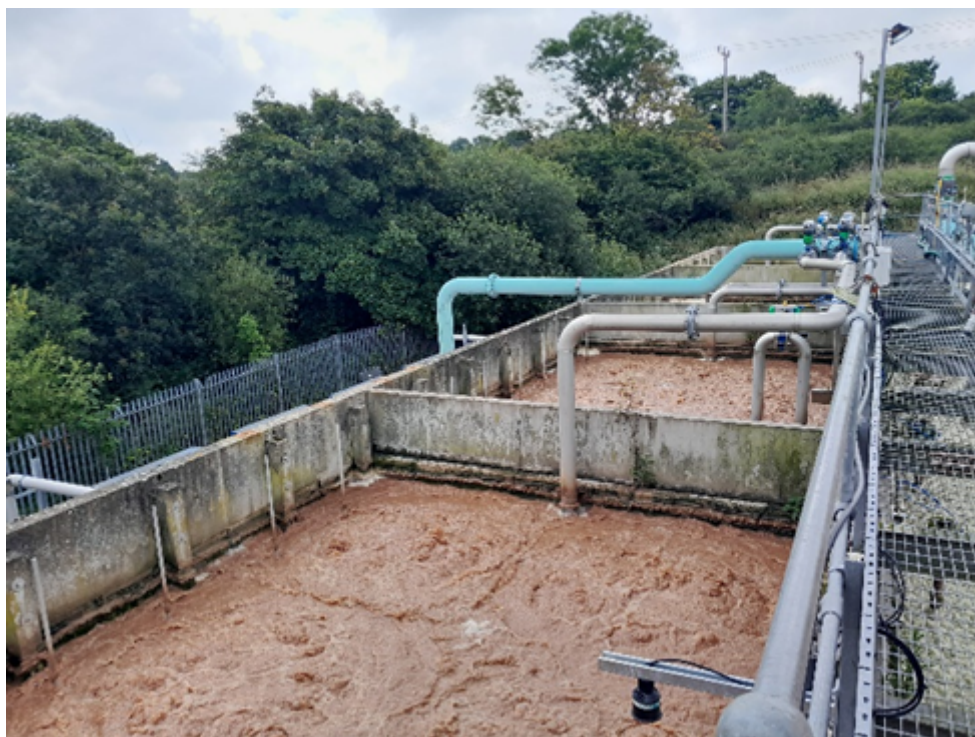
The First Milk ETP is operated by Aqueous Operations Limited. AOL representatives provided an overview of the MBR installation, commissioning, and operation. There are four cells/bays each with 6 MBR's in place. All 24 MBRs were observed to be operational, AOL representatives then explained to NRW officers how the filters operate and how the system is cleaned, monitored, and maintained. The first Clean in Place (CIP) of the MBR filters was undertaken on the 15th of May 2024, with the second CIP cycle occurring around seven weeks later. There is a cleaning schedule in place with each cell being cleaned on rotation every 6 weeks. The MBRs installed at the First Milk are engineered to have a lifespan of approximately 10 years with the implementation of a cleaning and maintenance schedule. Each pair of MBRs have a designated sample point located behind the cells. A sample of the water was taken from one of the sample points with the sample observed to be clean and free from contaminants and suspended solids.

Image 08 – Recently commissioned MBR filters operational.

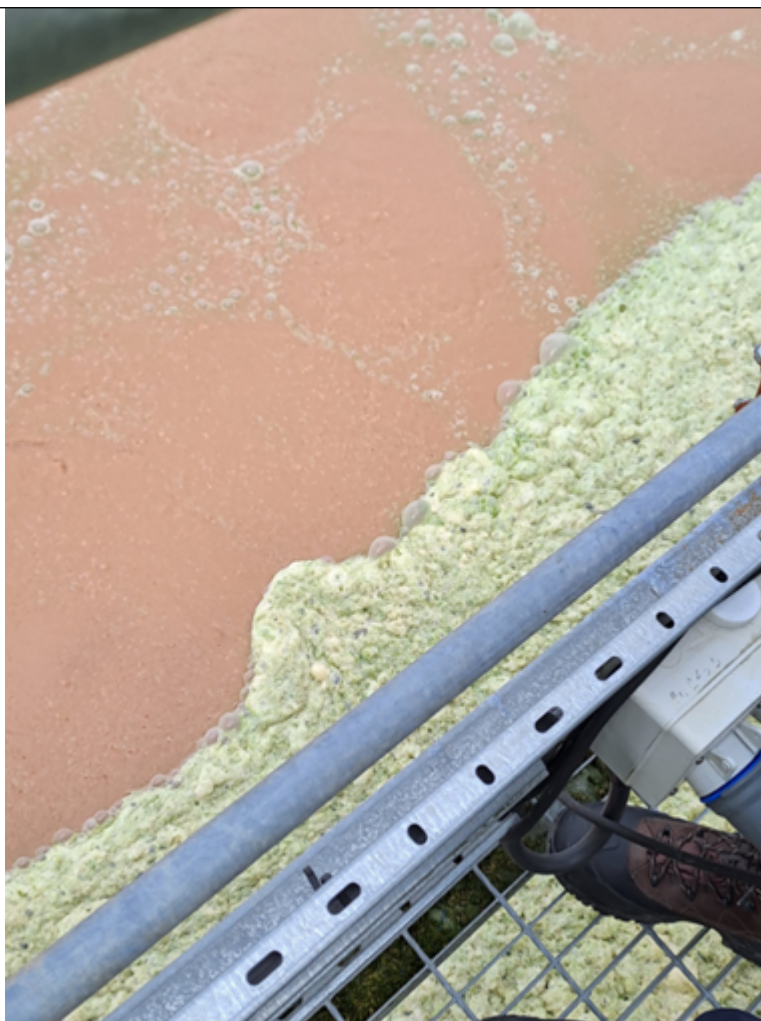
Green algae was observed on the surface of the effluent within the aeration lanes. AOL stated that the algae dissipates usually in the evening when the ambient temperature drops. They also informed NRW officers that they had engaged in discussions with ETP specialists on the algae, who had confirmed that is not thought to be an issue or likely to lead to any issues. AOL also stated that there was no need to add any chemicals or to provide any further treatment. The final effluent from the ETP remains within quality parameter limits set out in their environmental permit. Further investigations into the algae may be required should the issue persist, worsen, or further concerns come to light.

Image 09 – Algae observed on the surface of the aeration lanes.

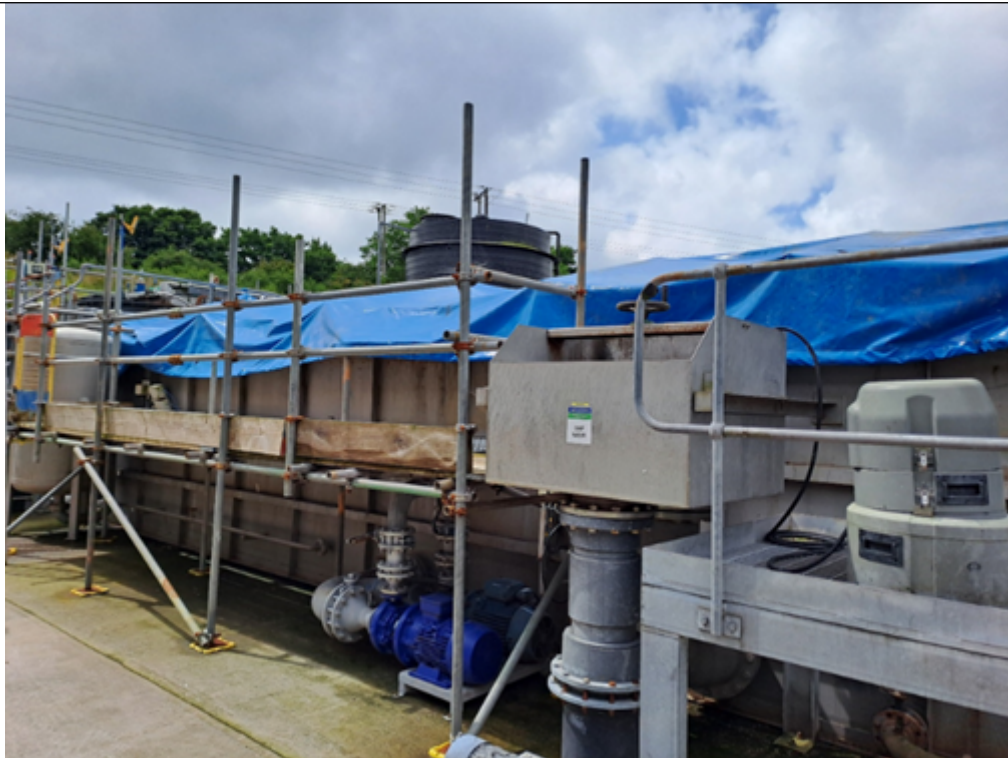
The operator explained that the secondary DAF plant was now redundant, it is being retained on site for the time being but there are no plans to recommission it. One of the two redundant Mecana filters had also been retained onsite. The primary DAF was also observed by NRW officers. There was a plastic cover pinned over the top of the primary DAF, used to contain any potential odour emissions.

Image 10 – Primary DAF with plastic cover
