Compliance Assessment Report CAR_NRW0045205

Permit being assessed: AW1000501

For: Beulah Wastewater Treatment Works, held by DWR CYMRU CYFYNGEDIG
At: Track past '2 Glancammarch', Beulah, Llanwrtyd Wells, LD5 4UT.

Type of assessment carried out: Site Inspection, Reason: Routine.

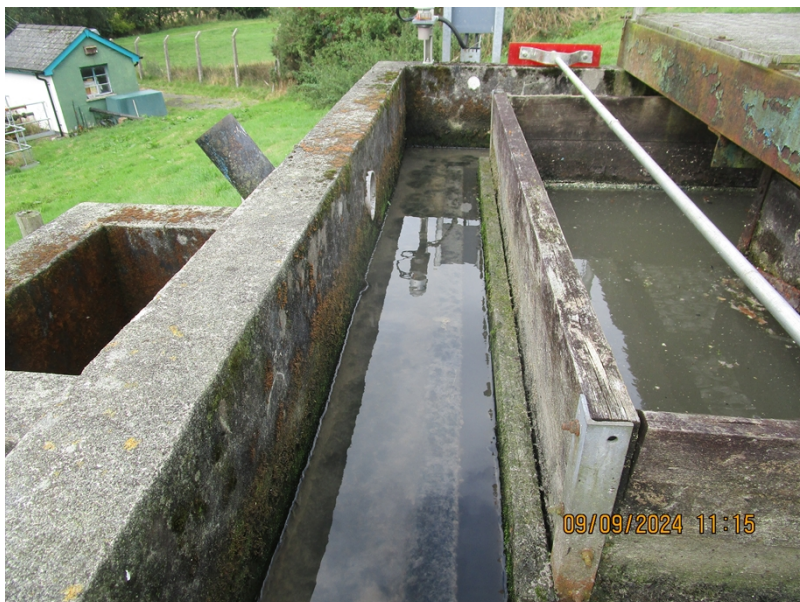
The primary settlement tank at the works is an older square shaped tank, with wooden scum boards for retaining solids. Overall, the settlement system appeared to be operating effectively and was preventing solids from passing through to the next stage of treatment. There was some sewage fungus present on the base of the channels outside of the retention boards; however, which may indicate increased nutrient levels, but is not a sign of any noncompliance at this point.

There is an overflow outlet at the works, the overflow is a hard-set pipe located on the outside wall of the primary tank. Once levels within the primary tank reaches the pipe level the works will start flowing through the overflow channel to overflow tanks onsite. The overflow channel is a shared channel with the sludge return channel. Leading into three separate brick tanks, with manually operated penstocks for directing flow to overflow storage or sludge storage. There is a level sensor located on the primary tank to monitor when flows reach the overflow setting.

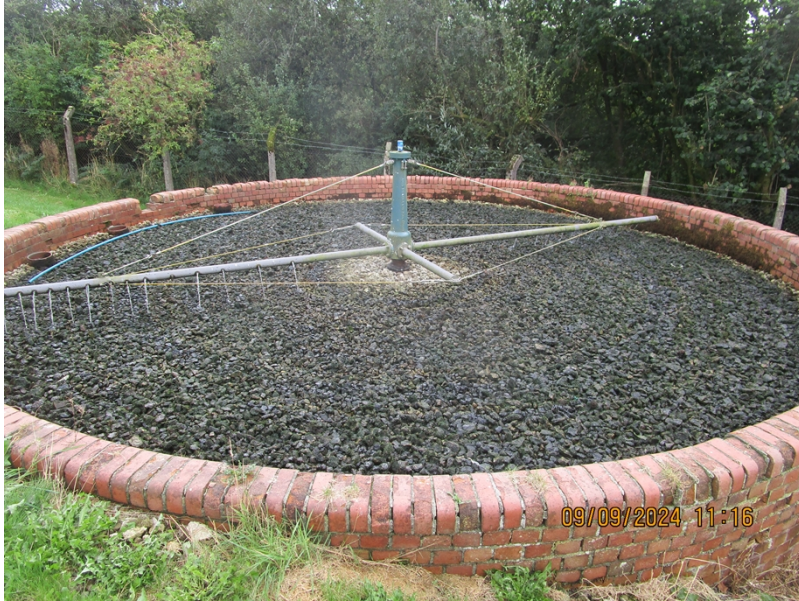
Filter Bed

The works contains a single filter bed containing stone media. The rotation arm was moving free and unhindered. There were no signs of ponding or dry patches across the filter bed. A metal bund has been installed on the downhill side of the filter bed. There is a centre column release valve present on the filter bed, this was not in use at the time of inspection.

Overall, the filter bed appeared to be operating effectively.

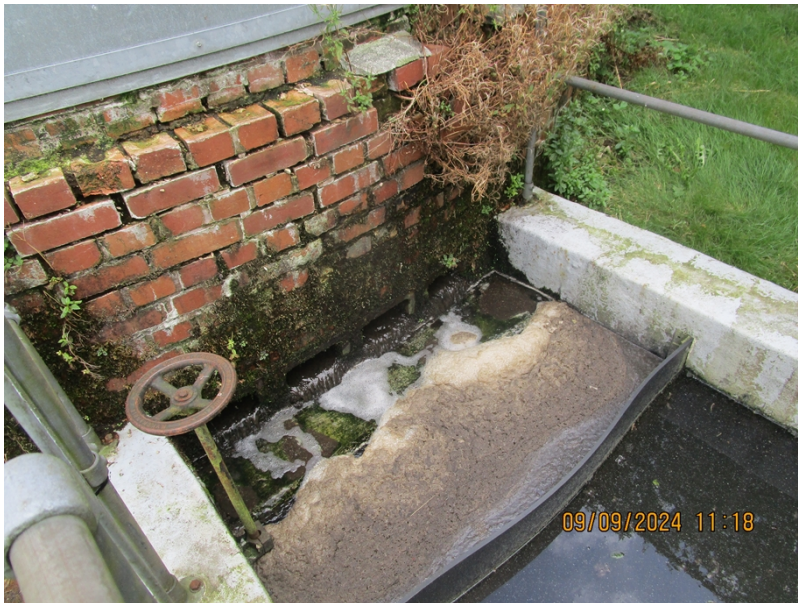
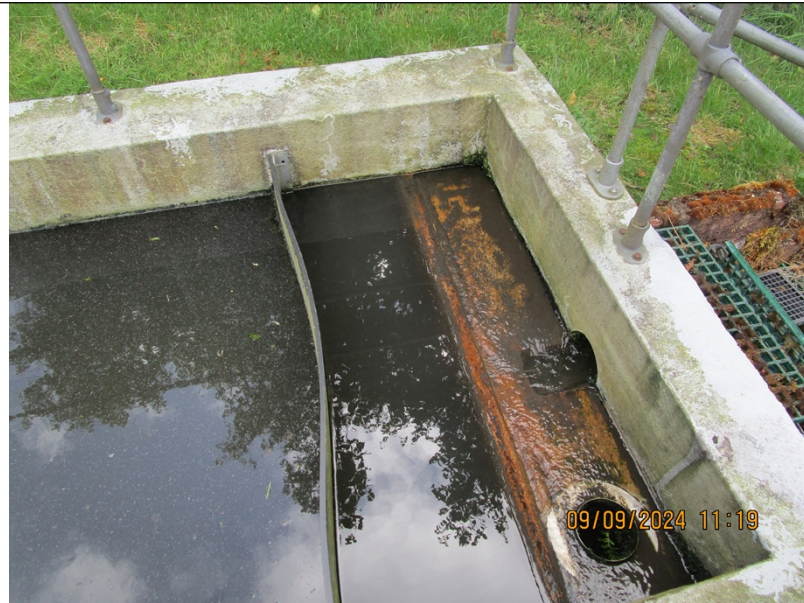
Humus Tank

The outfall from the filter bed, flows directly into a single rectangular humus tank with retention boards to hold back solids from passing through. There was a build-up of foam present at the outfall from the filter bed, which was being retained by the first set of retention boards. This may be a sign of high nutrient load within the filter bed effluent. The effluent from the hummus tank was clear and there were no signs of significant solids or sewage fungus around the outfall.

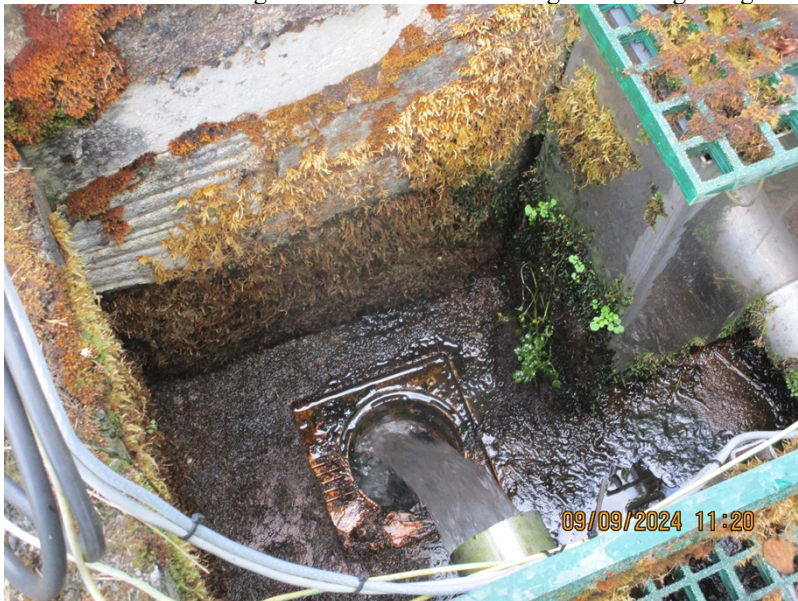
Outfall and Sampling point

The final effluent from the humus tank passes through an MCERTS flow meter, which appeared to be operating as required and accessible for inspection. It is located just before a bend in the pipe, which is not ideal but also not a breach of permit conditions. The sample point is clearly marked with appropriate signage including the sample point number. The effluent was running clear and there were no signs of sewage fungus or significant solids being present.

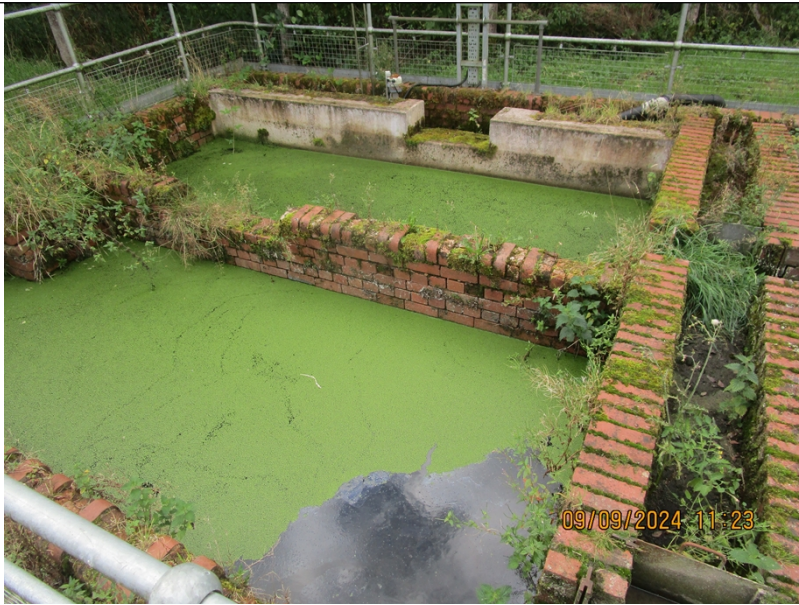
Overflow Tanks and Sludge storage.

The overflow storage tanks, and sludge tanks are of an open brick construction. The flow is diverted to overflow, or sludge return tanks manually by moving penstocks on the inlet channel. Concrete walls have been installed to prevent leakage from the tanks, as a result of actions from a previous inspection (2021). The additional concrete appears to be effectively preventing any leakage from the tanks into the storm channel.

The overflow tanks contained water but was well below the level where it would discharge via the storm channel. There was a coverage of duckweed present in the overflow tanks. There is an EDM sensor operating within the second overflow tank, to monitor when discharges are made from the overflow system. There is a COPA sack present within the storm outfall for removal of any larger solids or rag, this appeared clear of any blockages.
