| Location Plan: | <b>Avalanche East Sea Wall</b><br>Assessment Date: 20/04/2021 | |
| | Structure Reference: | <b>W2291320</b> |

# COASTAL ASSET CONDITION SURVEY REPORT

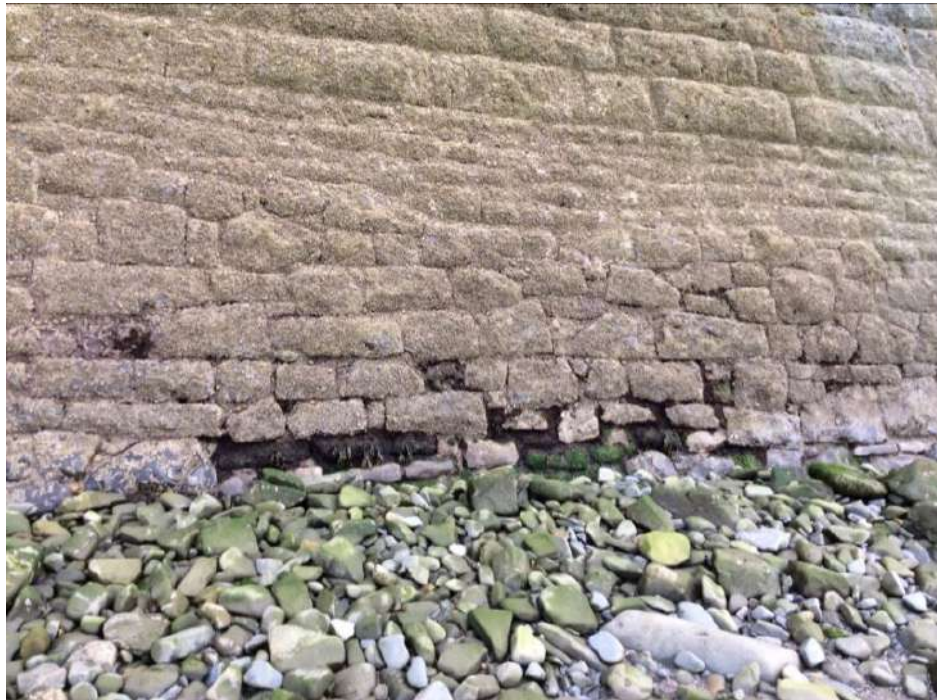
**Photo number: 71**

**Section A**  
**Wall section**  
**Defect Ref: D1**  
**Description:** Open joints. Between the 2020 and 2021 examinations, there is no change.

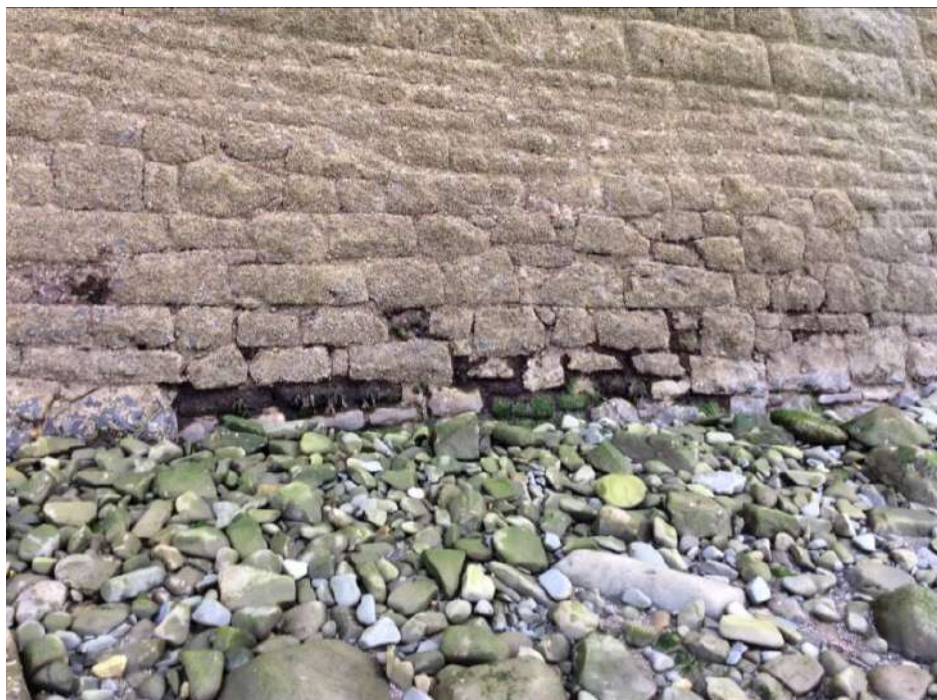
**Photo number: 72**

**Section A**  
**Wall section**  
**Defect Ref: D1**  
**Description:** Open joints. Between the 2020 and 2021 examinations, there is no change.

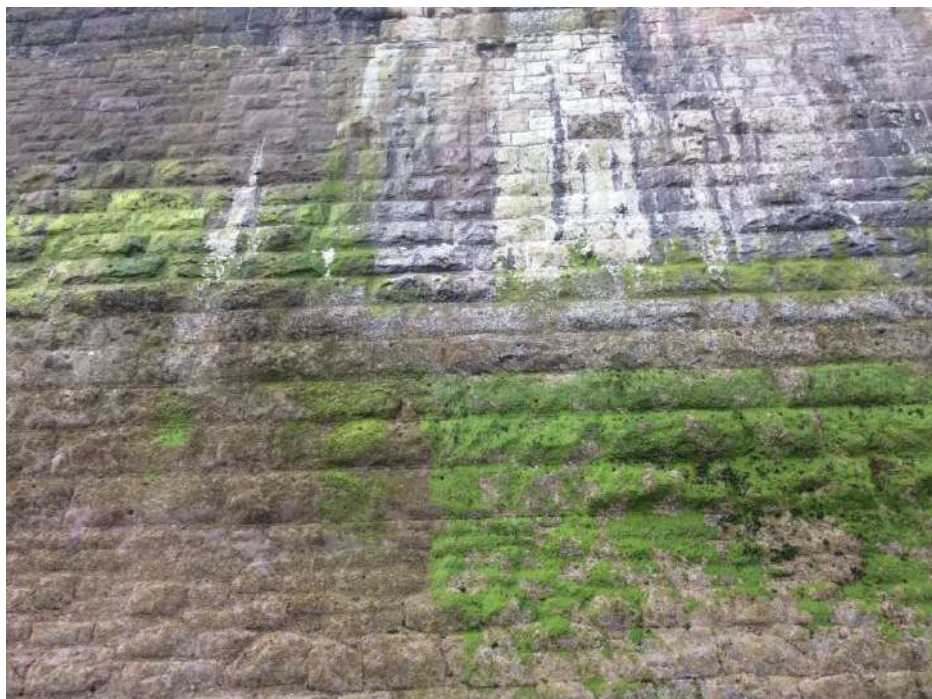
**Photo number: 82**

**Section A**  
**Wall section**  
**Defect Ref: D1**  
**Description:** Open joints. Between the 2020 and 2021 examinations, there is no change.

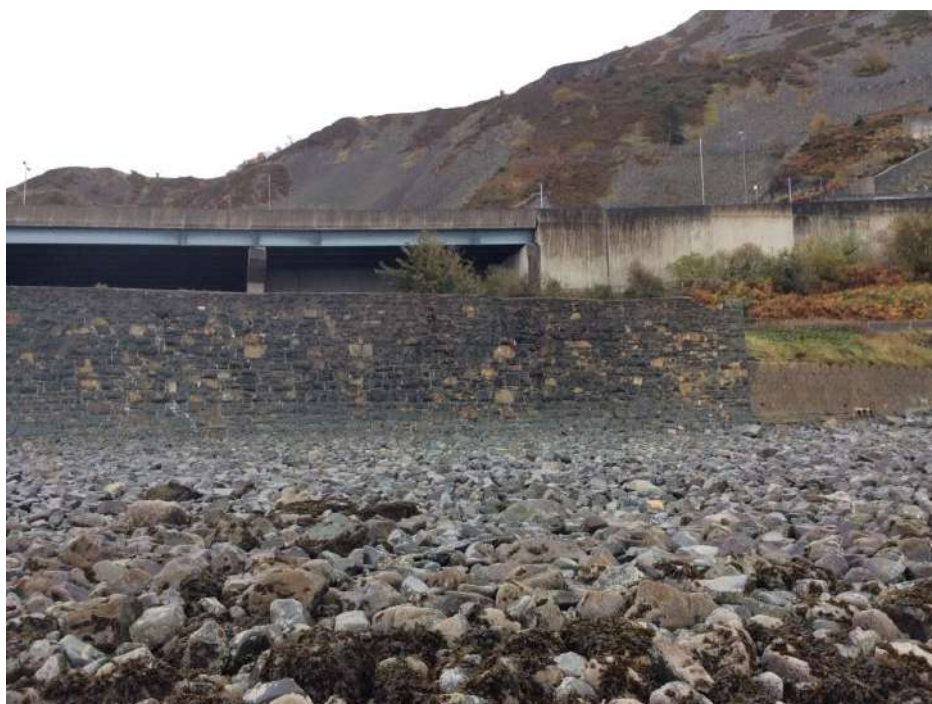
| Defect Ref No. | Defect Location (NGR) | Major Element | Minor Element | Photo Ref | Severity | Probability | Risk Score | Below MHWS | Defect Group | Defect Description | Recommendations | Defect Priority |
|---|---|---|---|---|---|---|---|---|---|---|---|---|
| D1 | N/A | Wall | Wall section | 104, 102, 42, 80 | 2 | 4 | 8 | True | N/A | Open joints. 600mm deep near the repair. Between the 2020 and 2021 examinations, no change to defects. Open joints are still present with some minor loss of blocks | Re-point open joints | 6 |

**Section B**  
**Wall section**  
**Defect Ref: D1**  
**Description:** Open joints. 600mm deep near the repair. Between the 2020 and 2021 examinations, no change to defects. Open joints are still present with some minor loss of blocks  
**Photo number: 104**

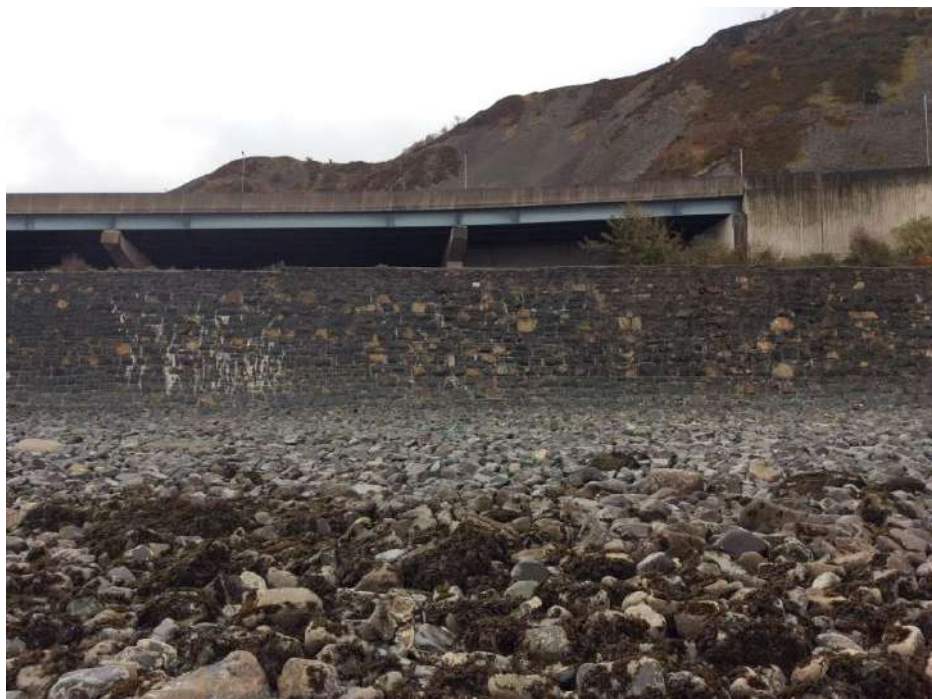
| Defect Ref No. | Defect Location (NGR) | Major Element | Minor Element | Photo Ref | Severity | Probability | Risk Score | Below MHWS | Defect Group | Defect Description | Recommendations | Defect Priority |
|---|---|---|---|---|---|---|---|---|---|---|---|---|
| | 270563, 376305 CNH3 229.125 | Wall | Wall section | 103 | 2 | 4 | 8 | True | N/A | Missing blocks around the outfall | Replace missing blocks, and further investigation of the services and source of water seepage | 4 |

**Section B**  
**Wall section**  
**Defect Ref: D2**  
**Description:** Missing  
blocks around the  
outfall  
**Photo number: 103**

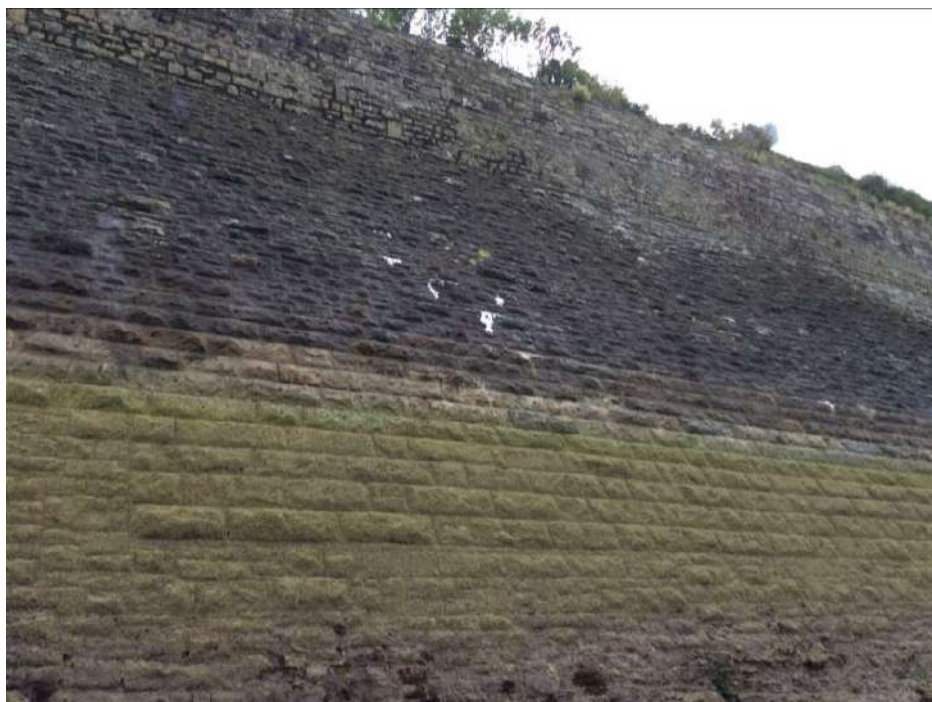
**Photo number: 61**

**Section A**  
**Wall section**  
**Defect Ref: D3**  
**Description:** Mineral  
seepage. Between  
the 2016 and 2020,  
and 2020 and 2021  
examinations, there  
has been no change.

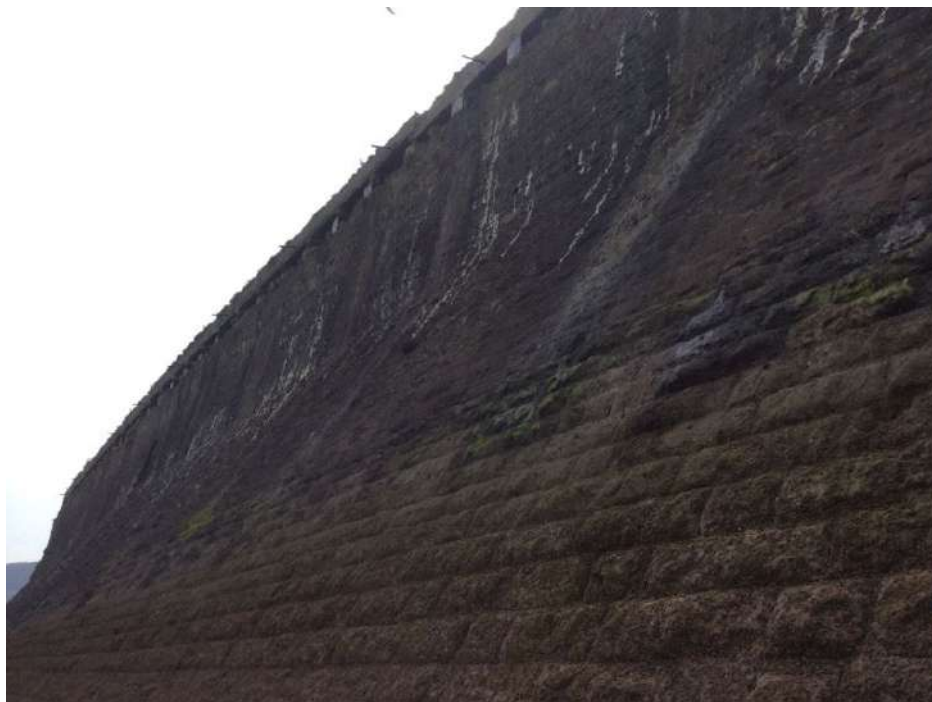
**Photo number: 84**

**Section A**  
**Wall section**  
**Defect Ref: D3**  
**Description:** Mineral seepage. Between the 2016 and 2020, and 2020 and 2021 examinations, there has been no change.

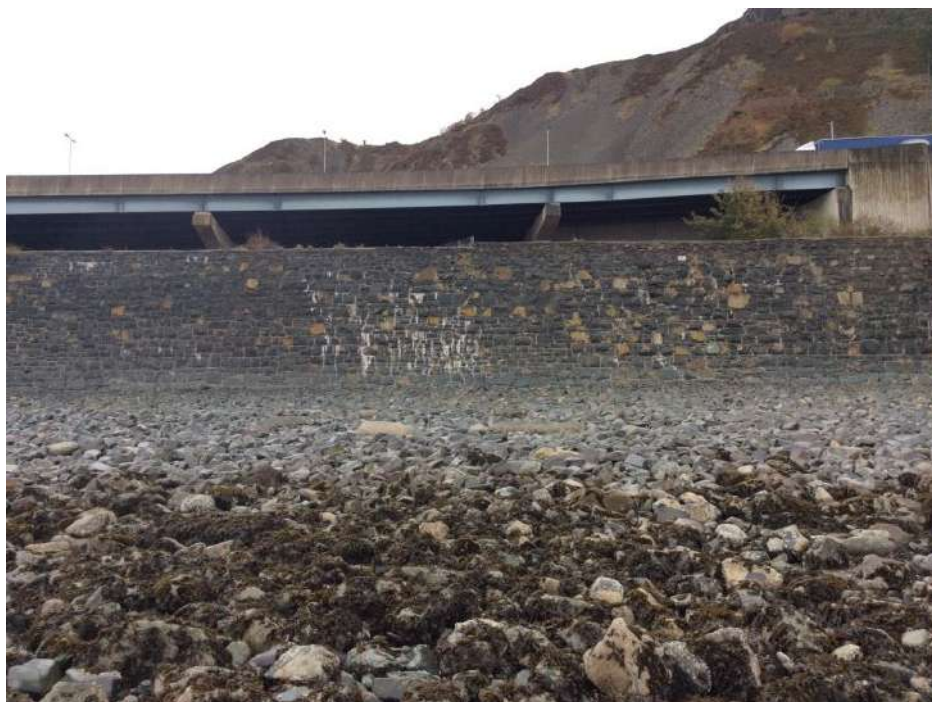
**Section B**  
**Wall section**  
**Defect Ref: D3**  
**Description:** There is mineral seepage. Between the 2016 and 2020, and 2020 and 2021 examinations, there has been no change.

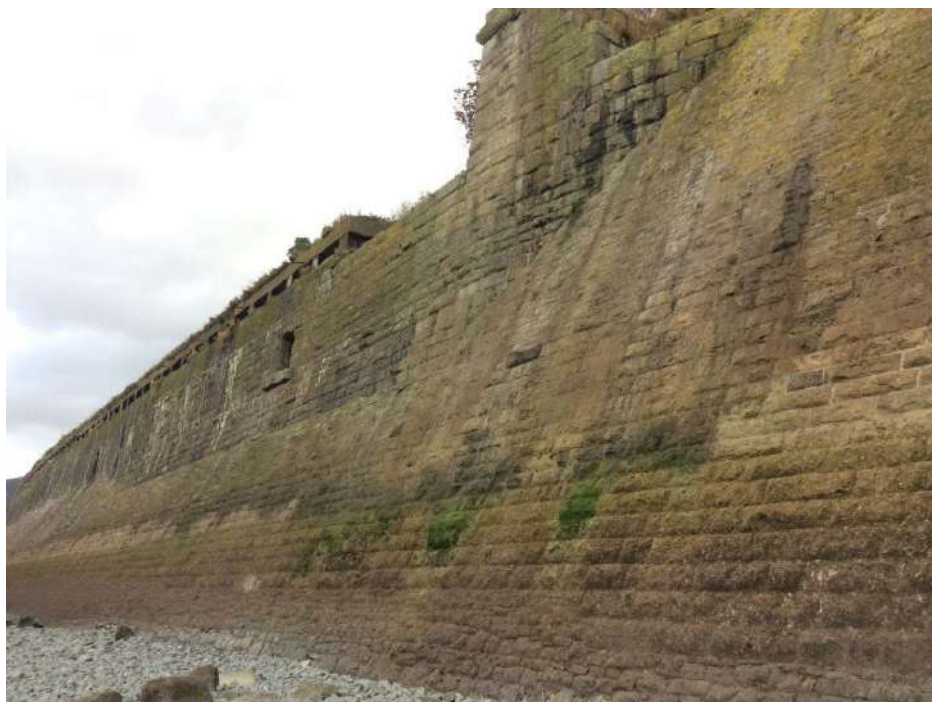
**Photo number: 106**

Seepage through the wall. Between the 2020 and 2021 inspections, there has been no change.

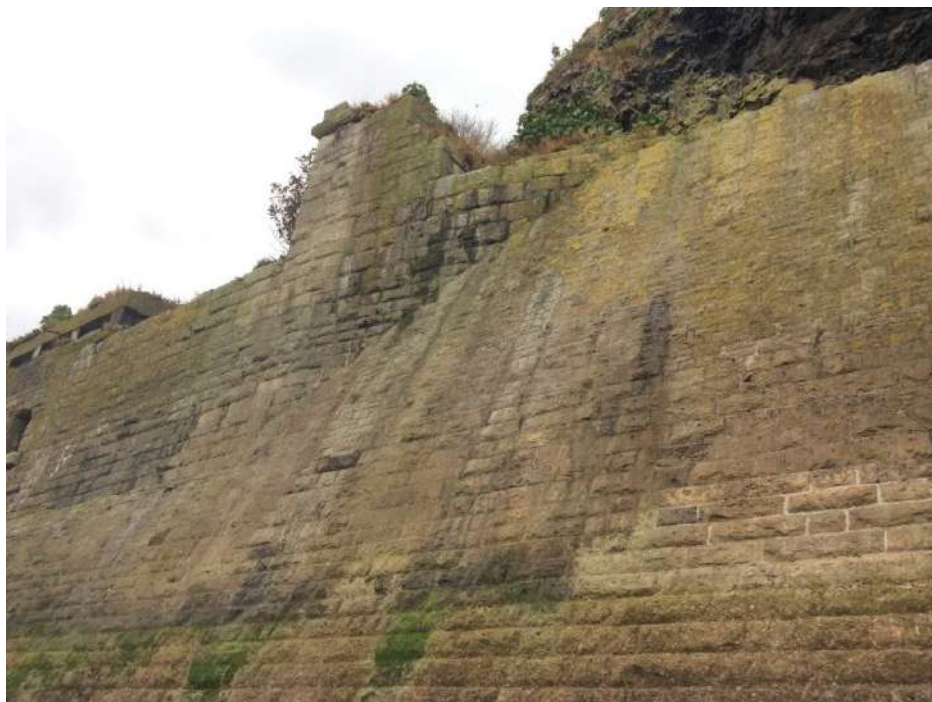
**Section A**  
**Wall section**  
**Defect Ref: D4**  
**Description:**  
Seepage through the wall. Between the 2020 and 2021 inspections, there has been no change.  
**Photo number: 108**

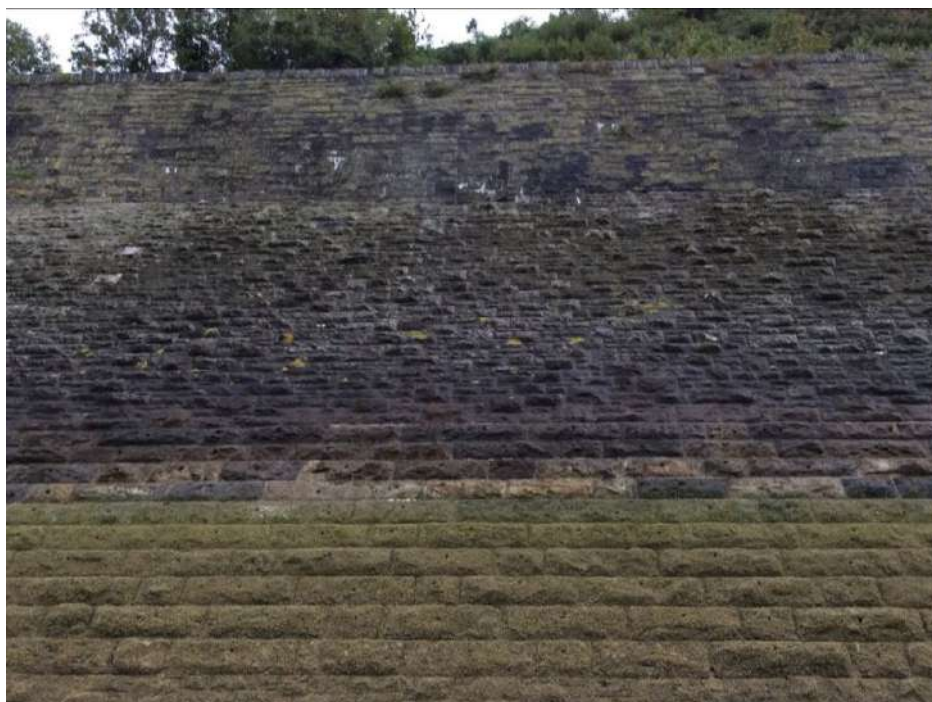
**Section A**  
**Wall section**  
**Defect Ref: D4**  
**Description:**  
Seepage through the wall. Between the 2020 and 2021 inspections, there has been no change.  
**Photo number: 63**

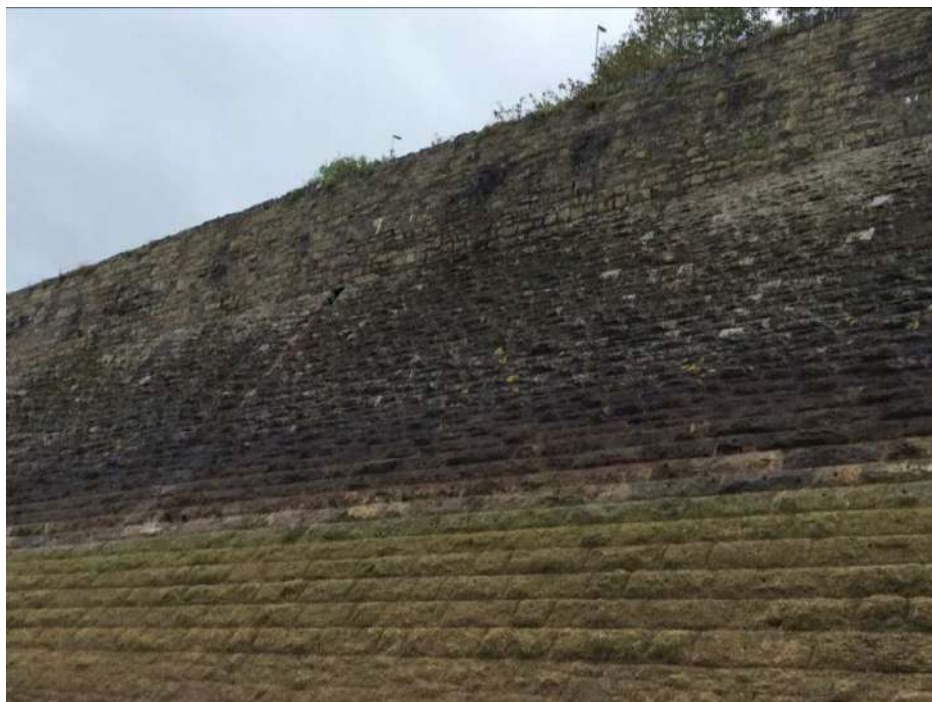
**Section A**  
**Wall section**  
**Defect Ref: D4**  
**Description:**  
Seepage through the wall. Between the 2020 and 2021 inspections, there has been no change.  
**Photo number: 64**

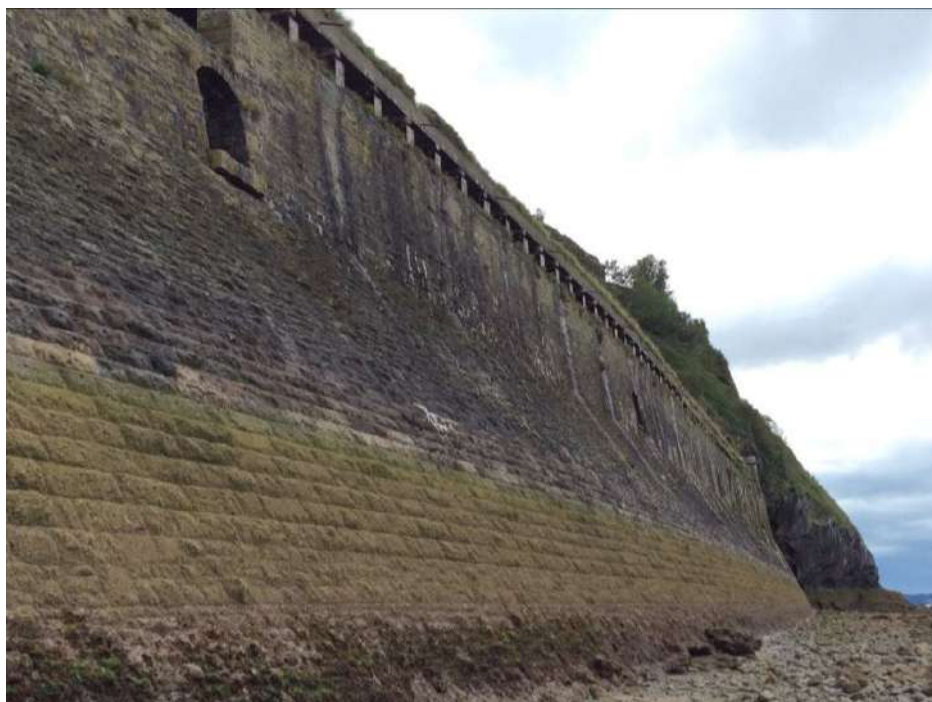
**Section A**  
**Wall section**  
**Defect Ref: D4**  
**Description:**  
Seepage through the wall. Between the 2020 and 2021 inspections, there has been no change.  
**Photo number: 65**

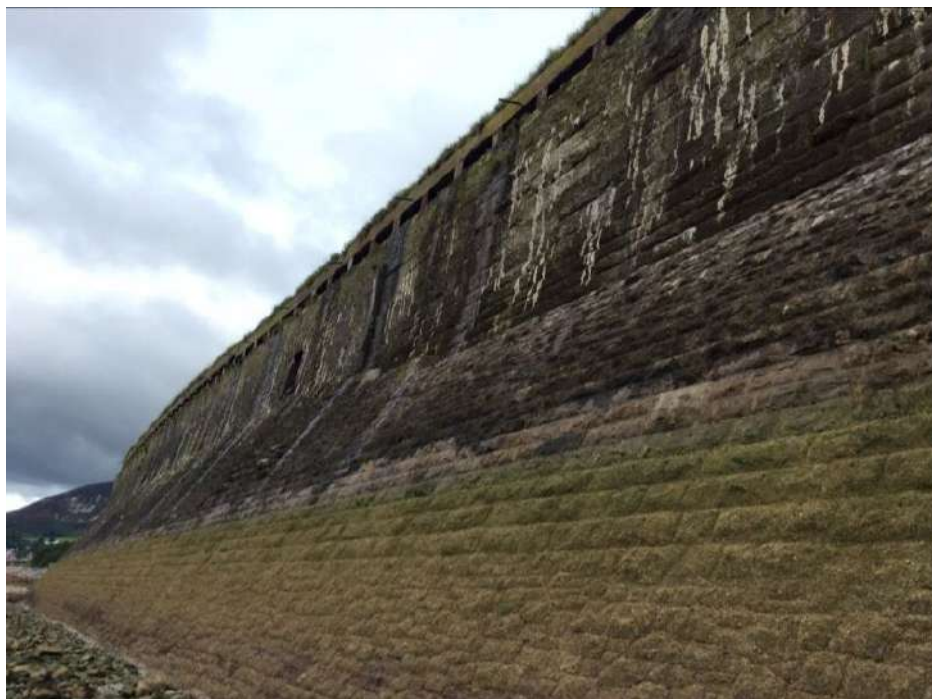
**Section A**  
**Wall section**  
**Defect Ref: D4**  
**Description:**  
Seepage through the wall. Between the 2020 and 2021 inspections, there has been no change.  
**Photo number: 73**

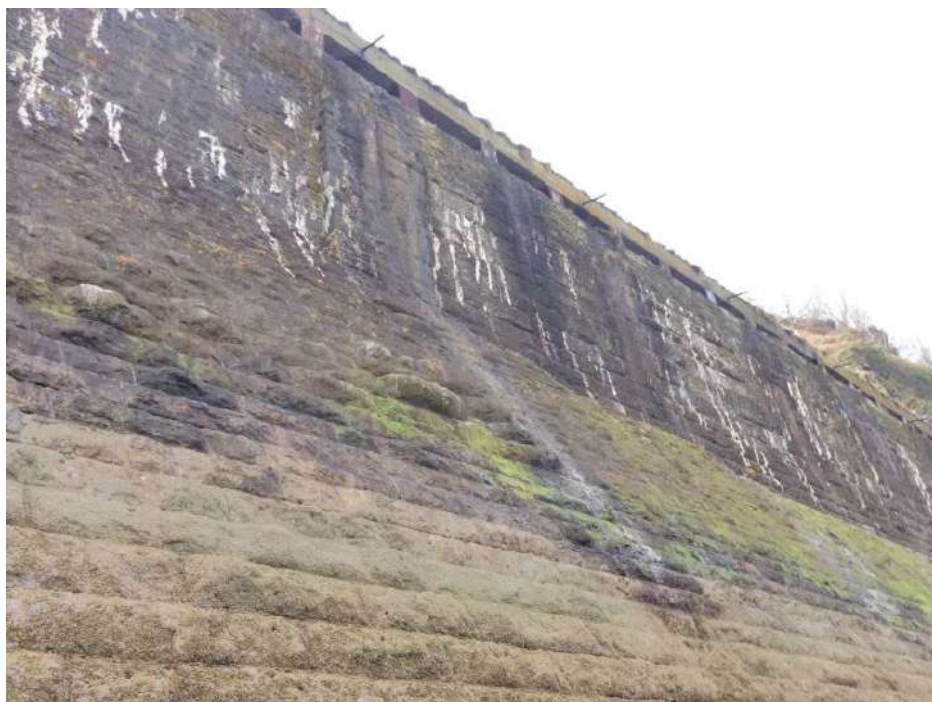
**Section A**  
**Wall section**  
**Defect Ref: D4**  
**Description:**  
Seepage through the wall. Between the 2020 and 2021 inspections, there has been no change.  
**Photo number: 85**

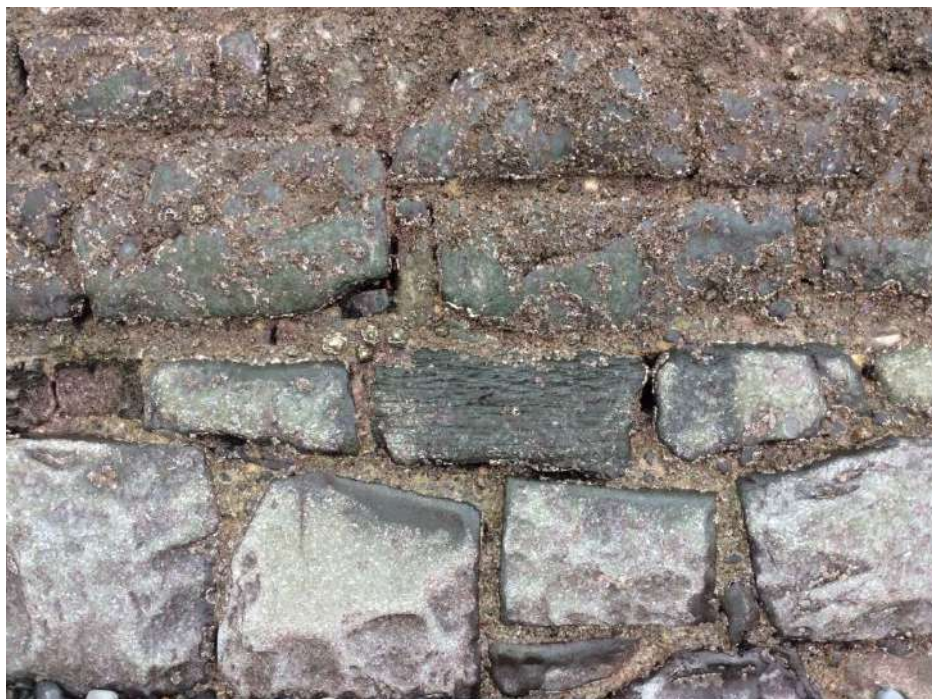
**Photo number: 109**

| Defect Ref No. | Defect Location (NGR) | Major Element | Minor Element | Photo Ref | Severity | Probability | Risk Score | Below MHWS | Defect Group | Defect Description | Recommendations | Defect Priority |
|---|---|---|---|---|---|---|---|---|---|---|---|---|
| D5 | 270127, 376253 CNH3 229.168 | Wall | Wall section | 109, 110, 123, 124, 125, 126, 135, 131, 133, 132, 134, 136, 138, 137, 58, 86 | 2 | 3 | 6 | True | N/A | Open joints. There have been some new joint pointing undertaken, however open joints at the toe were not able to be found due to probable burial from shingle material. Between the 2020 and 2021 examinations, there is no change. | Repoint open joints | 3 |

**Description:** Open joints. There have been some new joint pointing undertaken, however open joints at the toe were not able to be found due to probable burial from shingle material. Between the 2020 and 2021 examinations, there is no change.

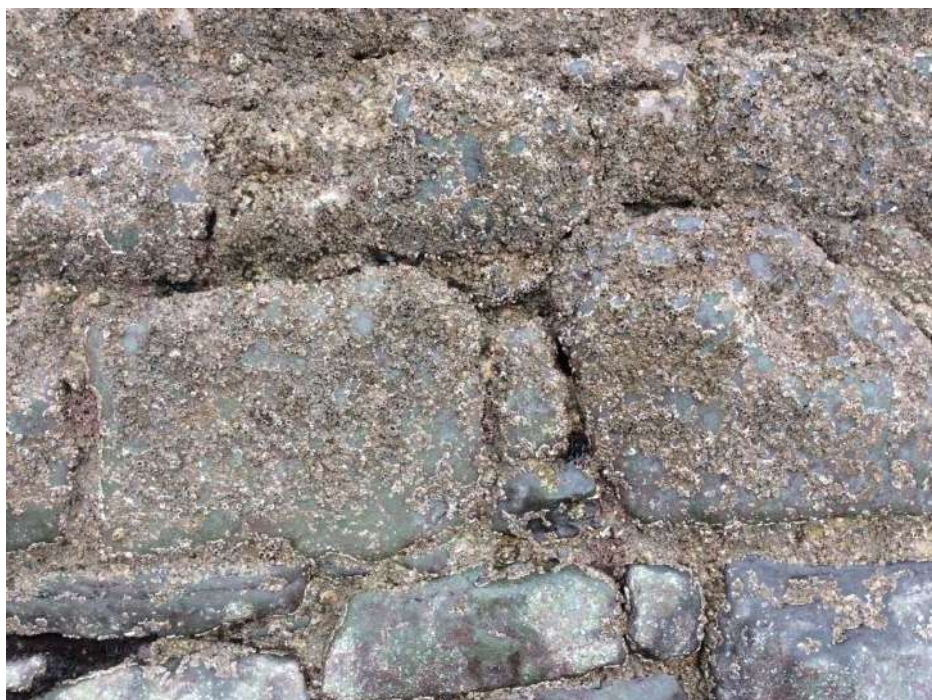
**Photo number: 110**

**Description:** Open joints. There have been some new joint pointing undertaken, however open joints at the toe were not able to be found due to probable burial from shingle material. Between the 2020 and 2021 examinations, there is no change.

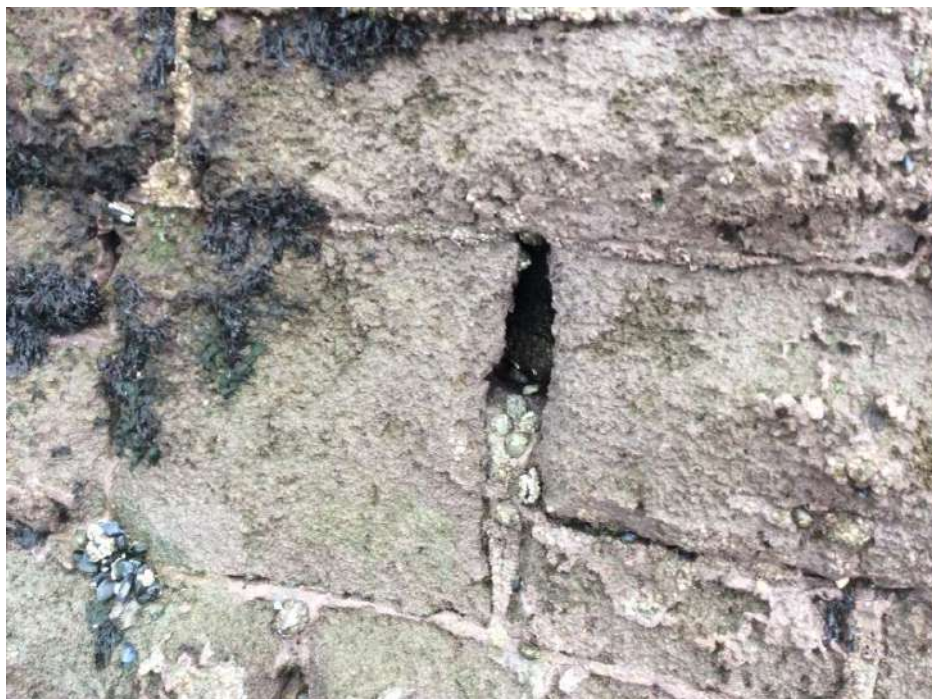
**Photo number: 134**

**Description:** Open joints. There have been some new joint pointing undertaken, however open joints at the toe were not able to be found due to probable burial from shingle material. Between the 2020 and 2021 examinations, there is no change.

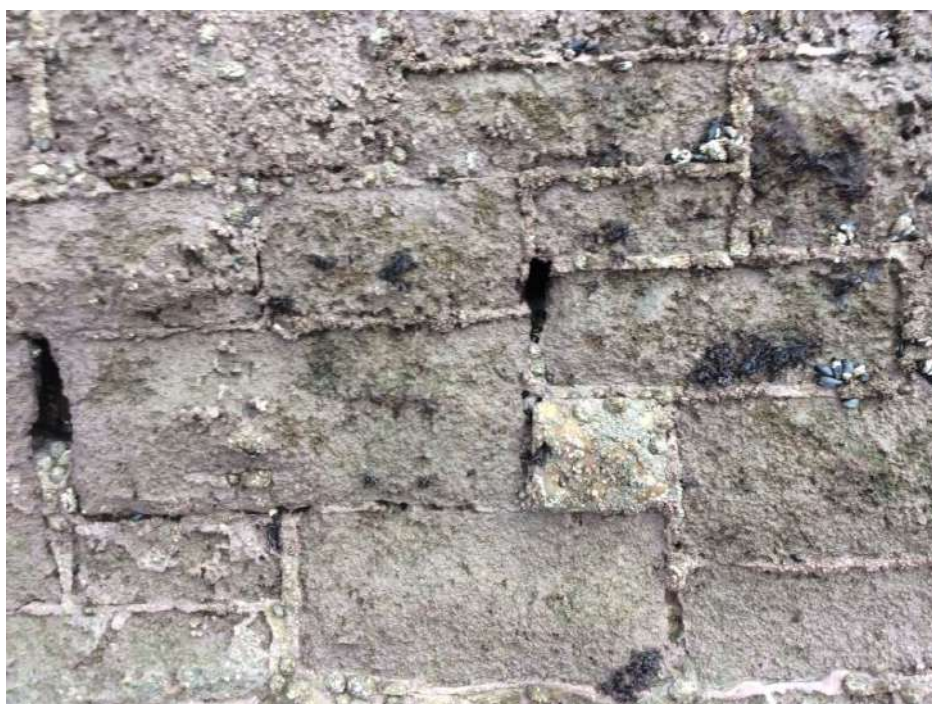
**Photo number: 136**

**Description:** Open joints. There have been some new joint pointing undertaken, however open joints at the toe were not able to be found due to probable burial from shingle material. Between the 2020 and 2021 examinations, there is no change.

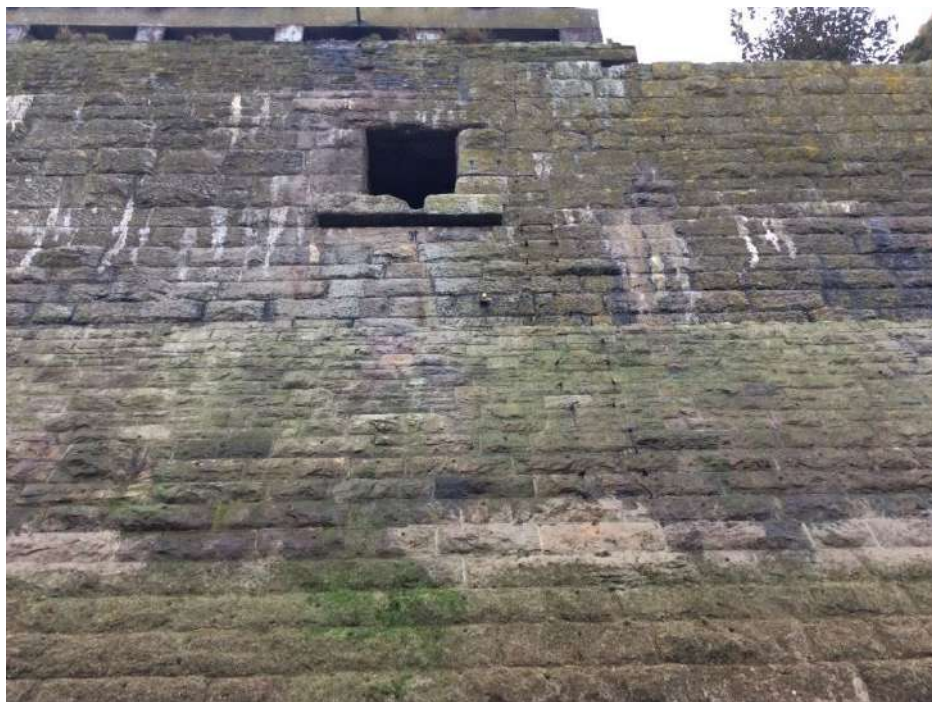
| Defect Ref No. | Defect Location (NGR) | Major Element | Minor Element | Photo Ref | Severity | Probability | Risk Score | Below MHWS | Defect Group | Defect Description | Recommendations | Defect Priority |
|---|---|---|---|---|---|---|---|---|---|---|---|---|
| D6 | 270138, 376255 CNH3 229.166 | Wall | Wall section | 111, 112, 122, 130, 129, 150, 149, 55, 66, 81 | 2 | 4 | 8 | True | N/A | Old corroded access ladder. Between the 2020 and 2021 examinations, there has been no change all the ladder points are corroded along with the extent of the asset. | Consider replacing the ladder | 1 |

**Section A**  
**Wall section**  
**Defect Ref: D6**  
**Description:** Old corroded access ladder. Between the 2020 and 2021 examinations, there has been no change all the ladder points are corroded along with the extent of the asset.  
**Photo number: 111**

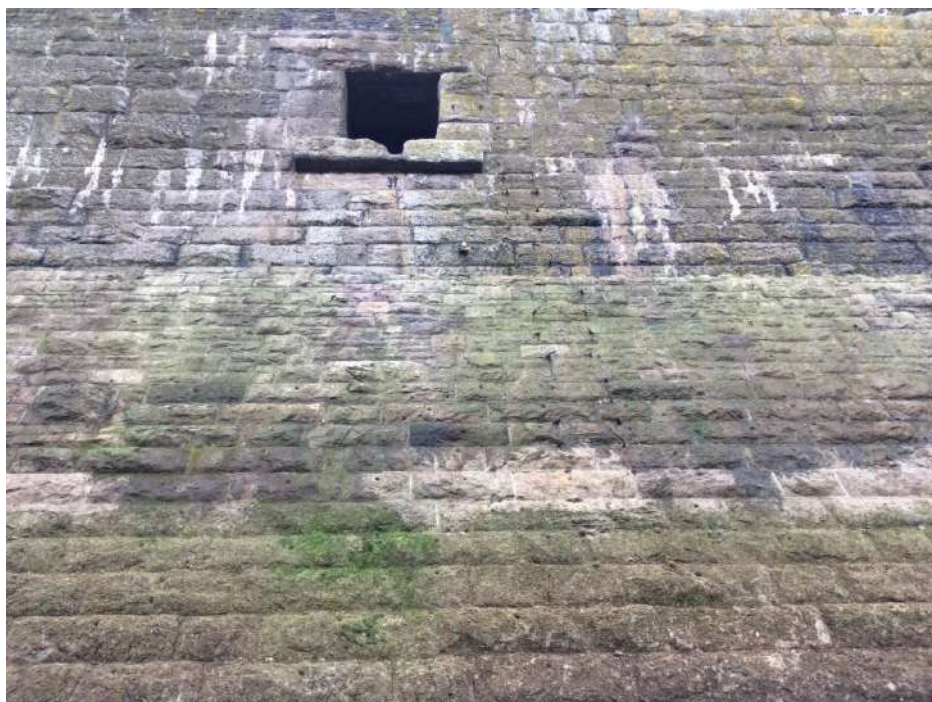
**Section A**  
**Wall section**  
**Defect Ref: D6**  
**Description:** Old corroded access ladder. Between the 2020 and 2021 examinations, there has been no change all the ladder points are corroded along with the extent of the asset.  
**Photo number: 112**

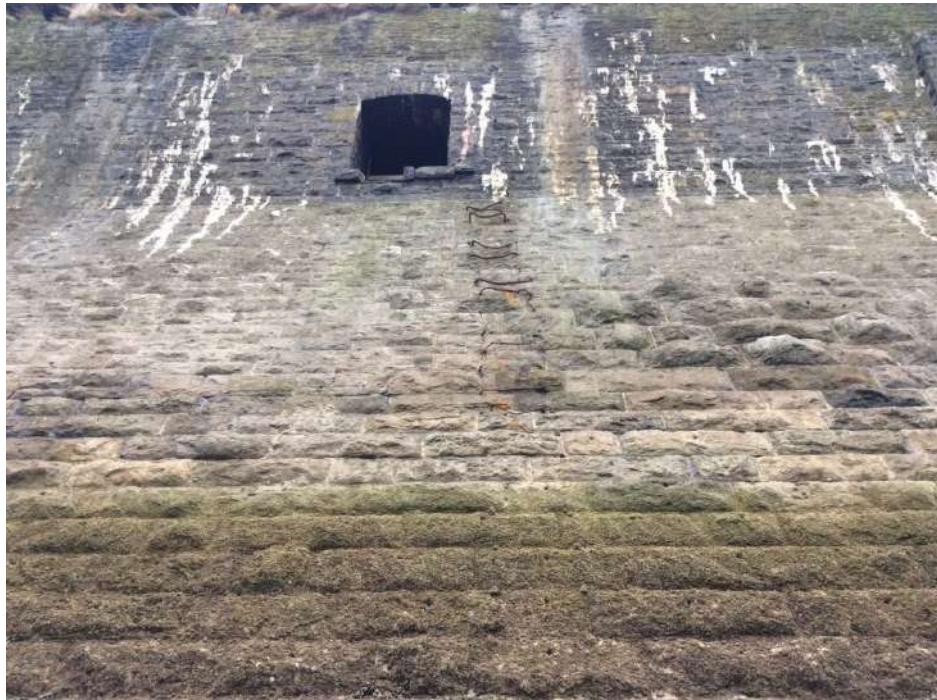
**Section A**  
**Wall section**  
**Defect Ref: D6**  
**Description:** Old corroded access ladder. Between the 2020 and 2021 examinations, there has been no change all the ladder points are corroded along with the extent of the asset.  
**Photo number: 122**

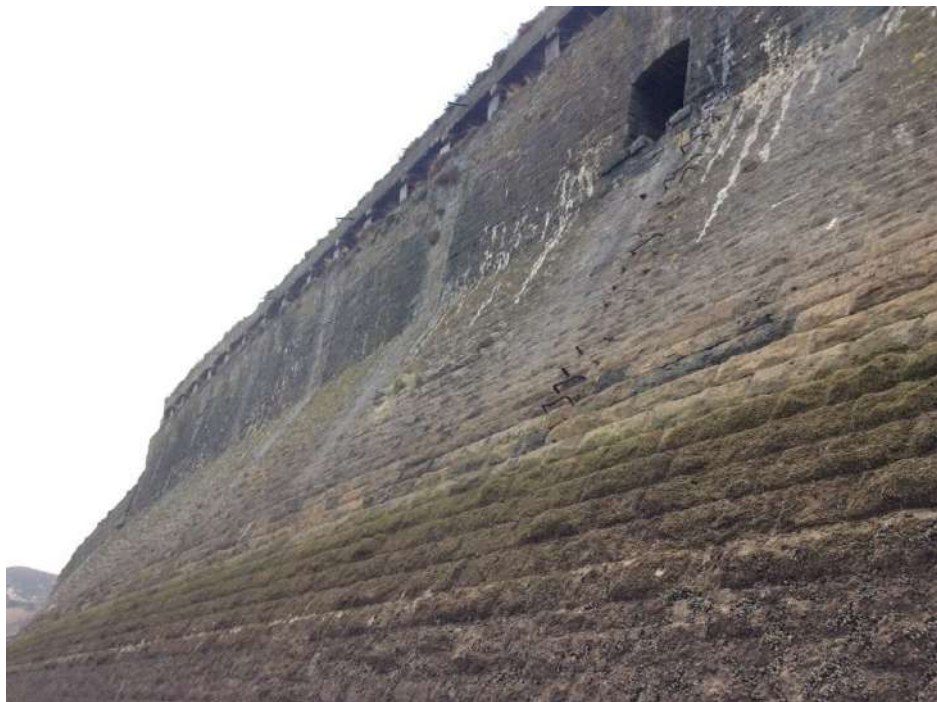
**Section A**  
**Wall section**  
**Defect Ref: D6**  
**Description:** Old corroded access ladder. Between the 2020 and 2021 examinations, there has been no change all the ladder points are corroded along with the extent of the asset.  
**Photo number: 130**

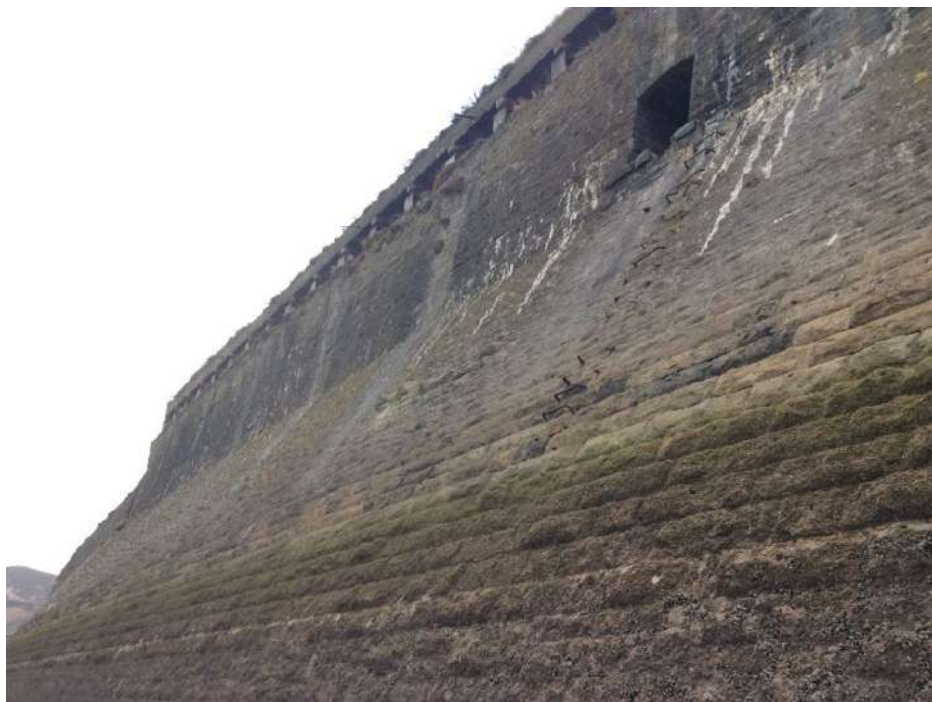
**Section A**  
**Wall section**  
**Defect Ref: D6**  
**Description:** Old corroded access ladder. Between the 2020 and 2021 examinations, there has been no change all the ladder points are corroded along with the extent of the asset.  
**Photo number: 129**

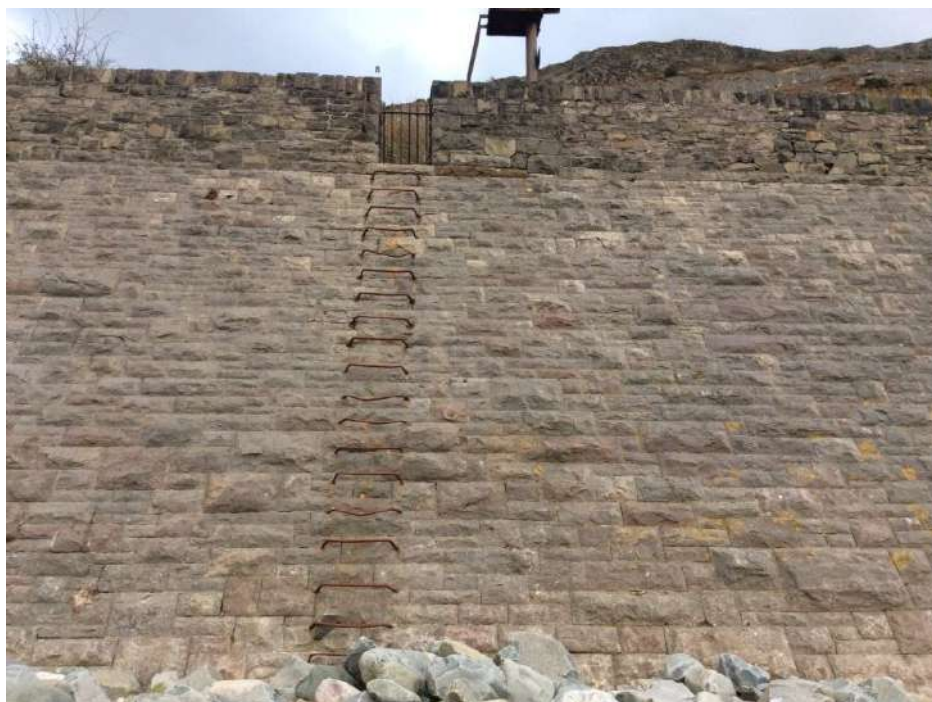
**Section A**  
**Wall section**  
**Defect Ref: D6**  
**Description:** Old corroded access ladder. Between the 2020 and 2021 examinations, there has been no change all the ladder points are corroded along with the extent of the asset.  
**Photo number: 150**

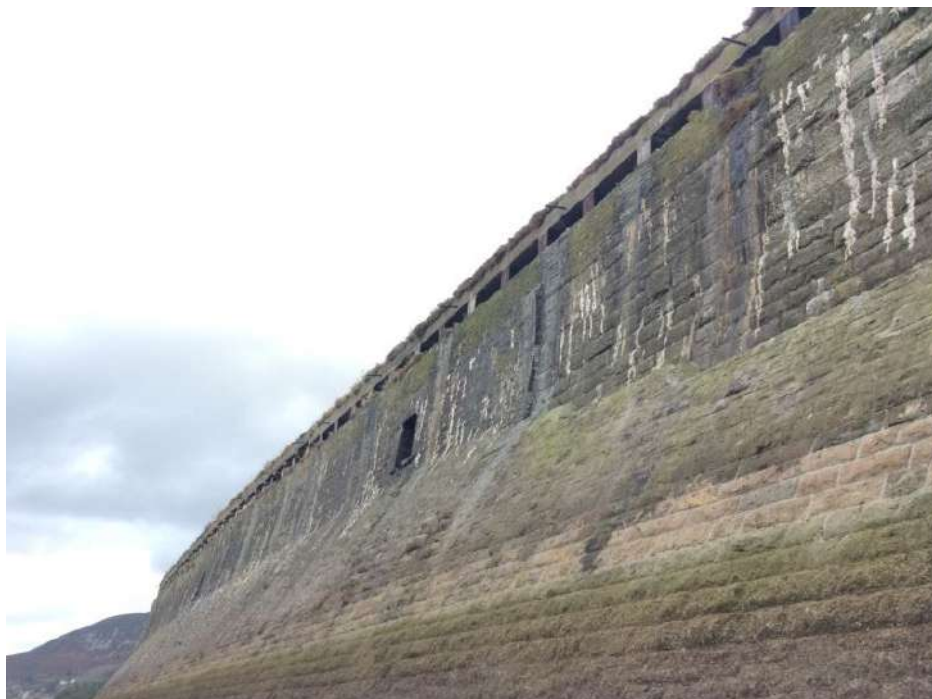
**Section A**  
**Wall section**  
**Defect Ref: D7**  
**Description:**  
Vegetation growth on  
top of the wall.  
Between the 2020  
and 2021  
examinations, there is  
no change.  
**Photo number: 115**

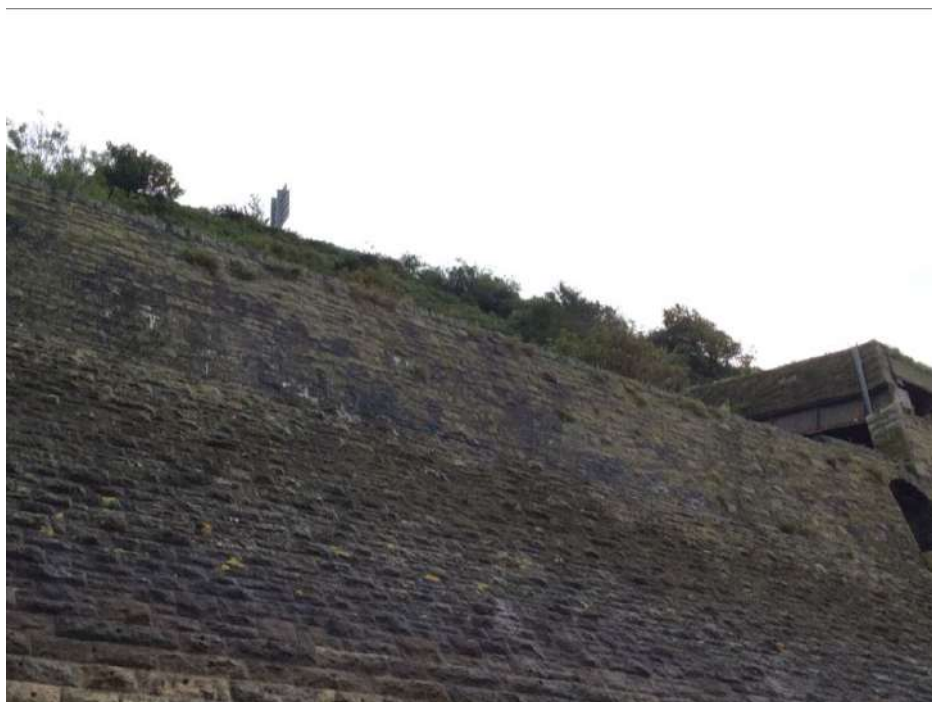
**Section A**  
**Wall section**  
**Defect Ref: D7**  
**Description:**  
Vegetation growth on  
top of the wall.  
Between the 2020  
and 2021  
examinations, there is  
no change.  
**Photo number: 62**

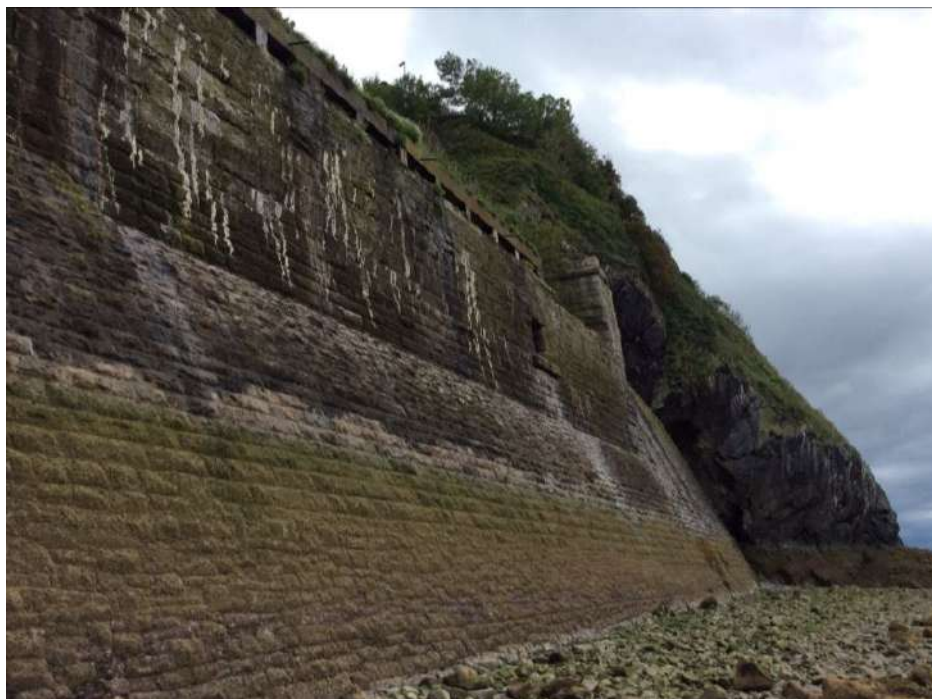
**Section A**  
**Wall section**  
**Defect Ref: D7**  
**Description:**  
Vegetation growth on  
top of the wall.  
Between the 2020  
and 2021  
examinations, there is  
no change.  
**Photo number: 74**

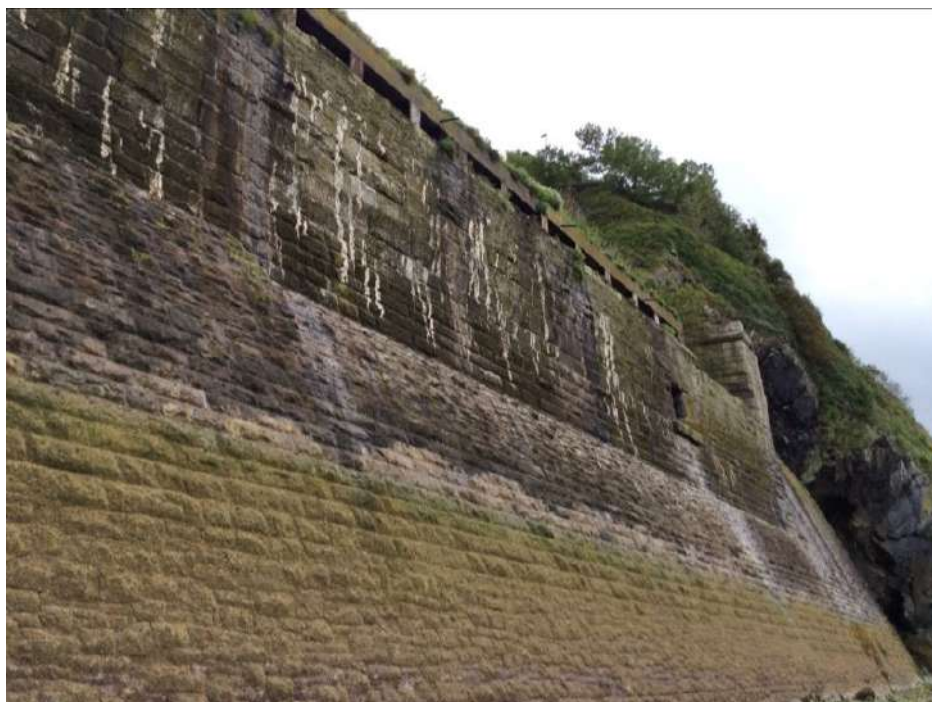
**Section A**  
**Wall section**  
**Defect Ref: D7**  
**Description:**  
Vegetation growth on  
top of the wall.  
Between the 2020  
and 2021  
examinations, there is  
no change.  
**Photo number: 75**
