| Location Plan: | <b>Avalanche East Sea Wall</b><br>Assessment Date: 20/04/2021 | |
| | Structure Reference: | <b>W2291320</b> |

# COASTAL ASSET CONDITION SURVEY REPORT

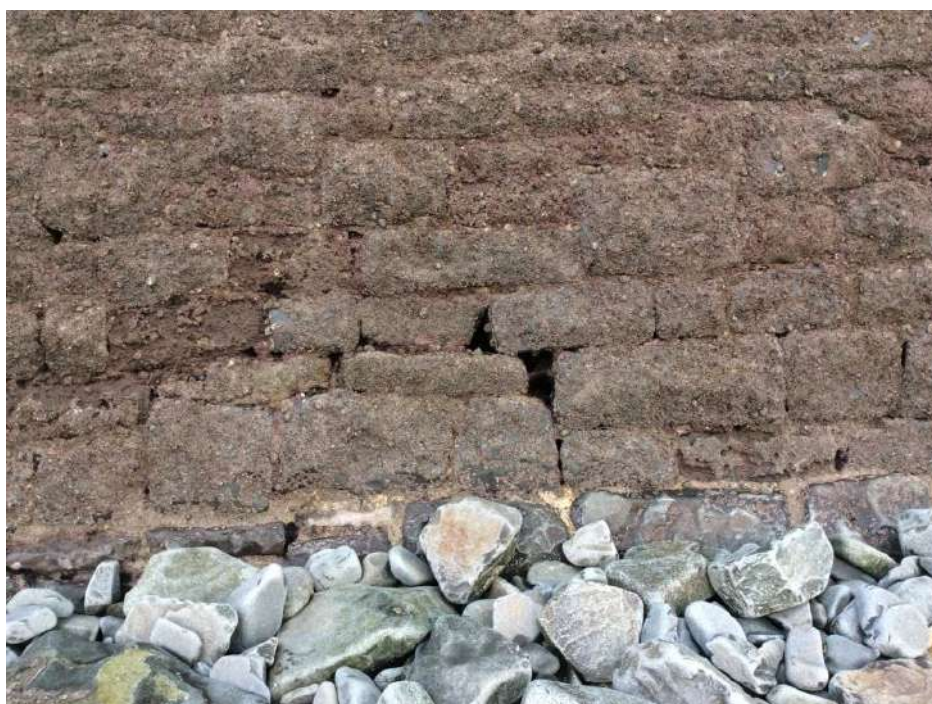
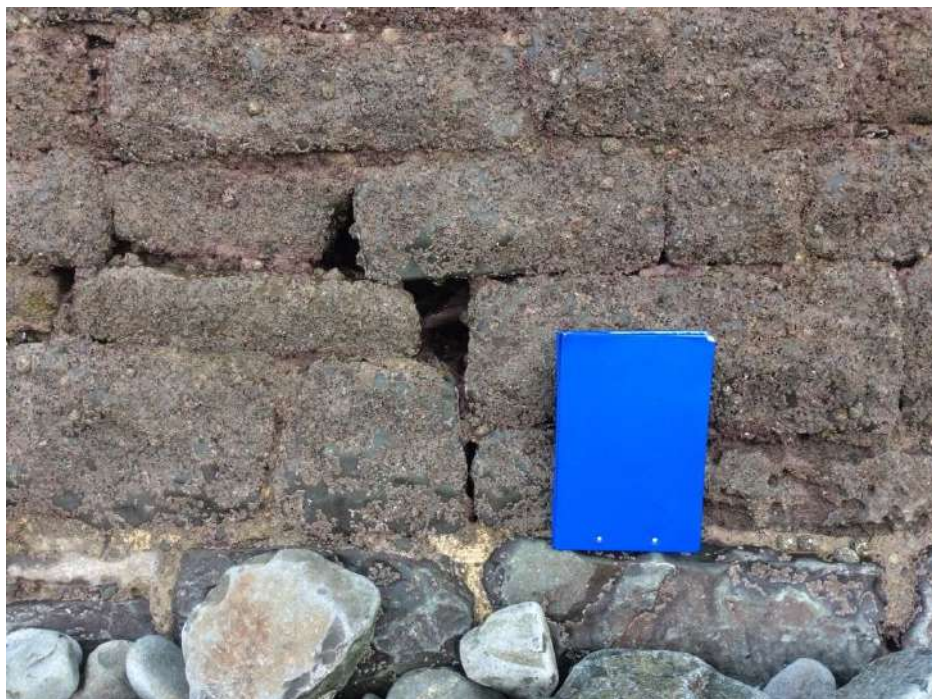
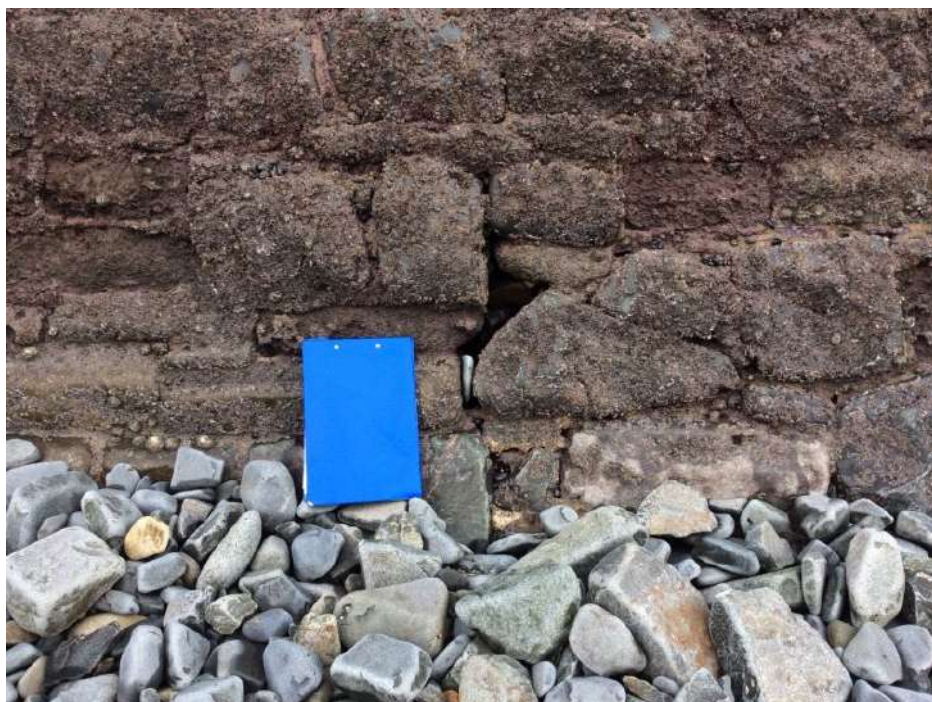
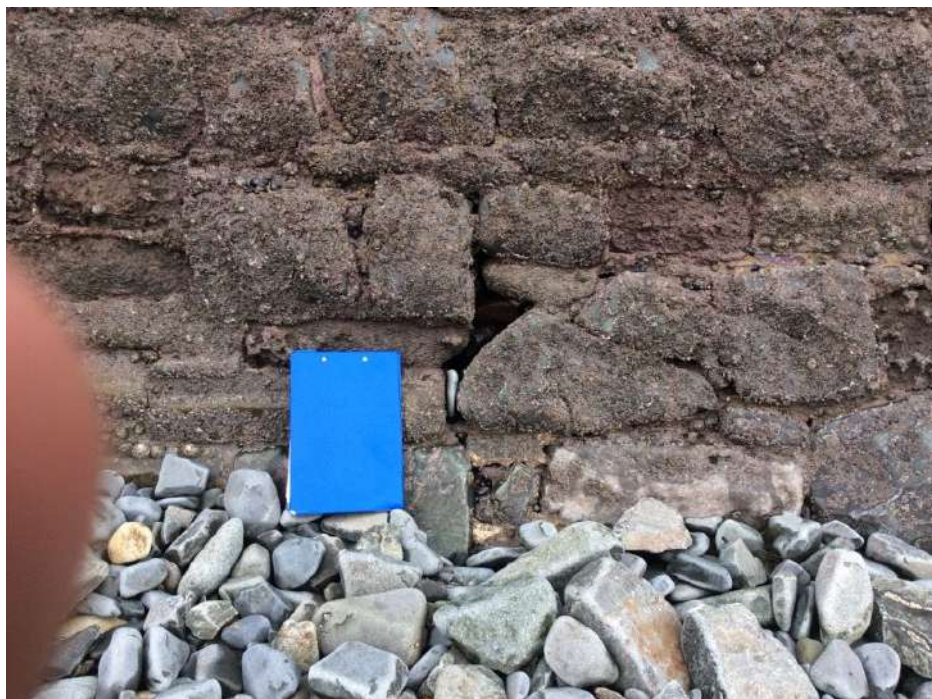
| Defect Ref No. | Defect Location (NGR) | Major Element | Minor Element | Photo Ref | Severity | Probability | Risk Score | Below MHWS | Defect Group | Defect Description | Recommendations | Defect Priority |
|---|---|---|---|---|---|---|---|---|---|---|---|---|
| D8 | N/A | Wall | Wall section | 117, 116, 119, 118, 120, 121, 78, 88 | 2 | 3 | 6 | True | N/A | There are Voids at the toe of the blockwork 300mm deep. The defect is unidentifiable or has been repaired. Between the 2020 and 2021 examinations, original photograph defect was not located but voids were noted in similar location. | Re-point open joints in parapet wall | 7 |

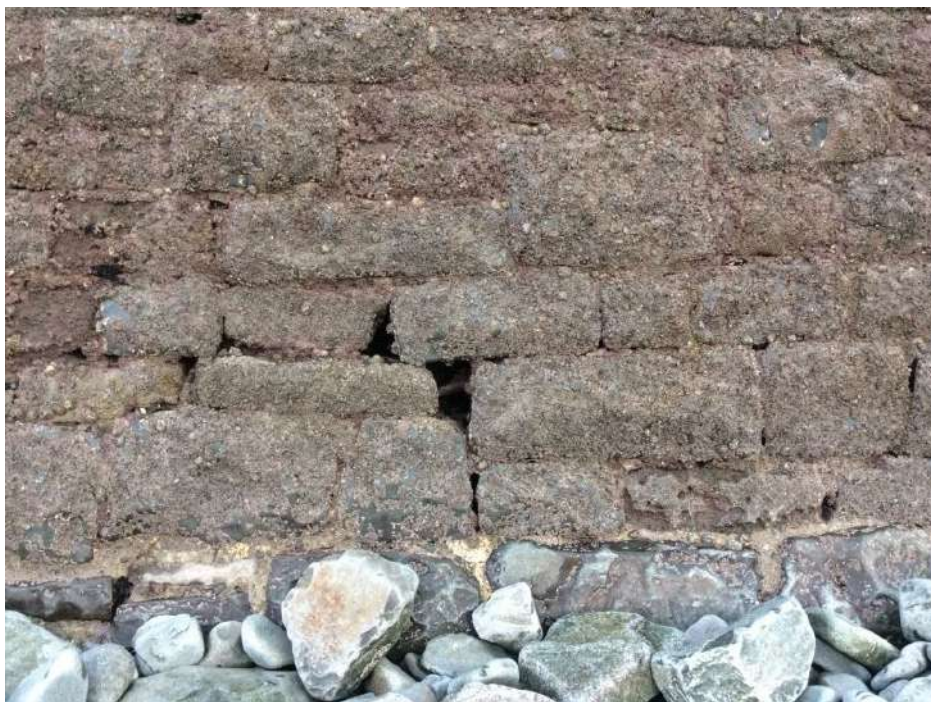
**Section A**  
**Wall section**  
**Defect Ref: D8**  
**Description:** There are Voids at the toe of the blockwork 300mm deep. The defect is unidentifiable or has been repaired. Between the 2020 and 2021 examinations, original photograph defect was not located but voids were noted in similar location.  
**Photo number: 116**

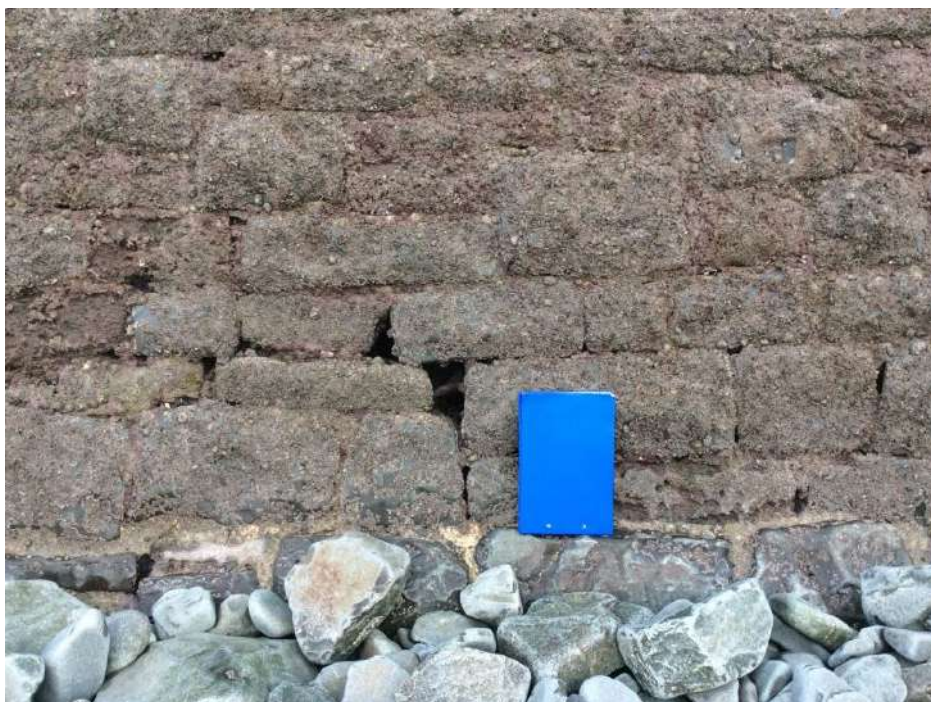
**Section A**  
**Wall section**  
**Defect Ref: D8**  
**Description:** There are Voids at the toe of the blockwork 300mm deep. The defect is unidentifiable or has been repaired. Between the 2020 and 2021 examinations, original photograph defect was not located but voids were noted in similar location.  
**Photo number: 119**

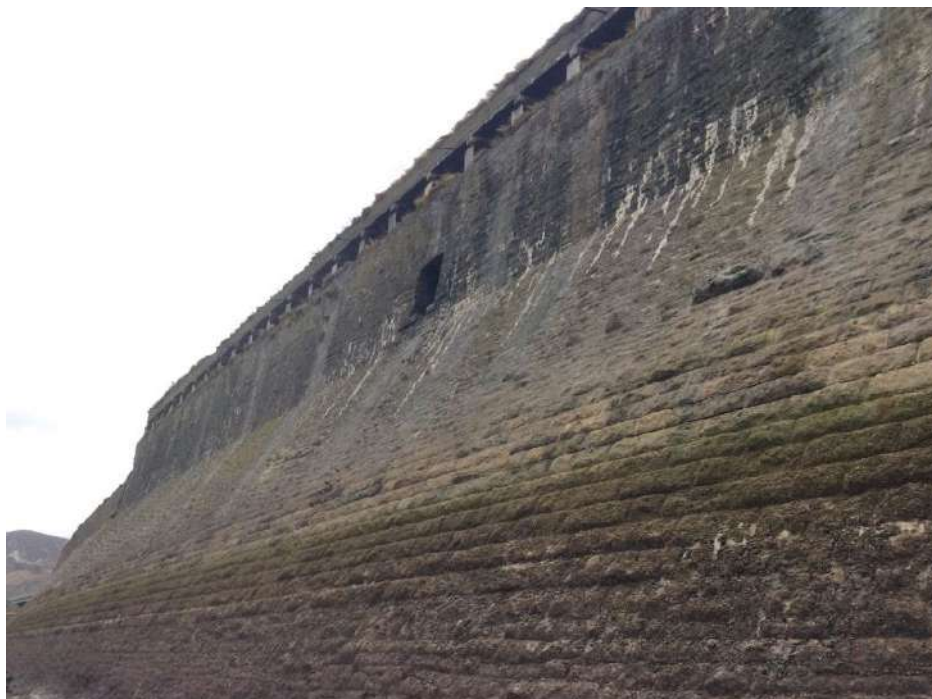
**Section A**  
**Wall section**  
**Defect Ref: D9**  
**Description:** Mineral seepage. Between the 2020 and 2021 examinations, there is no change.  
**Photo number: 128**

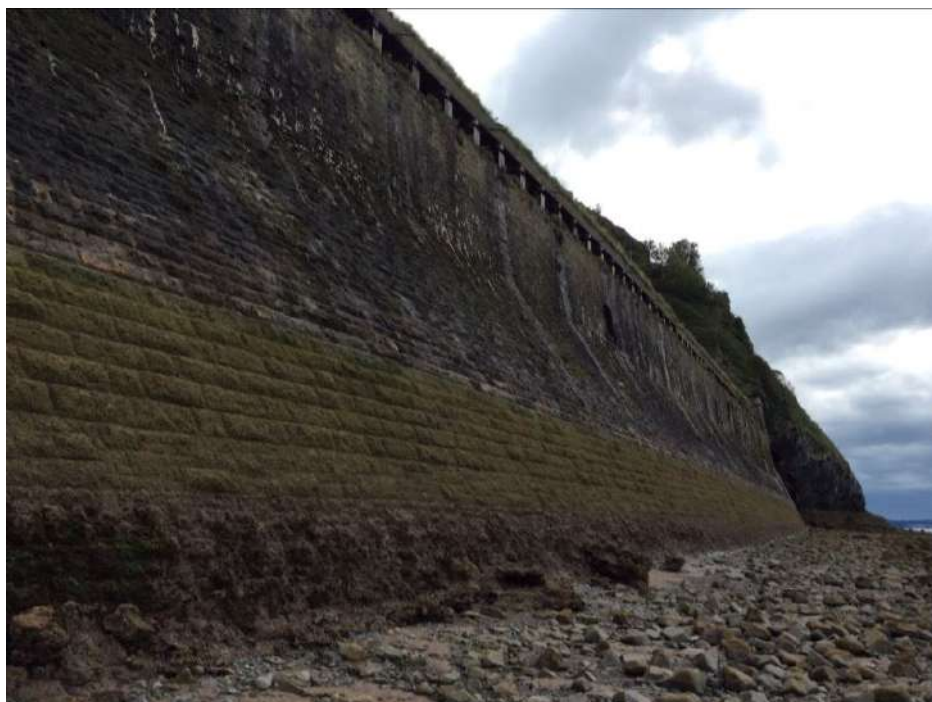
**Section A**  
**Wall section**  
**Defect Ref: D9**  
**Description:** Mineral seepage. Between the 2020 and 2021 examinations, there is no change.  
**Photo number: 67**

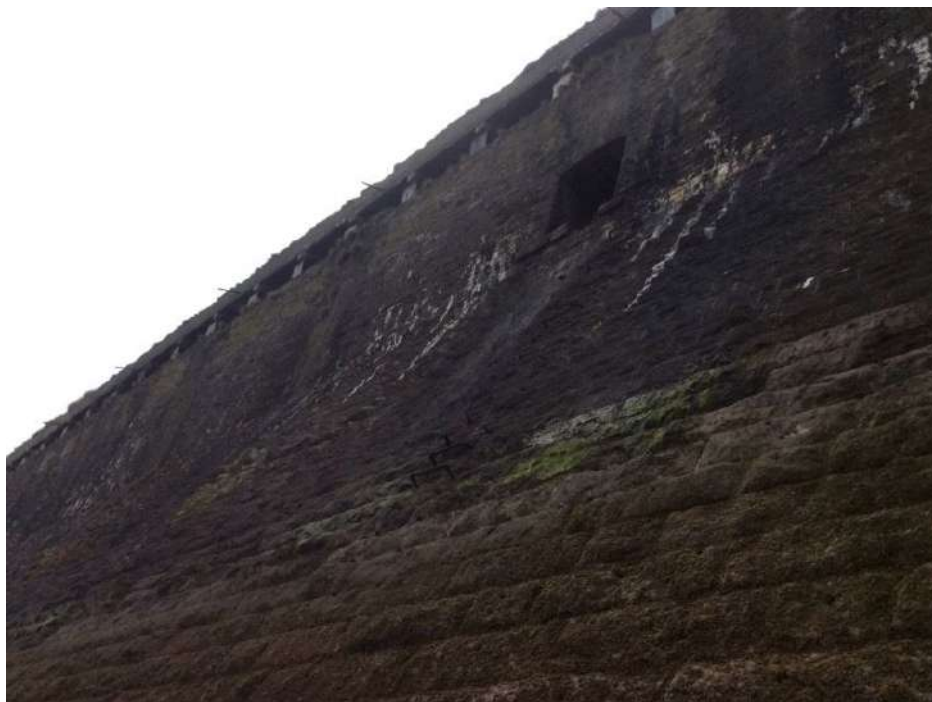
**Section A**  
**Wall section**  
**Defect Ref: D9**  
**Description:** Mineral seepage. Between the 2020 and 2021 examinations, there is no change.  
**Photo number: 90**

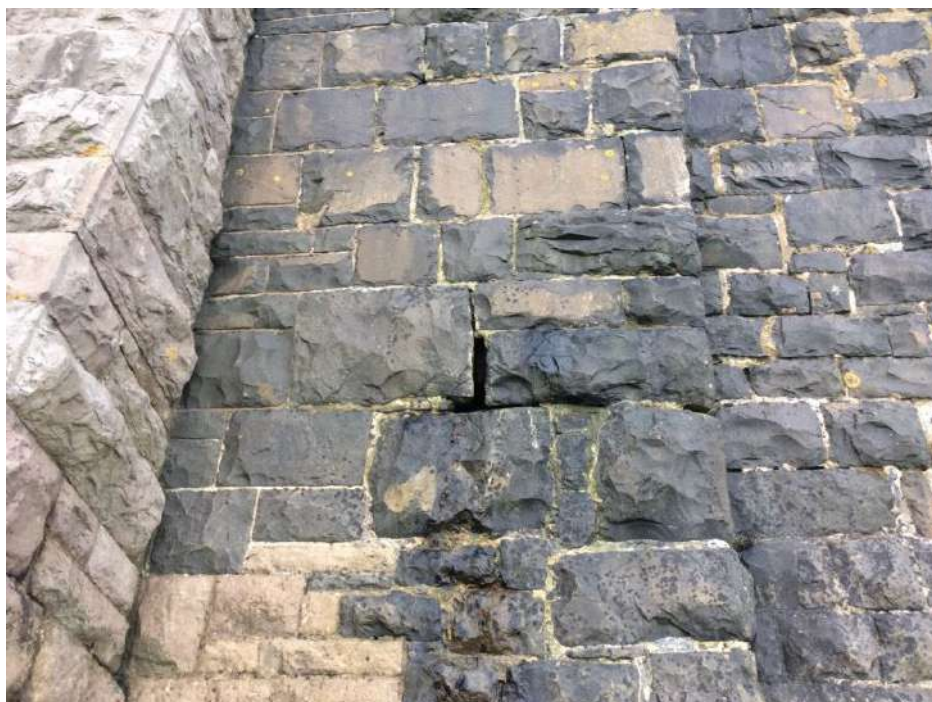
**Section A**  
**Wall section**  
**Defect Ref: D10**  
**Description:** There is a large open joint with seepage. The joint has been filled. Between the 2020 and 2021 examinations, additional large open joints were visible due to reduced wall toe protection.  
**Photo number: 144**

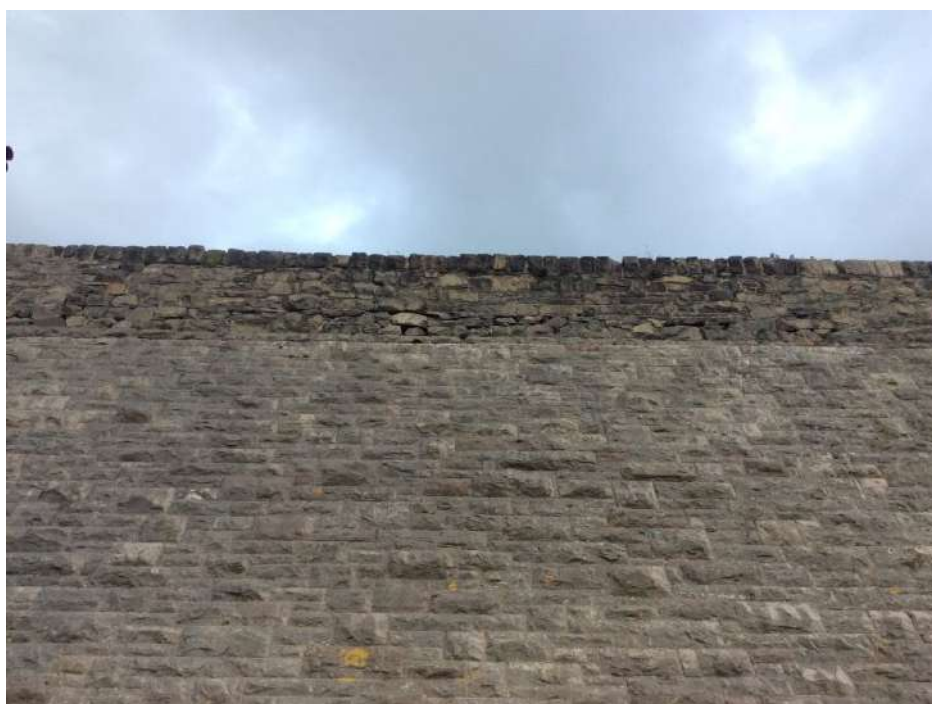
**Photo number: 148**

| Defect Ref No. | Defect Location (NGR) | Major Element | Minor Element | Photo Ref | Severity | Probability | Risk Score | Below MHWS | Defect Group | Defect Description | Recommendations | Defect Priority |
|---|---|---|---|---|---|---|---|---|---|---|---|---|
| D11 | N/A | Wall | Parapet/Capping | 148, 147, 57 | 1 | 1 | 1 | False | N/A | There are Large open joints present. Between the 2016 and 2020 examinations, the defect has been repaired. | Close out defect | 10 |

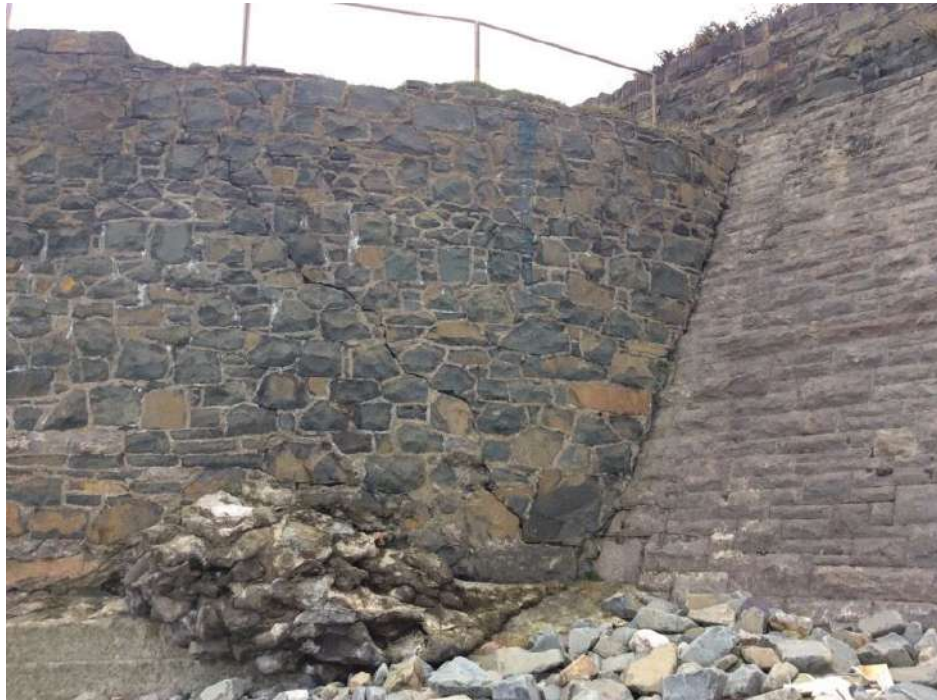
| Defect Ref No. | Defect Location (NGR) | Major Element | Minor Element | Photo Ref | Severity | Probability | Risk Score | Below MHWS | Defect Group | Defect Description | Recommendations | Defect Priority |
|---|---|---|---|---|---|---|---|---|---|---|---|---|
| D12 | 270459, 376255 CNH3 229.132 | Wall | Wall section | 152, 151, 53, 54, 93, 94 | 2 | 4 | 8 | True | N/A | There is a Poorer condition of the adjacent connecting sea wall. Fractures have been formed, mineral washout, and seepage. Between the 2020 and 2021 examinations, fracture appears to have widened slightly | Consider repairing the fractures | 5 |

**Description:** There is a Poorer condition of the adjacent connecting sea wall. Fractures have been formed, mineral washout, and seepage. Between the 2020 and 2021 examinations, fracture appears to have widened slightly  
**Photo number: 152**

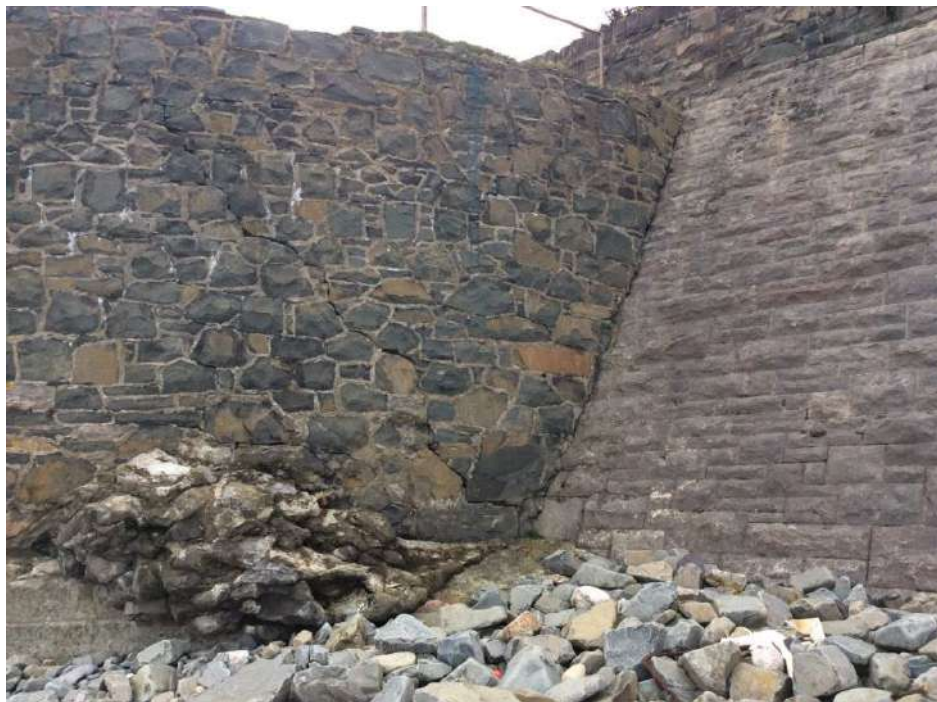
**Description:** There is a Poorer condition of the adjacent connecting sea wall. Fractures have been formed, mineral washout, and seepage. Between the 2020 and 2021 examinations, fracture appears to have widened slightly  
**Photo number: 151**

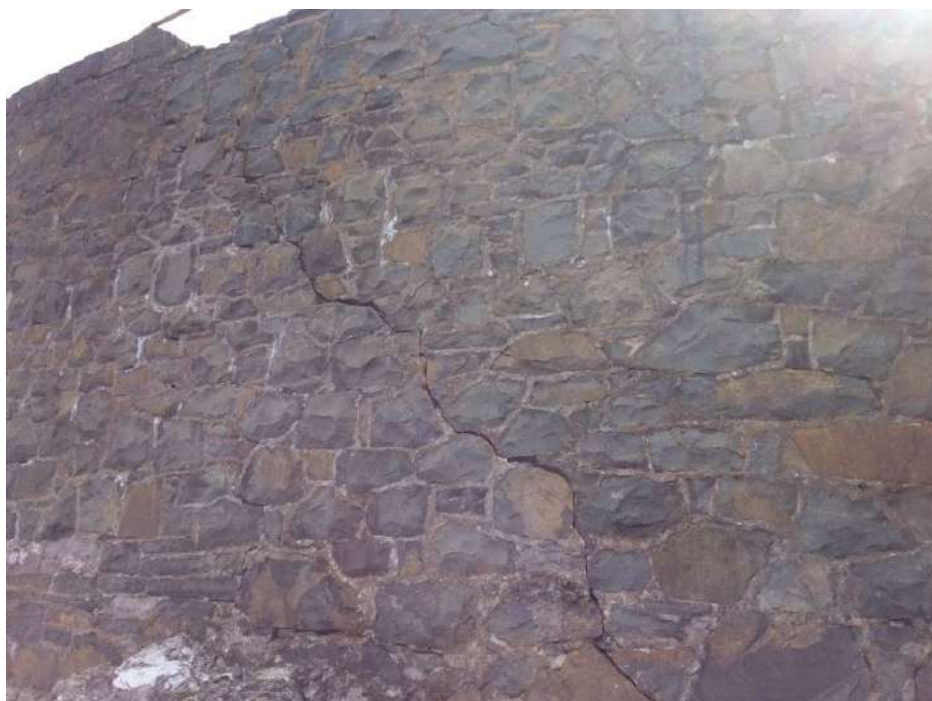
**Section A**  
**Wall section**  
**Defect Ref: D12**  
**Description:** There is a Poorer condition of the adjacent connecting sea wall. Fractures have been formed, mineral washout, and seepage. Between the 2020 and 2021 examinations, fracture appears to have widened slightly  
**Photo number: 93**

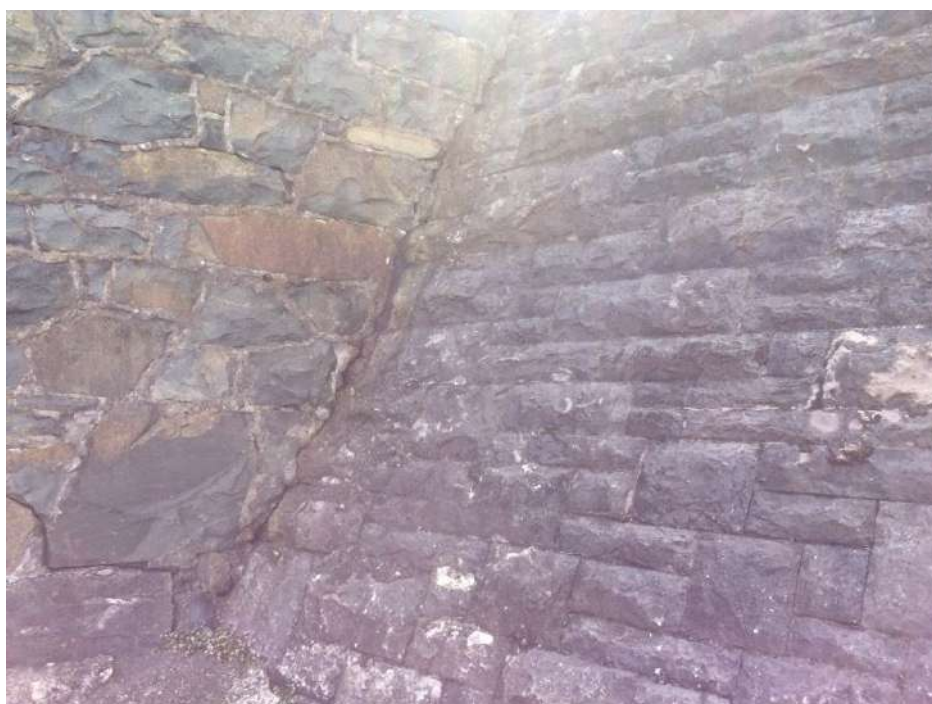
**Section A**  
**Wall section**  
**Defect Ref: D12**  
**Description:** There is a Poorer condition of the adjacent connecting sea wall. Fractures have been formed, mineral washout, and seepage. Between the 2020 and 2021 examinations, fracture appears to have widened slightly  
**Photo number: 94**

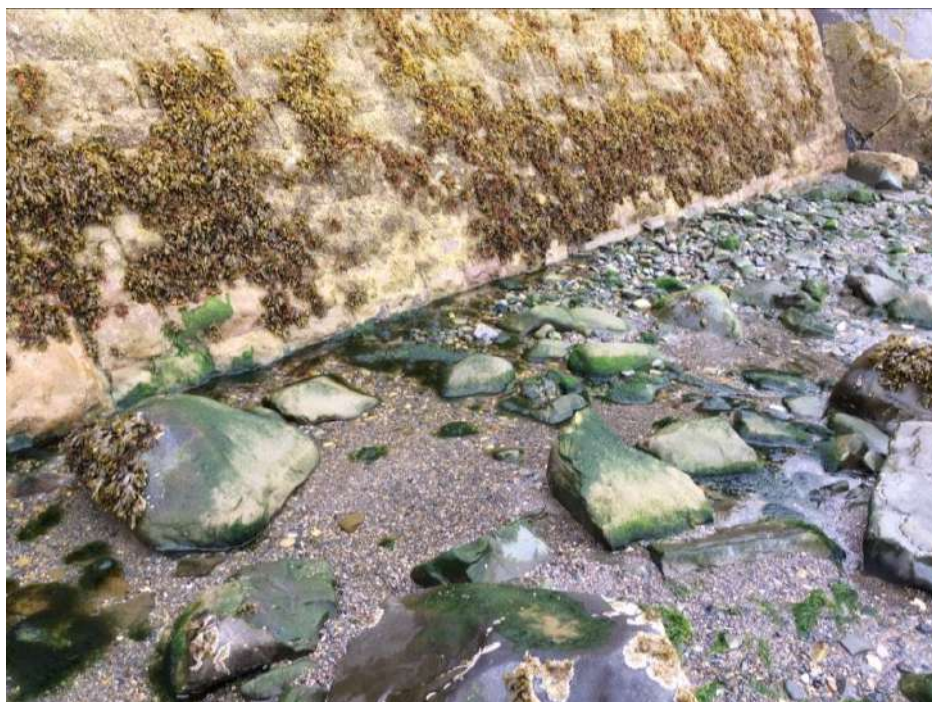
| Defect Ref No. | Defect Location (NGR) | Major Element | Minor Element | Photo Ref | Severity | Probability | Risk Score | Below MHWS | Defect Group | Defect Description | Recommendations | Defect Priority |
|---|---|---|---|---|---|---|---|---|---|---|---|---|
| D15 | N/A | Wall | Wall section | 59, 60, 96 | 2 | 3 | 6 | True | N/A | Undermining with pooling water approx 150mm deep. Defect not found in 2021 potentially buried in shingle | grout the toe of the wall to prevent undermining. | 2 |

**Section A**  
**Wall section**  
**Defect Ref: D15**  
**Description:**  
Undermining with  
pooling water approx  
150mm deep.  
Defect not found in  
2021 potentially  
buried in shingle  
**Photo number: 59**

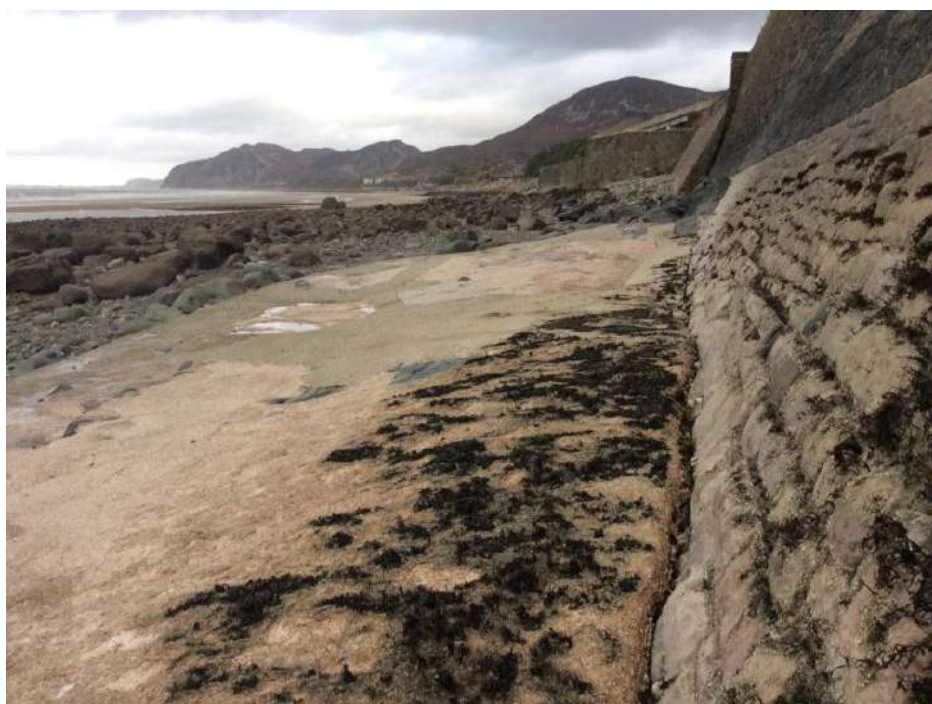
**Photo number: 141**

| Defect Ref No. | Defect Location (NGR) | Major Element | Minor Element | Photo Ref | Severity | Probability | Risk Score | Below MHWS | Defect Group | Defect Description | Recommendations | Defect Priority |
|---|---|---|---|---|---|---|---|---|---|---|---|---|
| D17 | 270359, 376260 CNH3 229.143 | Wall | Wall Apron | 141, 140, 139, 79, 95 | 2 | 3 | 6 | True | N/A | Minor spalling across the concrete apron. Between the 2020 and 2021 examinations, there is no change. | Consider repairing the apron | 9 |

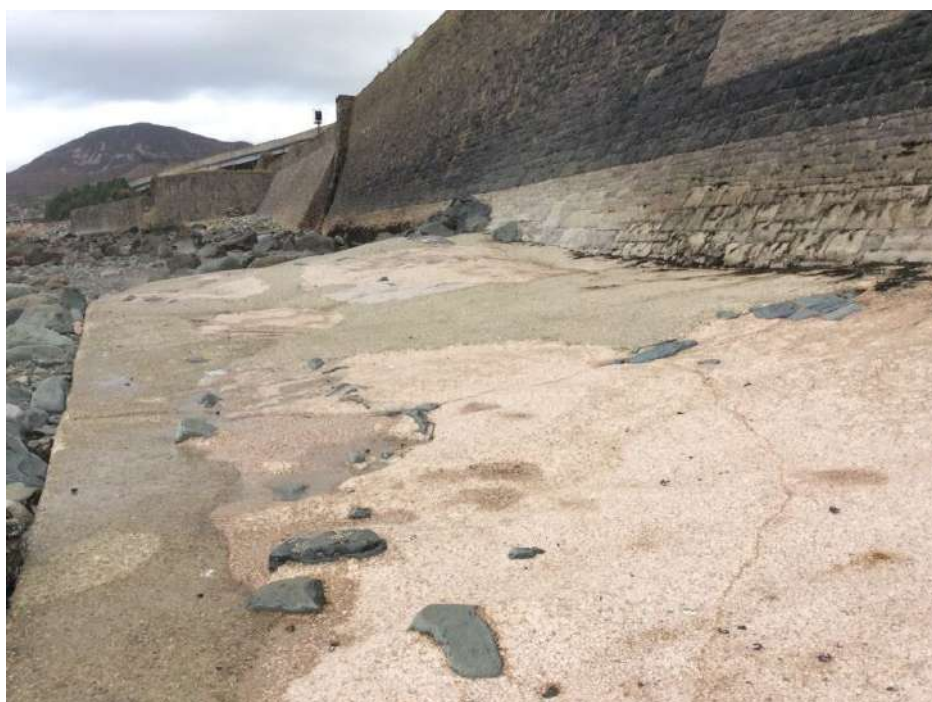
**Section A**  
**Wall Apron**  
**Defect Ref: D17**  
**Description:** Minor spalling across the concrete apron. Between the 2020 and 2021 examinations, there is no change.  
**Photo number: 139**

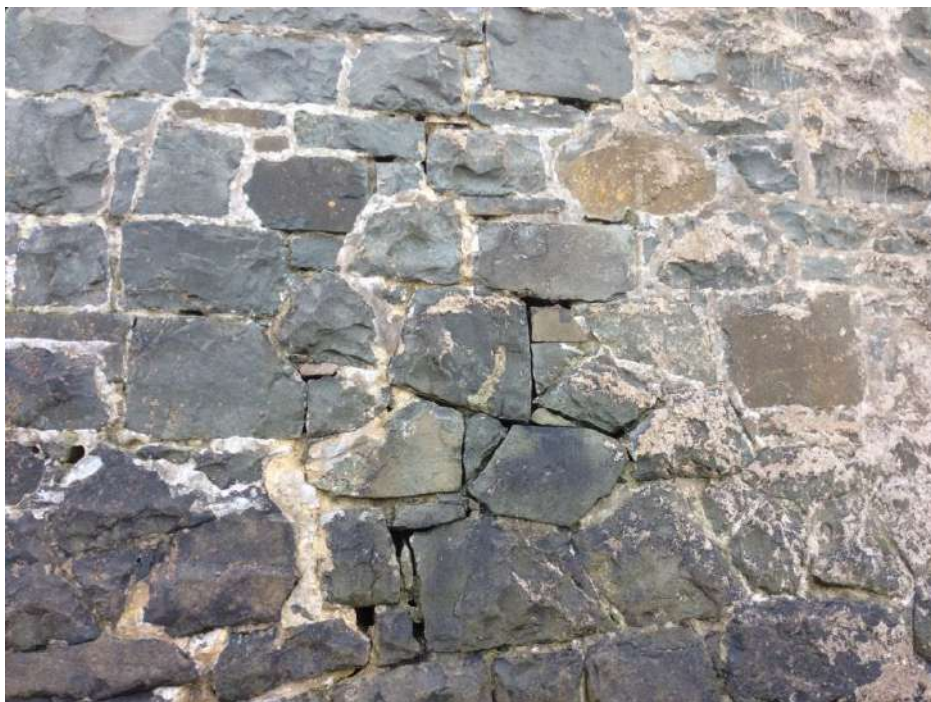
**Section A**  
**Wall section**  
**Defect Ref: D18**  
**Description:** Open joints and voids in the face of the wall  
**Photo number: 97**

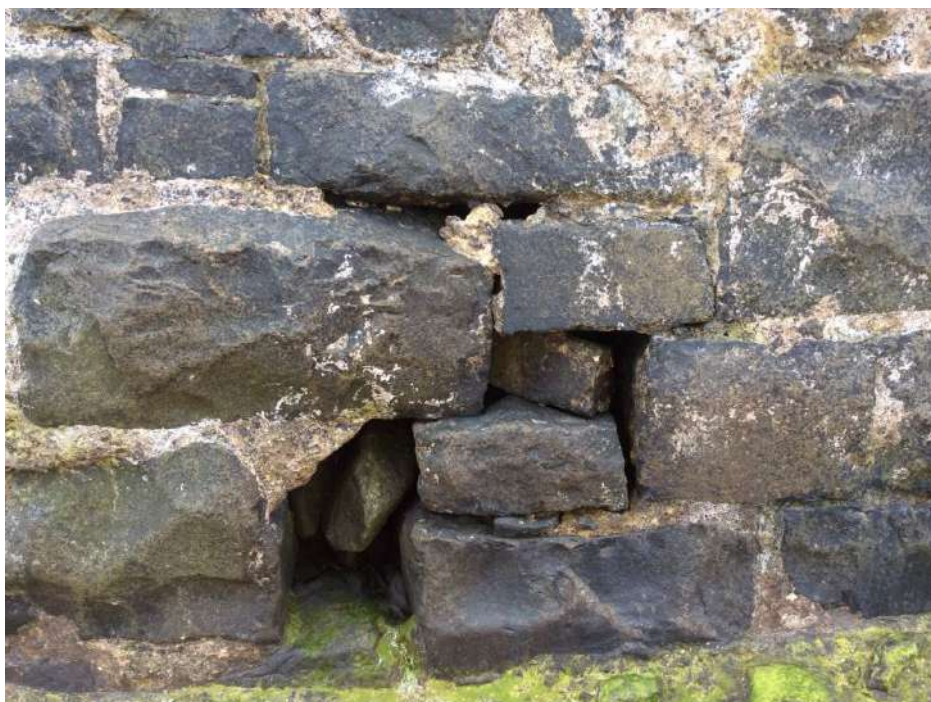
**Section A**  
**Wall section**  
**Defect Ref: D18**  
**Description:** Open joints and voids in the face of the wall  
**Photo number: 98**
