DŴR CYMRU WELSH WATER

EVENT DURATION MONITORING

**EDM TEN Initial investigation report
B05109601
Penclawdd CSO, Swansea**

Asset ID No. 72084

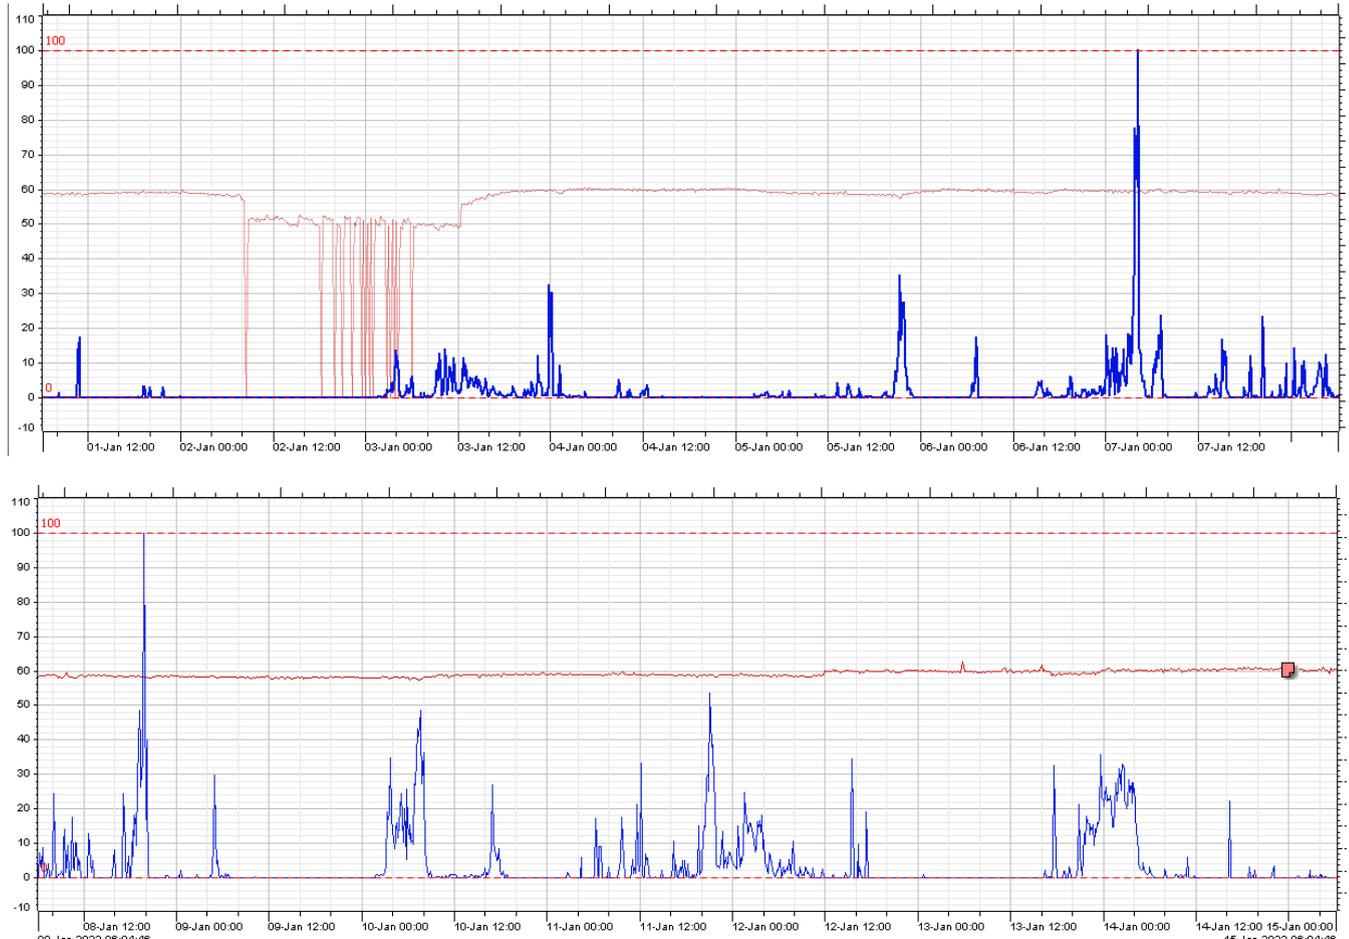
15 spills were between the 1st and 15th January 2023, this was over a prolonged period of heavy rain. Figure 2 demonstrates pump performance at SPS, with a maximum pass forward flow of approximately 60l/s. This would suggest an issue with the pass forward flow from the site, however this may possibly be attributed to the accuracy of the flow meter because the pumps were continuously running.

Figure 2 - Red displays volume of pumped flow at SPS. Blue displays rainfall. Data indicates direct link to rainfall events.

Maintenance works were carried out on the pumps in Penclawdd SPS in May 2024 and the pass forward flow has been restored. Spills have since dropped off to expected levels.

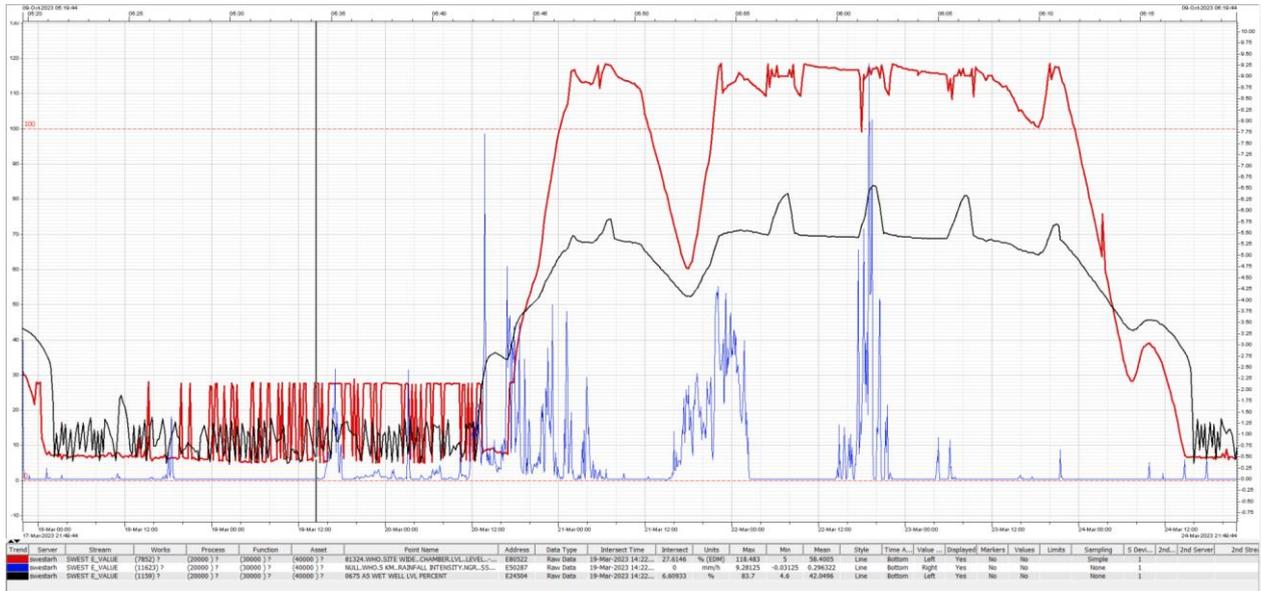
Figure 3 shows a comparison between levels at the SPS compared to levels at the CSO, and it can be confirmed that spills have only occurred when SPS wet well levels are high.

Figure 3 - Red displays levels at CSO. Dotted red line indicates spill level. Blue displays rainfall. Black displays SPS wet well levels. Data indicates direct link to rainfall events, and spills occurring only when SPS wet well levels are high.

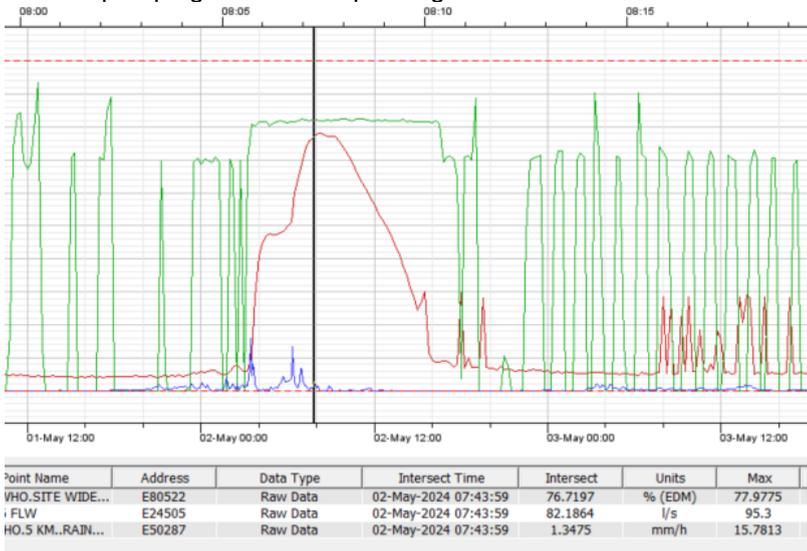
PFF returned to 82 l/s on 2nd May 2024, since this date the pumping station has been consistently exceeding its PFF consent of 82 l/s before spills occur. The number and duration of spills has dropped.

The following telemetry trends show the 82 l/s being achieved. In figure 4 it is evident that the asset didn't spill and the pumping station was passing forward 82 l/s.

Figure 4 - Red displays levels at CSO. Dotted red line indicates spill level. Blue displays rainfall. Green displays SPS Pass forward flow.

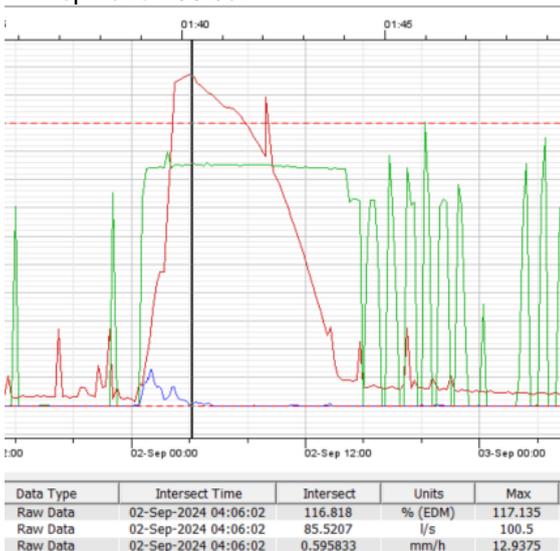
There have been 9 spills since the PFF has been restored at the down stream pumping station. All have been attributed to high rainfall intensity storm events. The following figure shows the SPS reaching a consistent 85 l/s with spike to 100 l/s.

Figure 5 - Red displays levels at CSO. Dotted red line indicates spill level. Blue displays rainfall. Green displays SPS Pass forward flow.

The spills at this asset were due to Penclawdd SPS not achieving its full pass forward flow. Maintenance works have been undertaken at the pumping station and spill numbers have been reduced.
