DŴR CYMRU WELSH WATER

EVENT DURATION MONITORING

EDM TEN Initial investigation report
BW4108401
Elmgrove Road CSO, Swansea

Asset ID No. 71023

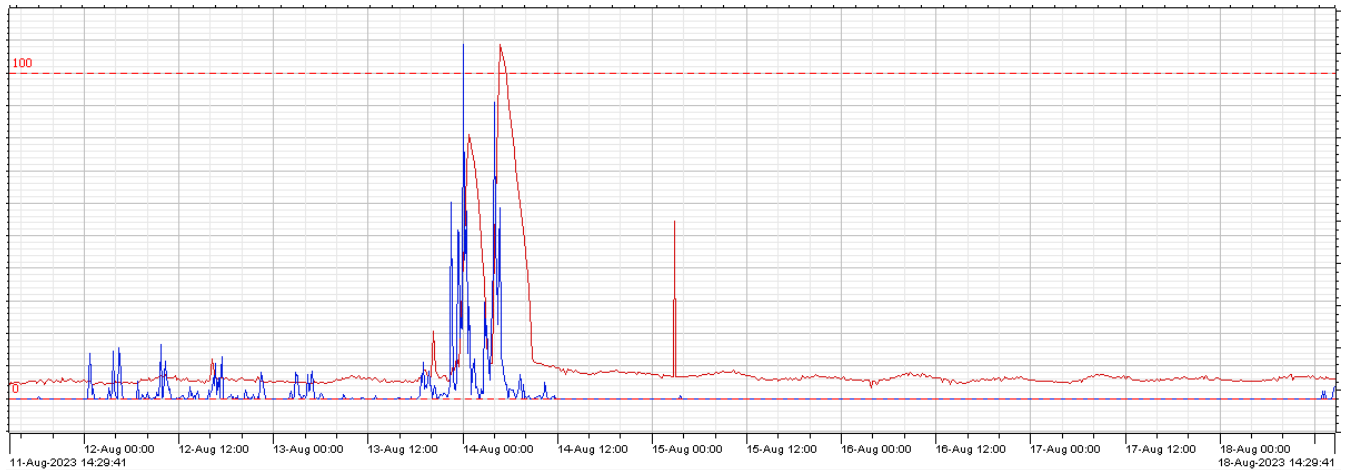
Figure 2 - Red displays wet well level. Dotted red line indicates spill level. Blue displays rainfall. Data indicates direct link to rainfall events and suggest hydraulic overload issues.

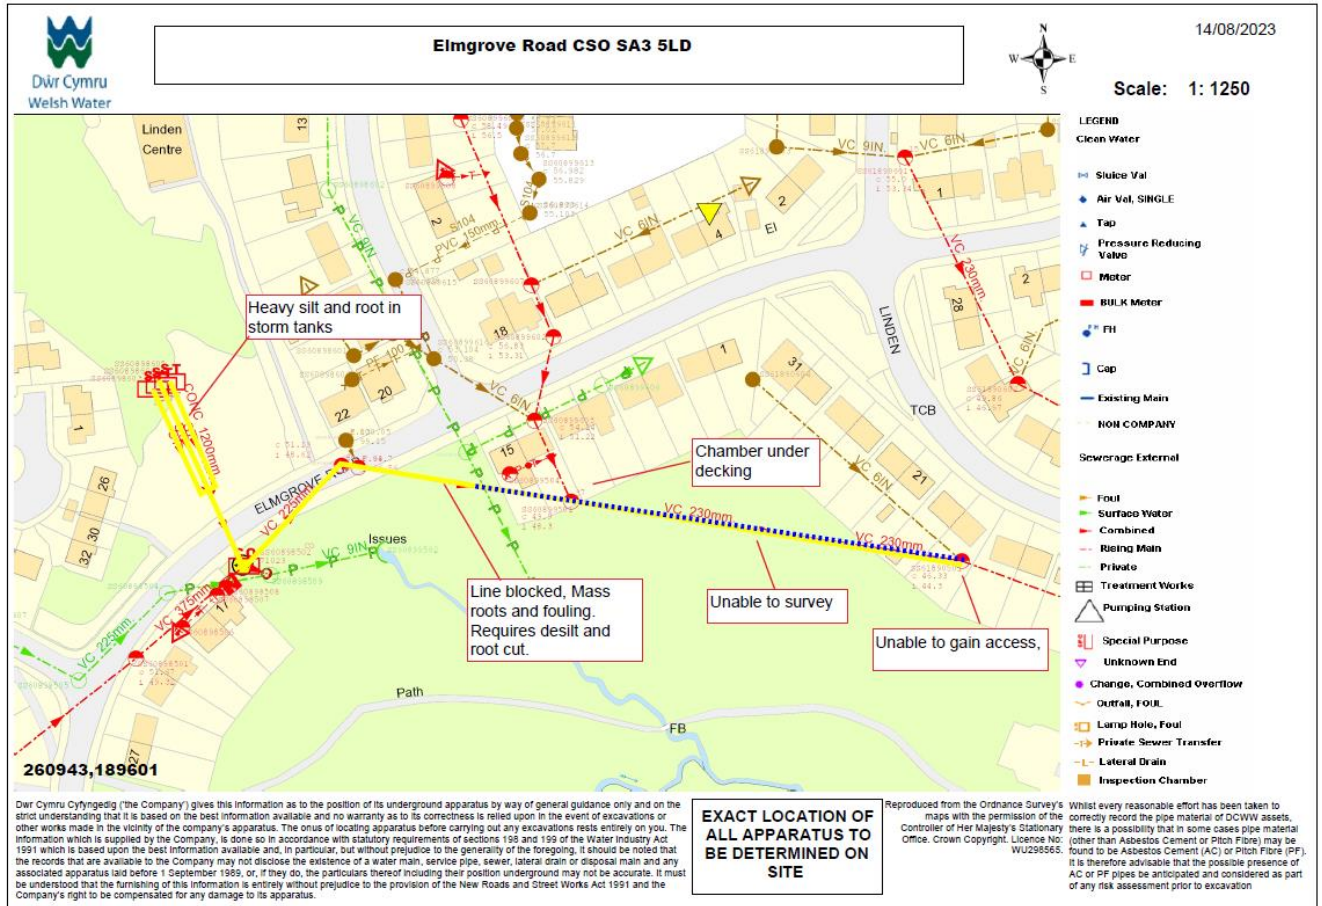
31.33	DEX	Other settled deposits 100% cross-sectional area loss - Remark: Blue roll and Wipes	8496288	Service / 5		
31.33	RM	Roots mass 100% cross-sectional area loss - Remark: Blue roll push off and identified mass roots	8496310	Service / 5

31.33	SA	Survey abandoned - Remark: Blocked Sewer - Mass roots and Fouling	8496333	Comment / 0		
End Node Ref:SS60898501 VL : metres Depth: N/A metres

CCTV and cleansing work have been undertaken at the asset. Material was removed from the storage tanks and a root mass removed from the downstream network.

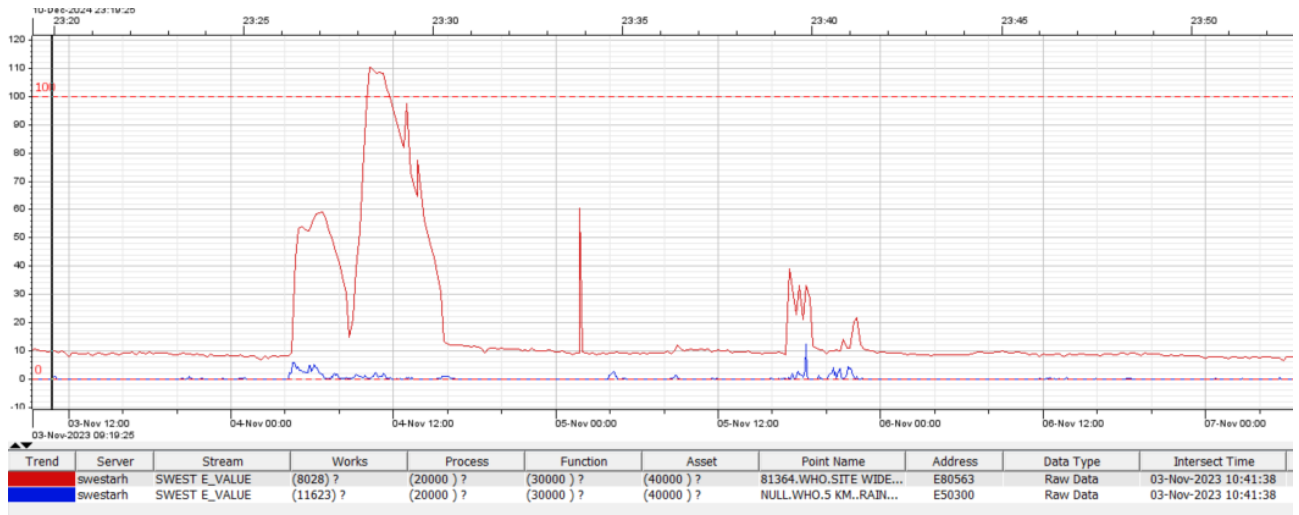
Figure 1: extract showing telemetry trend before cleansing task complete

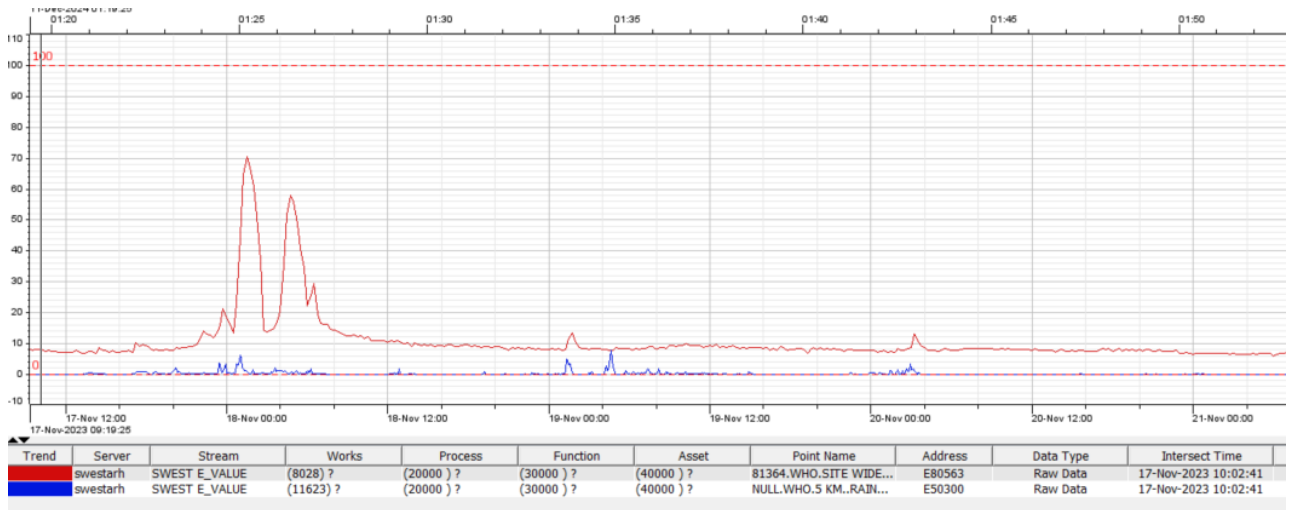
There have been 4 spills since 1st January this year, these are all related to heavy rainfall and storm conditions. See appendix 2 for spill trend pre and post cleansing.

Figure 2: extract showing telemetry trend after cleansing task complete
