## Compliance Assessment Report CAR\_NRW0043577

**Permit being assessed:** AW1002101

For: Glasbury Wastewater Treatment Works, held by DWR CYMRU CYFYNGEDIG  
At: Track past 'Hampton Cottage', Off A438, Glasbury, Powys, HR3 5NL.

**Type of assessment carried out:** Site Inspection, Reason: Routine.

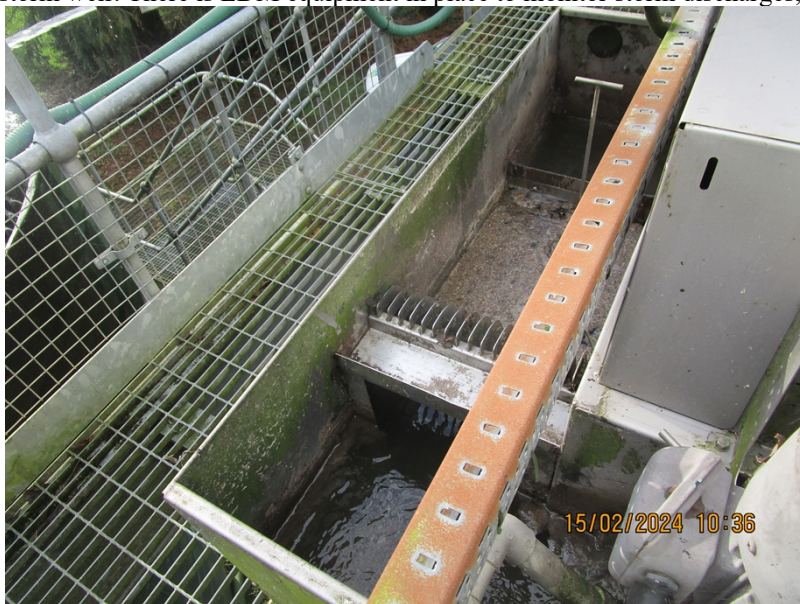
The incoming flow to the site is pumped up to the inlet point, where telemetry is in place to monitor flows. The inlet is clearly marked and was clear of blockages, the main screen is a rotating brush screen, which was clearly operational at the time of inspection. There is a bypass screen in place which is approximately one inch in aperture, this is used when the main screen is out of use for maintenance or in the event of a failure.

The flows from both screens are then passed through a macerator. Following the macerator, the flows then pass the storm weir. There is EDM equipment in place to monitor storm discharges, this appeared in working order.

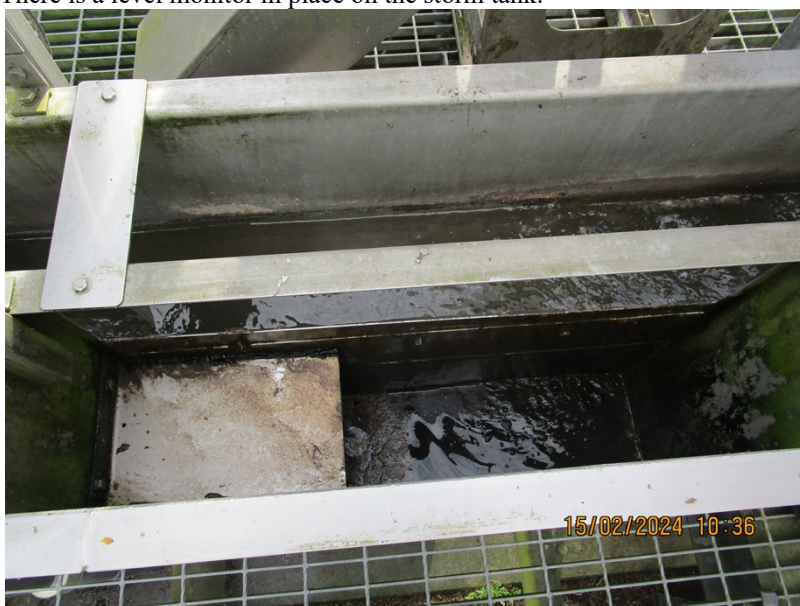
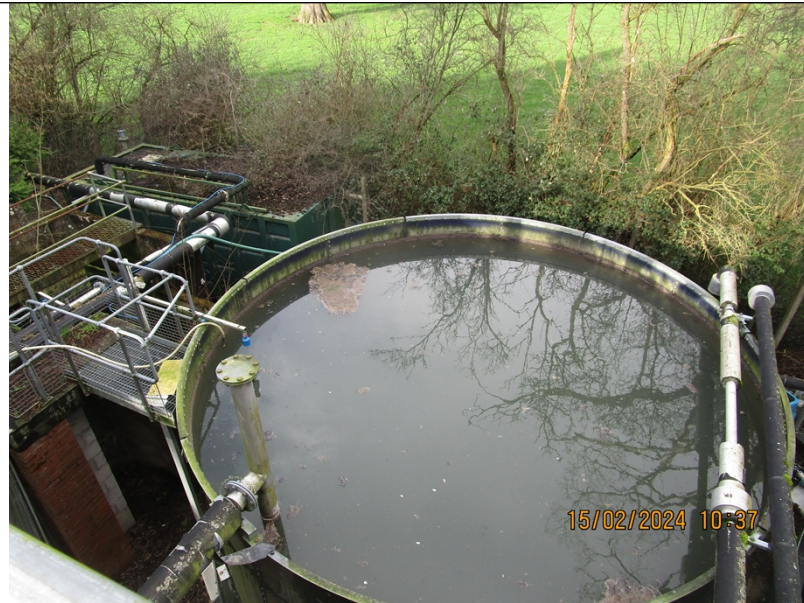
The flows were right at the top of the storm weir and there was evidence of flows recently entering the storm channel. The storm channel appeared clear of debris or blockages. The storm channel does not have additional screening as all flows pass through the screening and macerator before reaching the storm weir.

There is a single storm tank on site, which appeared completely full upon inspection. The storm tank has an automatic return to the head of the works once incoming flow levels drop to the required amount. There had been persistent rainfall in the preceding days, so it is likely the site had been discharging via the storm discharge, as the storm storage was full. There is a level monitor in place on the storm tank.

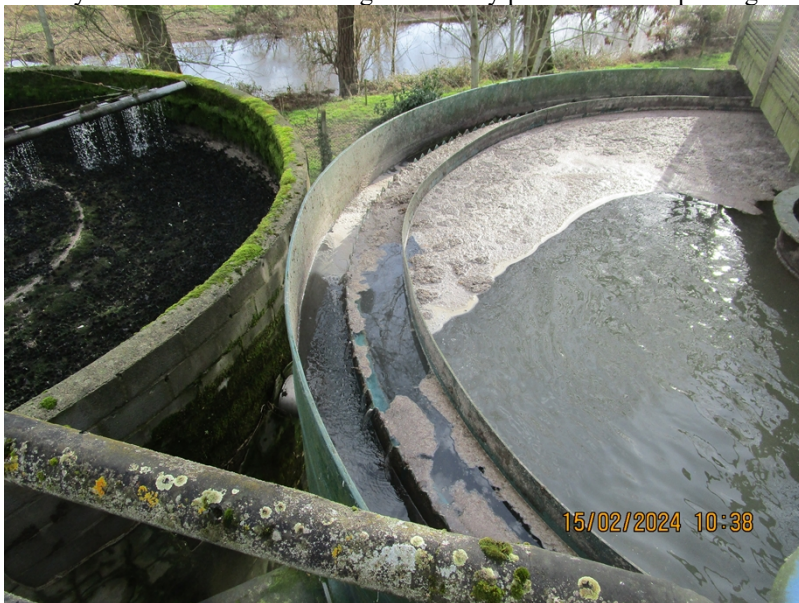
The primary settlement tank on site is a raised circular settlement tank, with retention boards to hold back solids from travelling into the outfall channel. There is a hose in operation spraying water onto the surface of the settlement tank, this I was advised is to encourage more solids to settle out of the influent. There was a build up of foam present on the opposite side of the tank from the hose, which was passing over into the outfall channel of the settlement tank. It is likely that this is partially because of the surface disturbance caused by the hose sparing on the surface. This made it difficult to identify whether solids were being sufficiently prevented from passing over to the next stage of treatment.

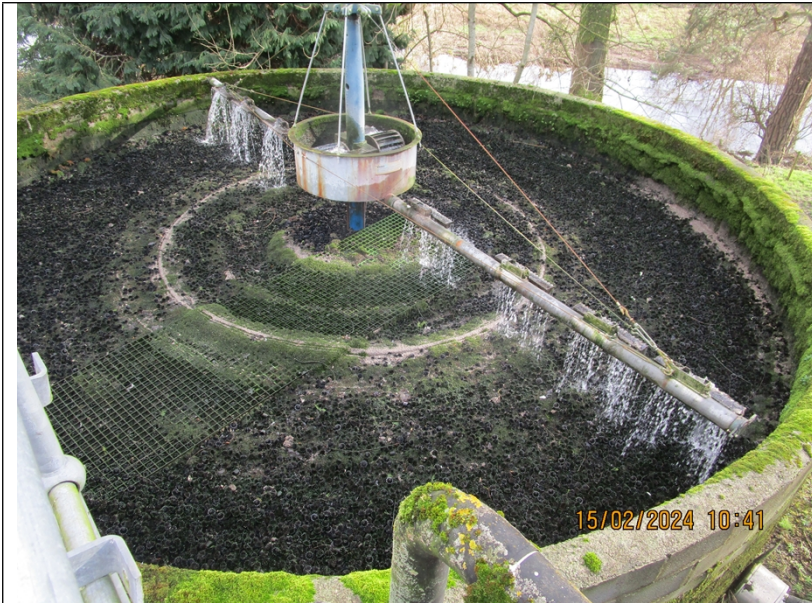
There is a single filter bed which contains plastic filter media. The rotation arm was moving in a free and unhindered manner. The distribution points on the arm were clear of debris and water was flowing freely. The filter media had a build-up of vegetation and some surface ponding in places. At the time it did not appear that these were hindering flows into the filter media, however this should be monitored as it could lead to problems with final effluent quality. On questioning about removal of vegetation and maintenance of the filter bed, I was advised that only certain areas of the filter bed are safe for access

The external walls of the filter bed appear in need of maintenance. A render which had been previously installed has cracked and fallen away in many places. The outer wall has vegetation growth and appears wet during the visit. It is not clear if the moisture present is from the tank leaking, or from rainfall and vegetation. I was advised that DCWW are looking into viable solutions, as the visual appearance is causing complaints from members of the public, as the site is visible from a nearby footpath.

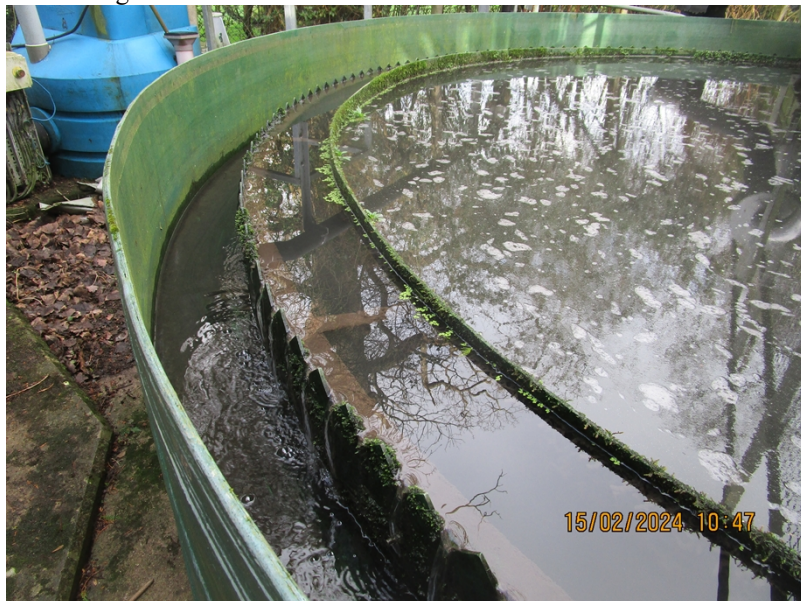
There is a single circular humus tank with retention boards in place to hold back solids. This appeared to be operating effectively and there were no signs of solids in the outfall channels. The effluent within the outfall was clear and there were no signs of concern.

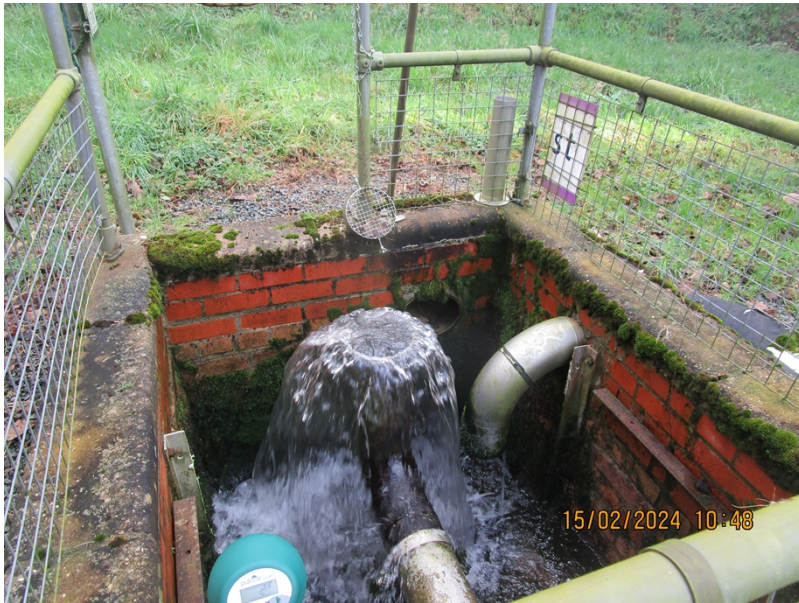
The final effluent from the humus tank passes through a Magflow flow meter, which appeared to be operating as required and accessible for inspection. The sample point is clearly marked with appropriate signage including the NGR. The inspection chamber and outfall were clear of debris and effluent was flowing freely to the outfall. The outfall into the watercourse was not checked during this inspection due to high river levels.

Both final effluent and storm effluent outfall from the same outlet points. The works has two permitted outfall points. The main outfall is the lower outfall channel within the chamber. When the receiving watercourse is in spate this outfall becomes underwater. When the watercourse reaches a certain level, the outlet chamber fills and the works discharges

through the top outlet pipe in the outfall chamber, leading to the short outfall location.
