## Compliance Assessment Report CAR\_NRW0045871

**Permit being assessed:** AD0000901

For: Trecastle Wastewater Treatment Works, held by DWR CYMRU CYFYNGEDIG

**Type of assessment carried out:** Site Inspection, Reason: Routine.

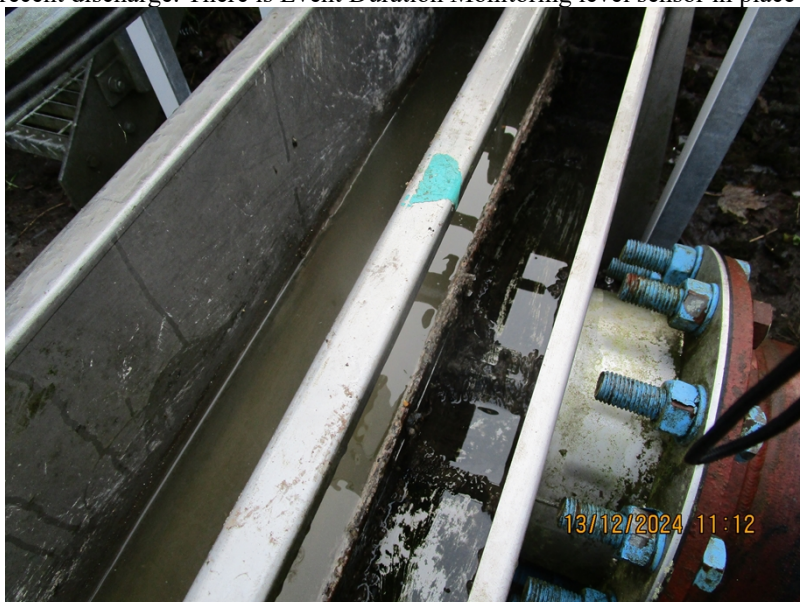
The incoming flow comes into the works via a gravity sewer. The works is a powered works however does not have a backup power source in place. The incoming flows to the works pass through a mechanical screen within the inlet unit. The screen clearly operation at the time of visit, and there were no signs of significant rag or solids passing through to the next stage of treatment. There is an additional bypass channel with a fixed 6mm bar screen, which can be used when undertaking screen maintenance.

The storm weir in place is a hard-set weir at the side of the inlet, following the inlet screen and bypass channel. The flow can only pass to storm when flows reach the level of the weir. The storm channel has no additional screening in place, as all flows pass through the mechanical screen or bar screen beforehand. The incoming flows were well below the weir height, and no storm discharge was occurring. There was some water present within the channel, suggesting a recent discharge. There is Event Duration Monitoring level sensor in place to monitor storm discharges (to storm tanks).

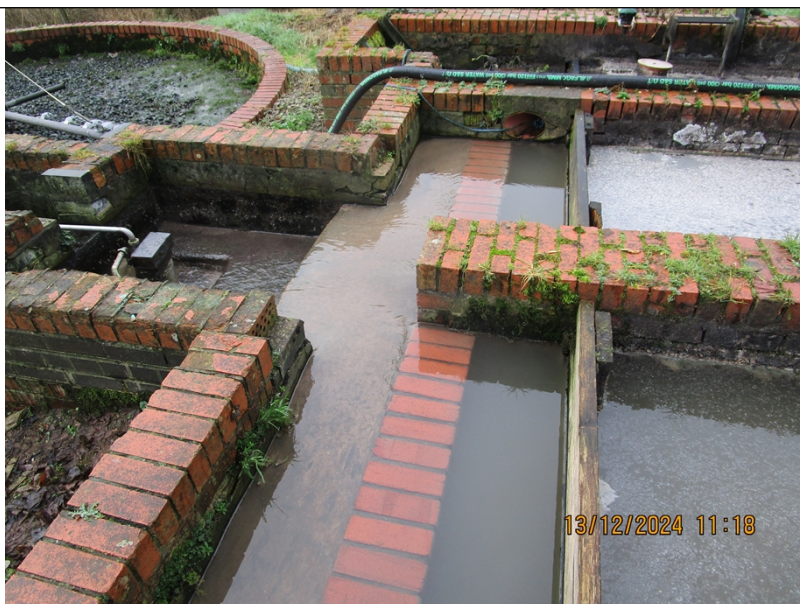
There are two primary settlement tanks at the works are rectangular brick housed tanks with retention boards in place to hold back solids. The primary settlement tanks appeared to be operating effectively and there were no signs excessive carry over in the outfall channels of the tanks.

The joint outfalls from the primary settlement tanks lead to a syphon chamber, which fills up before discharging to the two filter beds on site. This is to ensure there is enough water pressure to rotate the filter bed arms. The syphon was clearly operational at the time of the inspection.

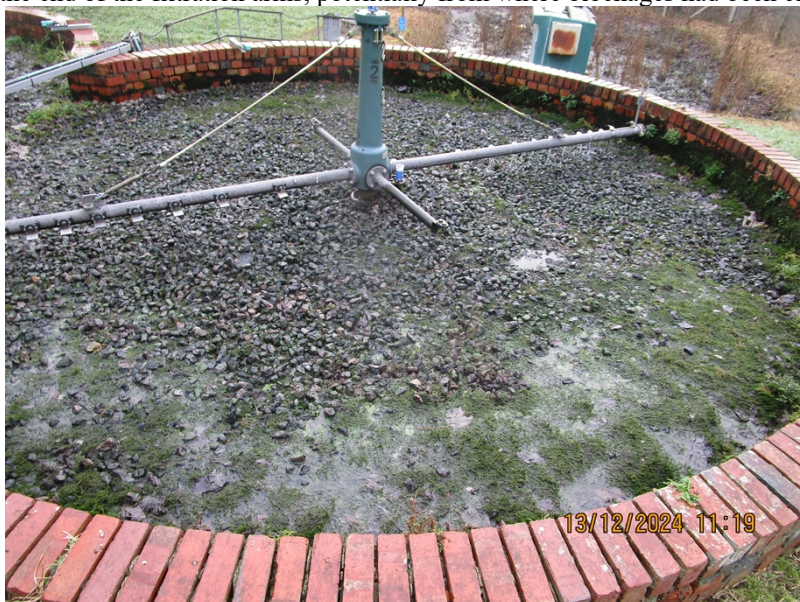
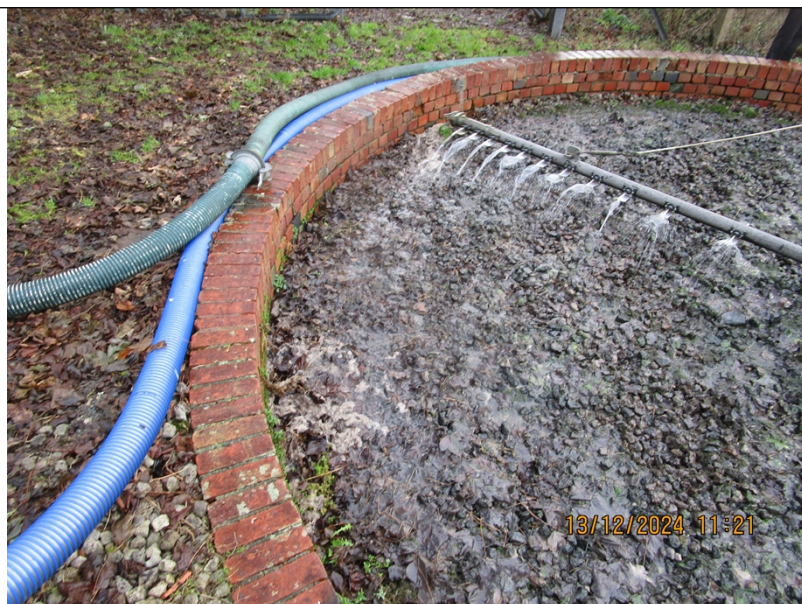
The works contains a two filter beds of stone media. The rotation arms were moving freely when discharging. There were no signs of blocked outlets, and the rotating arms appeared to be distributing effectively. The filter beds had some coverage of moss growth on the surface of the filter., however this was not excessive.

Both filter beds had areas of pooling on the surface of the filter bed, each tank had one area of more significant pooling. There had been significant rainfall in the days preceding this inspection, which may have contributed to this pooling. This this should be monitored and managed to ensure the pooling does not prevent the flows receiving sufficient filtration. There were some areas where there was rag present on the surface of the filter bed, these appeared localised to the end of the filtration arms, potentially from where blockages had been cleared.

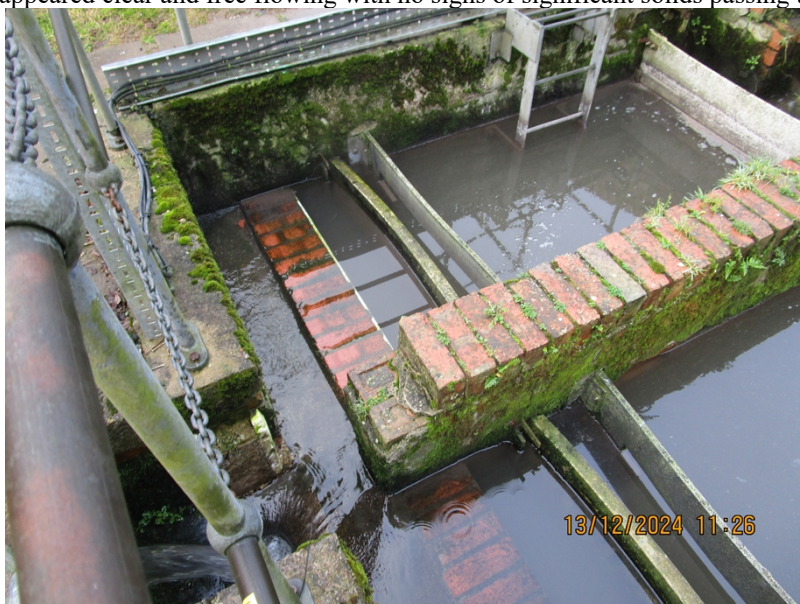
The final settlement tanks on the works are two small rectangular tanks with retention boards to slow the flow down and prevent solids passing over. The final settlement system appeared to be operating effectively. The outfall channel tank appeared clear and free flowing with no signs of significant solids passing through or sewage fungus growth.

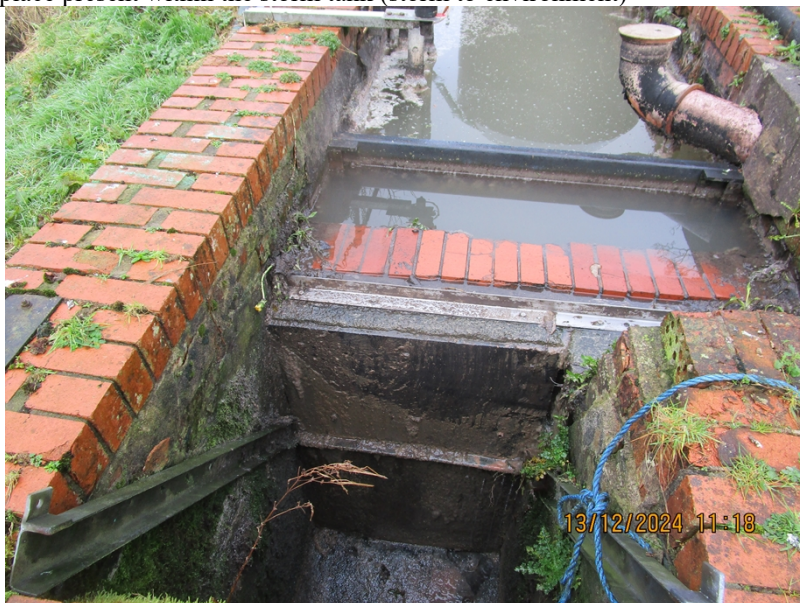
The storm tank on site is located next to the two primary settlement tanks. It is a brick built open rectangular tank. At the time of inspection, the storm tank was completely full and just below the level where the storm tanks would discharge. The storm tank when filled is pumped back to the head of the works on a set timer. There is an EMD level sensor in place present within the storm tank (storm to environment)

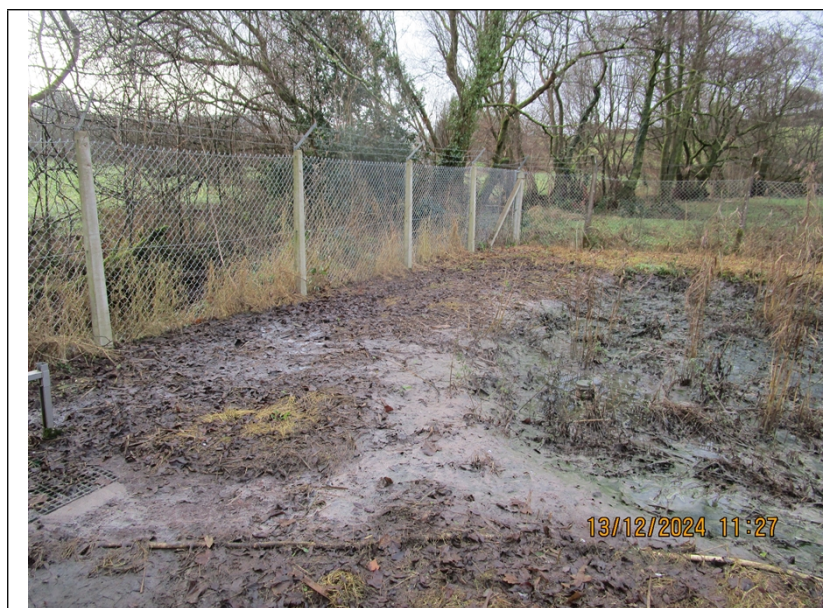
At the time of inspection there it was evident that the reed bed on site had recently flooded and spilled out of its housing. The excess water had travelled over land within the works compound and had flowed into the final effluent channel. As a result of the flooding, the discharge from the storm reed bed has been made via the works outfall (and partially over land) and therefore not via the designated storm channel. This would usually be considered a noncompliance against permit conditions. I am satisfied at this time that this was because of heavy rainfall and surface flooding at the location. It is likely this occurred as a result of named storm Darragh, which resulted in significant surface water flooding within the area. As such I do not feel it would be appropriate to record this as a noncompliance against the permitted conditions. As there were no signs of negative impact on the receiving environment and the watercourse appeared clear at the time of inspection.
