Compliance Assessment Report CAR_NRW0045835

Permit being assessed: XP3830UR.

For: Haverfordwest Creamery, **held by:** The First Milk Cheese Company Ltd

Type of assessment: Site Inspection,

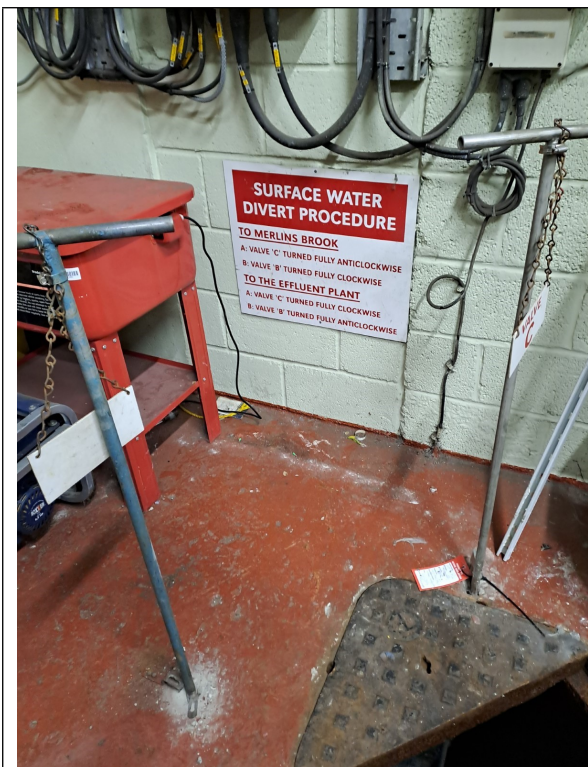
1.1. Manual isolation valves - Valve located within the engineering stores which currently diverts all surface water from the site to the ETP (Image 1). The manual isolation valve located within the Engineering stores building (located adjacent to the northern site boundary), has been shut and is locked in a closed position meaning all surface water from several site locations is diverted to the ETP and not out via the W1 outfall. A surface water procedure sign was displayed in the area.

Image 1 - Manual Isolation Valves within the engineering stores

ACTION 1 - Provide written procedures for the diversion mechanisms in place for the

surface water runoff from site to the ETP, in particular, areas that previously drained to emission point W1 (including actions and checks to be undertaken by staff). Please also provide evidence of sufficient capacity at the ETP to cope with storm event.

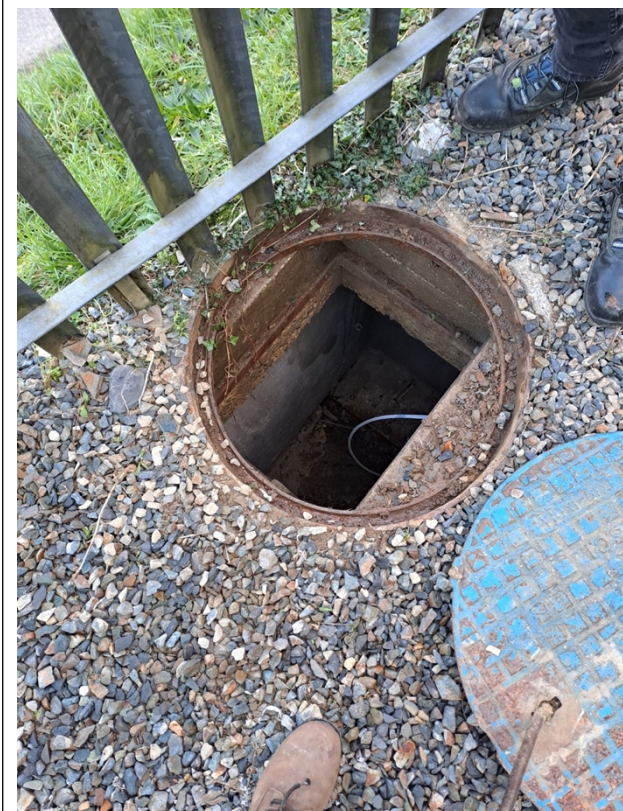
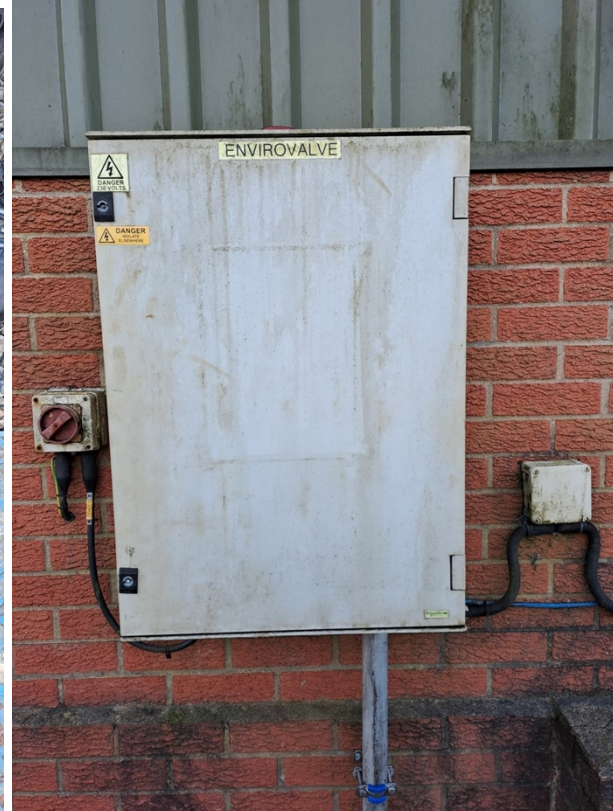
2.2. Inflatable bladder - Within the line running from the valve area within the engineering building to the W1 outfall, there is an inflatable bladder in place. This bladder has an airline linked to a pH meter located within the engineering stores (Image 2). If effluent enters the line outside of the parameters of the pH meter, the Envirovalve device (Image 3) is triggered, and the bladder is automatically inflated to seal the pipe.

Image 2&3 - Airline to the inflatable bladder from the Envirovalve system

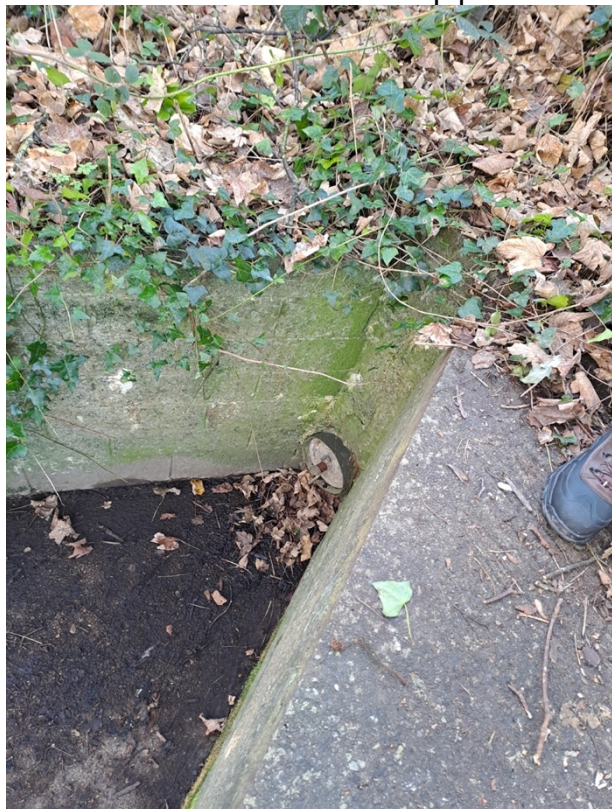
2.3. Bung - The final mitigation measure is the use of a manual bung at the outfall which seals the end of the pipe – this bung can be observed at the outfall (Image 4).

Image 4 - Bung at the outfall

The outfall itself appeared in good condition, the bung was visible with no evidence of leaks or spills of any liquids from the outfall onto the plinth. Merlin's Brook appeared to be flowing clear with no evidence of any pollution or matter to give rise to any concerns. First Milk employees undertake a weekly visual check of the W1 outfall.

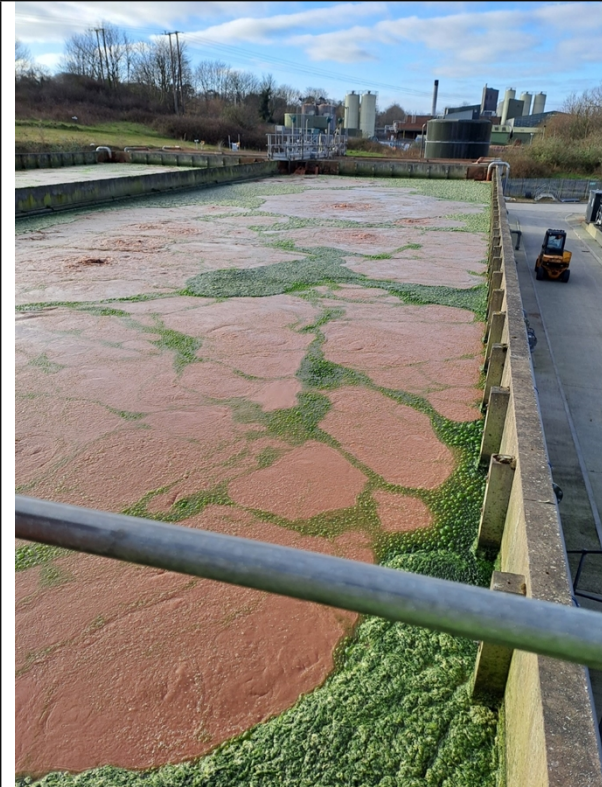
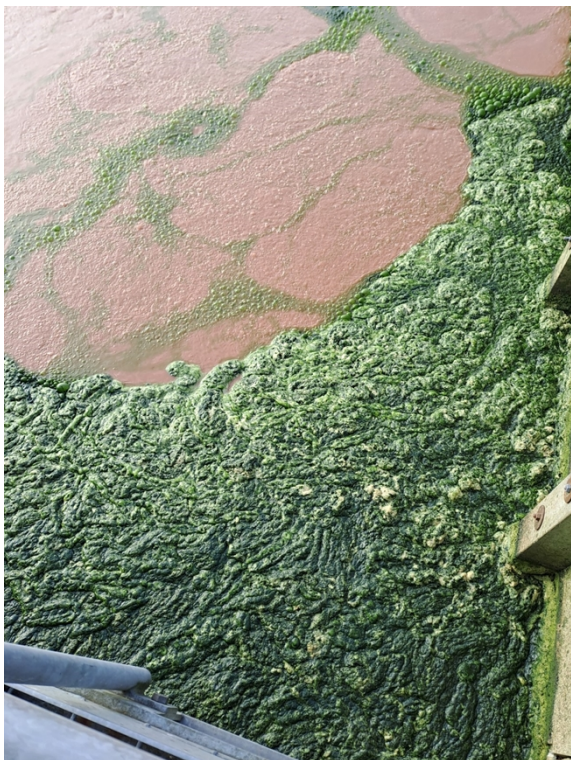
A green algae within the ETP aeration lanes was first identified during a previous site inspection on 16 July 2024 and documented in CAR_NRW0044817. During the time of the previous inspection AOL stated that the algae was likely due to the ambient temperature and usually dissipates over night as the temperature decreases. This algae was observed once more on the 11 December 2024 and appeared to be in a significantly greater volume compared to the previous observation. The presence of algae indicates high levels of nutrients.

Image 5&6 - Green algae seen within the ETP aeration lanes

AOL again stated that further investigations had been undertaken, and the algae appears to have no impact on the final discharge with the effluent remaining within the parameters

ACTION 6 - Please provide further information on the conclusion of the investigations into the root cause of the green algae. Please also provide evidence demonstrating that the algae is not impacting ETP performance and/or the final discharge.

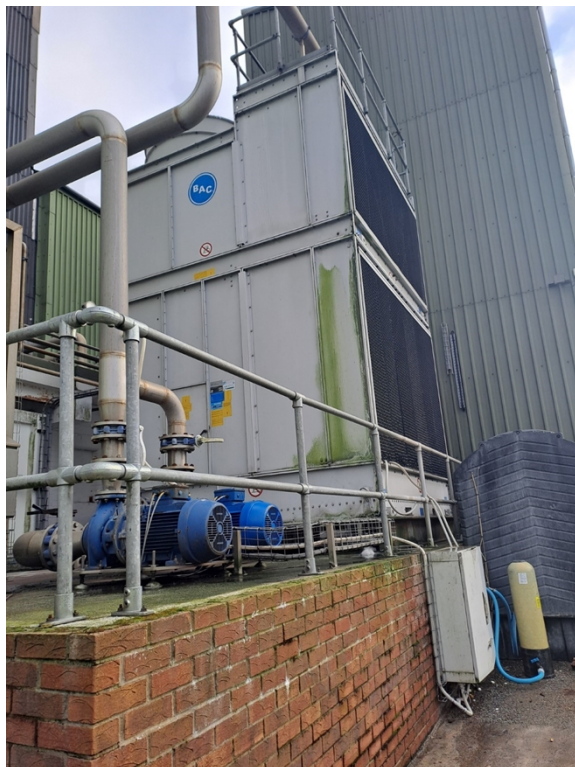
Main evaporator/main evaporator pump (Image 7);

During the inspection, varying noise was heard within the site boundary. During NRW Officers first arrival to site, noise generated by the main evaporator was most dominant.

First Milk talked NRW Officers through their proposed noise improvement programme with the first improvements lined up for Q1 2025. Proposed improvements included a range of mitigation options e.g. acoustic barriers.

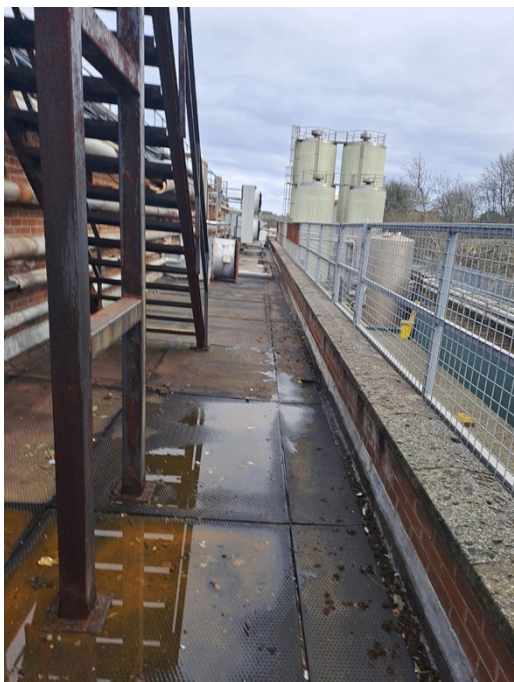
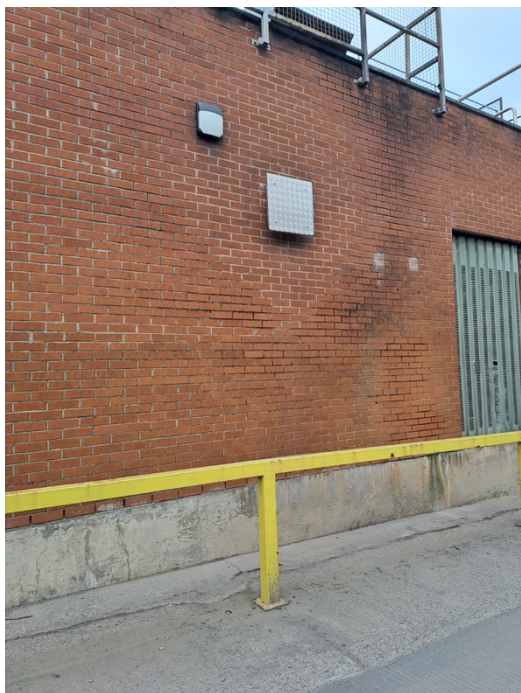
Cheese room outlet, vacuum pump room outlet and condenser fans (Image 8&9);

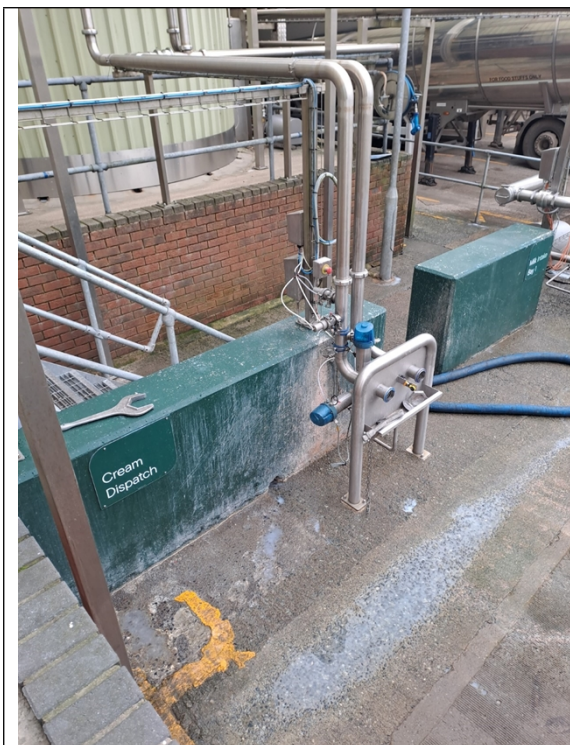
Cream dispatch pump (Image 10);

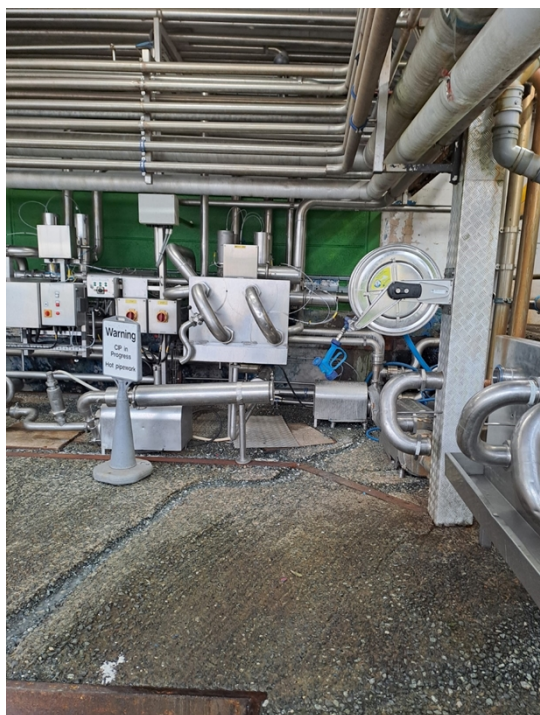
Milk intake pumps (Image 11);
