## Compliance Assessment Report CAR\_NRW0046436

**Permit being assessed:** AB0076001

For: Libanus Wastewater Treatment Works, held by DWR CYMRU CYFYNGEDIG

**Type of assessment carried out:** Site Inspection, Reason: Routine.

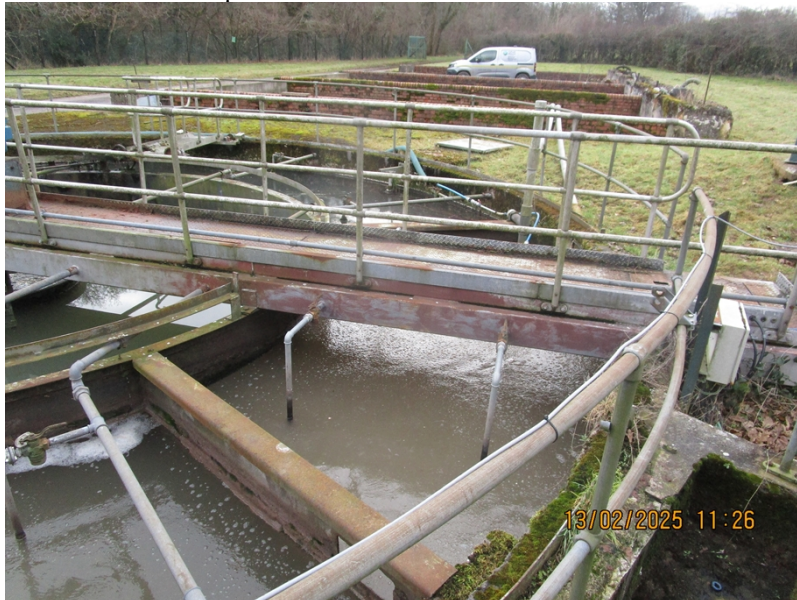
The macerated flows from the inlet then pass into the main treatment chamber of the works, which is located closest to the inlet of the works. This chamber is the activated sludge tank which has aerators to maintain the required Dissolved oxygen levels within the tank to encourage bacterial breakdown of the influent. A dissolved oxygen probe is in operation to monitor levels and was clearly operation at the time of the inspection. The aeration pumps operate on a set timer to control the oxygen levels within the treatment chamber. At the time of inspection, the aerators were not initially active. I questioned whether this was an issue, as without aeration there could be a reduced amount of treatment. I was advised that it was likely as a result of the incoming flows containing higher levels of dissolved oxygen, in which case less aeration would be required.

1. Clean up the sewage fungus build up within the Final Settlement out and below the outfall into the river. Provide confirmation and pictures to show that this has been completed by 13/03/2025.
2. Advisory Action- Investigate whether changes are required to the aerator timing sequences to improve the treatment process. As the aerators did not appear to be running for quite some time whilst on site. Improved aeration may help improve effluent quality.

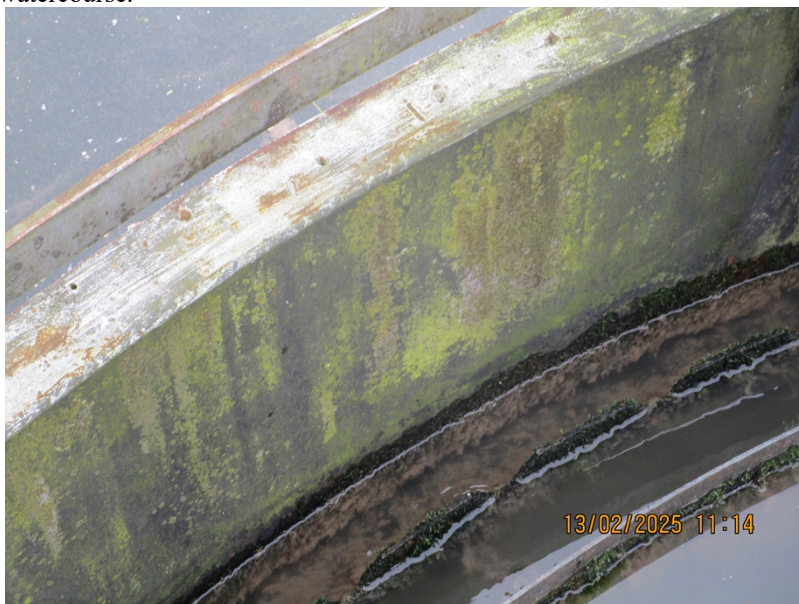
In the centre of the treatment system tank is a circular Final settlement tank. The tank does not have a rotating bridge in place and uses scum retention boards, to hold back solids from the outfall and to promote sludge settlement. There did not appear to be any significant solids passing over into the outfall channel. However, there was a visible and persistent build-up of sewage fungus present within the outfall channel, suggesting a high ammonia content or issues within the treatment process. The level of build-up is a cause for concern, as it indicates that appropriate maintenance and cleaning has not been taking place, which increases a risk of pollution being caused, especially as there is no further staged of treatment before the outfall. This is therefore a breach of permit condition 1.1.1 (a) which states.

This has been classified as a category 3 noncompliance, as this could potentially have a minor impact on the receiving watercourse.

| Criteria | Action needed | Complete by |
|---|---|---|
| WQ-A1 | Clean up the sewage fungus build up within the Final Settlement out and below the outfall into the river. Provide confirmation and pictures to show that this has been completed by 14/03/2025. | 14/03/2025 |

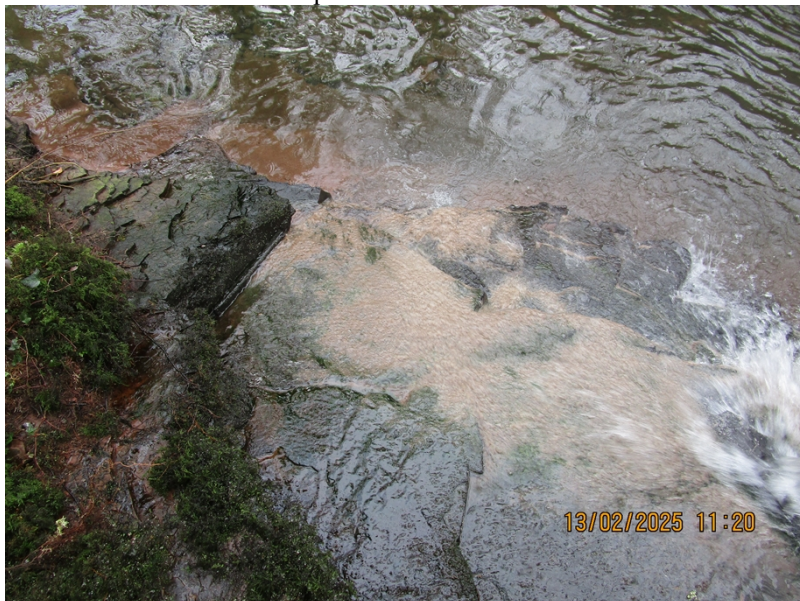
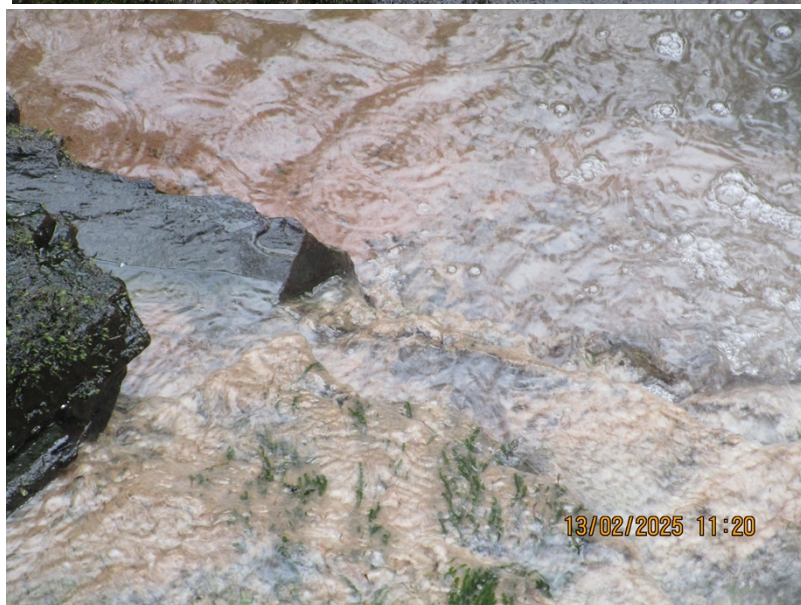
The outfall into the Afon Tarell was inspected, and there was a visible build up of grey sewage fungus on the surface of the rocks below the outfall pipe. The fungus was present on all parts where the effluent passes over the rocks, which is partially due to the outfall pipe being situated further back on the riverbank. During higher flows it is likely that the river is much closer to the outfall pipe. The sewage fungus build up indicates high nutrient levels within the effluent over a period of time and is a negative impact on the receiving environment. This is therefore an additional breach of permit condition 1.1.1 (a), as the effluent is clearly having a negative impact on the receiving watercourse (and riverbank).

This has been classified as a category 3 noncompliance, as this could potentially have a minor impact on the receiving watercourse. There were no signs of downstream discolouration or sewage fungus present within the main body of the watercourse at the time of inspection.

The sewerage fungus present on the riverbank below the outfall (and final settlement outfall channel) is a cause of concern as it suggests issues with the treatment process and poor effluent quality. Records do not show that there have been any recent sampling exceedances at this location, however there is a clear visual impact. The site received updated emissions limits effective 15/12/2023. The works appears to require increased monitoring/maintenance, to prevent the excessive sewerage fungus build up which was present at the time of inspection.
