## Compliance Assessment Report CAR\_NRW0046354

**Permit being assessed:** BR9685IX.

**For:** Barry Silicone Plant, **held by:** Dow Silicones UK Limited

**Type of assessment:** Audit,

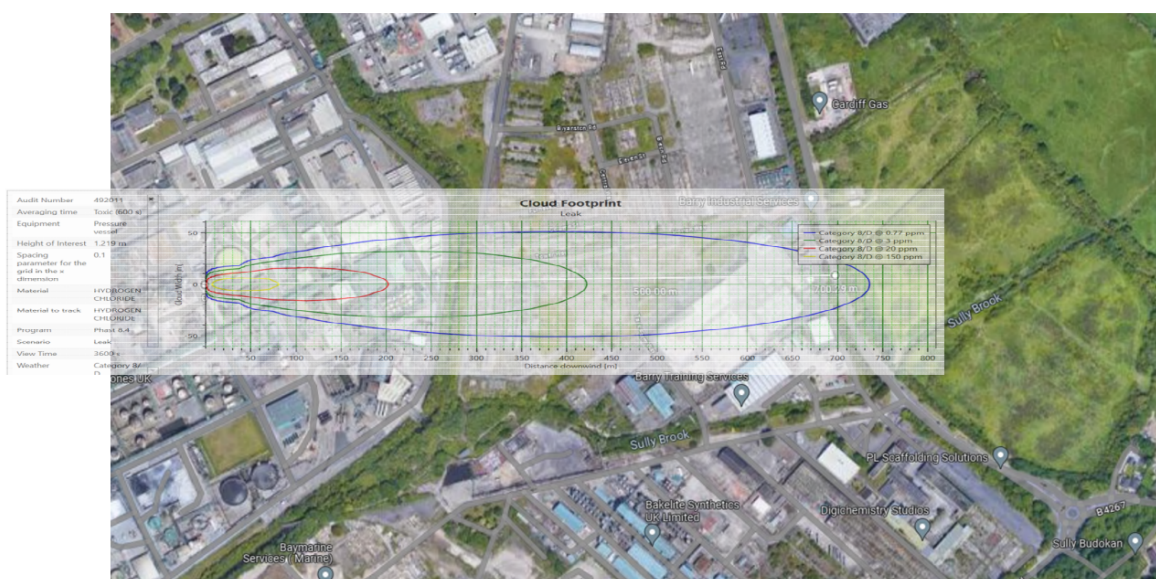
#### PHAST MODEL

Dow's PHAST modelling output, below, shows the worst-case scenario at the peak of the release, with the ERPG guideline concentrations overlaid.

- The Yellow line shows the point where ERPG 3 is exceeded at 150ppm – 75 m from the release point
- The Red line shows the point where ERPG 2 is exceeded at 20 ppm – 200m from the release point
- The Green line shows the point where ERPG 1 is exceeded at 3 ppm – 425m from the release point
- The Blue line shows the point where the odour is no longer detectable at < 1ppm – 700m from the release point

This modelling represents a worst-case scenario whereby none of the emissions would have been abated. This was not the case, since the application of water occurred within minutes. However, notwithstanding the application of water application, NRW, considers permit condition 3.2.1 to have been breached during this incident. To breach this condition three key facets need to be considered, these include:
