Compliance Assessment Report CAR_NRW0046621

Permit being assessed: BC0018601

For: Llannant Wastewater Treatment Works, held by DWR CYMRU CYFYNGEDIG

At: Llannant Road, Gorseinon, Swansea, SA4 4ND.

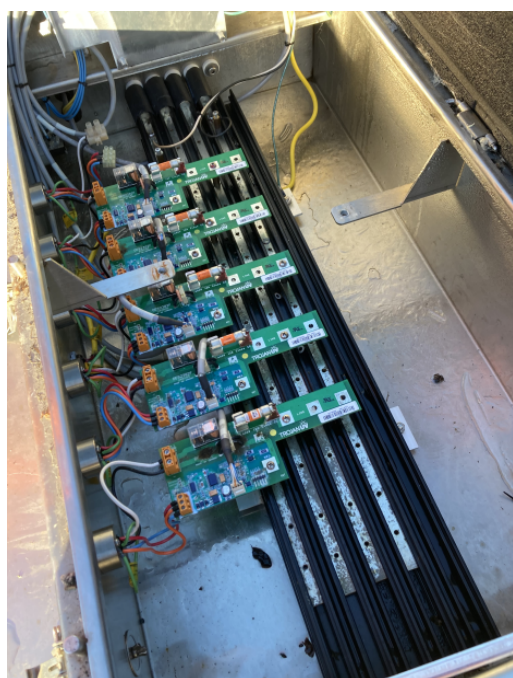
Power to the UV system could not be restored following this process which indicated that there may be a fault further down the communications link. The cubicles housing the motherboard and individual UV module controllers are situated above each of the 3 UV banks and these are sealed weatherproof stainless-steel housings. Each cubicle was opened in turn and bank C cubicle was found to contain a small amount of water/ice in the base approximately a few millimetres deep. There was some indication of a small amount of corrosion present on some areas of the circuitry on the motherboard and module controllers.

Photographs below of bank C cubicle with thin layer of ice visible in base:-

The standard design of the communications cable between all 3 banks and the PLC is a 'daisy chain' design which means a single communications card serves all 3 banks and a fault or short circuit in the chain can potentially cause all 3 banks to be affected. Under normal circumstances when a bank becomes unavailable, provided the communications link is not severed or corrupted, the standby bank will be called into service and an alarm generated. In this instance the communication was corrupted due to the short circuiting or similar impact in the circuitry of bank C, and this caused all 3 banks to become unavailable until bank C had been electrically isolated from the communications chain.

An inspection of the cubicle could not identify the route that water had entered the unit, and this will be monitored over the next few weeks. A replacement motherboard and modules have been ordered and will be installed as soon as possible. In the meantime, the UV plant is operating on the duty/assist banks and is meeting the target measured applied dose.

I acknowledge that you could not have anticipated that the sealed weatherproof cubicle would allow the ingress of water and can accept that routinely opening the cubicles to inspect them could increase the risk of water ingress. However, **now that you have identified the risk, we would expect it to be taken into consideration when drawing up maintenance plans and UV alarm response procedures at this site and others that utilise the same or similar equipment. I recommend that you review your maintenance plan to ensure that it is robust enough to minimise all known risks.**
