## Compliance Assessment Report for: CAR\_NRW0046792 – Amended

<b>Permit number</b>	EPR/BX9471IU	<b>Operator name</b>	Tata Steel UK Limited
----------------------	--------------	----------------------	-----------------------

<b>Site name</b>	Trostre Works
<b>Site address</b>	Trostre, Llanelli, Carmarthenshire, SA14 9SD
<b>Type of assessment</b>	Site inspection

<b>Date of assessment</b>	17/02/2025	<b>Time in</b>	11:20	<b>Time out</b>	13:30
---------------------------	------------	----------------	-------	-----------------	-------

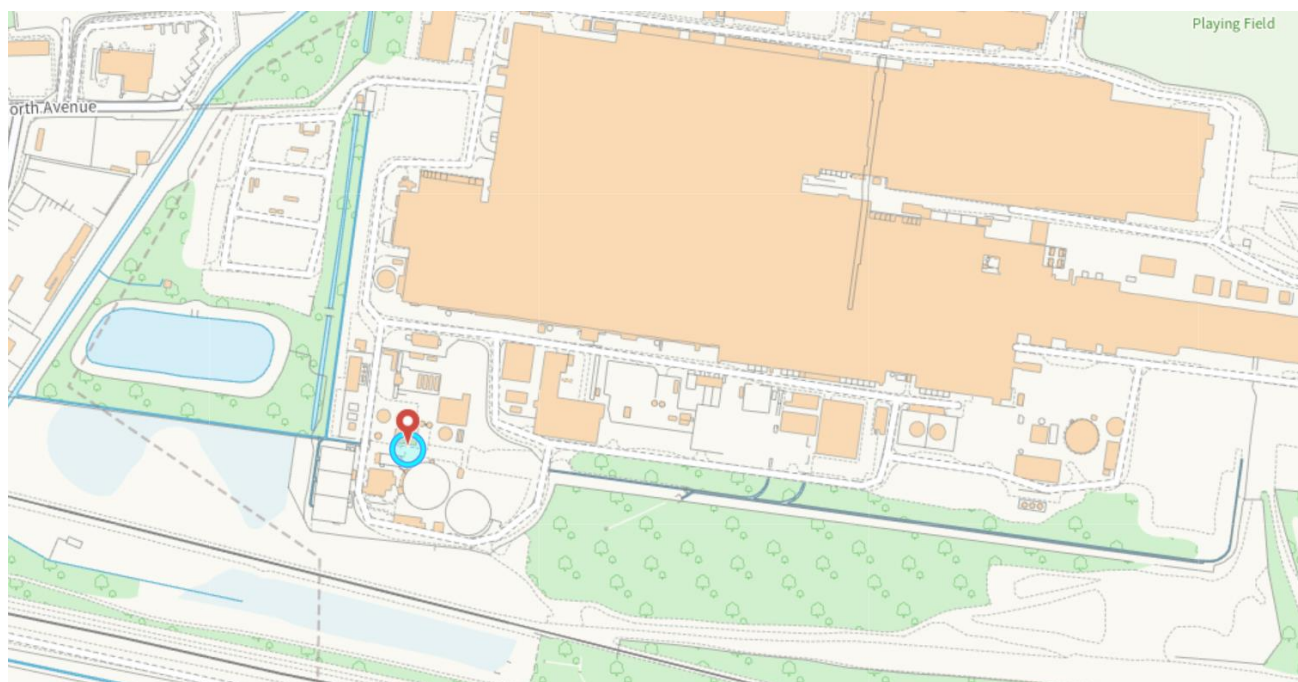
*Image 1 – Location of flume leak*

TSUK confirmed the incident was a result of a leak from the effluent flume which was detected on the 6<sup>th</sup> February 2025. The leak was located within the ETP area (made ground between the flume and clarifiers), national grid reference SS 52544 99186 as shown in *image 1*. The impacted section of the flume is of concrete and masonry brick construction with an internal fibreglass liner.

The leak was identified via an annual thermal drone survey carried out by a 3<sup>rd</sup> party specialist which identified an increase in ground temperature emanating from the flume flowing in the direction of the clarifiers; which are located within the southeastern corner of the ETP area. TSUK informed NRW that there was a delay in submitting the Schedule 5 Notification to NRW in order to facilitate a follow-up drone survey in order to confirm the presence of the leak.

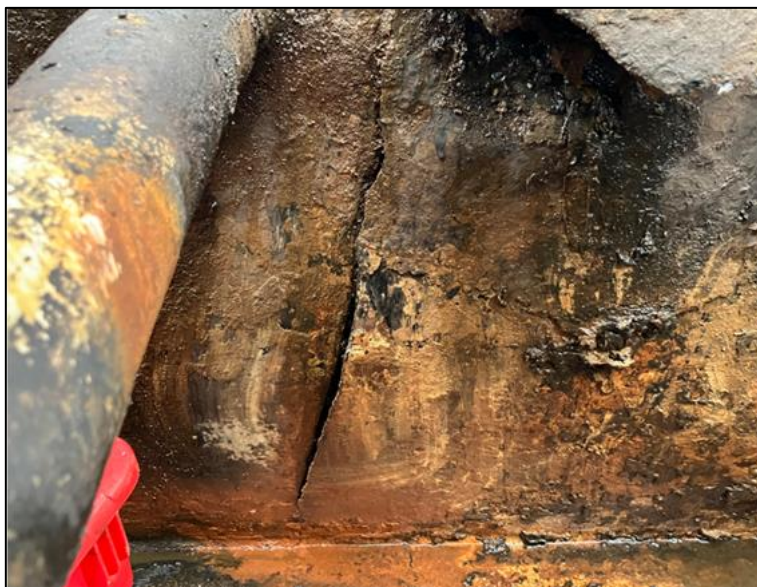
Upon further inspection, and following the damming of the flume, TSUK identified the presence of a 16” crack on the fibreglass liner of the flume wall, which allowed for the escape of contaminated liquid to ground within the ETP area. Thermal imaging showed the fluids path flowing towards the clarifiers (*drone survey draft report – s2502 Flume Leak Trostre – February 2025 (002)*, submitted via email on the 27<sup>th</sup> February 2025 by TSUK Engineering Manager).

Image 2 – Crack in flume wall

TSUK at this time are unaware of how long the leak had been taking place and the quantity of effluent released to made ground between the flume and clarifiers is unknown. Prior to the recent thermal drone survey carried out in February 2025, where the leak was first identified, the previous thermal drone survey was conducted on the 12<sup>th</sup> February 2024.

TSUK confirmed the crack was present within the flume which contains effluent from the factory's pickling line and other sources. The effluent at this point had not yet been treated by the ETP. At the same location, incoming effluent from the tank farm (which includes chromium, a product used on site) is discharged to the flume. Chrome is piped directly from the production line to the tank farm, treated and then discharged into the flume.

**ACTION – TSUK to repair the crack identified (and any additional cracks/issues identified as part of the annual drone survey work) in the flume with appropriate materials. TSUK to submit evidence of repairs taken place, including details of materials used – Already complete.**

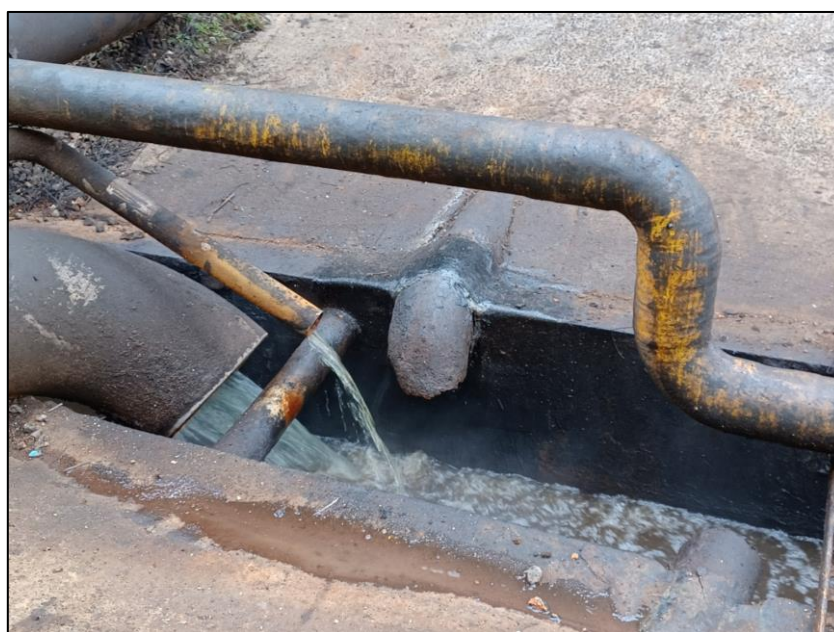
NRW Officers observed the flume area where the failure had been identified. It was evident that repair work had been completed since the original notification, as shown in *Image 3*. TSUK informed NRW that to ensure the integrity and longevity of remediation works, they have opted to deploy a fibreglass sheet to encompass the area of failure as opposed to a smaller localised repair. TSUK also confirmed that they had allowed sufficient curing time (>24 hours) to ensure the deployed fibreglass repair hardened<sup>3</sup>. Inspection of the failure point from the opposite bank of the flume showed no obvious signs of failure from a visual perspective.

*Image 3 – Flume following remediation works*

**NOTE –** TSUK/Veolia confirmed that monthly visual flume inspections were carried out prior to the flume leak incident and have now (temporarily) converted to having weekly flume visual inspections. NRW would recommend reviewing the flume inspection frequency and maintaining a weekly visual inspection. The use of thermal imaging cameras as part of the visual inspections should also be considered by TSUK.

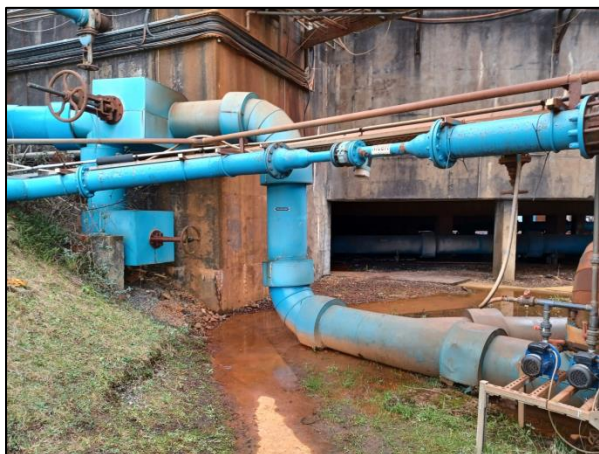
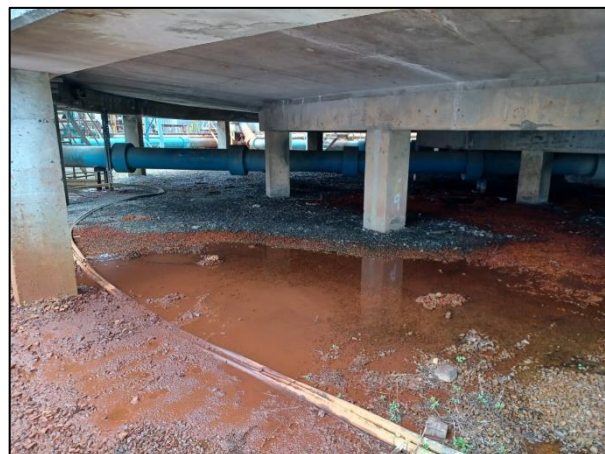
NRW Officers walked to the southern boundary of the site to inspect the AOI beneath the clarifiers. NRW Officers observed pooling of effluent in the area of the clarifiers. TSUK claimed that a plastic liner (of unknown composition) is in place under the clarifiers overlain by stone chippings. TSUK claim the plastic liner is in place and working effectively in minimising migration of contaminants to groundwater as pooling of water/effluent was evident. At the time of the inspection, TSUK/Veolia were unable to immediately access the records for the liner and they have been tasked to obtain this – see action.

Image 5 and Image 4 – effluent pooling at clarifiers

TSUK stated the effluent pooled within the clarifier area and was contained and no effluent had run off to any surface water bodies. NRW Officers observed that effluent appeared to be contained within the ETP area and no evidence of run-off to a drainage ditch to the south of the site boundary was evident. However it should be noted that there are no groundwater monitoring points downgradient of the ETP. NRW informed TSUK that they should determine a suitable remediation methodology as soon as practicable to be carried out by competent contractors using the appropriate equipment.

**ACTION - TSUK to provide details relating to the ground “plastic” liner installed at the ETP. The submission should include: date/s of the liner installation; the specification of the liner; details of how the liner panels were welded, details of the liner protection (e.g. geotextile protection fabrics); the extent of the liner deployment (including a drawing); liner/jointing detail around any penetration through the liner (e.g. clarifier concrete support etc.); any engineering reports or construction quality assurance documents.**

**ACTION - TSUK to submit their records of maintenance inspections and integrity checks on the liner system installed at the ETP.**
