PENRHOS SUBSTATION

Site Walkover Summary

794-ENV-GDE-21696
Penrhos Substation
1
15 April 2025

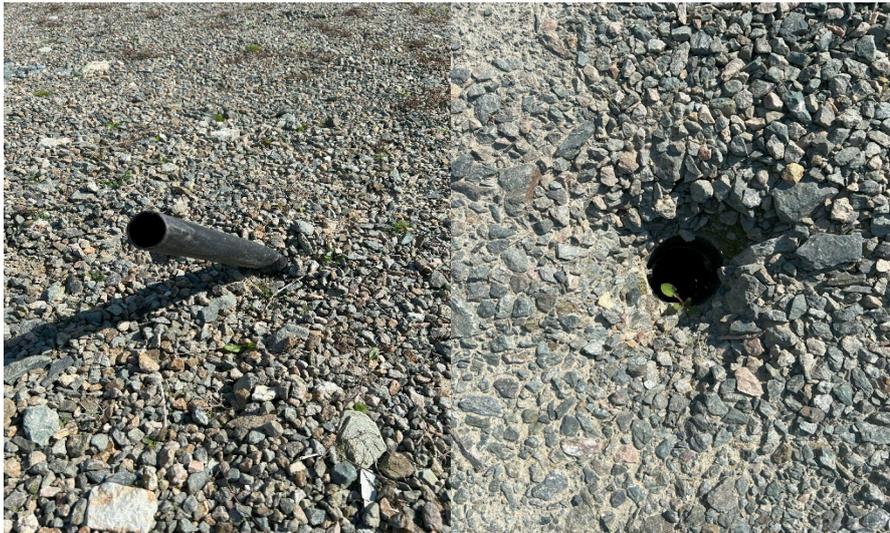
Picture 1: Boreholes on the substation compound

1a - Bent borehole

1b - Silted borehole

investigation was to identify and inspect any remaining installations to see if they could be repurposed for further monitoring. Picture 1 shows the only two installations identified during the walkover of the original substation site. Picture 1a shows a monitoring well which has been damaged by the previous demolition works at the compound. The angle of the bend in the pipe did not facilitate the procurement of a water level measurement. Picture 1b also shows a borehole which is intact at the surface. This borehole was, however, filled with sediment from a depth of 51cm below ground level (bgl) and therefore water level data was not able to be collected.

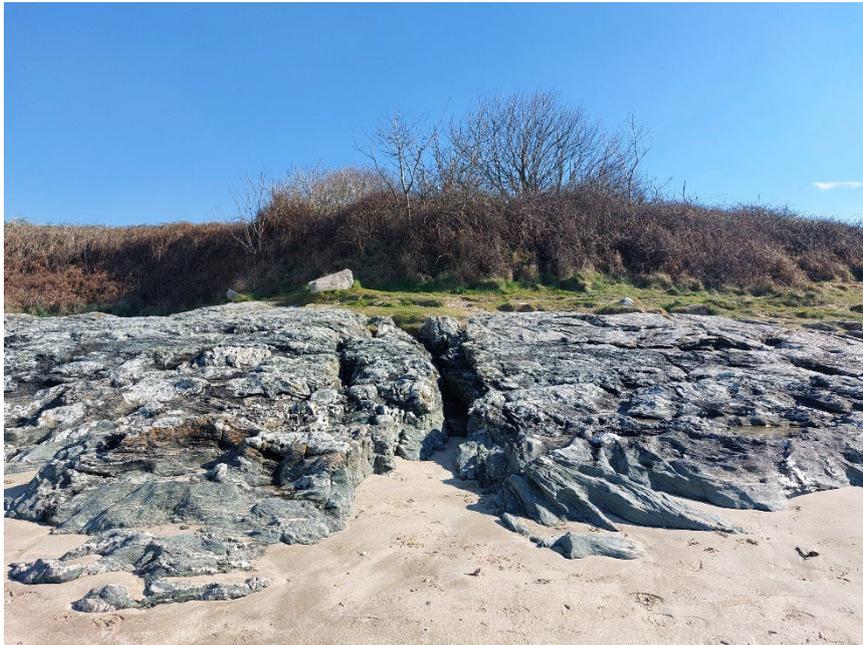
Picture 2 Outcrop of local bedrock observed at NGR SH 27557 81401 facing south

- 3.8 An exposed outcrop of the local bedrock was viewed at L7, at the northern end of Penrhos coastal park. The bedrock was observed to be comprised of competent but highly eroded, fractured schist, as shown in Picture 2.
- 3.9 Picture 3 depicts a close-up image of the bedrock texture. The rock texture is foliated, and the matrix is fine grained and crystalline. The high degree of foliation with persistent green colouration, indicates a high proportion of planar phyllosilicate minerals, particularly chlorite. Localised areas with a higher density of quartz veining were common.
- 3.10 Preferential erosion of jointing and fractures was observed to be the primary form of porosity.

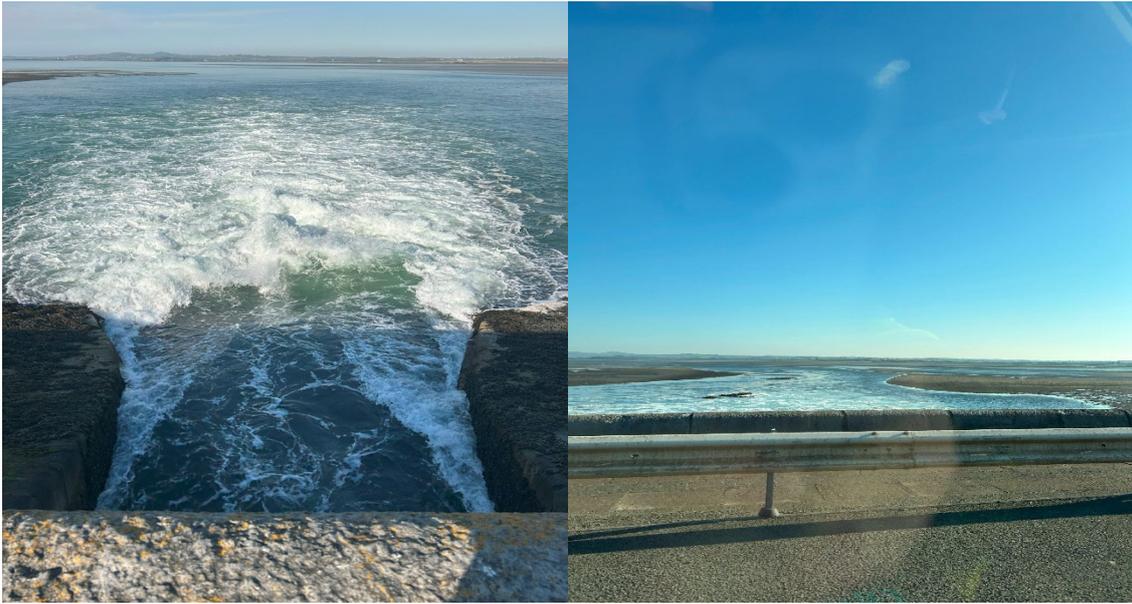
Picture 4: Embankment through-flow at high and low tide, facing north. NGR SH 27874 80162 Photos were captured at approx. 3pm 01/04/25 and 08:48 am 02/04/25 respectively.

- 3.11 Surface water drains were observed to be present at regular intervals along Holyhead Road which runs along the northeastern side of Stanley Embankment.
- 3.12 Photographs were taken facing northeast from the embankment at NGR SH 27874 80162. Picture 3a was taken at approximately 3pm on the 1st of April and depicts flow conditions at the Stanley Embankment resulting from the falling tide passing through the embankment just after high tide. Picture 3b was captured on the 02/04/25 at 08:48 am on the rising tide shortly after low tide. Tidal fluctuations were observed to be in the range of 2-3m.

5a Embankment through-flow at high tide conditions

5b Embankment through-flow at low tide conditions

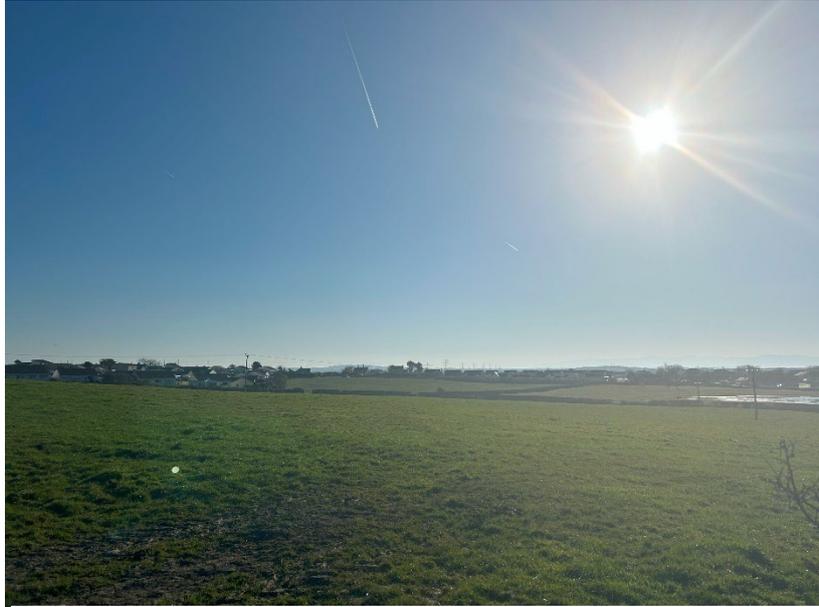
Picture 5: Location 10, facing east, taken at NGR SH 28612 79859

- 3.13 During the site induction, the RPS personnel were advised that a bull was present in the field at L10. Subsequently, no attempt was made to access the field. Picture 6, facing NEE depicts the terrain along the proposed cable corridor from the gate at NGR SH 28612 79859. Ground conditions were observed to be dry with some slight dew and moisture on the grass. The soil was noted as appearing to have a low clay content and the field well drained. Terrain in the field was observed to slope from northwest to southeast.

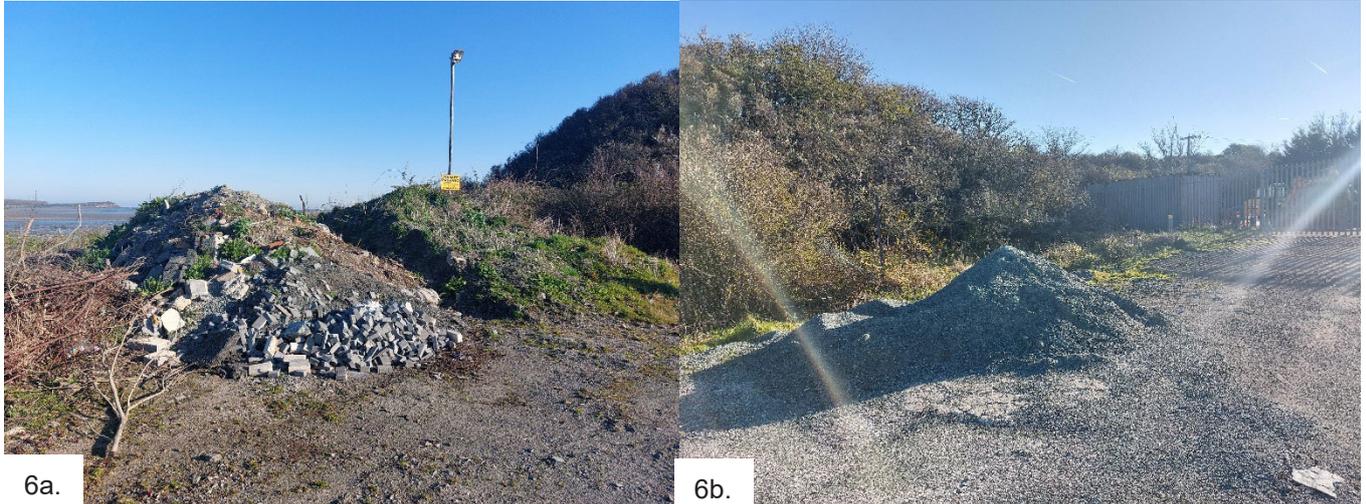
Picture 6: Spoil heap (6a) and aggregate mound (6b) in the carpark of Derwyn garage

- 3.15 L9 is the point where the cable corridor moves from the North Wales Expressway, across Derwyn Garage, onto agricultural land. The existing cable runs under the car park of the garage; up a slight are of inclination and onto agricultural land. Picture 6a and Picture 6b depict spoil heaps and aggregate mounds which were observed in the carpark at NGR SH 28504 79856

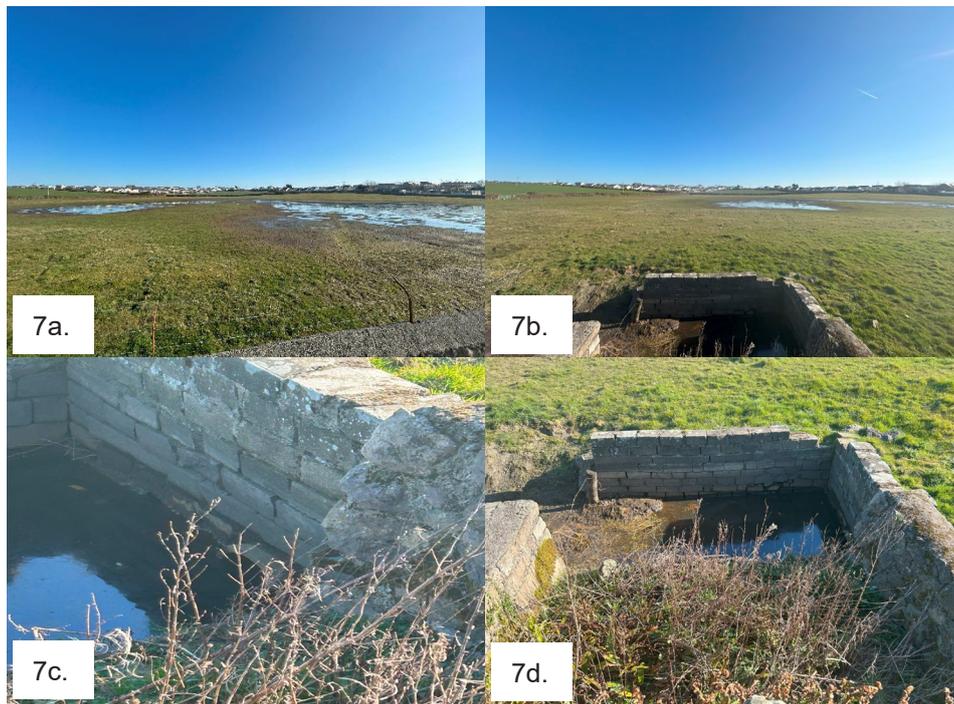
Picture 7: Ponding and drainage features at Location 10, facing north

- 3.16 L13, situated at NGR SH 27557 81401, was selected for investigation due the area exhibiting very poor drainage conditions. The area is downgradient of the alignment of the proposed cable corridor and is situated at an elevation of 4-5mAOD. The field was severely waterlogged, despite persistent dry weather conditions, with a large area of ponding (see Picture 7a). A drainage ditch was present along the southern boundary (Picture 7c & d), which connected to a culvert. Flow in the ditch appeared stagnant. It is not currently known where the culvert leads.

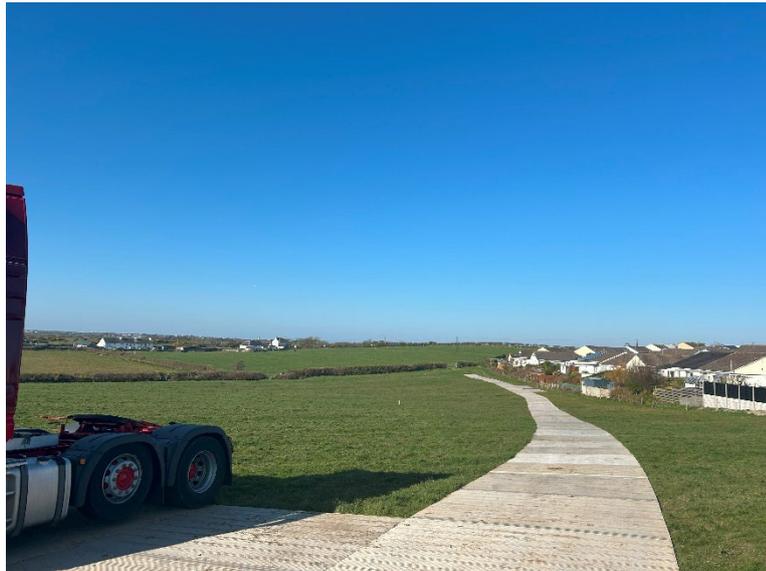
Picture 8: Location 12, facing west NGR SH 28996 79909

- 3.17 L11 & 12 lie to the west of Gorad Road. As detailed in Table 1, L11 and L12 were selected as locations of investigation in order to observe the ground conditions along the land between Delwyn Garage and Gorad Road that falls within the red line boundary for the cable corridor. L11 and L12 were located in the same field. The circumference of the field was walked and no discernible change in ground conditions was observed. Ground conditions were observed to be dry with a fine sandy, slightly clayey soil texture.
- 3.18 During the visit track matting was being laid down across this field for the purposes of ground investigation. Waterlogging was not observed to be present at L11 or L12. The field slopes southwest, towards Location 9. Picture 8, taken at L12 facing southwest depicts the site.

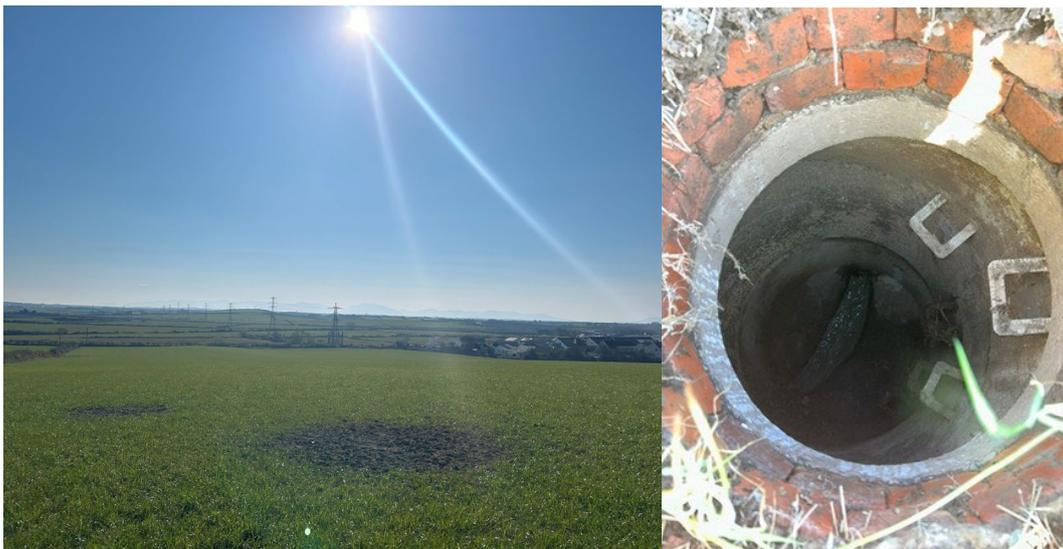
Picture 9: Location 14 ground conditions and drainage feature.

- 3.19 L14 lies halfway between Gorad Road and the point of grid connection at tower EV86. This field slopes eastwards, towards the pylon. Track matting was also being laid here during this visit (See SW16, Appendix B). Ground conditions in the field were generally dry asides from at the lower lying, eastern edge of the pasture where waterlogged ground conditions and wetland vegetation species were observed (See SW19, Appendix B).
- 3.20 Drainage ditches were observed at SW19 running along the eastern and southern boundaries respectively. Minimal water was observed in these ditches which were heavily vegetated.
- 3.21 A subsurface drainage feature, potentially a sewer was observed at NGR SH 29079 79911. The manhole cover had been displaced from the surface and the opening had been covered with

9a – NGR SH 29079 79911 Facing southeast, tower EV86 can be seen in the distance

9b - Subsurface drainage feature observed at NGR SH 29079 79911

temporary plastic matting for health and safety purposes. As shown in Picture 9b, an inspection of the hole revealed an access ladder down to a small sewer where brown water was observed running NW to SE.

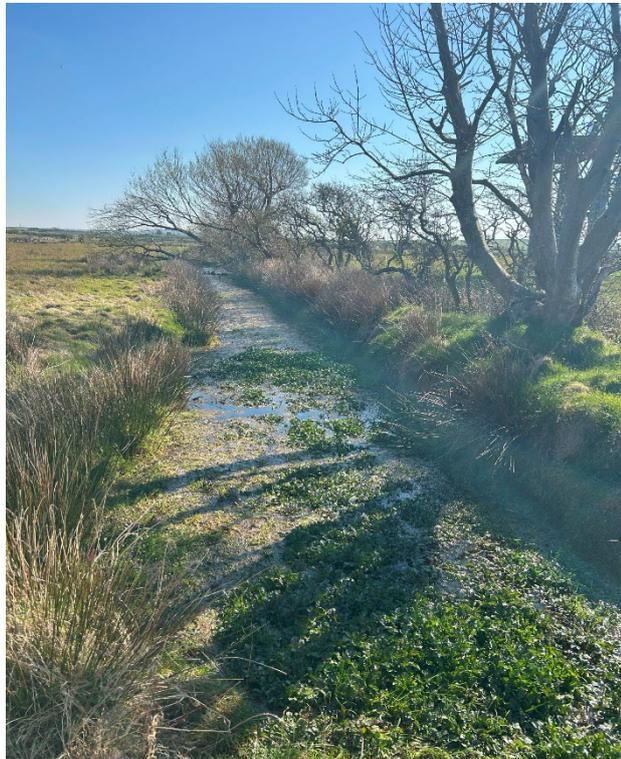
Picture 10: Field drain photographed at NGR SH 29357 79855, facing east.

- 3.22 L15, as shown in Picture 10, is a mapped surface water feature immediately to the north of tower EV86. Flow was inferred to be to the east from local mapping, but no directional flow was observed in person. The drain was observed to be approximately 2m wide with unknown depth. Surrounding ground conditions suggested the area was frequently waterlogged.
- 3.23 The field immediately to the south, containing tower EV86 (see SW20, Appendix B), was not observed as being waterlogged despite being exceptionally flat. Ditches were present along all boundaries however to facilitate site drainage. The ditch along the eastern boundary (see SW21, Appendix B), contained a large volume of water but was stagnant. The condition of the ditch along the northern boundary was similar.
