Compliance Assessment Report CAR_NRW0046630

Permit being assessed: AN0305101

For: SIX BELLS MINEWATER TREATMENT SCHEM, held by The Coal Authority
At: SIX BELLS MINEWATER TREATMENT, FORMER EMPRESS CAR SALES SITE, ADJ ABERTILLERY LEISURE CENTRE, ABERTILLERY, .

Type of assessment carried out: Site Inspection, Reason: Routine.

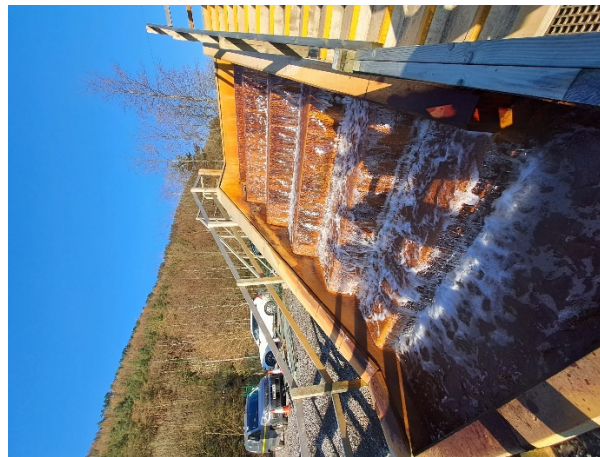
The cascade was observed to be in operation at the time of the visit, albeit intermittently due to the raising of the stop level as described above. There was no excessive build up of oxidised Fe, and the rate of flow was within the expected range. This can be seen in Figure 1.

Figure 1 – Cascade in operation at the time of the visit.

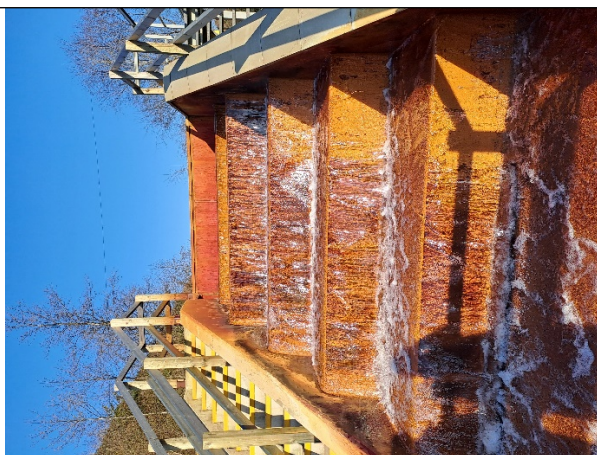
It was noted by MRA that since the installation of the current cascade ~2 years prior to this visit, a small defect regarding flow distribution has become apparent on the right hand cascade where the water favours a pathway on the left hand side (as seen in Figure 2). This has not caused an issues regarding the aeration and initial settlement of Fe, so continued monitoring and visual spot checks will be sufficient to manage the cascade, however if significant changes or issue develop because of this defect they should be assessed and remedied as soon as practicable.

Figure 2 – Right hand cascade displaying the flow distribution disparity, favouring the left hand side.

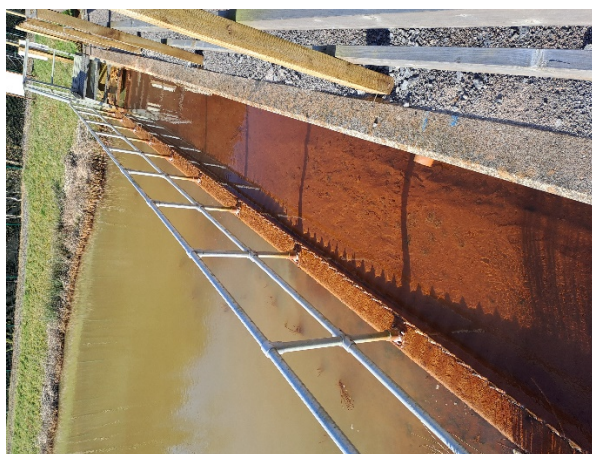
The outlet from the cascades (to both lagoons) were observed to be accumulating significant amounts of sediment and oxidised iron particles. While the discharge itself was clear, and flow was linear along the teeth I advised that a de-sludge of both outlets should be undertaken. The conditions observed during the visit are seen in Figure 3 (left hand outlet) and Figure 4 (right hand outlet).

Figure 3 – Left hand outlet with significant sediment build up at the time of the visit.

4. Organise and undertake a de-sludge/clear out of the cascade outlet channels prior to discharge into the settlement lagoons.

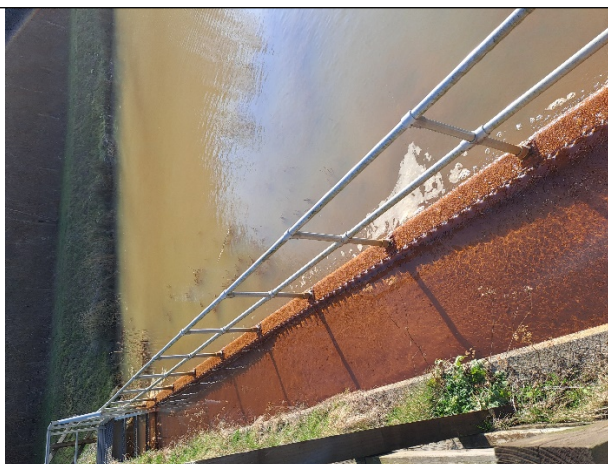
Figure 4 – Right hand outlet with significant sediment build up at the time of the visit.

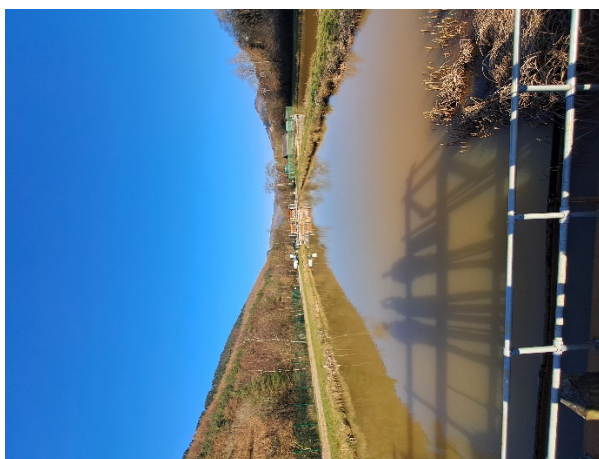
The settlement lagoons were in very good condition, as seen in Figure 5. It was noted that the most recent de-sludge was undertaken ~3 years prior to this visit. As per condition 10(c) of the permit (lagoon maintenance) *“all settlement lagoons shall be de-sludged at sufficient frequency and in such a manner to prevent excessive carryover of suspended solids”*, I request that the MRA review its management system for the site and make an assessment of when the next de-sludge will be undertaken.

Figure 5 – An example of the lagoon conditions at the time of the visit.

5. Assess and inform NRW when the next de-sludge of the lagoons will take place.

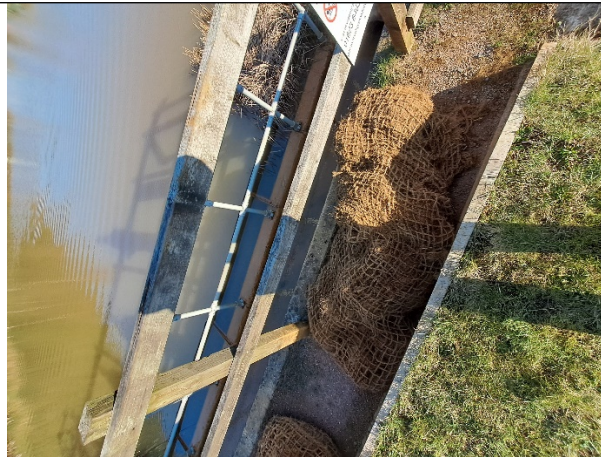
At the side of the lagoons it was observed that the flocculant matting placed near the lagoon outlets had been removed (Figure 6). It was stated this was done ~6 months prior to this visit. I welcome the cessation of their use as well as the MRA's proposals to vary the permit (as noted above) to enable continued reliable performance at the site. I request that the flocculant matting be removed from site by a registered waste carrier if it is no longer in use and constitutes a waste product.

Figure 6 – Flocculant matting removed from the settlement lagoons.

6. Remove and dispose of the used flocculant matting located at the outlet of the settlement lagoons. This should be undertaken by a registered waste carrier and copies of waste transfer notes kept for a period of no less than 2 years.

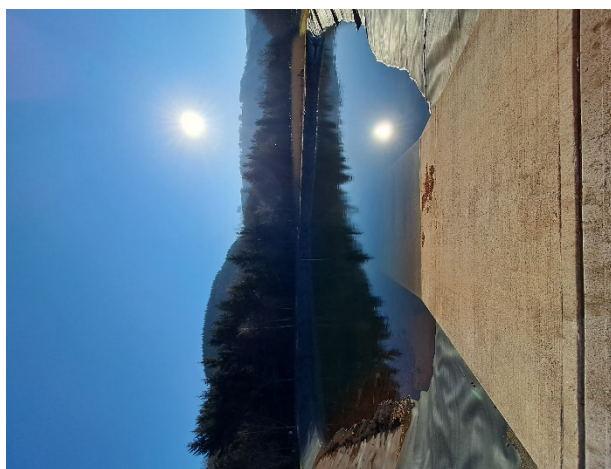
The drain down pond was not in use at the time of the visit but there was evidence of sediment build up on the northern side as seen in Figure 7. It was noted that there is currently no pump in the chamber, with safety concerns hindering the installation of a new unit. At the time of the visit the system was fit for purpose, but improvement possibilities were discussed, along with position statements signed by NRW officers. I will check with the relevant officers regarding this position statement and contact the MRA if any further information is required.

Figure 7 – The drain down pond as observed during the visit.

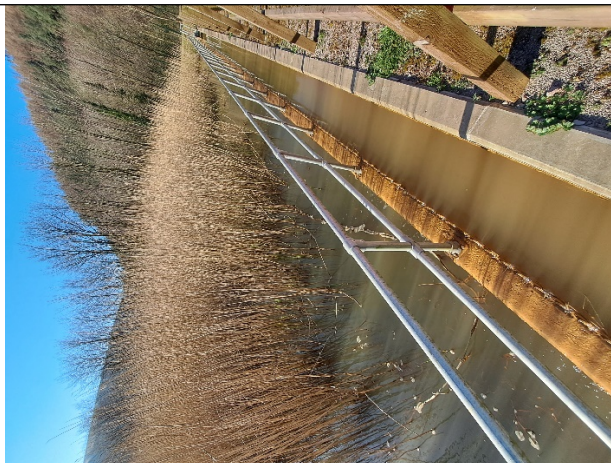
The reedbeds were assessed, with the inlet appearing mostly clear and linear flow across the teeth. The reeds themselves looked to be in a serviceable condition, with new growth beginning to show after the winter dieback. This is seen in Figures 8 and 9. At the time of the visit the reedbed was still treating the water effectively.

Figure 9 – The inlet to the reedbed as observed during the visit.

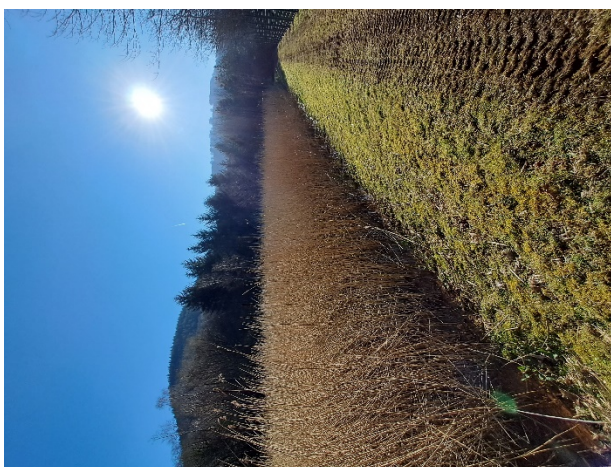
Figure 10 – The reedbed as observed during the visit.

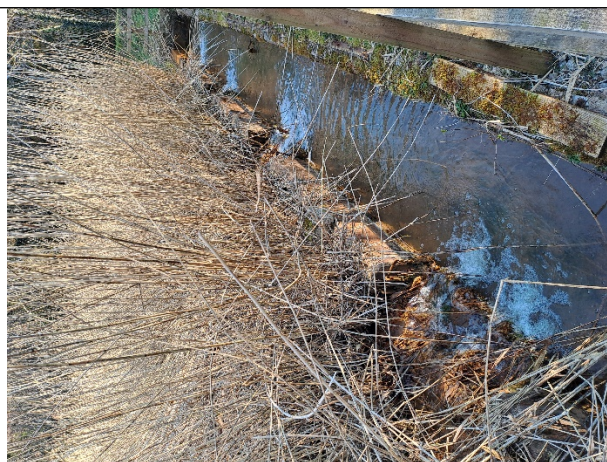
This reedbed is on an 18 month – 2 year cut programme, as stated by MRA operators. However, the last maintenance conducted was a full refurb ~5 years prior to the visit. As a result, it is overdue a cut. This was made evident when observing the outlet of the reedbed. As seen in Figures 11 and 12, there is a significant build up of dead and decaying vegetation in the castellations, causing the water to overtop in several locations (Figure 13). As per condition 10 of the permit (reedbed maintenance), I have breached the site on this and actioned a cut and clear out of the reedbed to address the issues observed. Please see below for further details.

Figure 11 – Outlet of the reedbed showing build up of vegetation impacting flow.

1. Clear excess vegetation from the Reedbed to ensure even flow distribution throughout. This can be done in conjunction with action 2 below.

2. Undertake a cut of the Reedbed and remove excess growth in line with the planned cut regime. This can be done in conjunction with action 1 above.

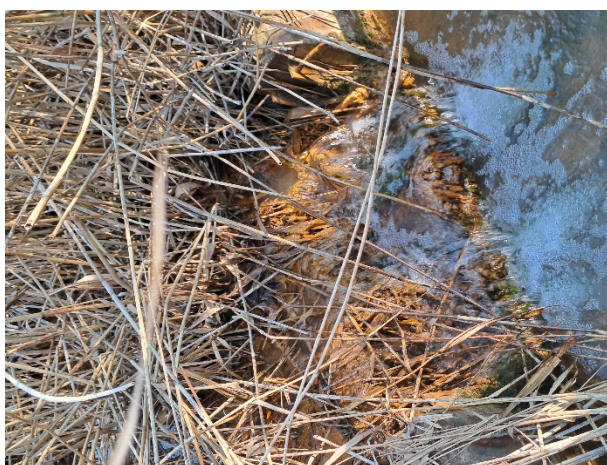
Figure 12 – One of the castellations with a build up of vegetation impacting flow.

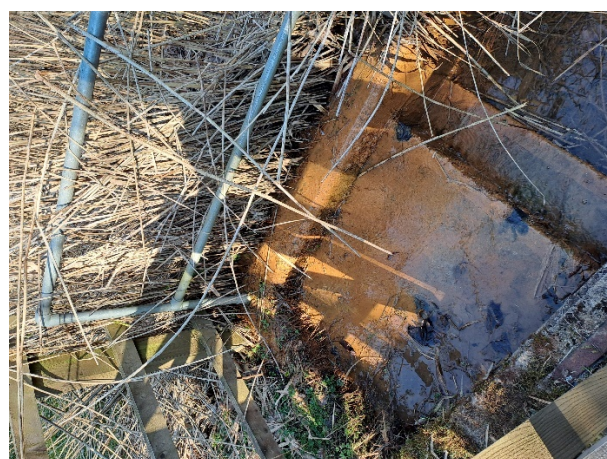
Figure 13 – Water overtopping the reedbed and flowing towards the discharge point due to vegetation build up.

1. CATEGORY C3 BREACH – PERMIT CONDITION 10(e) – Water bypassing the reedbed castellations.

Due to excessive build up of vegetation and sediments in the Reedbed the mine water was bypassing it in several locations as evidenced in Figure 13 above. This constitutes a Category 3 breach. The required actions and deadlines to address this breach are listed below.

2. CATEGORY C3 BREACH – PERMIT CONDITION 10(g) – Excessive weed growth and build up

The build up of vegetation which caused the mine water to bypass the Reedbed (as outlined above) can be attributed to the extended period of time since the last maintenance programme was conducted, said to have been a complete refurb of the Reedbed ~5 years prior to this visit. This constitutes a Category 3 breach. The required actions and

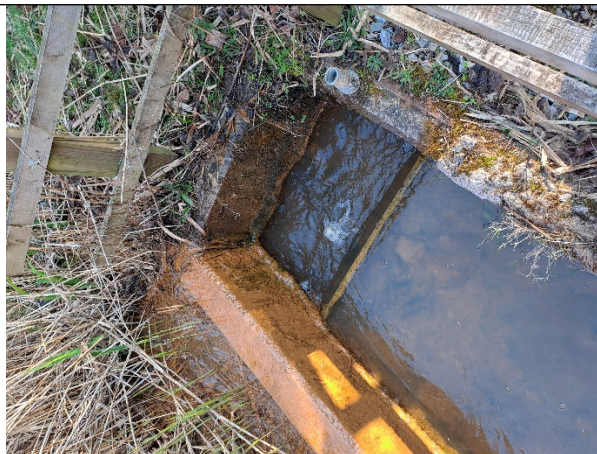
The outlet towards the discharge point (as seen in Figure 14) was visibly clear and the quality of the effluent look to be sufficient.

Figure 14 – The outlet from the reedbed at the time of the visit.

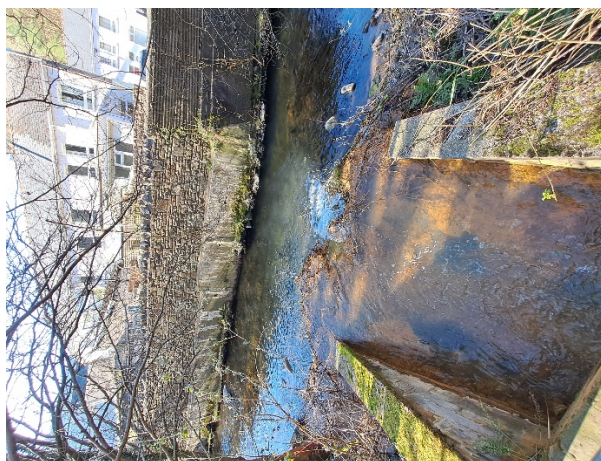
The discharge point itself was in good condition with the water visually very clear and no downstream discolouration or staining present, as seen in figures 15 and 16. I will request an updated example of discharge flow data for the site to reflect the change in stop level noted at the outset of this report. See details below.

Figure 15 – The discharge point at the time of the visit.

3. Provide NRW with final treated effluent discharge rates for the period 18/09/2024 – 18/03/2025. This is to reflect the change in stop level at the abstraction/cascade.

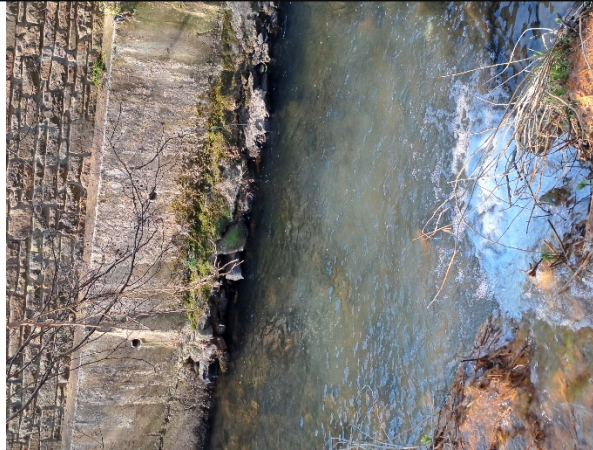
Figure 16 – Downstream of the discharge point at the time of the visit.
