## Compliance Assessment Report CAR\_NRW0046312

**Permit being assessed:** AB0064001

For: Llanfrechfa Storm Tanks, held by DWR CYMRU CYFYNGEDIG

At: Ponthir WwTW Inlet Works, Track opposite Graig House, Station Road, Ponthir, NP44 3EU.

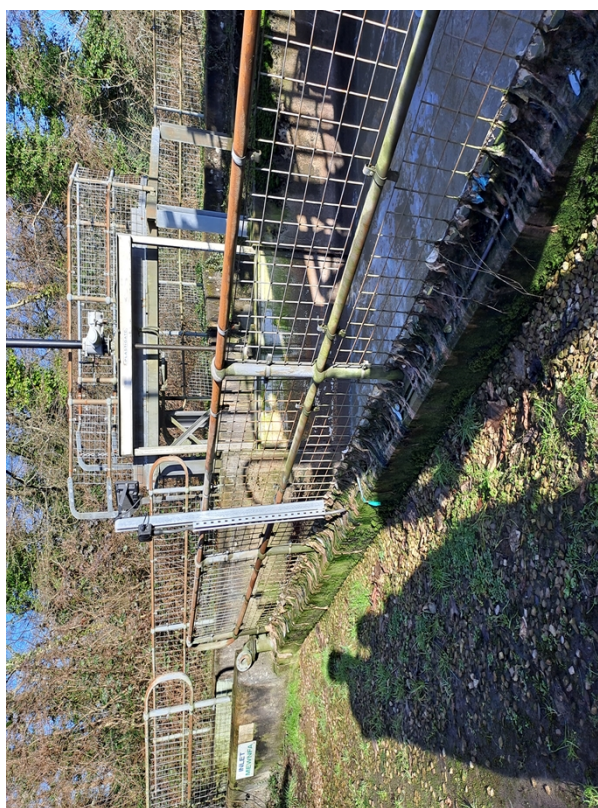
The flow and channel into the inlet was clear of debris build-up at the time of the visit but previous evidence of blockage and overflow i.e. ragging, was present caught in the safety railings and bushes near the inlet. This is evidenced in Figures 1 & 2. No records of when and why this spill occurred. This is a breach of Condition 4.3.1 (notifications) and is reflected in the scoring below.

Figure 1 – Ragging and debris buildup on the safety railings showing evidence of a spill/overflow at the site.

Due to the evidence of a spill occurring at the inlet works, which caused significant debris

deposition as well as the flooding of the control room, and the subsequent lack of notification (via self-report or OPNOT) NRW consider this a breach of the above condition and have issued a Category 3 breach accordingly.

1. Identify when and why the spill at the inlet occurred and provide NRW with a report of the findings as well as evidence of any maintenance work required to ensure this does not re-occur.

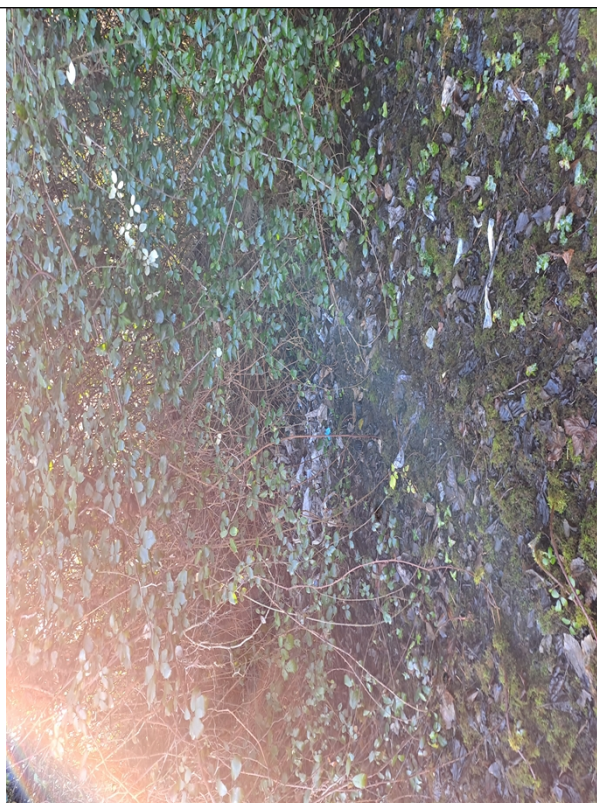
Figure 2 – Ragging and debris buildup caught in the bushes near the inlet. As in Figure 1, evidence of a spill but no records of this were known.

The sensors in place should have triggered the opening of the sluice/overflow and used the bypass system before any spills such as this could have occurred. It is also noted that NRW did not receive an OPNOT for this spill. A request was made for DCWW operators to check their records and identify why this spill was not recorded and communicated with NRW. It was noted by DCWW operators that the valve to open the sluice is manual as opposed to being automatic. DCWW noted that this will be replaced to reinstate the automatic functionality, and it is a part of the maintenance programme for the site. The system can still use the bypass if required but the valves would be manually opened/closed as opposed to using an automatic opening function. The bypass would only be used if all screening had failed and prevented forward flow.

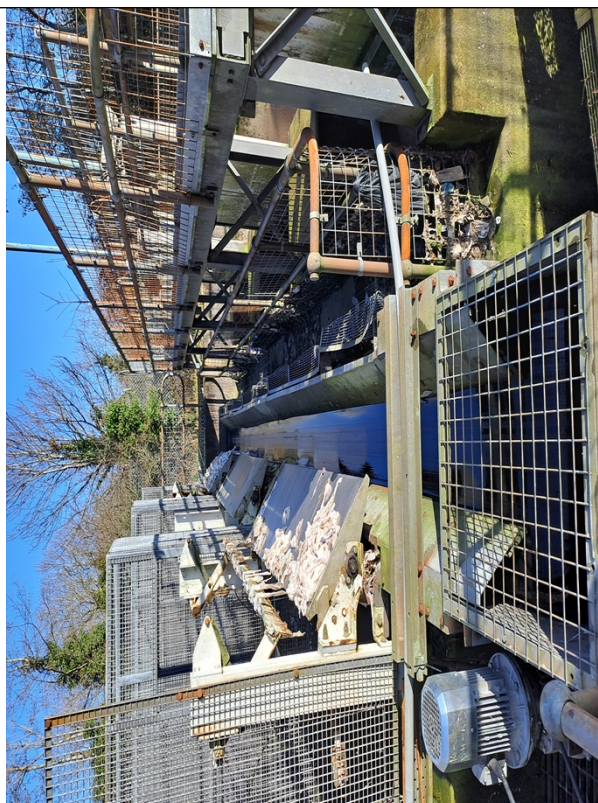
On inspecting the inlet screens it was stated that one of the three coarse (2inch spacing) screens was out of service at the time of the visit, however no flow was passing through this screen. Parts were reported to be on order, but I request that evidence is provided once the repairs are complete. See list of actions below for further details. However, the operational screens appeared to be working effectively, with solids being removed and no excessive build-up present. This is evidenced in Figure 3.

Figure 3 – Coarse screen conveyors as observed during the visit. No excessive buildup of debris present.

3. Return all inlet screens to working order and provide NRW with evidence of completion.

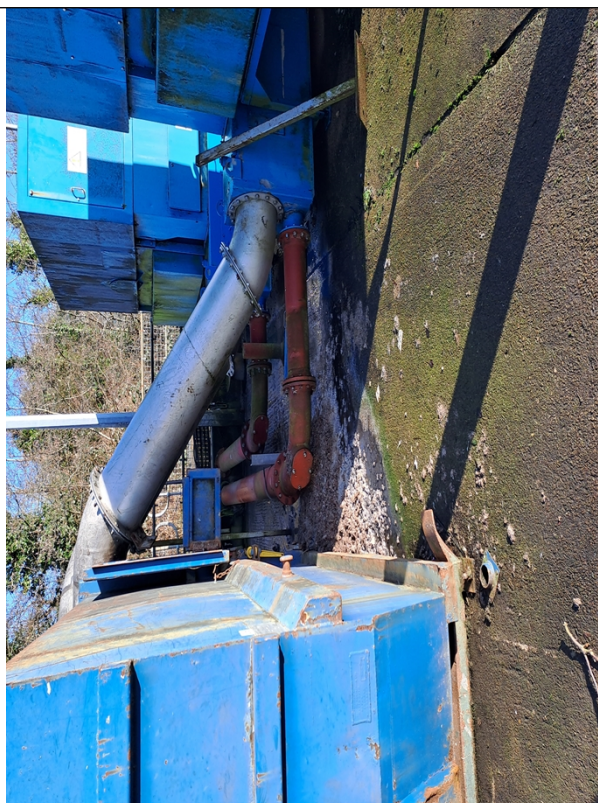
Management practices of these screens were noted to be manual daily cleaning by operators of conveyors and screens 7 days a week, with wastes from the screens and conveyors being deposited in the waste skips on site. These skips are then emptied every “few weeks” by a third party contractor based on DCWW’s operators visual assessments. It was observed during this visit that a significant quantity of separated wastes had collected on the ground outside of these skips, as seen in Figure 4. A clean up of these wastes was actioned immediately by DCWW, but management improvements are reflected in the advisory actions list below.

Figure 4 – The on-site waste skips with the escaped wastes collecting beneath them as observed during the visit.

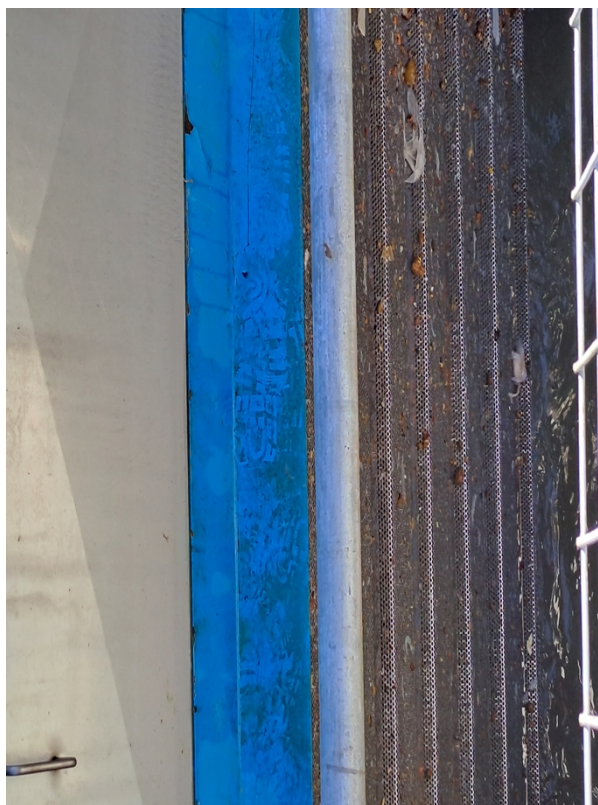
The fine screens (6mm apertures) on site were observed with no buildup of debris present. The apertures appeared to be appropriate and within the consent of the permit. This is evidenced in Figure 5. The macerator was working effectively at the time of the visit.

Figure 5 – The fine screens as observed at the time of the visit.

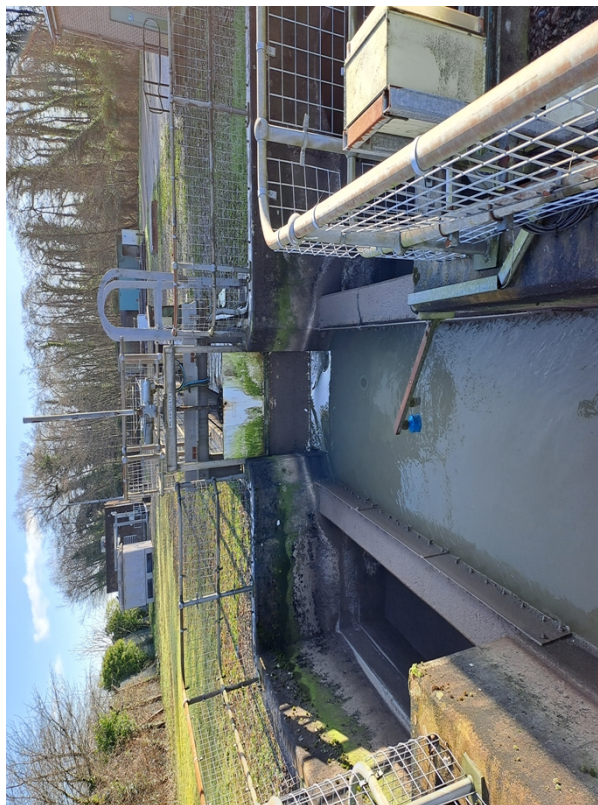
The storm overflow weirs were observed, and were not in use during the visit with all flows passing to treatment. It was stated that the Emergency Storm Overflow weir (discharging directly to river) is set at 6 x Dry Weather Flow, and the Storm Overflow weir (discharging to the storm tanks) is set at 3 x Dry Weather Flow. Sensors were in place at both weirs as per the permit requirements, as seen in Figures 6 & 7. There were no observable cracks or damage present on either weir. DCWW operators stated it was unknown when the storm overflow was last operational, but that it was recent (to the date of the visit), and that the data would clearly display when. No issues were noted at this location.

Figure 6 – Storm overflow weir with sensor visibly in place.

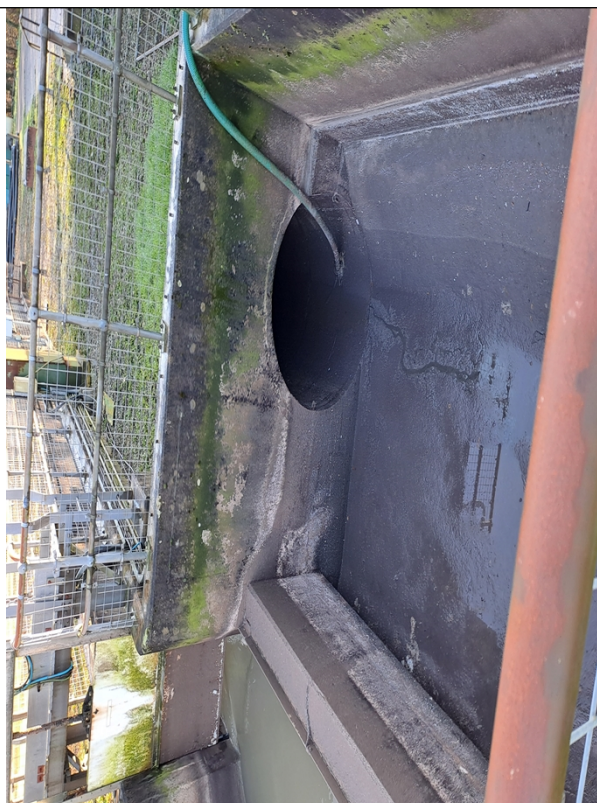
Figure 7 – Storm overflow outlet to the storm tanks.

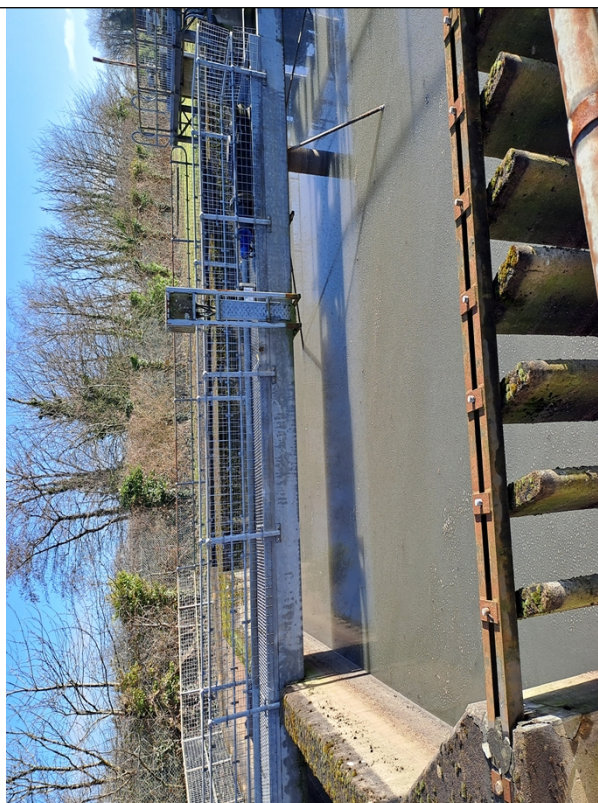
When asked about the grit removal process at the inlet it was stated that the site does have a grit classifier, but it is not currently in use and has not been operational for a considerable amount of time. The infrastructure is still in place (see Figure 8), but the effluent currently bypasses it. DCWW are looking at AMP budgets to bring it back online, but it is noted that the inclusion of grit removal in this manner is not a permit requirement. At present, grit is removed during the primary treatment process. An advisory comment below reflects these intentions.

Figure 8 – The isolated/bypassed grit classifier as observed during the visit.

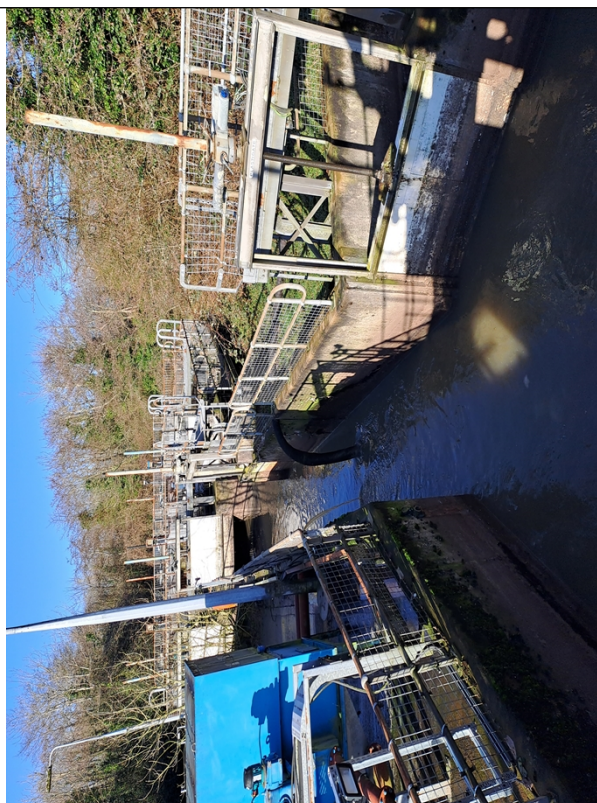
As seen in Figure 9, there was a large black pipe seen in the channel prior to the fine screens, raising concerns of causing an obstruction in the system. When queried, DCWW operators noted that some pumping work had clearly been taking place. It was later confirmed that the pipe was being used to pump flows from the Llanfrechfra SPS into the flow. At the time of the visit this work had been completed and the pipe was left hanging and not connected. DCWW have actioned for the pipe's removal as soon as practicable.

Figure 9 – Large black pipe as observed during the visit.

4. Remove the large black pipe observed in the channel and inform NRW of when this has been completed.

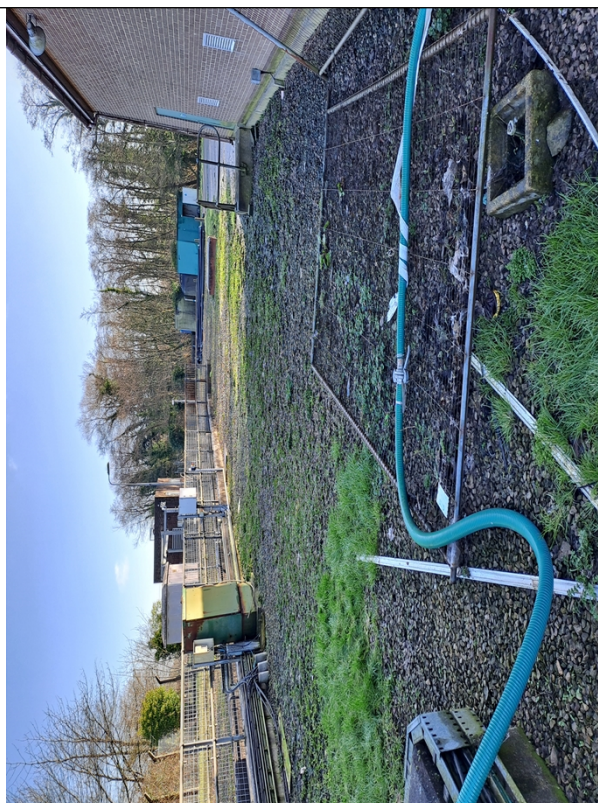
A green pipe was seen running from the control building and into the storm overflow channel, as seen in Figure 10. This was noted to be the outlet pipe for a sump pump for when the control building was flooded. There was ragging and debris scattered around the general area which is unmistakable evidence of spills/overflows on site. NRW were not passed an OPNOT informing of any issues being experienced, constituting a breach of condition 4.3.1. This is listed below along with the requisite actions.

Figure 10 – The sump pump outlet pipe as observed during the visit.

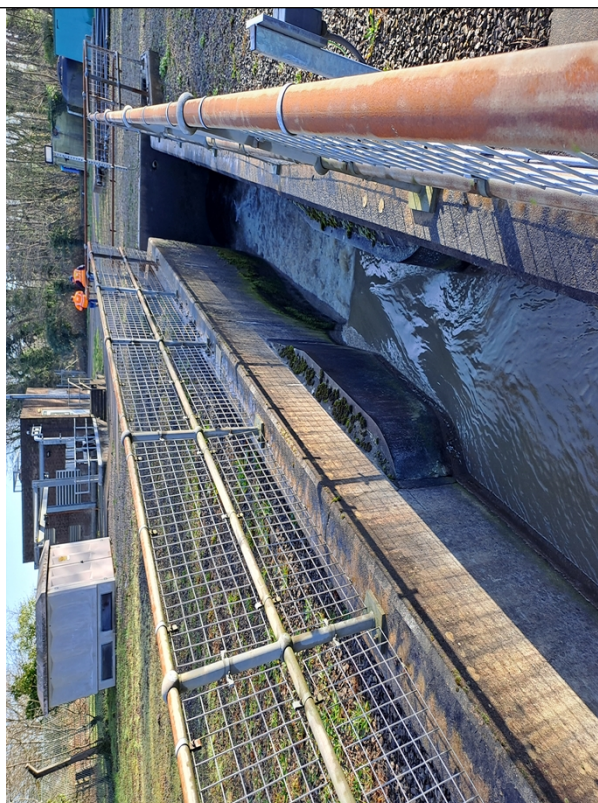
The Flume was observed (Figure 11), with level sensors to calculate FPF in place (Figure 12). The penstock is calibrated to shut at 826l/s.

Figure 11 – Flume as observed during the visit with fixed flow control.

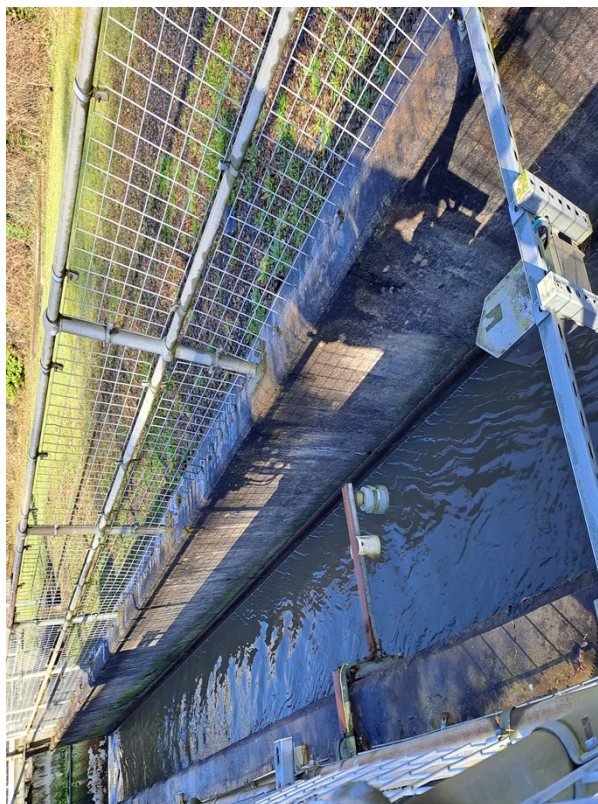
Figure 12 – Level sensors observed to be in place on the flume

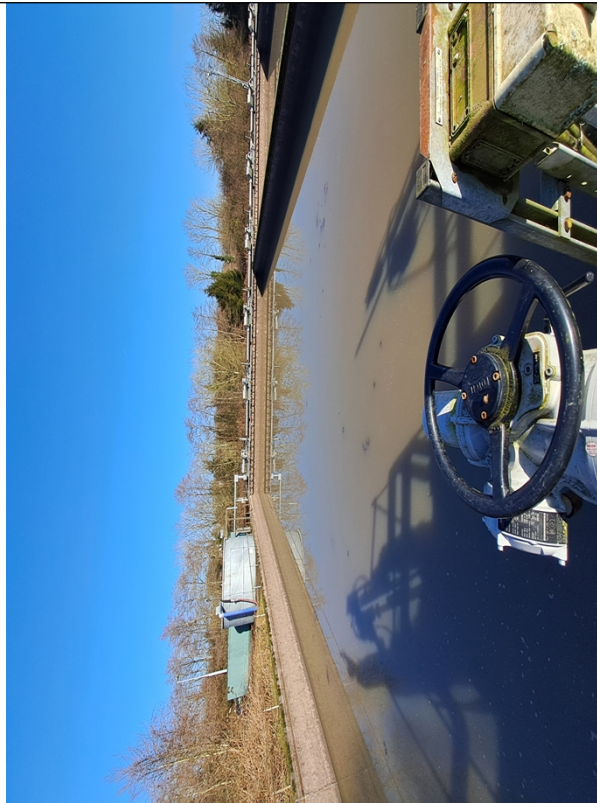
Storm Tank 1 was holding water at the time of the visit, as evidenced in Figure 13. There was some sludge buildup at the inlet (Figure 14) which I verbally actioned DCWW operators to clear out as a priority. No cracks or damage to the tank was observed.

Figure 13 – Storm Tank 1 as observed during the visit.

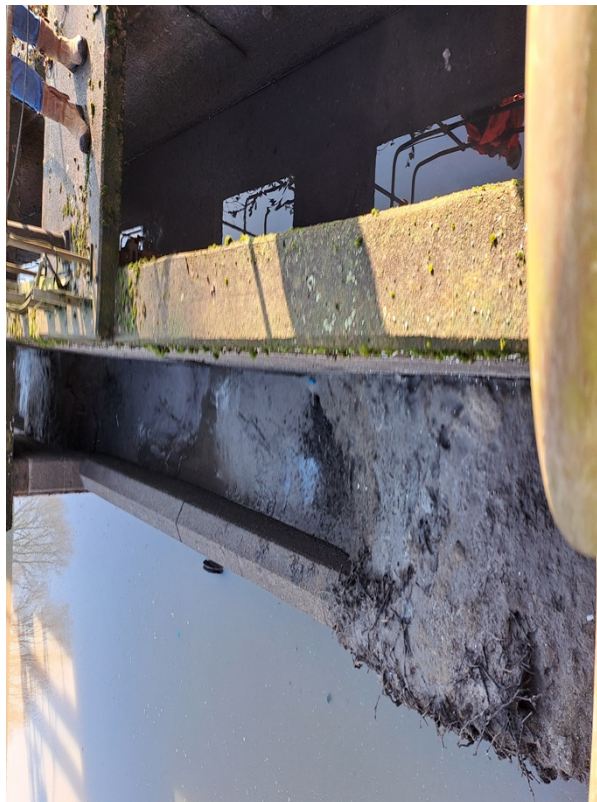
Figure 14 – Sludge buildup at the inlet of Storm Tank 1.

Based on the evidence observed a maintenance failure has occurred regarding the clearing out of settled sludge from the storage tanks, resulting in an estimated  $\frac{1}{3}$  reduction in storage capacity due to the excessive sludge buildup. This constitutes a significant environmental hazard and has been assessed as a Category 2 breach of the above condition.

6. Undertake maintenance to clear out the settled sludge from the storm tanks as a matter of urgency. Provide NRW with the dates that this will be undertaken and continual updates on progress.

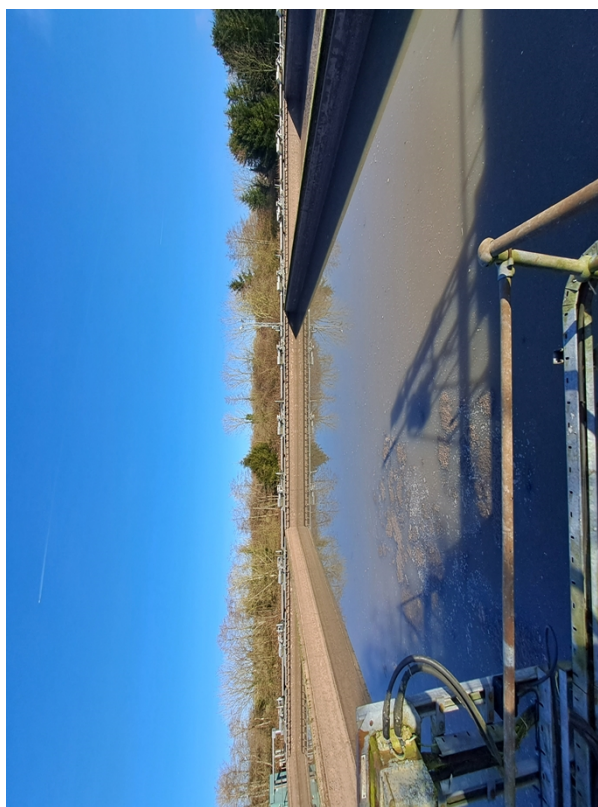
Storm Tank 2 was holding water (Figure 15) and displayed a similar buildup of sludge at the inlet

Figure 15 – Storm Tank 2 as observed during the visit.

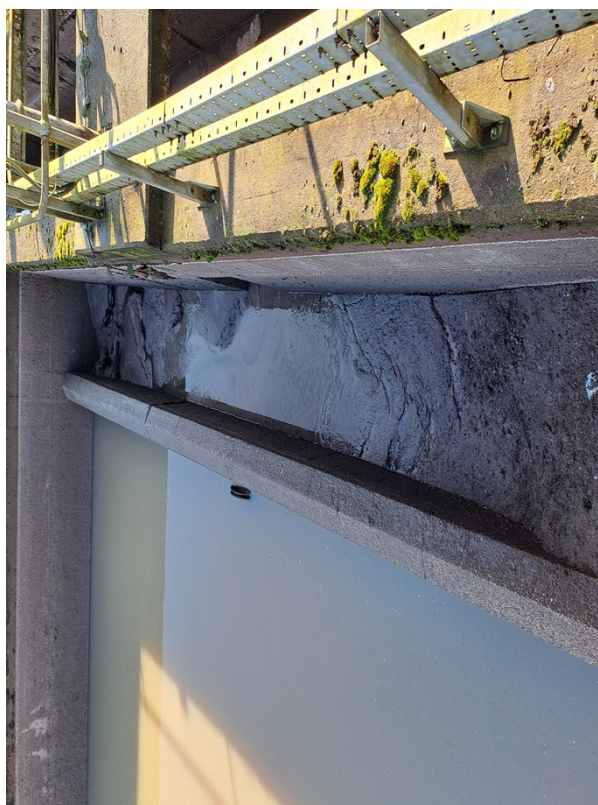
Figure 16 – Sludge buildup at the inlet of Storm Tank 2.

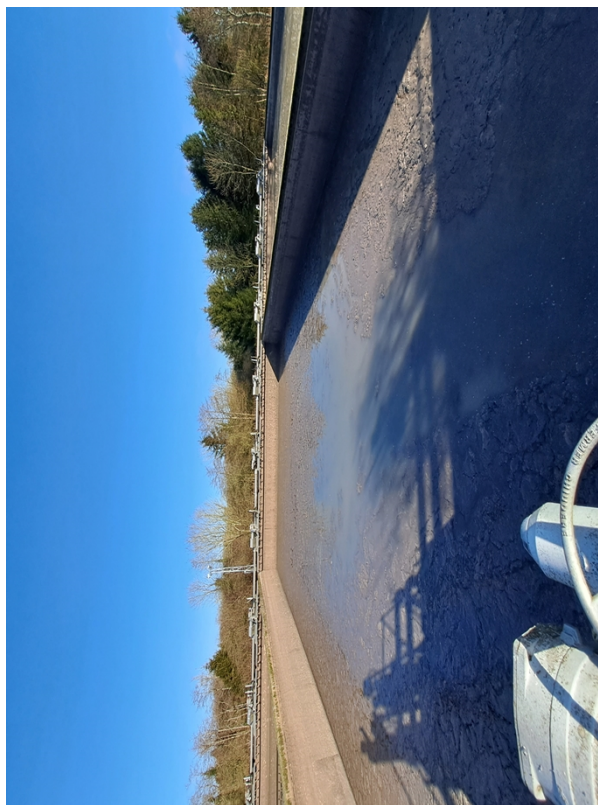
Storm Tank 3 had drained down more than 1,2 and 4 but displayed a significant amount of sludge buildup estimated to be ~1-1.5m deep at the deepest point (as seen in Figures 17 and 18). This is clearly reducing tank capacity, and it was estimated that the tank is operating at  $\frac{2}{3}$  capacity. I requested information on when the last time the tanks were cleared out, but this information was not known at the time of the visit.

Figure 17– Storm Tank 3 as observed during the visit.

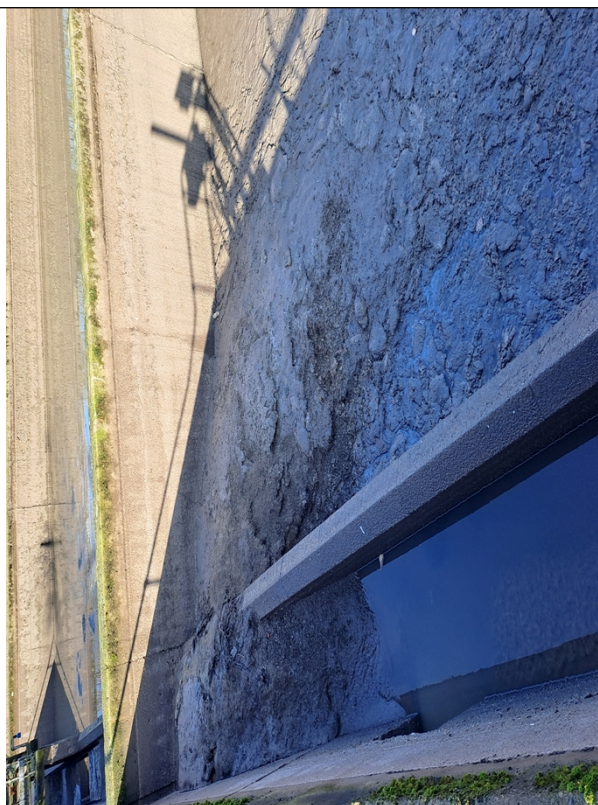
Figure 18 – Significant sludge buildup at the inlet of Storm Tank 3.

In all instances where sludge build up was present, the material was dry and hard in parts, and in other areas it was wet. This indicates a build up over time and not just an isolated incident/storm event.

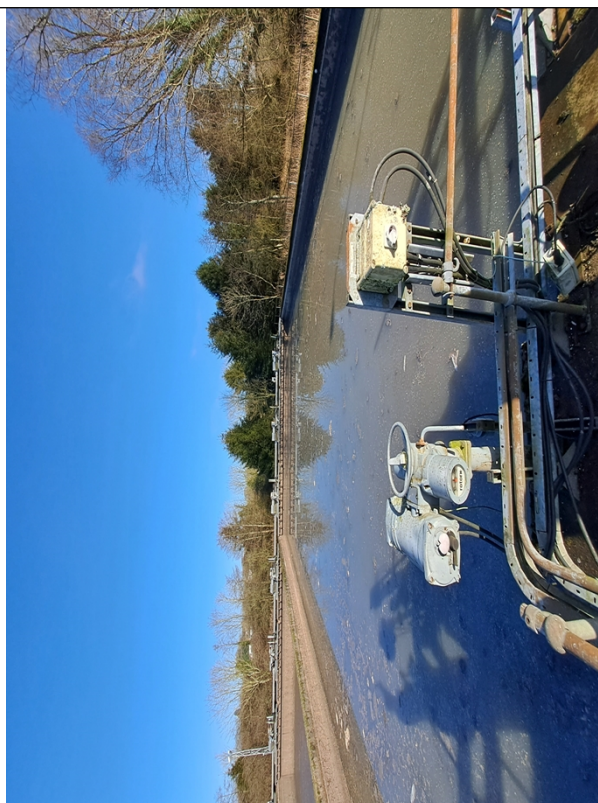
Storm Tank 4 was holding a significantly larger volume of water than Tanks 1-3 (Figure 19), raising concerns that it was not draining down effectively, potentially due to a drain down valve issue. I actioned DCWW to check this with the network manager. And, as observed with tanks 1-3, there was a buildup of sludge in the inlet channel, although photographic evidence of this was not taken at the time.

Figure 19 – Storm Tank 4 as observed during the visit.

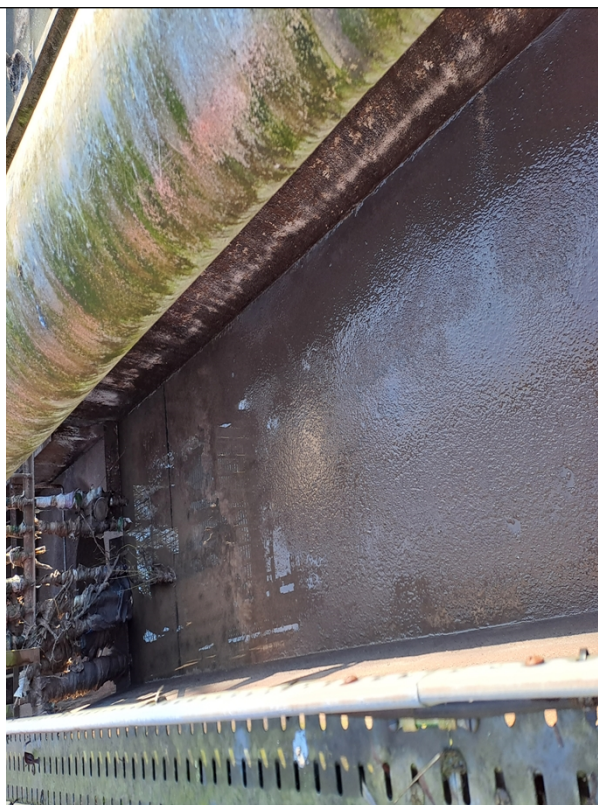
The effluent channel to the storm outlet was clear at the time of the visit, as seen in Figure 20.

Figure 20 – Effluent channel to Storm Outlet as observed during the visit.

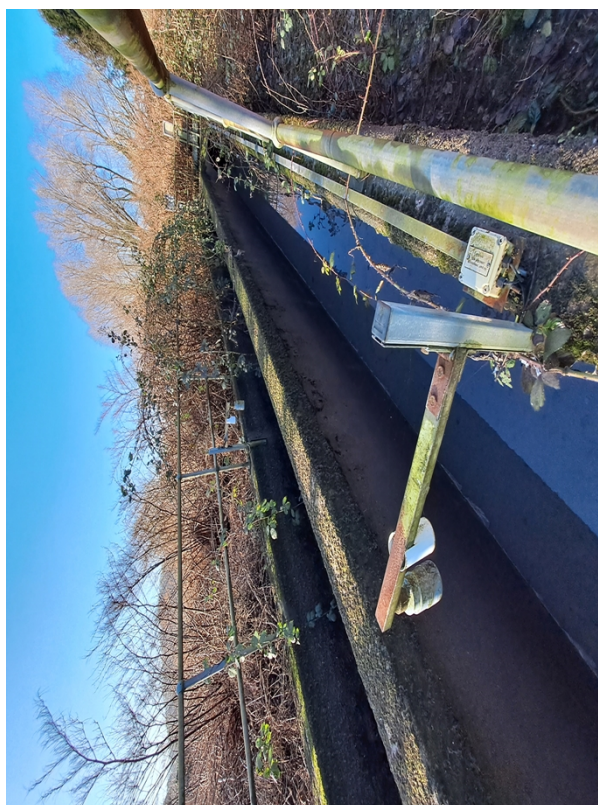
The Storm Outlet to the river was then inspected. EDM sensors were observed to be in place (Figure 21), however there was no flow or discharge to the river at the time of this visit.

Figure 21 – Storm outlet channel with EDM sensors in place. No flow at time of the visit.

General access and grounds maintenance need improvements at this location due to heavy vegetation. It also appears that a spill had occurred in the past similarly to that at the inlet works, with ragging a debris present around the channel retaining walls.

Access to the storm outlet channel was hindered by vegetation overgrowth. While not a direct influence on effluent treatment or quality it may affect individual's ability to access the site. As such NRW have assessed this as a Category 4 breach of the above condition.

7. Improve access to the storm outlet channel by removing excess vegetation. Provide NRW

with evidence of its completion.

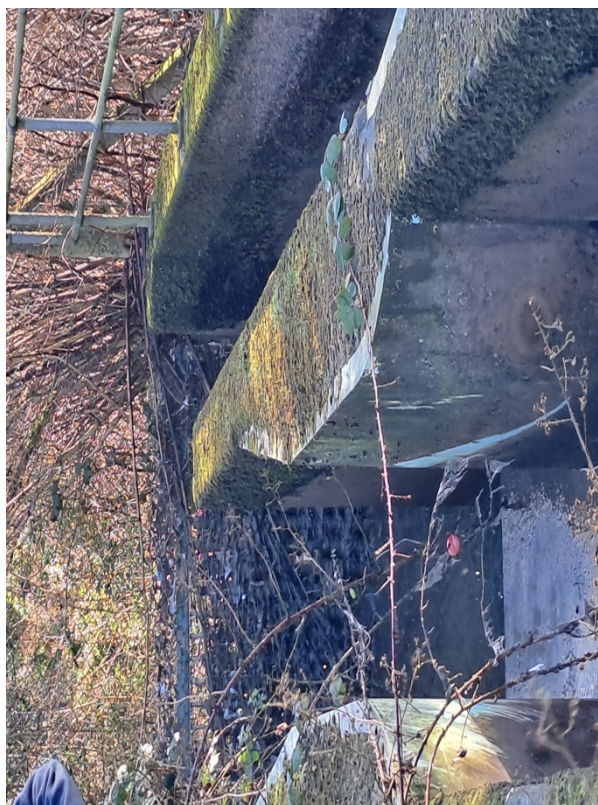
The screen directly prior to the outfall was heavily blocked by debris, as evidenced in Figure 22. I issued a verbal action for DCWW to clear this obstruction and to improve maintenance works at this site in future.

Figure 22 – Final screen prior to storm outfall blocked by debris as observed during the visit.

The blockage observed on the storm outlet channel screen poses a risk of impeded flows and has the potential to result in a spill overtopping the outlet channel. NRW have assessed this as a Category 3 breach for maintenance.

8. Clear the outfall screen blockage of built up debris to improve flow. Provide NRW with evidence of its completion.
