## Event Duration Monitoring

### Trigger Exceedance Notification

Report type: Stage 6: Close Out Report

Location: Combined Sewer Overflow at Dunns Lane/Park Street

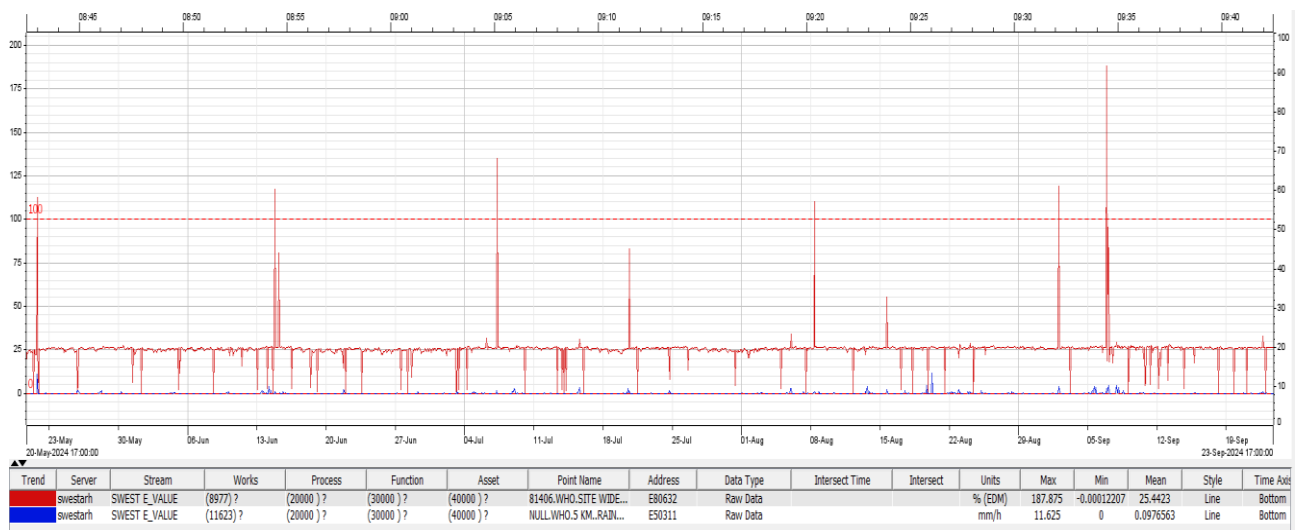
Figure 4: Scopex / Prism telemetry data.

3. Bathing season spills occurred from 21/05/2024 – 01/09/2024 as shown in the screen shot below (Figure 4) taken in from Scopex / Prism telemetry data.

| Action Ref. | Action Required | Action Due Date | Comments | Complete (Y/N) | Completion Date |
|---|---|---|---|---|---|
| 4 | Review of telemetry data for accuracy | 01/03/2025 | In reviewing the data, we found that the asset was spiking in both up and down. An asset of this size would be expected to see more or a gradual rise | y | 19/11/2024 |

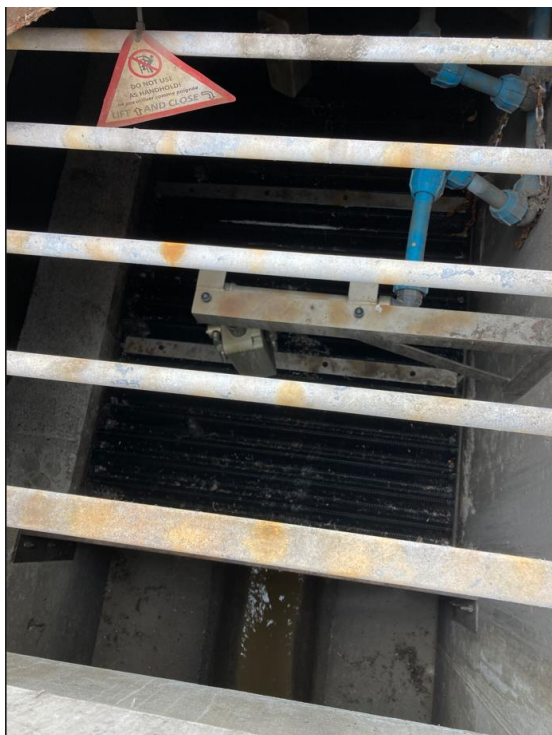
Fig 5. site visit with CSO maintenance team 21/06/2024

| Action Ref. | Action Required | Action Due Date | Comments | Complete (Y/N) | Completion Date |
|---|---|---|---|---|---|
| 5 | Site visit to check telemetry monitor | 01/03/2025 | Monitor checked – evidence of water entering through the cover and running over the monitor – possible water damage. | y | 21/06/2024 |

The weir wall and screen within the CSO are both clean, indicating that the asset hasn't been spilling. There had been a spill indicated by monitor on 14<sup>th</sup> June so we would have expected to see some debris.

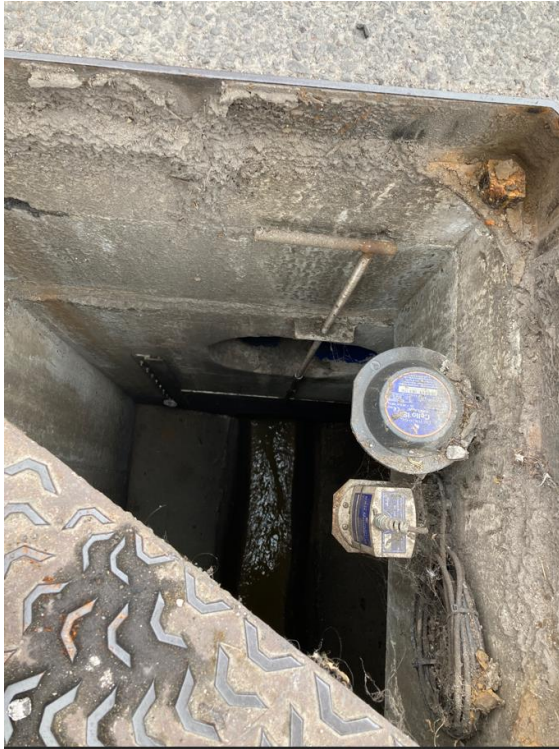
Fig 6. site visit check monitor 21/06/2024

The root cause has been found to be a faulty monitor in the asset. The monitor has now been replaced and is trending well. It seems on average the monitor was reading 20% above what it should have been and was also giving false spikes, both up and down. This is evidenced in the following figures.

Photo shows monitor and ultrasonic head in chamber – although in dry weather, there is evidence of where water and debris have been entering through chamber lid and running over sensor.

| Action Ref. | Action Required | Action Due Date | Comments | Complete (Y/N) | Completion Date |
|---|---|---|---|---|---|
| 6 | Task raised for the telemetry monitor to be replaced. | 01/03/2025 | Complete – step change in readings and spikes up and down no longer evident. | y | 09/01/2025 |

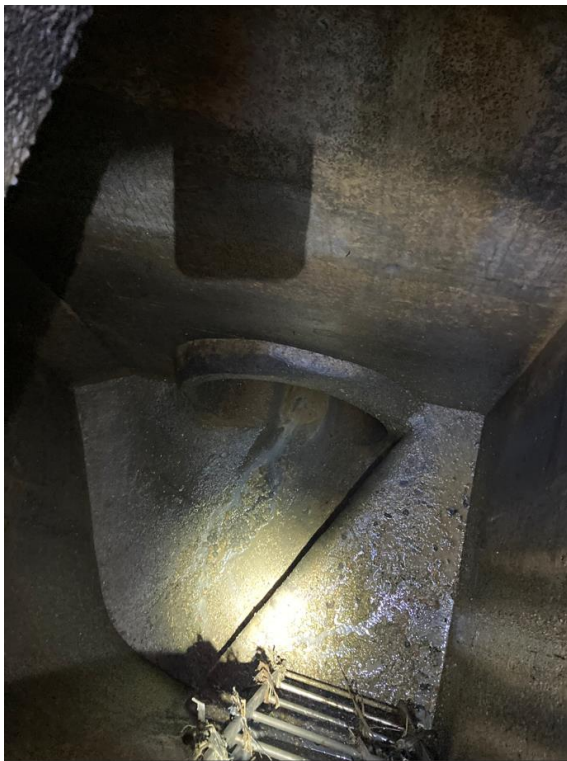
Fig 7. Outfall survey @ high tide 12/09/2024

| Action Ref. | Action Required | Action Due Date | Comments | Complete (Y/N) | Completion Date |
|---|---|---|---|---|---|
| 2 | Check tidal flap valve | 01/03/2025 | Completed, no issues found | y | 12/09/2024 |

Photo shows no tidal influence on outfall chamber.

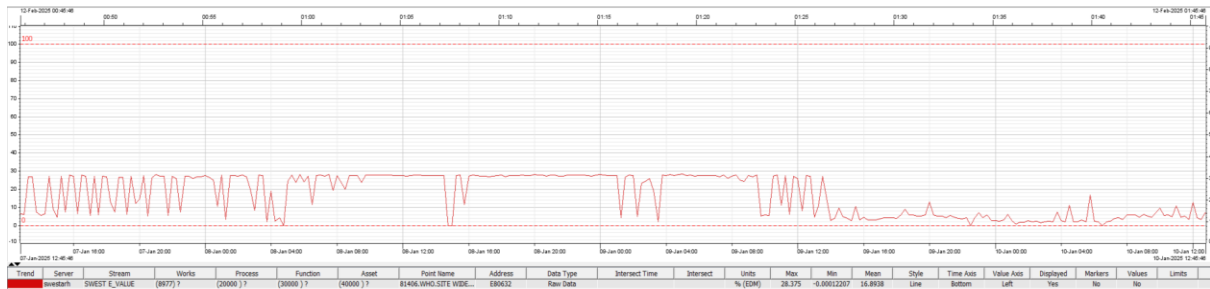
Fig 8. telemetry monitor replaced 9<sup>th</sup> January 2025 @2pm trend over multiple days.

Figures above show the level trend between the 7<sup>th</sup> and the 10<sup>th</sup> of January, this picks up the step change. The high- and low-level spikes are no longer there, and the base line is a lot lower 20%.

Since the monitor was replaced and calibrated on 9th January, there is a distinct change in trend, with levels reading a 20% lower base line with removal of positive and negative spikes in readings.
