## Event Duration Monitoring

### Trigger Exceedance Notification

Report type: Stage 2: Full Investigation Proposal

Location: CSO 121 at Sandfields Pumping Station (Outfall 'L')

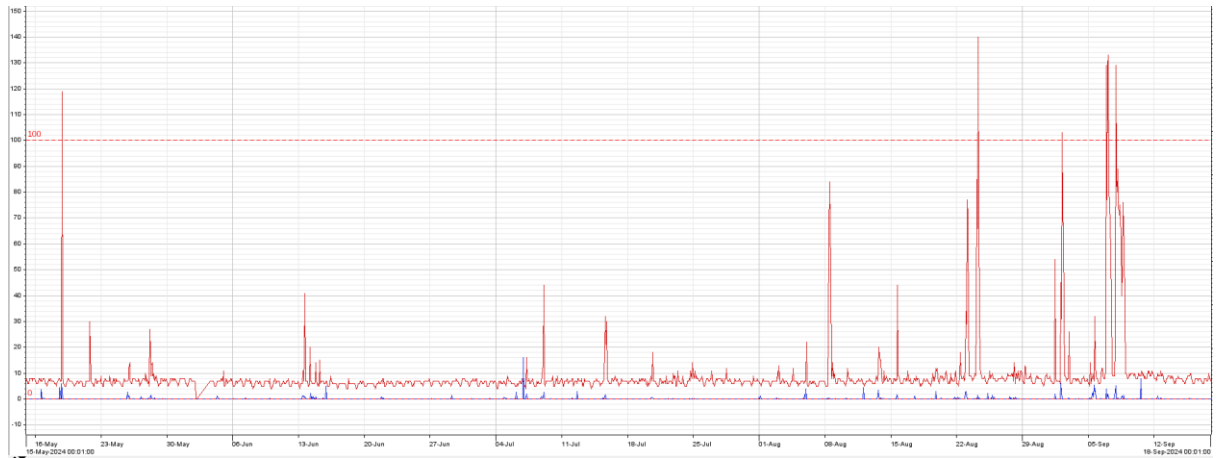
Figure 6: Scopex / Prism telemetry data.

3. Bathing Water spills were recorded to occurred between 18/05/2024 – 06/09/2024 as shown in the screen shot below (Figure 6) taken in from Scopex / Prism telemetry data.

On reviewing the telemetry for these spills, we found that a few of the spill didn't occur and the readings were telemetry spikes. This is captured on the following table: -

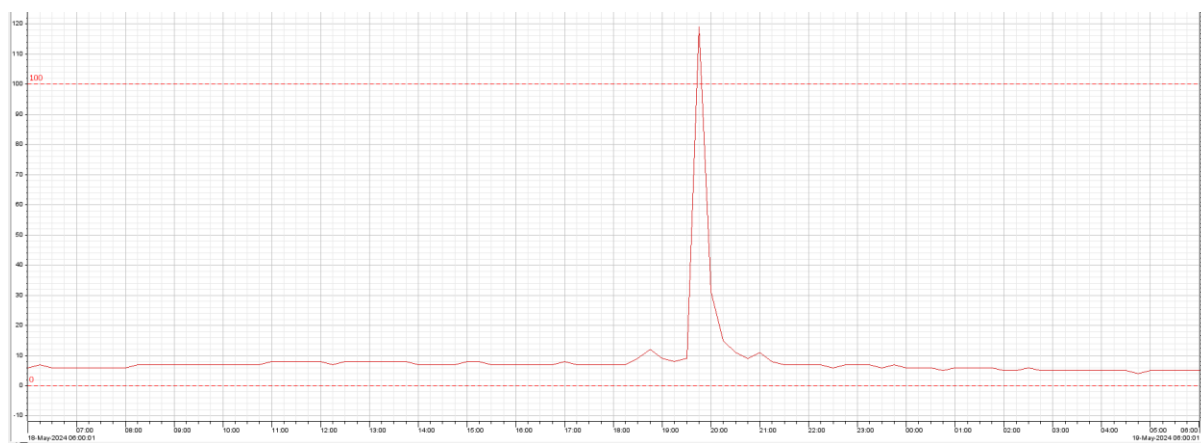
Figure 8: graph of spill no1 spiking data.

We are not confident with the telemetry data, as an asset of this size would be expected to fill up and descend quite slowly. The spill would normally be seen as a flat line on the graph. In this case 4 spills were spike data, an example of which is shown beneath: -

This pattern of spill would not be possible for an asset of this type.

A detailed Root cause cannot be determined at this stage as there are concerns over the reliability of the data due to the current location of the EDM monitor. Work to be carried out to move EDM monitor to the spill channel, currently reading off the screen level monitor.

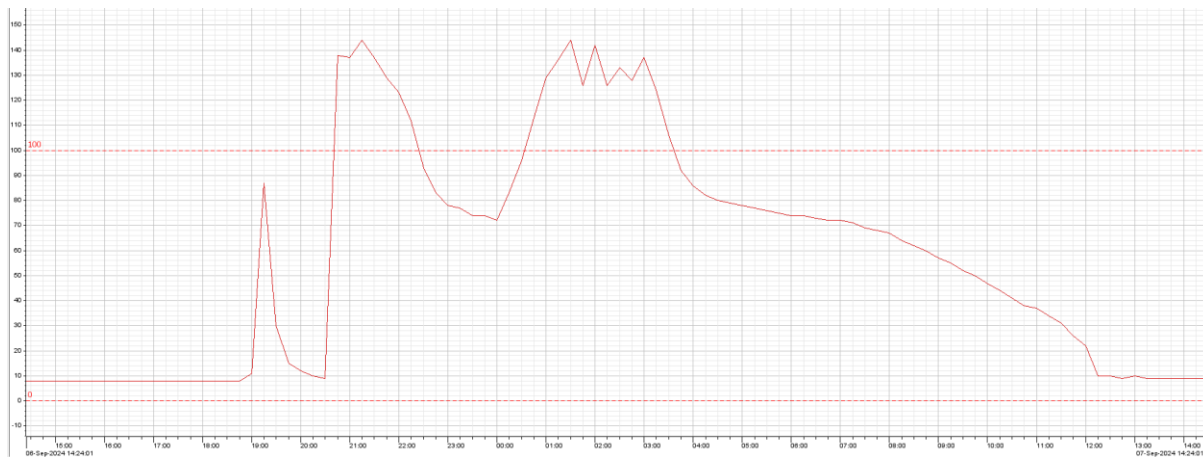
Figure 9: graph of spill no7 showing no profile change at 100% rising to over 140%

There are some instances where data doesn't look very reliable, however we haven't omitted it as it is possible that a spill could have occurred. We would expect to see a flat line around the 100% line where water starts to pass over the weir, however we are seeing spikes up to 140+%. We have still recorded these as spills. An example of this data is shown in the following graph:-

Removing the spiking data and keeping the data that looks more reliable would push the possible breach date to 26/09/2024.
