## Compliance Assessment Report for: CAR\_NRW0048882

| <b>Site name</b> | Llangadog Pet Foods Plant. |
| <b>Type of assessment</b> | Site Inspection |

| <b>Date of assessment</b> | 20/05/2025 | <b>Time in</b> | 09:50 | <b>Time out</b> | 12:45 |

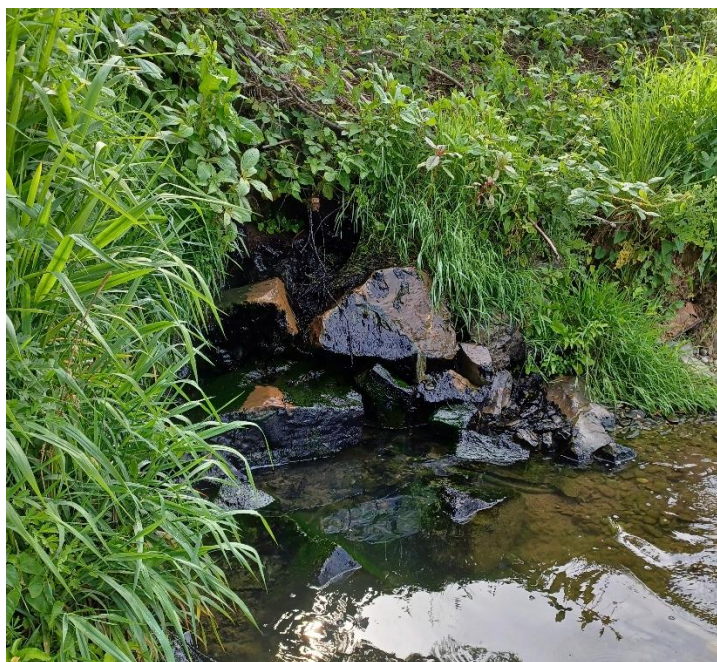
*Image 1: S1 Outfall into Afon Tywi*

be visually clean, with no discolouration or significant odours detected at the time of the inspection. The immediate area surrounding the outfall appeared to be in an acceptable condition from a visual perspective with only minor green algal growth noted as present on the rocky surface beneath the pipe outlet (illustrated within *Image 1* above).

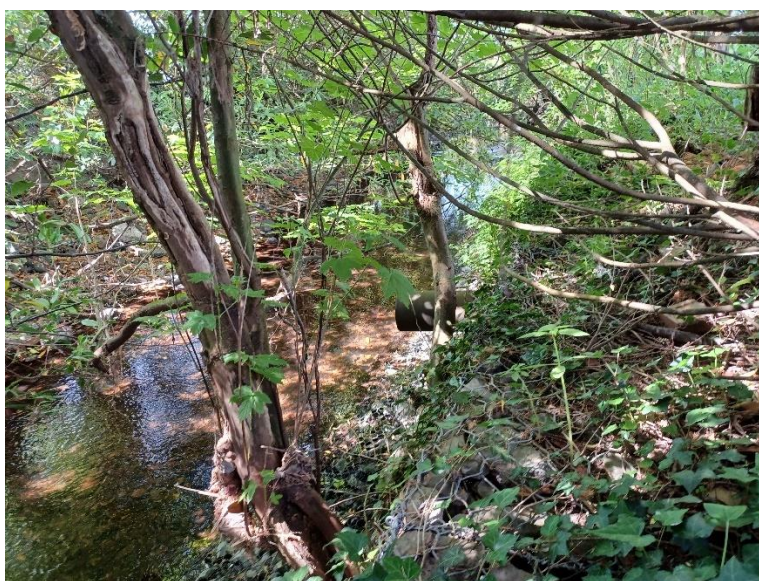
*Image 2: Outfall associated with the unpermitted discharge believed to be from the western warehouses.*

NRW Officers requested to be guided to the un-permitted outfall into the Afon Bran (which is a tributary to the Afon Tywi) to facilitate its inspection, whilst also determining the exact point of entry to controlled waters. Based on the operator's current drainage plan<sup>[3]</sup>, it is the understanding of NRW that this outfall receives surface water generated from the western warehouses. There was no discharge or significant odours noted from the outfall at the time of the inspection, which was expected given the prolonged period of dry weather

leading up to the inspection day. NRW has already informed United Petfoods (UK) Ltd that a permit variation is required to incorporate this new (un-permitted) emission point into their EPR permit. The operator was instructed to submit this application in a previous CAR<sup>4</sup> form. The operator has failed to comply with this action and it is now overdue. The Operator must seek to incorporate this outfall into their EPR permit with the utmost urgency. The Operator should be minded that addition of this outfall into the permit is not guaranteed and ultimately is at the discretion of NRW's Permitting Team. Furthermore, the Operator must ensure that the drainage plan is referred to prior to any developments/alterations to the site drainage within this area that may result in contaminated water being inadvertently discharged into the Afon Bran. NRW was made aware during previous visits that there are alterations being made to the road layout of the Site which will result in changes being made to the drainage infrastructure, the drainage plan must be amended and updated so that it accurately reflects the drainage infrastructure upon completion of these works. During the inspection, there were a number of additional outfalls noted as entering Afon Bran along the banking, whilst these may be redundant, they do pose a potential pathway for rapid migration into controlled waters and must be sealed off to minimise any risk.

**United Petfoods (UK) Ltd is to identify all outfalls on the site and where the operator is claiming they are redundant they are to provide evidence to confirm this. The operator must also permanently seal all redundant drainage outfalls entering the Afon Bran using a suitable sealing material. The operator must submit evidence to NRW once this has been completed.**

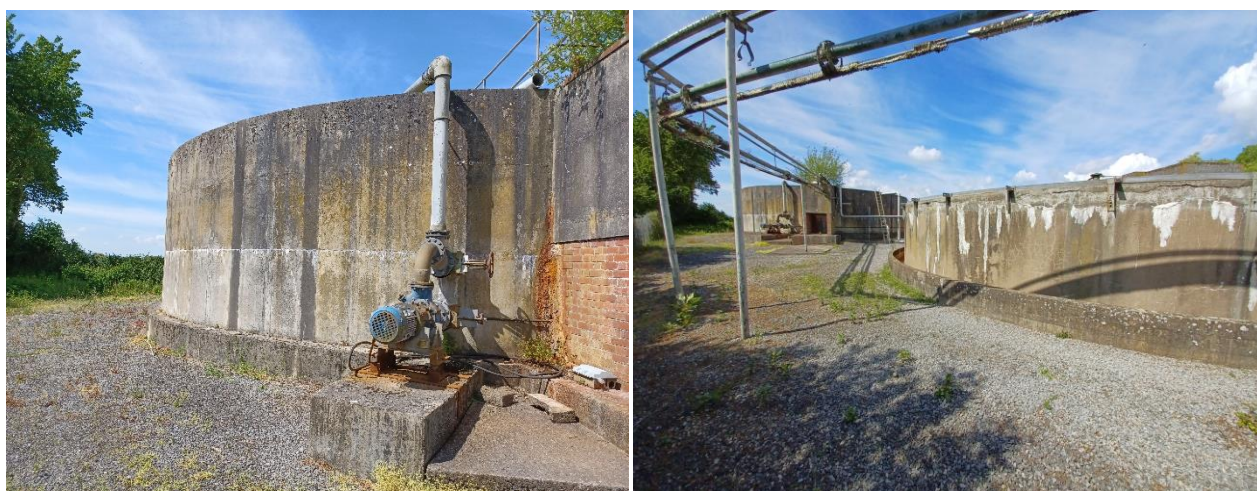
*Images 3 & 4: Permeable ground surrounding LUBEK Tank (left) and Rotary Filter Bed (right)*

It is important to highlight, that there are a number of legacy ETP assets that were associated with the former Creamery which previously operated onsite. Some of these were noted as still holding potentially polluting liquid. During the visit, the Operator clearly outlined to NRW which of these assets were currently operational within their ETP process. NRW is aware that the Settlement Towers, which are part of their permitted ETP process have been non-operational since April 2024. We have not compliance assessed this aspect as part of this inspection and this will be considered as part of a future inspection. NRW Officers noted that the ETP assets were predominantly of concrete construction, a brief visual inspection of the tanks, structures and transfer systems indicted degradation of the concrete surface consistent with exposure and weathering.

Concern over the perceived lack of secondary containment is further exacerbated by the presence of permeable ground throughout large portions of the ETP Works Area i.e. surrounding the LUBEK and Rotary Filter Bed. This permeable ground is considered a vulnerability, acting as a potential pathway which would allow for rapid of migration of contaminants into the soil matrix/groundwater. Furthermore, the close proximity of the ETP Works Area to Afon Bran<sup>[6]</sup> presents a sufficient risk of contaminant entry in the event of containment failure either directly via above ground surface flow or indirectly via groundwater throughflow.

The ETP assets and pipework noted during this inspection (which contain potentially polluting liquids) did not have adequate secondary containment in place. This is contrary to permit condition 3.2.3 of the EPR permit. Based on the condition and number of assets at the ETP, their proximity to highly sensitive environmental receptors and the polluting nature of the effluents, we consider that a containment failure has the potential to cause a significant environmental impact. As a result, a non-compliance score of C2 has been allocated to this failure, against this compliance criteria (IR3B).

**United Petfoods (UK) Ltd is to undertake a secondary containment assessment (in line with CIRIA 736) using a competent third-party contractor for all tanks, sumps, bunds, pipes and containers. Upon completion, this report is to be submitted to NRW as evidence.**

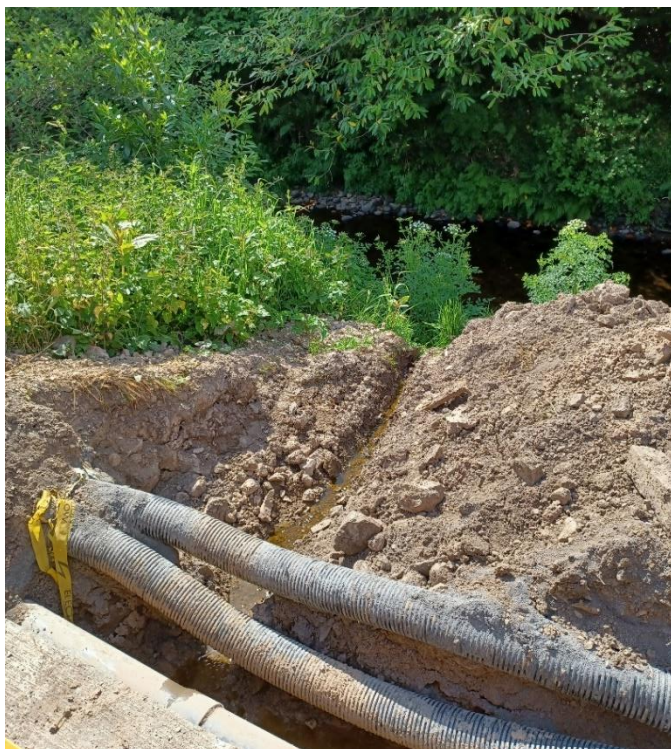
*Image 5: Loss of containment from failed Retort Water Pipework into the Afon Bran*

NRW were already aware via a Schedule 5 Notification<sup>[7]</sup> of the failure of underground pipework associated with the retort water overflow. In response to this incident the Operator had diverted this flow back into the V-Notch Chamber, which acts as a form of dilution. NRW Officers observed the excavated area and noted a minor discharge into the Afon Bran from the failed joint associated with the retort pipework, the Operator assured NRW that the pipework has been isolated and guided Officers to the upstream activation lever; which was confirmed to be in the 'off' position. As a result, the minor flow may be attributed to minor losses through the mechanism associated with the upstream valve. The Operator outlined to NRW that the retort water is clean water from their heat transfer system and as a result the only property that has been altered is its temperature. While temperature does have a polluting potential, it was not considered that temperature of the lost water was high enough to the touch to be of significant concern. NRW Officers collected a water sample directly from the failed pipework for compliance assurance, the results of the analysis undertaken illustrated no elevated figures for tested parameters.

The Operator informed NRW that the failed retort pipework was due for repair by third-party contractors on the day following the visit. Subsequent to this visit the operator provided photographs indicating the pipework was repaired on the 23<sup>rd</sup> of May 2025.

**United Petfoods (UK) Ltd is to undertake emergency repairs on all failures that are resulting in the unauthorised release of process water to land and controlled waters. Evidence must be submitted to NRW once completed (partially complete).**

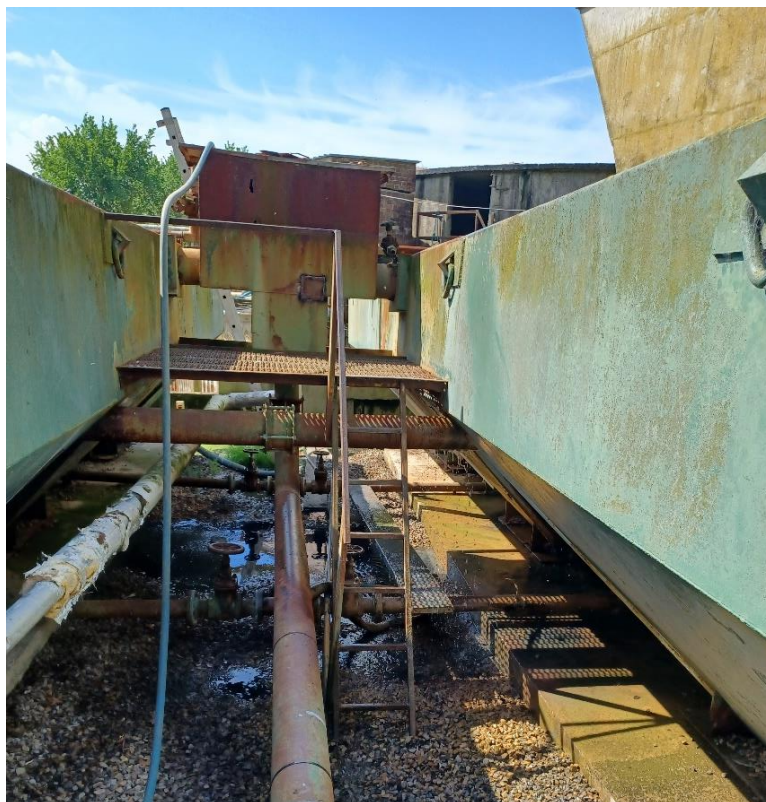
*Image 6: Discharge of partially treated effluent to ground from pipework associated with Final Clarifiers*

NRW Officers observed a loss from pipework associated with the Final Clarifiers of the effluent treatment process. Due to the lack of a secondary containment and situation of permeable ground, any losses (such as the one observed) are considered to be to ground with potential to impact the soil matrix and associated groundwater. NRW Officers noted discolouration of the partially treated effluent lost from the Clarifiers from a visual inspection, however a water sample was not collected at the time. NRW Officers also noted a further leakage from a failed welded joint associated with one of the Final Clarifier assets. The Operator informed NRW that this asset has required repeated repair works in order to maintain its functionality, this brings into question the suitability of this asset within the ETP process and a replacement may be required.

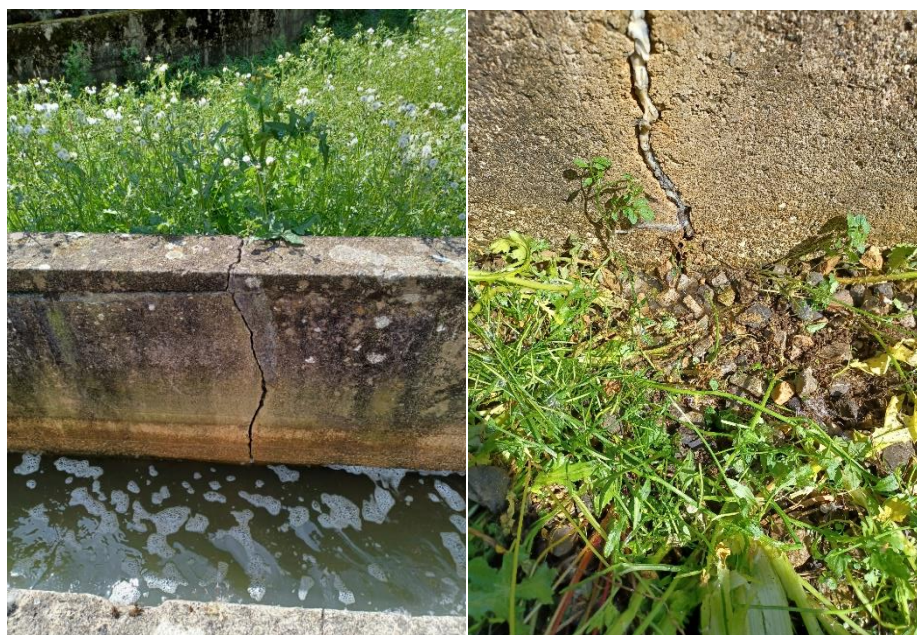
*Images 7 & 8: Structural failure of transfer flume associated with the ETP (left) and evidence of loss of containment (right)*

During the visit, NRW were informed that ETP Operatives clean and visually inspect the flume condition on a weekly basis<sup>[8]</sup>, and any issues identified would be reported to management. A partial and brief inspection of the flume by NRW Officers identified a significant structural failure of the concrete flume associated with the ETP, and whilst there is evidence that the Operator has attempted to seal the failure, NRW Officers observed a constant uncontrolled release of effluent to permeable ground. Furthermore, it is considered that the substantial vegetation growth within this area compared to other areas of the ETP is indicative that this loss may have been occurring over a prolonged period of time. It was noted by NRW Officers that the concrete within the immediate vicinity of the failure was degraded, with a slight swaying movement of the impacted section possible when touched. There were concerns that there is a viable risk of a structural failure in this area which would result in the release of contaminated water to ground in potentially very large quantities if not identified quickly by onsite staff. The Operator subsequently provided photographic evidence on the 23<sup>rd</sup> of May 2025 that a patch repair has been undertaken on the failure to prevent any further losses. While this action is acknowledged, NRW is uncertain of the integrity of this repair and how effective it is at preventing the further release of effluent to ground. Currently, NRW does not consider this patch repair to a permanent solution and further improvements into the integrity of the flume (and associated ETP components) must be investigated and proposed to NRW.

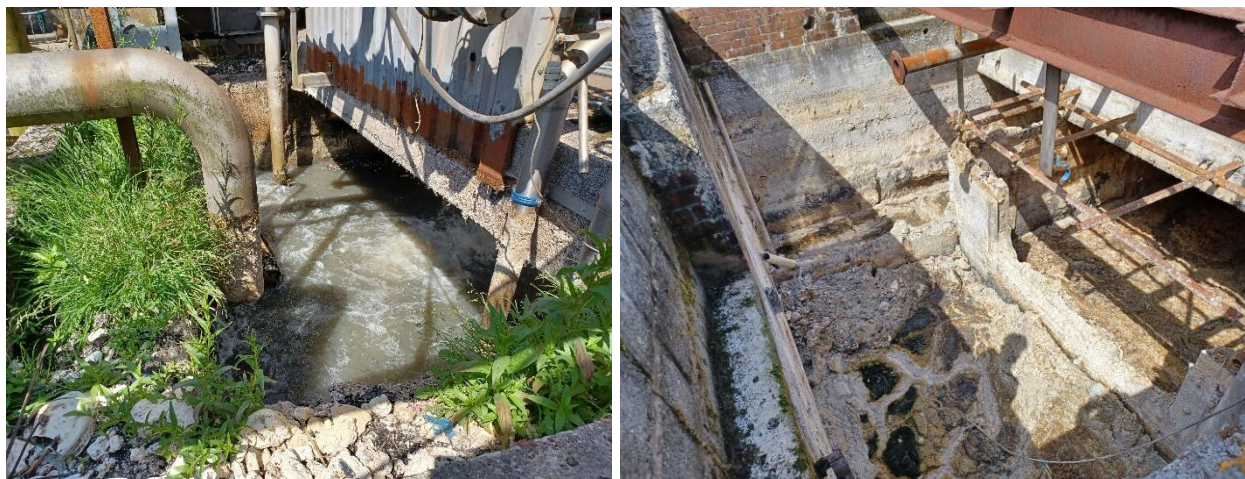
*Image 9 & 10: From surface view of Reception Pit (left) and Detritus Pit (right)*

During the visit, NRW Officers visually inspected from the Reception Pit and Detritus Pit which are associated with the ETP process from ground level. The Detritus Pit, which receives all wastewater from Site activities was noted as being in a particularly poor condition from a visual perspective, with a significant accumulation of foreign solid material present upon the effluent surface. It is unclear from on-site discussions with the representative of United Petfoods (UK) Ltd whether an integrity inspection has ever been undertaken on either the Detritus Pit and Reception Pit, or when they had been emptied previously. The internal structural walls of the Detritus Pit appeared to be of concrete construction above the material 'crust' of the effluent residue and this is presumed to be the case throughout the entirety of the asset. Concerns were raised regarding the potential presence of structural failures beneath the water line which may allow for the escape of contaminated liquid to ground in the absence of periodic integrity inspections and routine maintenance. The levels within the Detritus Pit are managed via an automatically activated pumping system which transfers effluent via above ground pipework across the Afon Bran and into the Reception Pit.

The Reception Pit appears to be acting as a balance tank within the effluent treatment process, with continual circulation through the system to maintain aeration and prevent settlement. While the condition of this asset appeared to be better from a visual perspective, evidence of fat deposits surrounding upper walls of the asset are indicative of

historic instances of effluent overflow. NRW were informed that the Reception Pit was significant in depth with majority of its structure being subterranean.

**United Petfoods (UK) Ltd is to investigate the structural integrity of the Detritus Pit and Reception Pit. All internal structural walls and components associated with the assets must be cleaned and foreign material removed to facilitate a full inspection by a suitably competent contractor, a report will need to be generated and is to be submitted to NRW as evidence.**
