**Cwm Clydach Culvert – Hydraulic Modelling Dimensional and
Constructional Survey**

10th March 2022

Structure No.	B21	Structure Name	Heathwood Road Culvert	
Date of Inspection	07/01/2020	Lead Inspector	N.Tucker

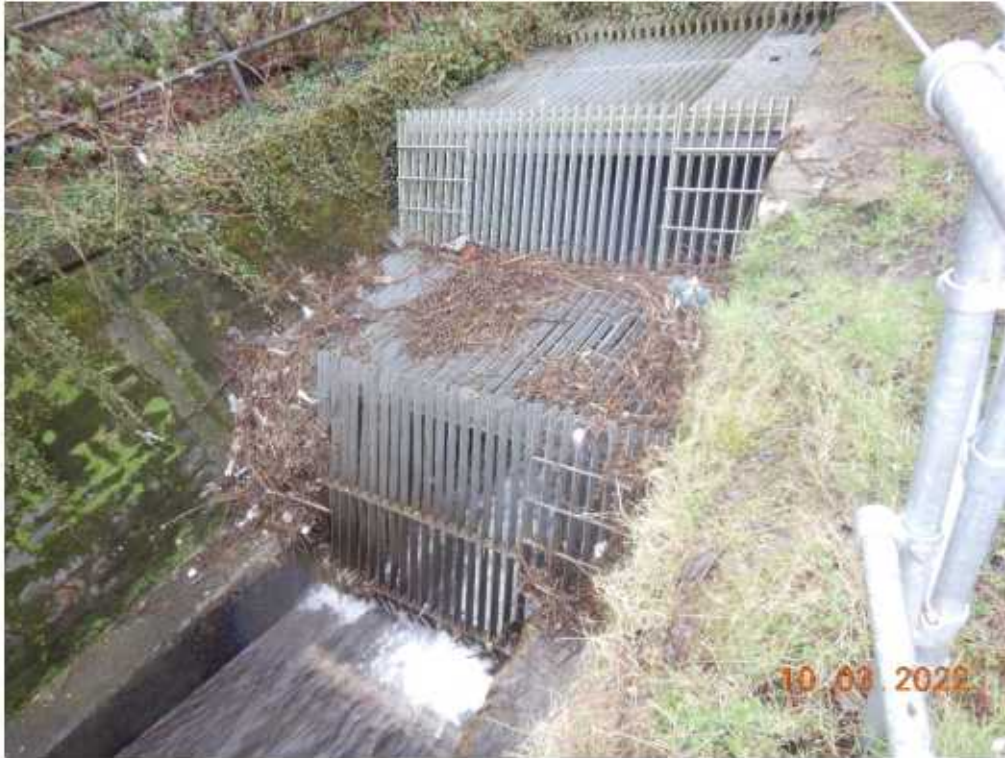
Photo 1 – Upstream elevation

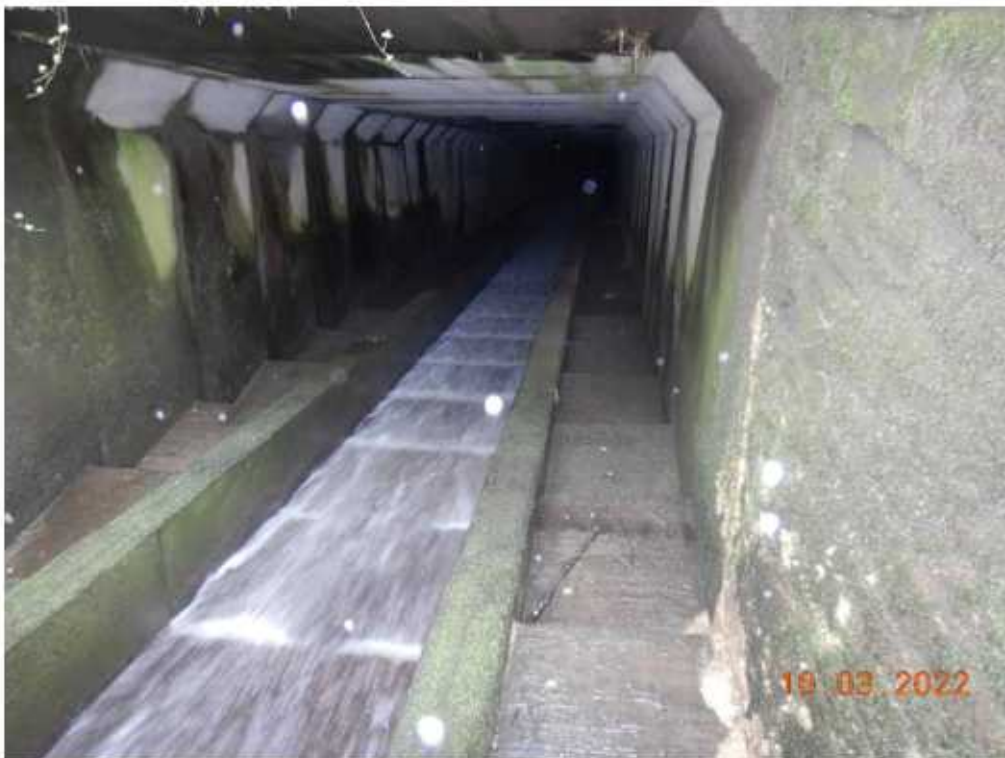
Photo 2 –View downstream from the structure inlet

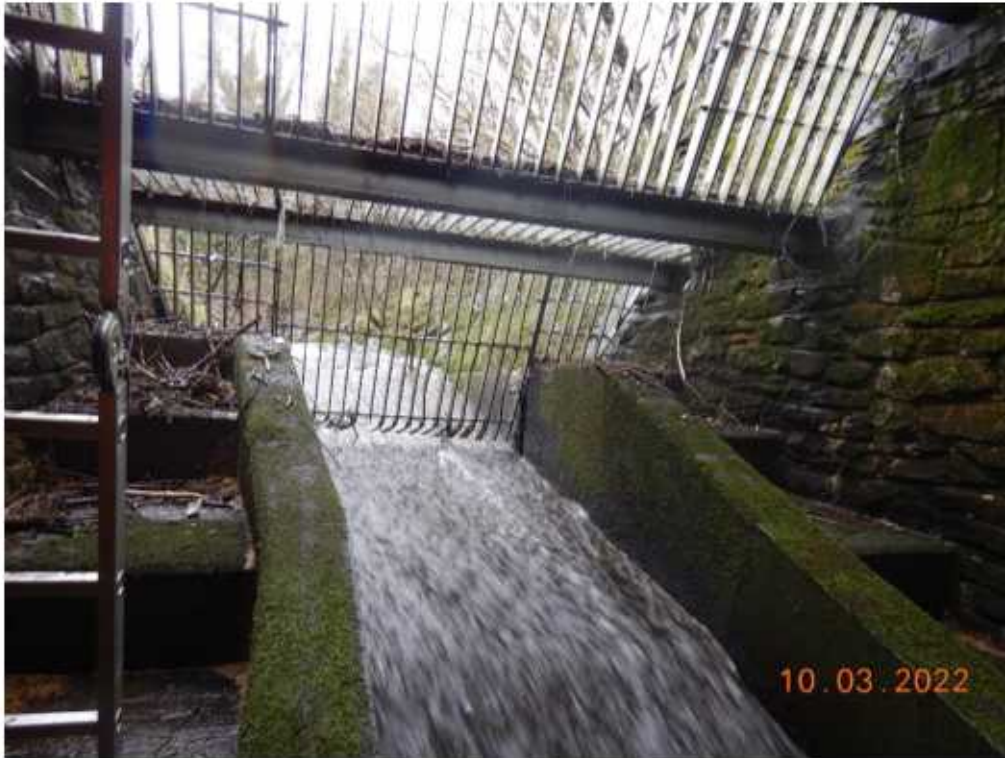
Photo 3 – View upstream from the structure inlet

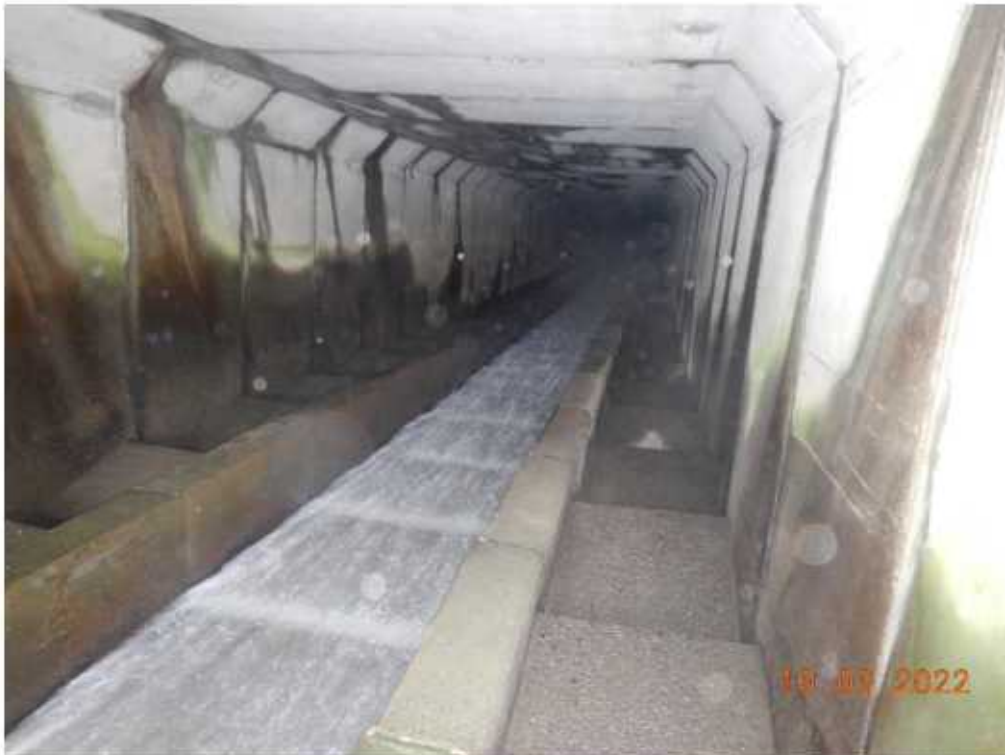
Photo 4 – General view downstream through span 1

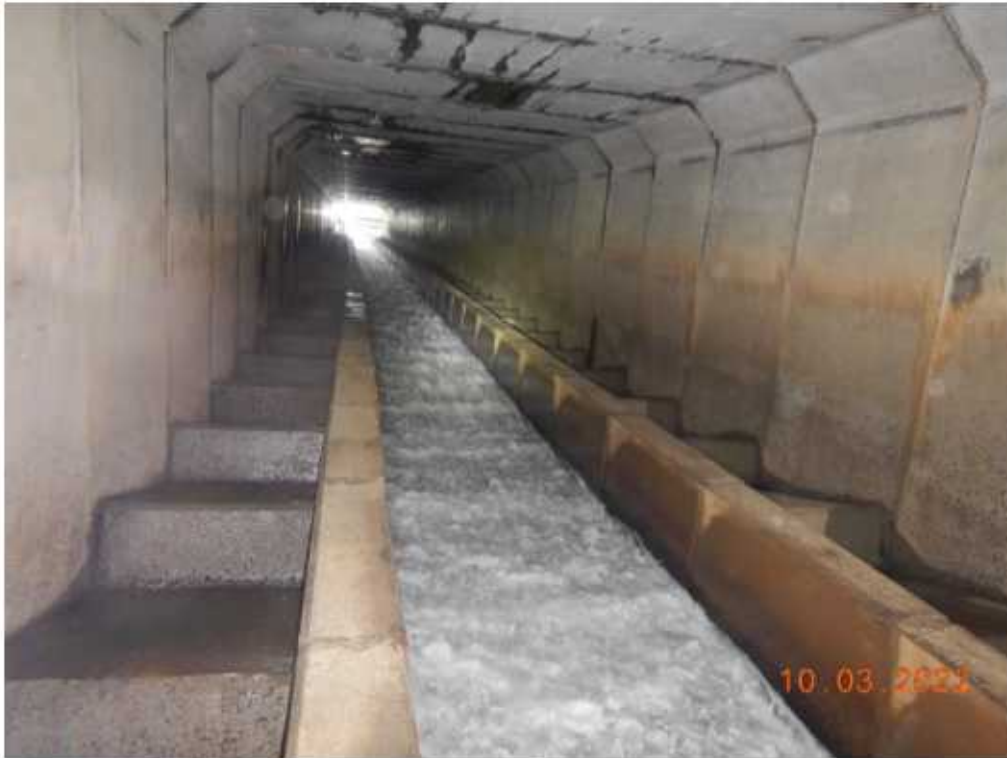
Photo 5 – General view upstream of span 1, taken from Ch54.5m

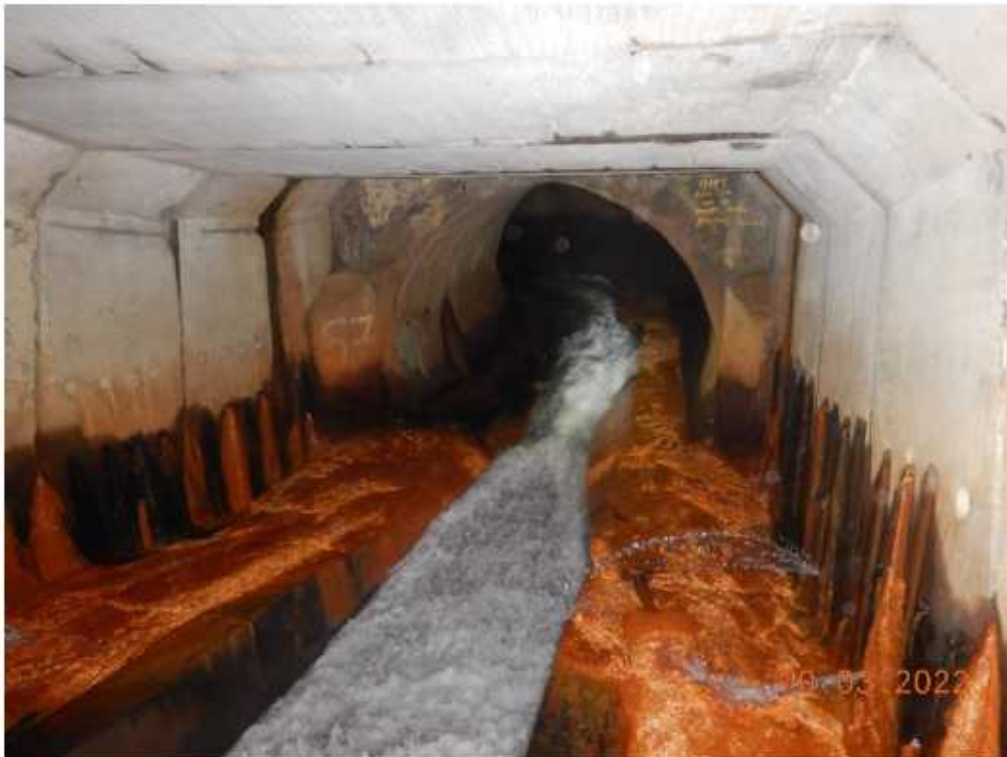
Photo 6 – View of the change in construction to span 2 (CH54.5m)

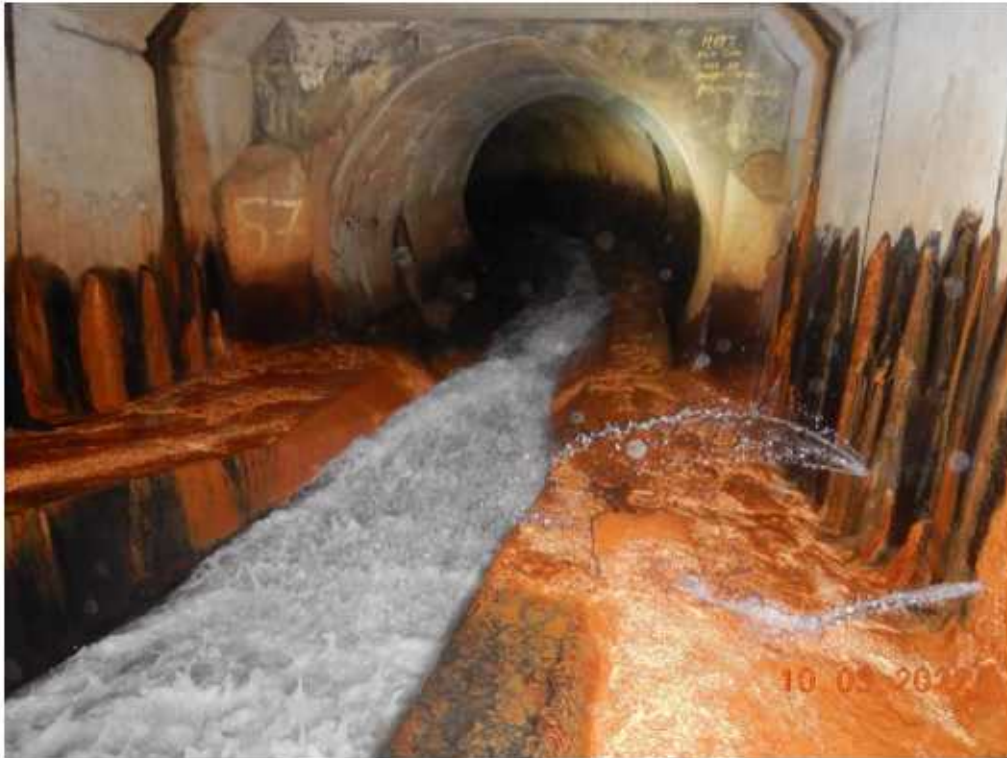
Photo 7 – View through span 2, looking downstream from Ch54.5m)

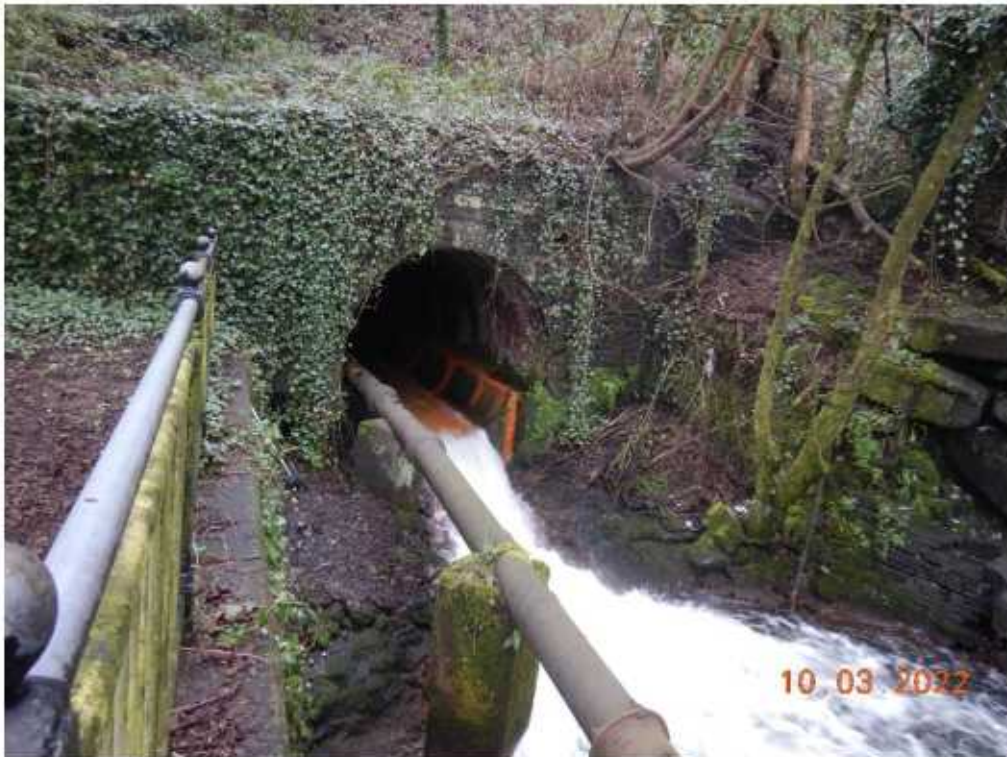
Photo 8 – General view of the culvert outlet

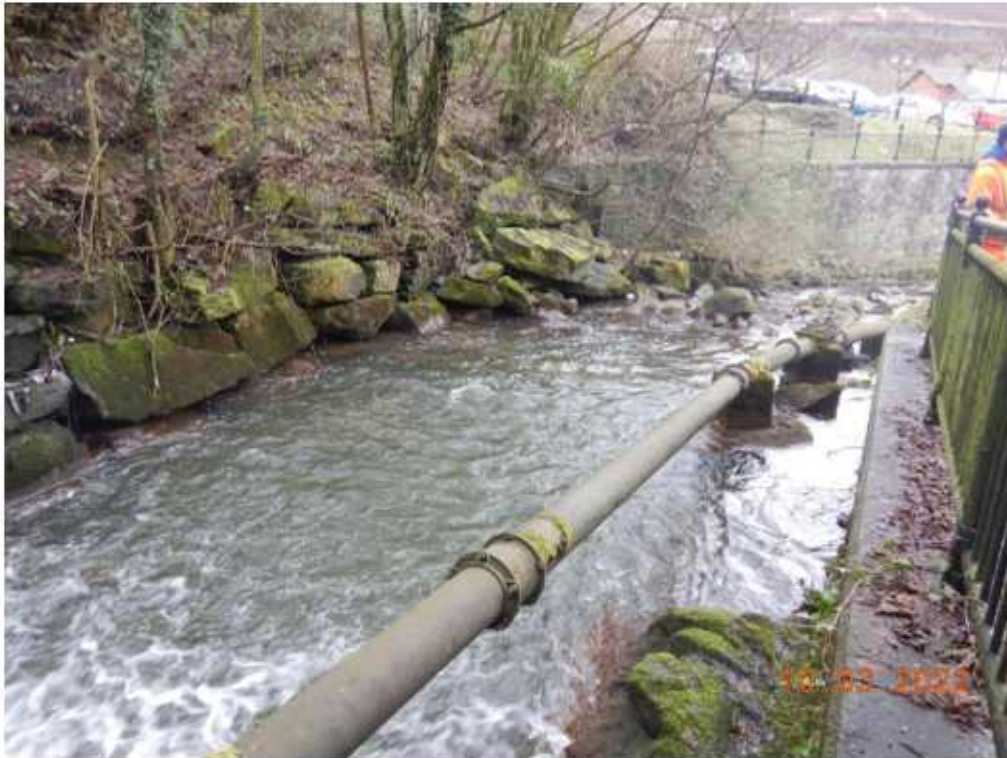
Photo 9 – View downstream from the culvert outlet

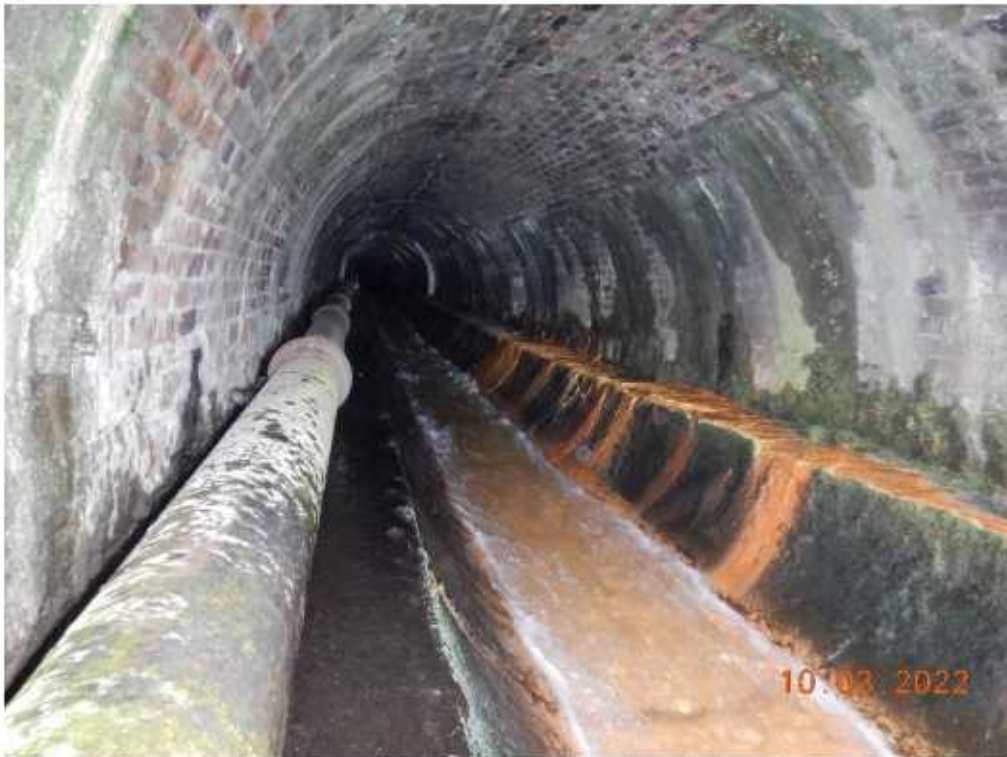
Photo 10 – View upstream of the culvert outlet

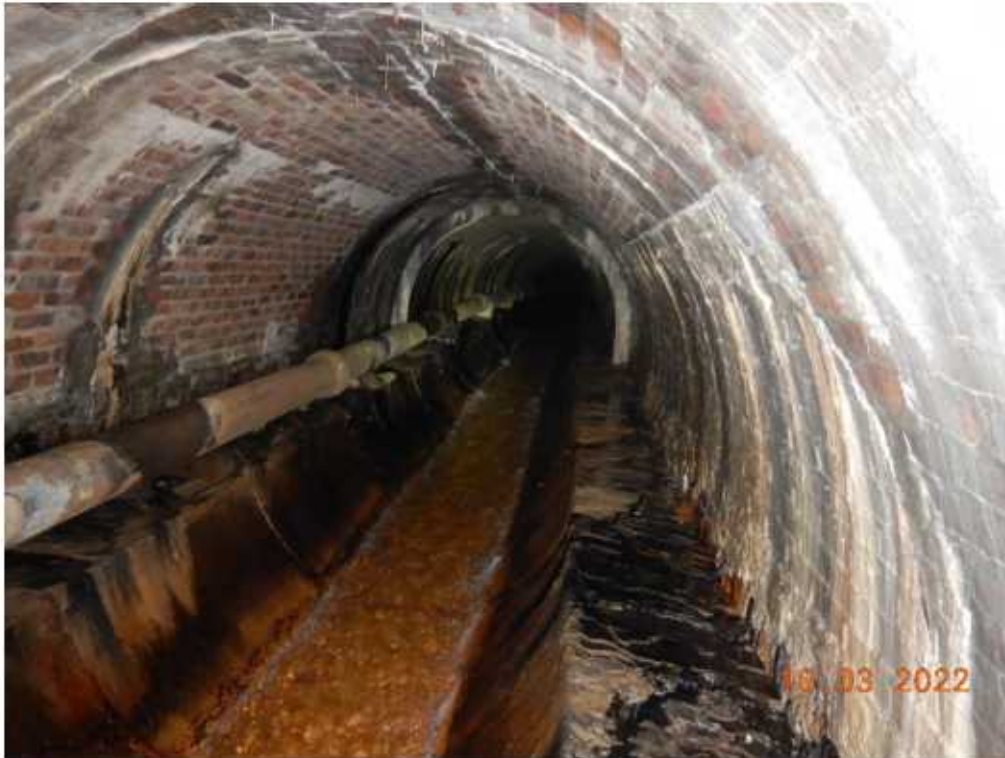
Photo 11 – General view through span 3, looking upstream

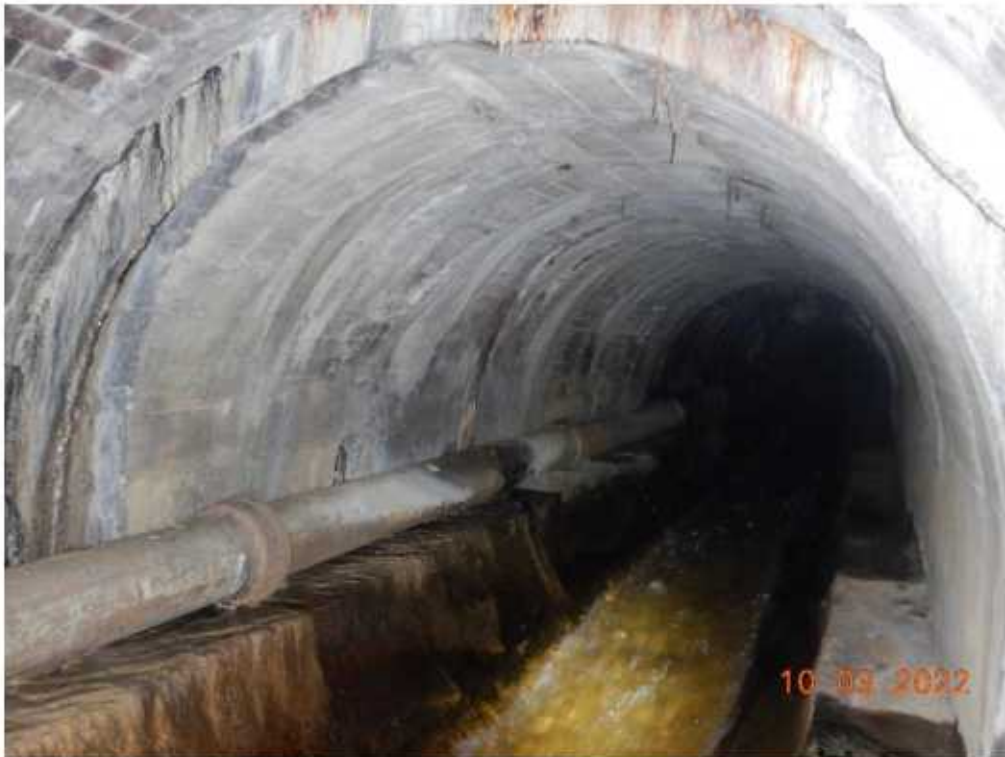
Photo 12 – Example of the cast in situ concrete repairs to the arch

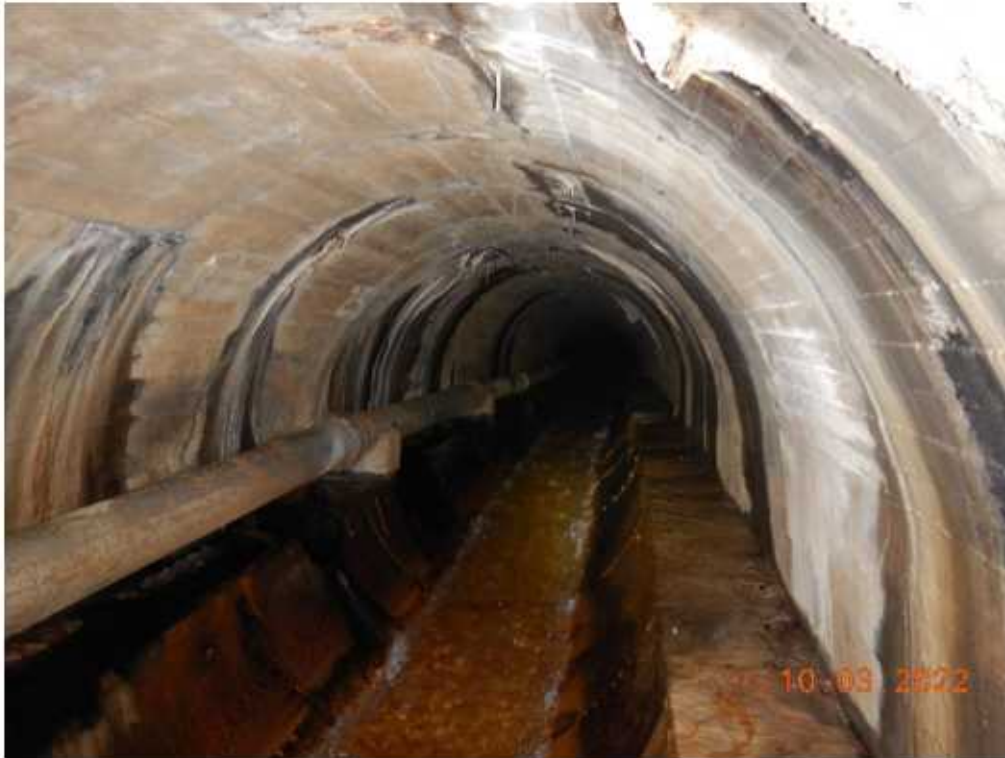
Photo 13 – General view through the cast in situ concrete arch repair sections

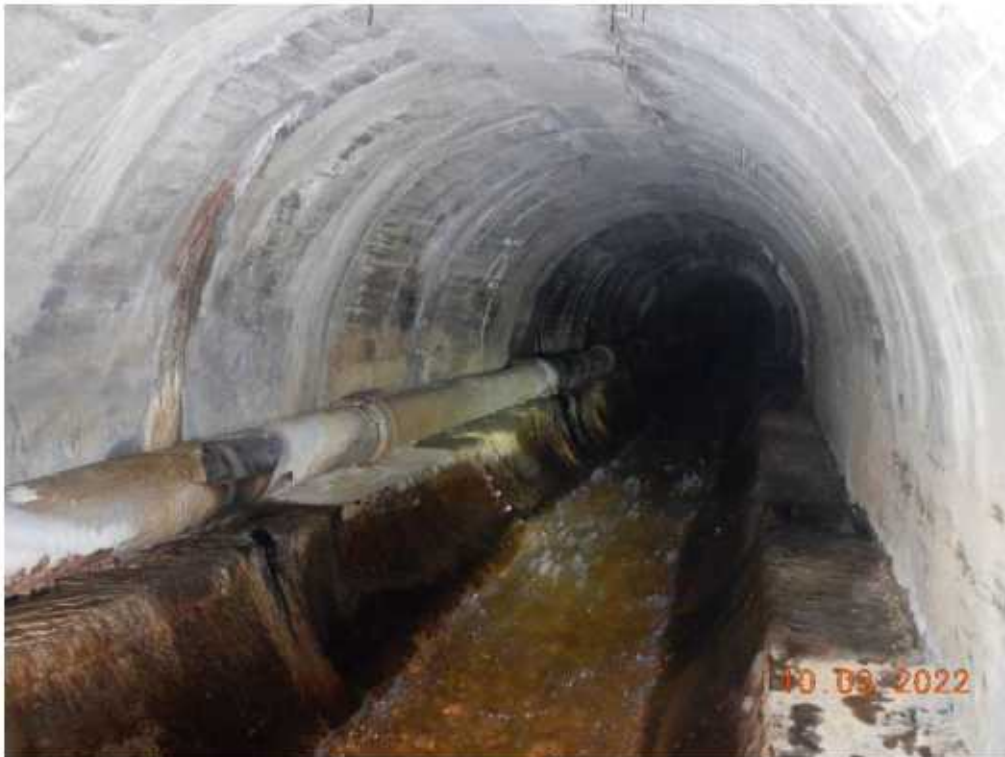
Photo 14 – General view up from the termination point.
