| | | <b>NETWORK RAIL</b><br><b>Bridge Detailed Examination Report</b> | | | | | | | | | | |
| ELR: LLA | | Contract Mileage: 004 m 1320 yds 60.00 ch | | | | | | Struc. Ref: 4 60 | | | | |
| Structure Name: River Gwilli. | | | | | | Type: BU | | Exam ID: 16370968 | | | | |

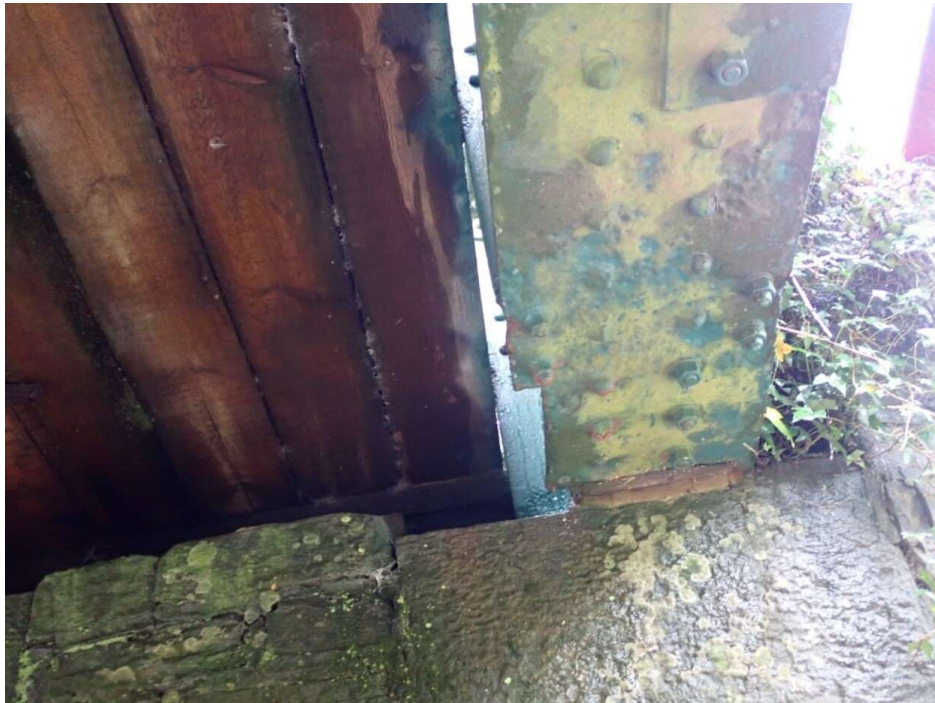
[Photo 8: Defect 12 28/08/24](#)

| | | | <b>NETWORK RAIL</b><br><b>Bridge Detailed Examination Report</b> | | | | | | | | | | |
|---|---|---|---|---|---|---|---|---|---|---|---|---|--|
| 12 | Loss of section x4. worst 400mm x 120mm | Bottom flange MGE1 Upside edge girder | 28/08/2024 | Y | D | N | 4 | N | No Deterioration | N | N | NFD | |

| <p><b>PREVIOUSLY RECORDED SIGNIFICANT (OPEN) DEFECT(S)</b></p> <p><b>DEFECT NUMBER 12</b><br/> Defect Location: Bottom flange MGE1 Upside edge girder<br/> Defect Description: Inner edge at first and second CG, outer edge at fourth stiffener<br/> Identified on: 15/05/2018<br/> Status: No deterioration<br/> Defect Comment:<br/> <a href="#">Previous Defect Photo: 8 - Defect 12 28/08/24</a></p> <p><b>DEFECT NUMBER 13</b><br/> Defect Location: LM abutment, HM abutment, between MGE1 and MGE2.<br/> Defect Description: Top three courses pushed to 20mm HM (part), isolated stones loose to hammer LM<br/> Identified on: 15/05/2018<br/> Status: No deterioration<br/> Defect Comment:<br/> <a href="#">Previous Defect Photo: 9 - Defect 13 28/08/24</a></p> <p><b>DEFECT NUMBER 14</b><br/> Defect Location: Substructure and superstructure soffit<br/> Defect Description: PNE - Watercourse<br/> Identified on: 30/09/2020<br/> Status: No deterioration<br/> Defect Comment:<br/> <a href="#">Previous Defect Photo: 10 - Defect 14 - 28/08/24</a></p> | | |

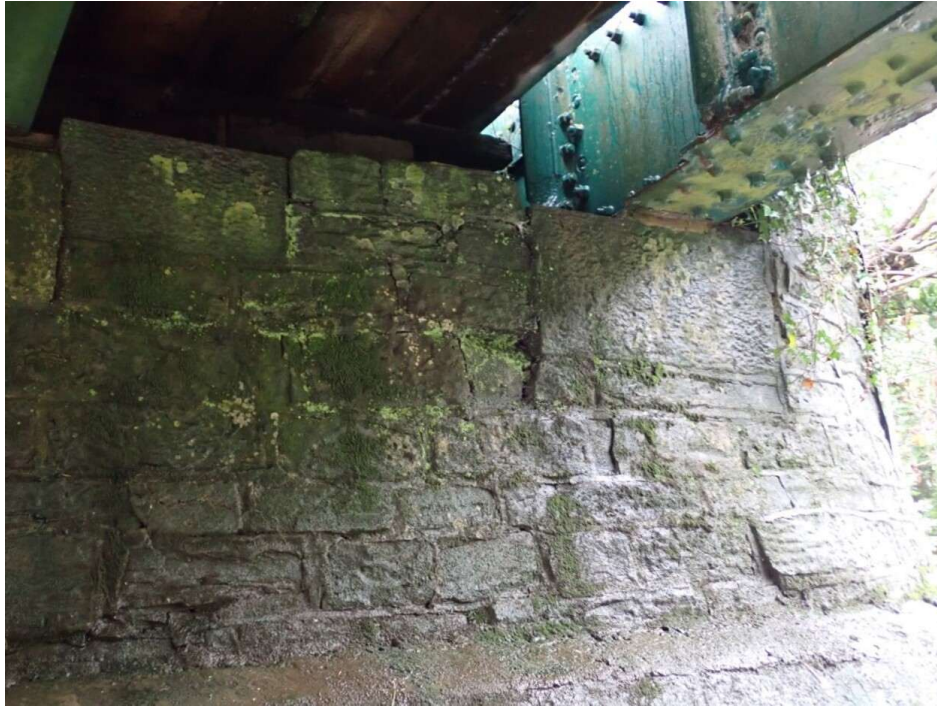
[Photo 9: Defect 13 28/08/24](#)

| | | | <b>NETWORK RAIL</b><br><b>Bridge Detailed Examination Report</b> | | | | | | | | | |
|---|---|---|---|---|---|---|---|---|---|---|---|---|
| 13 | Top three courses pushed to 20mm, with 4mm fracturing | HM abutment, between MGE1 and MGE2. | 28/08/2024 | Y | D | N | 4 | N | No Deterioration | N | N | NFD |

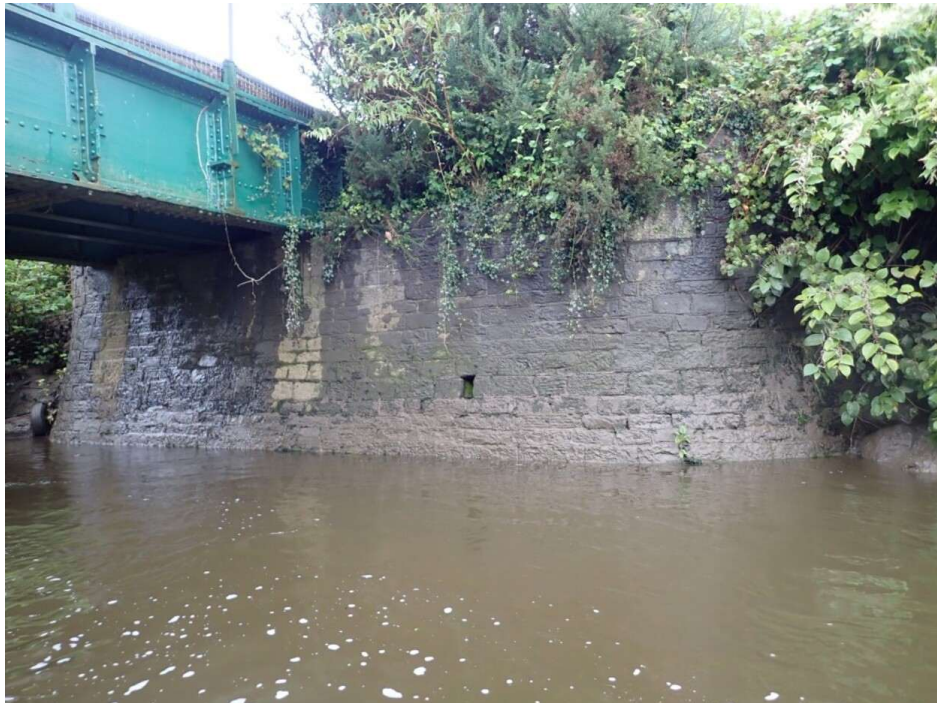
[Photo 10: Defect 14 - 28/08/24](#)

| | | | <b>NETWORK RAIL</b><br><b>Bridge Detailed Examination Report</b> | | | | | | | | | |
|---|---|---|---|---|---|---|---|---|---|---|---|---|
| 14 | PNE - Watercourse | Substructure and superstructure soffit | 28/08/2024 | Y | D | N | 1 | N | N/A | N/A | N | Access gaining and U.WAT examination last carried out 25/05/2023 |

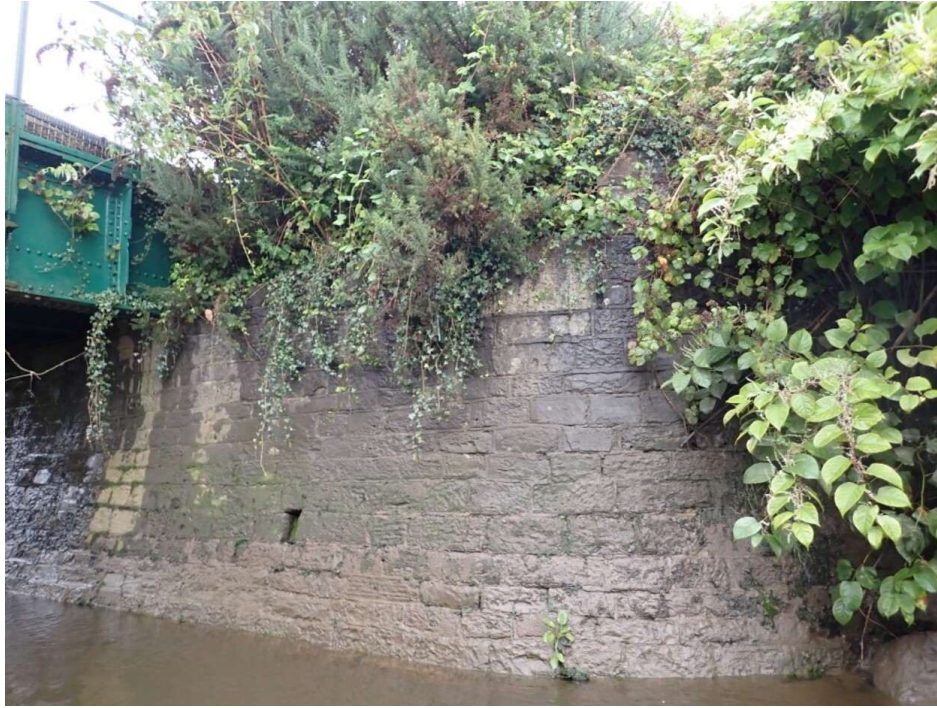
[Photo 11: HM Abutment 28/08/24](#)

| | | | <b>NETWORK RAIL</b><br><b>Bridge Detailed Examination Report</b> | | | | | | | | | |
|---|---|---|---|---|---|---|---|---|---|---|---|---|
| 15 | PNE - Vegetation (5m2) Japanese knotweed | DS of HM abutment | 28/08/2024 | Y | D | Y | 6 | Y | Baseline | N/A | N | Remove vegetation, including Japanese knotweed to allow compliant examination (New recommendation) |

| 1 | Japanese Knotweed present. | Gabion baskets to adjacent to upside of abutment and banking downside adjacent to abutments | |

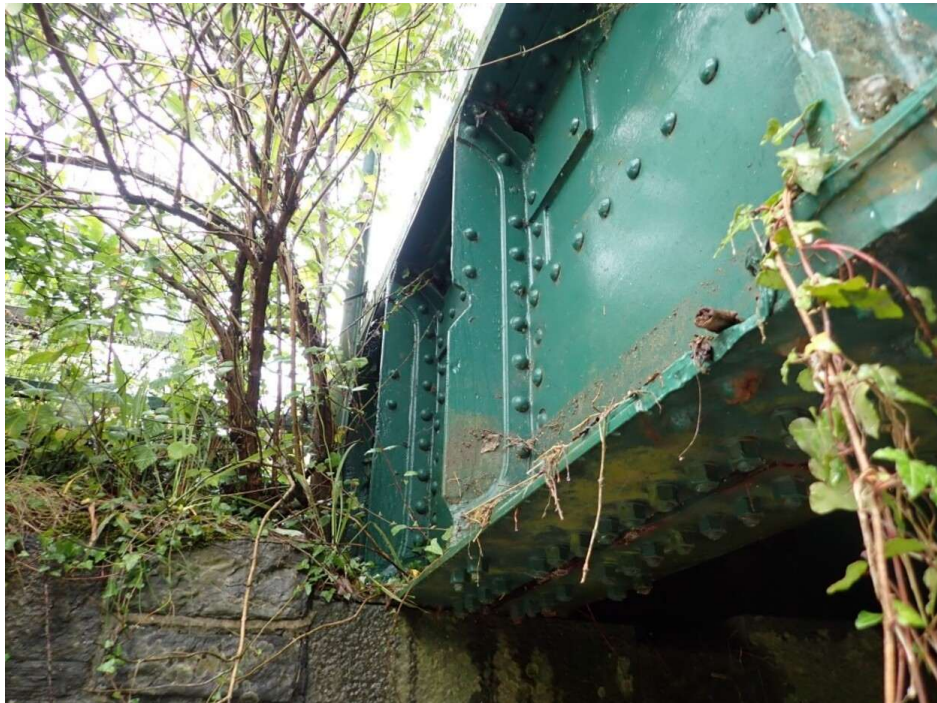
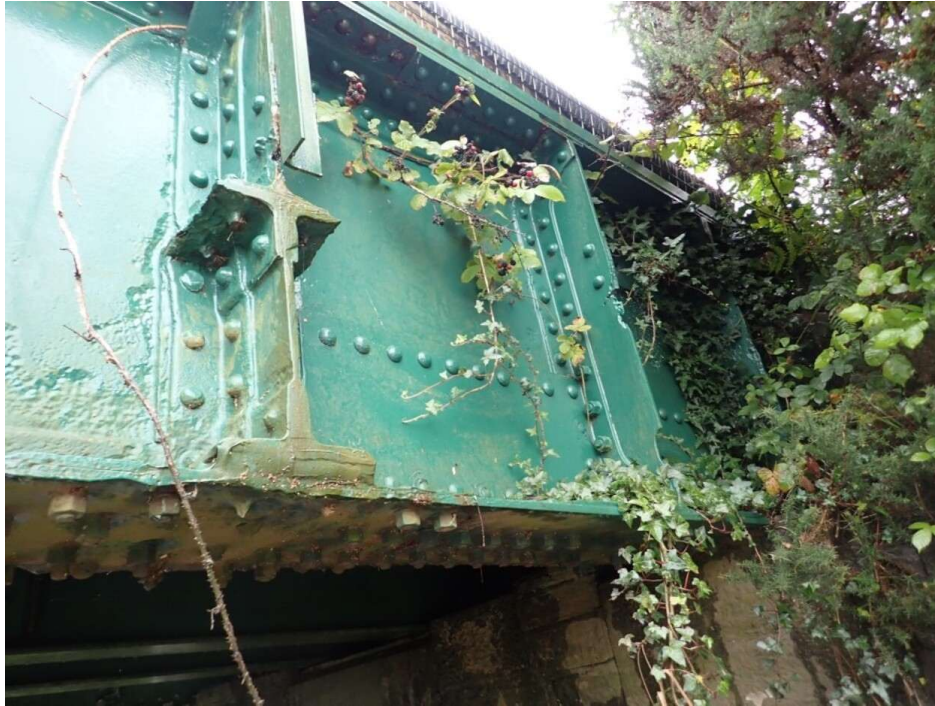
| | | | <b>NETWORK RAIL</b><br><b>Bridge Detailed Examination Report</b> | | | | | | | | | |
|---|---|---|---|---|---|---|---|---|---|---|---|---|
| 16 | Loss to stiffeners - worst 100mm x40mm x 10mm, O/S deep pitting to 8mm painted over. | MGE2 - DS edge girder | 28/08/2024 | Y | D | N | 4 | N | Baseline | N/A | N | Monitor during future examinations |

[Photo 16: Typical Loss to Stiffeners \(28/08/2024\)](#)

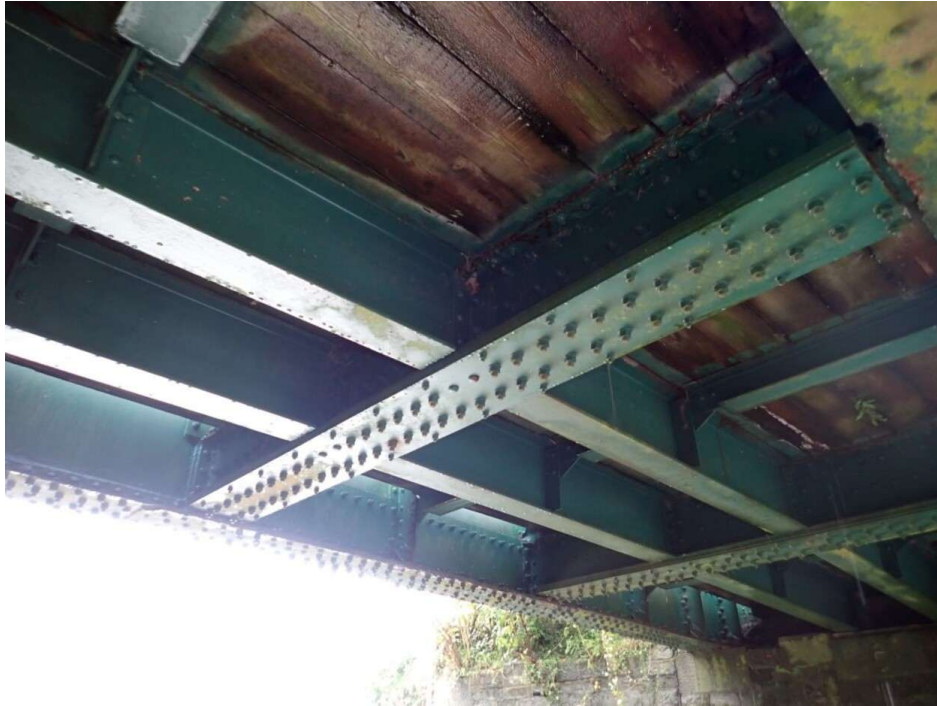
[Photo 19: HM Cross Girder \(28/08/2024\)](#)

| <p>(DK1- XGI1)</p> <p>Both cross girders in similar condition. Repairs carried out previously remain solid. Deep pitting visible to webs below paintwork. &lt;8mm deep. NFD.</p> <p>--</p> <p>Corrosion to top angles &lt;2mm. NEW. Photo 18,19.</p> <p><a href="#">See photo: 18 - LM Cross Girder (28/08/2024)</a></p> <p><a href="#">See photo: 19 - HM Cross Girder (28/08/2024)</a></p> | | | |

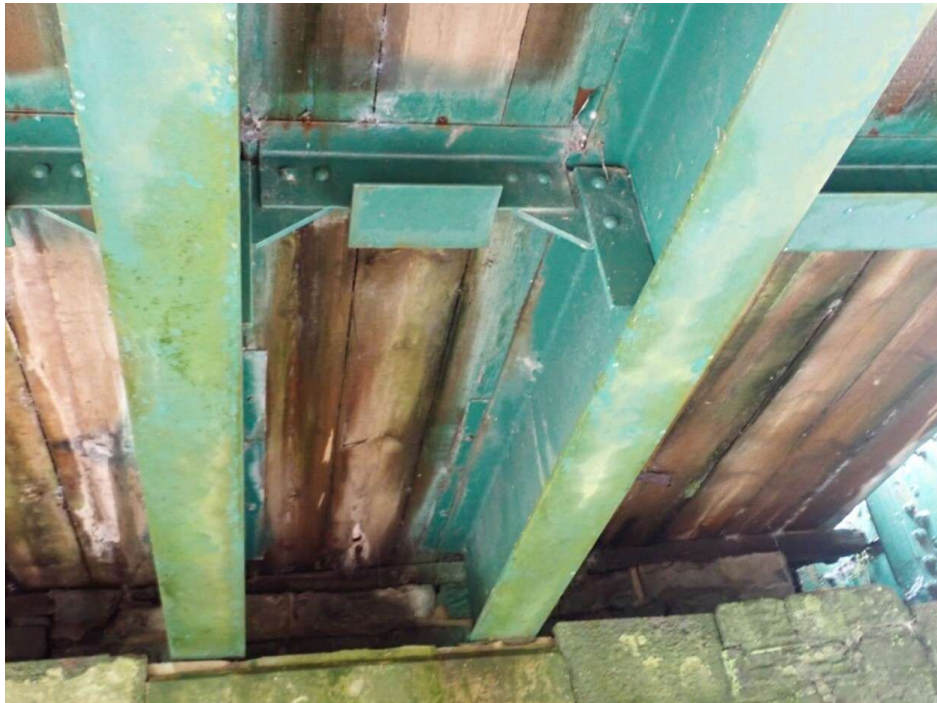
[Photo 20: Typical Rail Bearer Corrosion. \(28/08/2024\)](#)

| <p>(DK1-LSE1)</p> <p>Rail bearers renewed when bridge overhauled in 2016/17.</p> <p>--</p> <p>Surface corrosion to top flange in several areas to both &lt;1mm. NEW. Photo 20.</p> <p><a href="#">See photo: 20 - Typical Rail Bearer Corrosion. (28/08/2024)</a></p> | | | |

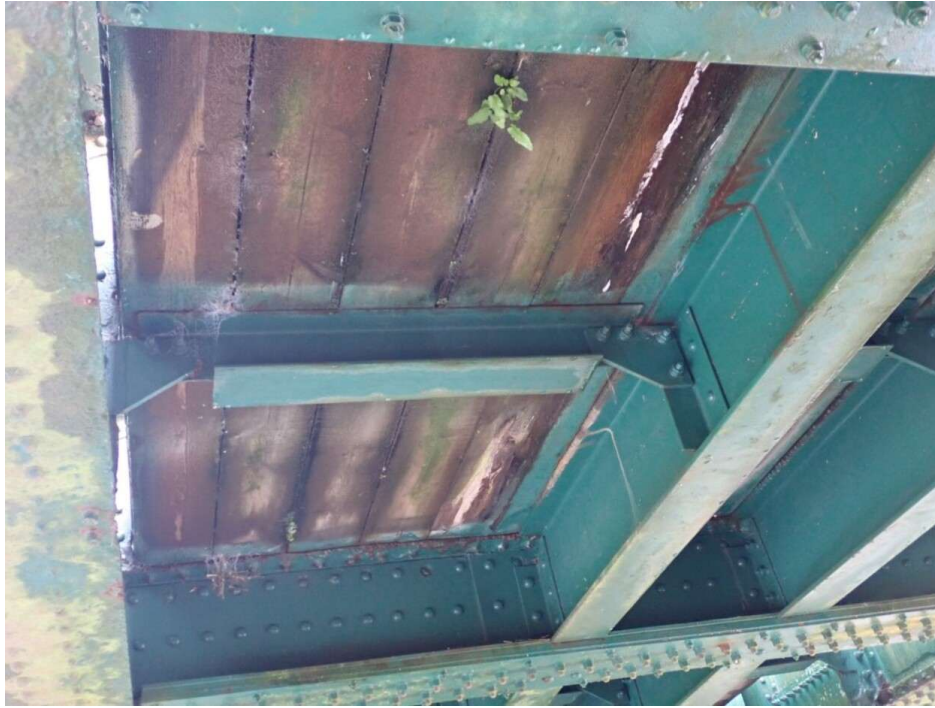
[Photo 21: Typical Deck Boards \(28/08/2024\)](#)

| <p>(DK1-DCK1)</p> <p>Algae staining to boards throughout.</p> <p>Minor vegetation growing between boards.</p> <p>White fungus type staining to several boards.</p> <p>Timbers probed where damp stained and fungus growth present&lt;5mm deep. Photo 21</p> <p><a href="#">See photo: 21 - Typical Deck Boards (28/08/2024)</a></p> | | | |

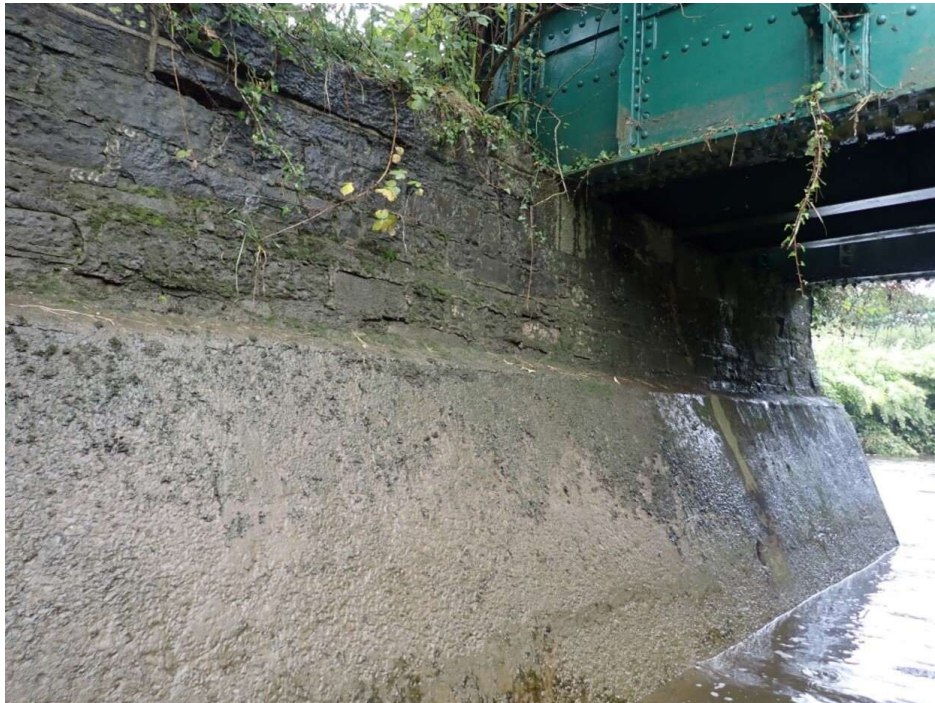
[Photo 22: LM Abutment \(28/08/2024\)](#)

| LM Abutment (ES1-ABT1)<br>Wall of uneven appearance to top stone section. Concrete apron to lower portion of wall. Photo 22.<br>--<br>Isolated stones loose to hammer mainly to upper courses. NFD.<br>--<br>Isolated spalling located at upside end return wall at water level 300mm L x 250mm H x <100mm deep. This is of longstanding. NFD. Photo 23.<br>--<br>Diagonal step joint fracture to upside on rounded area of return. Open 50mm at top of wall with stones displaced forward 50mm around tree growing from fracture. Open 10m at bottom of fracture. Full height of abutment from concrete apron. NEW. Photo 24,25.<br>---<br>HM Abutment (ES2-ABT1)<br>Previously reported - Isolated stone work displaced at worst located between DK1 MGE1&MGI1 to top 3No courses, 500mm L x 500mm W and pushed forward <20mm with fracturing <4mm wide. note, isolated stones loose to hammer. This is of longstanding and shows no further deterioration. Photo 26<br>--<br>Isolated pointing repairs have been carried out with open joints remaining mainly at the lower ¼ of the abutment. Date tab present on pointing repairs upside (1/11/16) and intact. Photo 27,28.<br><a href="#">See photo: 22 - LM Abutment (28/08/2024)</a><br><a href="#">See photo: 23 - Spalling (28/08/2024)</a><br><a href="#">See photo: 24 - Fracture (28/08/2024)</a><br><a href="#">See photo: 25 - Displacement Around Tree (28/08/2024)</a><br><a href="#">See photo: 26 - Loose to Hammer (28/08/2024)</a><br><a href="#">See photo: 27 - HM Abutment (28/08/2024)</a><br><a href="#">See photo: 28 - Date Tab (28/08/2024)</a> | | | |

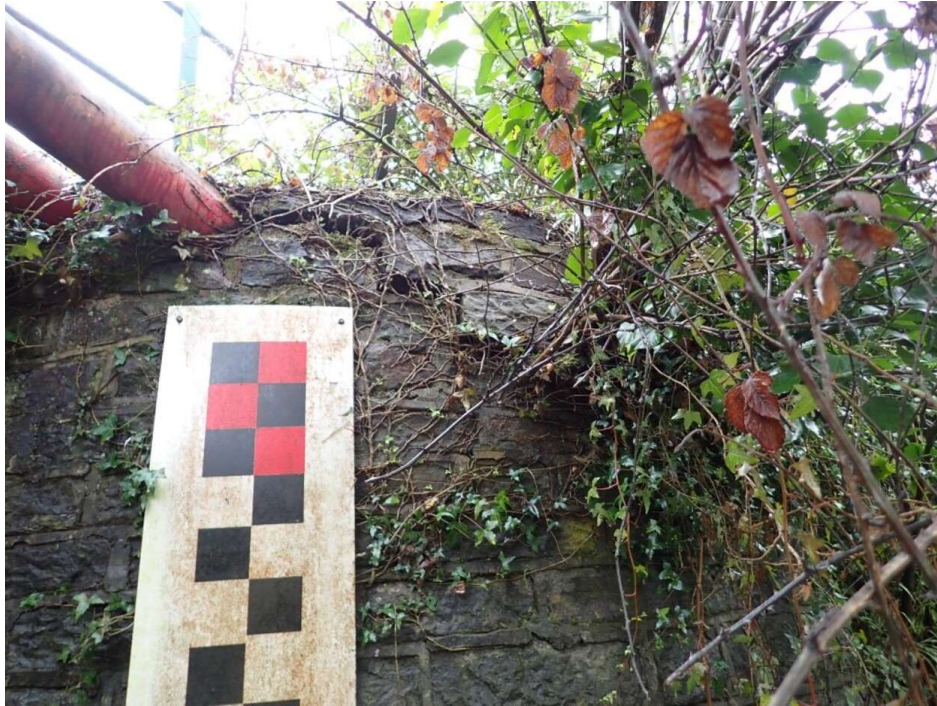
[Photo 25: Displacement Around Tree \(28/08/2024\)](#)

| | | | <b>NETWORK RAIL</b><br><b>Bridge Detailed Examination Report</b> | | | | | | | | | |
|---|---|---|---|---|---|---|---|---|---|---|---|---|
| 17 | Diagonal step joint fracture to upside on rounded area of return. Open 50mm at top of wall with stones displaced forward 50mm around tree growing from fracture. Open 10m at bottom of fracture. Full height of abutment from concrete apron | LM abutment, US end | 28/08/2024 | Y | D | Y | 9 | N | Baseline | N/A | N | Remove tree growing from fracture and repair area of displaced masonry |

| | | | <p align="center"><b>NETWORK RAIL</b></p> <p align="center"><b>Bridge Detailed Examination Report</b></p> | | | | | | | | | |
|---|---|---|---|---|---|---|---|---|---|---|---|---|
| | wall with stones displaced forward 50mm around tree growing from fracture. Open 10m at bottom of fracture. Full height of abutment from concrete apron | | | | | | | | | | | |

| 1 | Remove tree growing from fracture and repair area of displaced masonry (New recommendation) | LM abutment, US end | 4000 | 1yr | 1unit | 3 | 3 | E9 | Brickwork/Stone Repairs | | | |

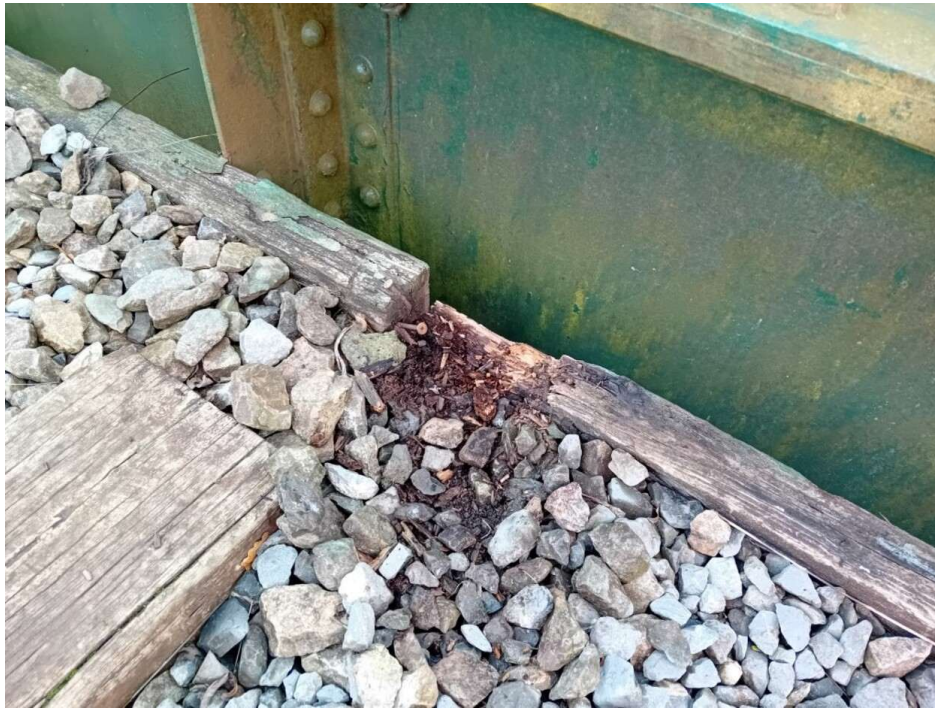
[Photo 31: Downside Ballast Board \(12/11/2024\)](#)

| | | | <p align="center"><b>NETWORK RAIL</b></p> <p align="center"><b>Bridge Detailed Examination Report</b></p> | | | | | | | | | |
|---|---|---|---|---|---|---|---|---|---|---|---|---|
| 20 | 2No rotten timber ballast boards to 100mm when probed, 1No to each side | Adjacent to main girders | 28/08/2024 | Y | D | Y | 6 | Y | Baseline | N/A | N | Replace 2No rotten timber ballast boards |

| Ballast boards to trackside show rot with loss to centre of downside boards. NEW. 200mm long x 60mm deep. Timbers probed in this area to 100mm deep Photo 31.<br>--<br>Upside boards show loss to top edge 50mm deep x 600mm long. NEW. Probed here to 70mm deep. Photo 32.<br>--<br>Remainder of boards appear to be in a good condition but unable to view below ballast level.<br>--<br>Ballast walls present at each end of deck. General weathering with isolated pointing loss. <2m2.<br><a href="#">See photo: 31 - Downside Ballast Board (12/11/2024)</a><br><a href="#">See photo: 32 - Upside Ballast Board (12/11/2024)</a> | | | |

| 4 | Replace 2No rotten timber ballast boards (New recommendation) | Adjacent to main girders | 1000 | 1yr | 2unit | 3 | 2 | M6 | Other | | | |

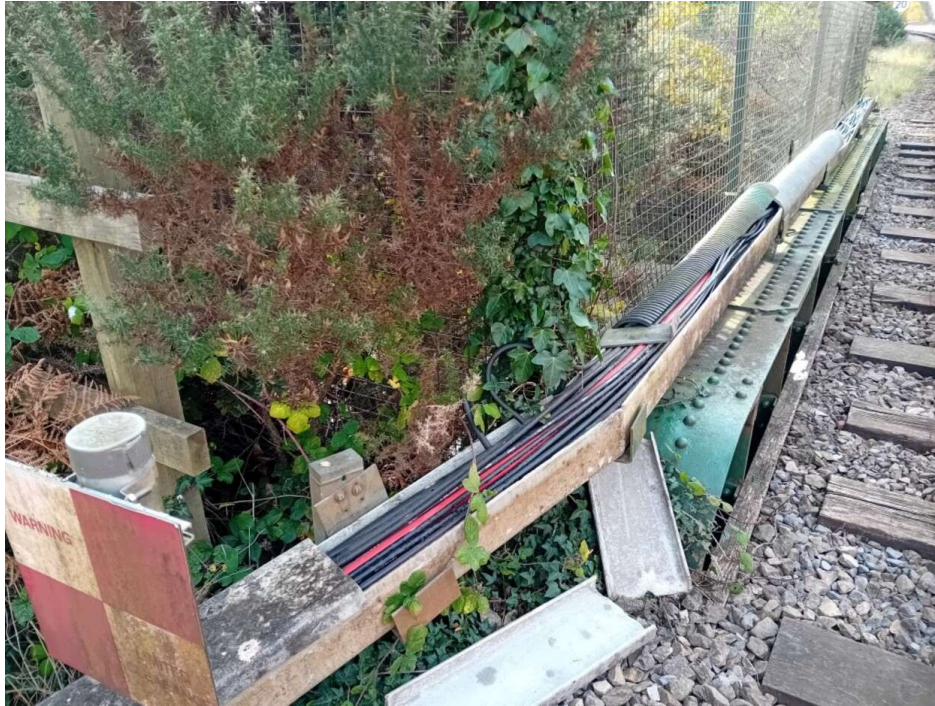
[Photo 37: S&C Trough \(12/11/2024\)](#)

| | | | <p align="center"><b>NETWORK RAIL</b></p> <p align="center"><b>Bridge Detailed Examination Report</b></p> | | | | | | | | | |
|---|---|---|---|---|---|---|---|---|---|---|---|---|
| 19 | Missing/displaced S & T troughing lids (5m) | Along the top od DS edge girder | 28/08/2024 | Y | D | Y | 5 | N | Baseline | N/A | N | Request S & T replace missing and displaced troughing lids |

| S&C Trough installed along top of downside main girder. Lids missing throughout almost full length.<br>Photo 37.<br><a href="#">See photo: 37 - S&amp;C Trough (12/11/2024)</a> | | | |

| 3 | Request S & T replace missing and displaced troughing lids (New recommendation) | Along the top od DS edge girder | | Immed | 5m2 | 5 | 1 | M5 | Other | | | |
