Pollution Incident Storyboard

Details	
Reported By	Adam Davies
Email	Adam.Davies3@dwrcymru.com
Contact Number	07990715669
Incident Date	19/10/2025 16:32
10 Day Report Date	29/10/2025
WIRS/NIRS Number	2509390
SAP Number	317604898
Address & Postcode	Westcliff, Pennard, Southgate, Swansea, SA3 2AP
Grid Reference	SS5538787144
Catchment	Southwest
Incident Type	
Notification Type	POLFAX
Could this incident have been Self-Reported?	No
If Yes – How?

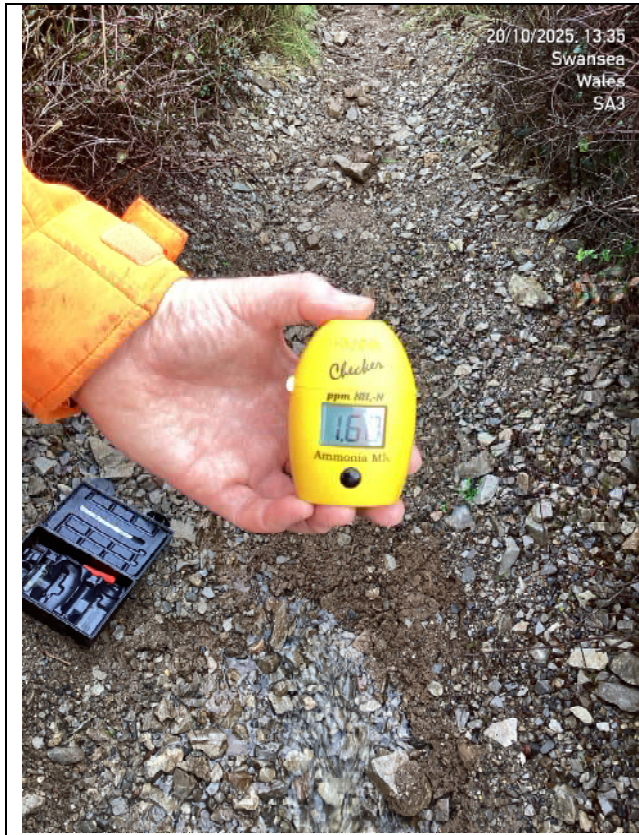
20/10/25 - W3W ///sometimes.flown.package
NH3 - N = 1.67ppm

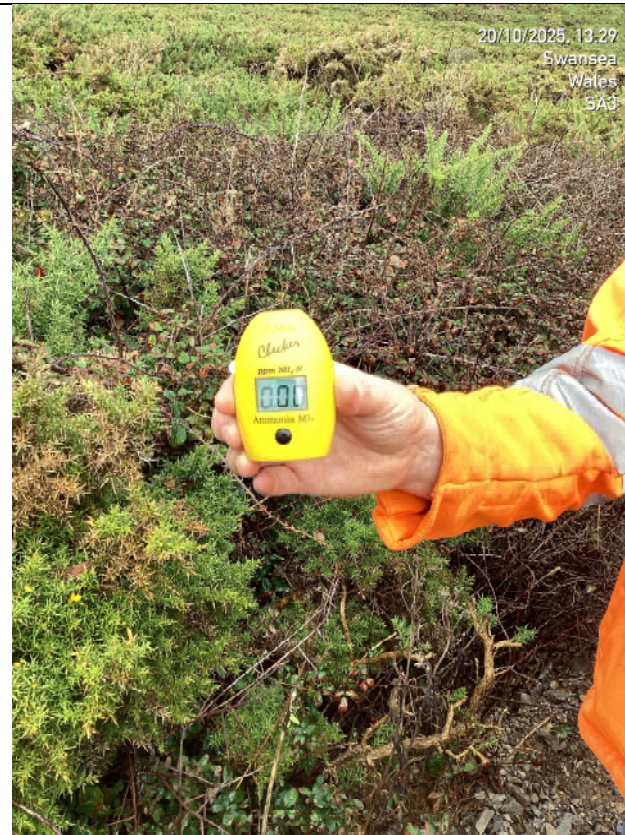
20/10/25 - W3W ///awaited.wrist.arise NH3 -N
= 0.00ppm

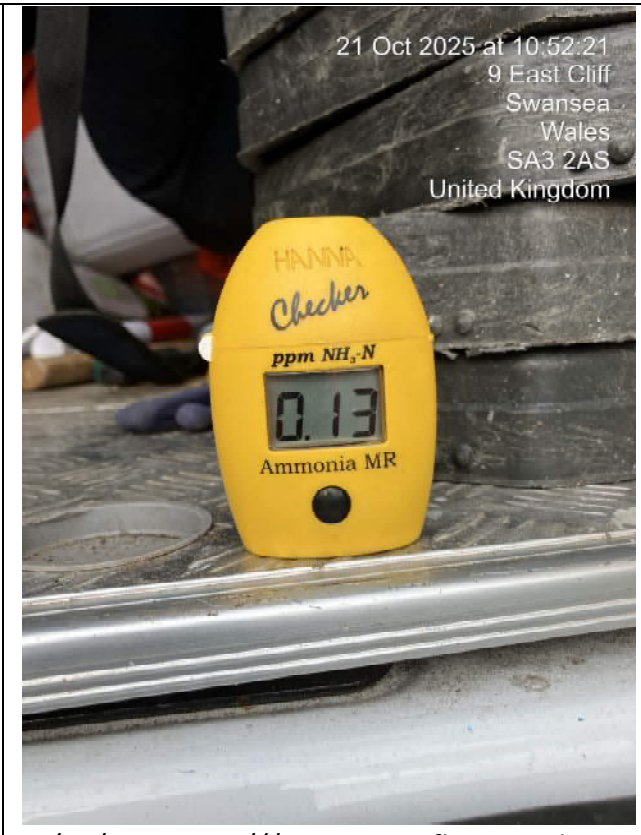
21/10/25 - W3W ///sometimes.flown.package
NH3 -N = 0.13ppm

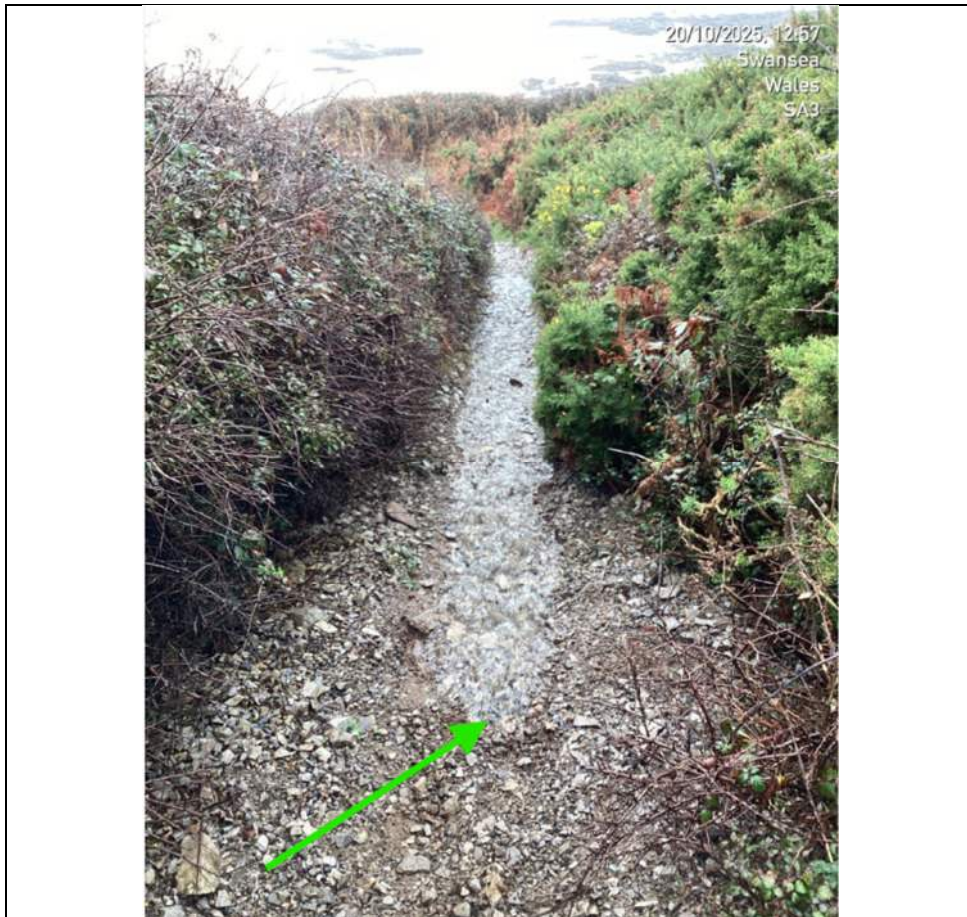
W3W ///sometimes.flown.package
Effluent has backed-up the line due to obstruction (metal sampling pot)
and has discharged from the nearest weak-point in the network

Details	
Primary Pollution Cause	Blockage-Partial
Secondary Pollution Cause	Water
Brief description of cause	A metal sampling pot, roughly the same diameter as the final effluent pipe (150mm), was discovered lodged in the pipe during the excavation. This caused the effluent to back up and discharge at the nearest release point (gravel footpath - W3W ///sometimes.flown.package).
Action taken (1)	Pollution Tech. attended site to document incident 20/10/25
Action taken (2)	CCTV arranged to camera from uncharted m/h at top of Foxhole Bay - 21/10/25. Identified buried m/h approx. 40m d/s.
Action taken (3)	22/10/25 - Approx. 10m ² cut-back of vegetation to inspect area around d/s dogleg of line, W3W ///sometimes.flown.package. No hatch/chamber was found.
Action taken (4)	24/10/25 - Hatch-plate released from effluent line W3W ///awaited.wrist.arise. CCTV performed and obstruction located approx. 1m d/s. Pumps isolated at Southgate PS for camera work. Obstruction could not be removed.

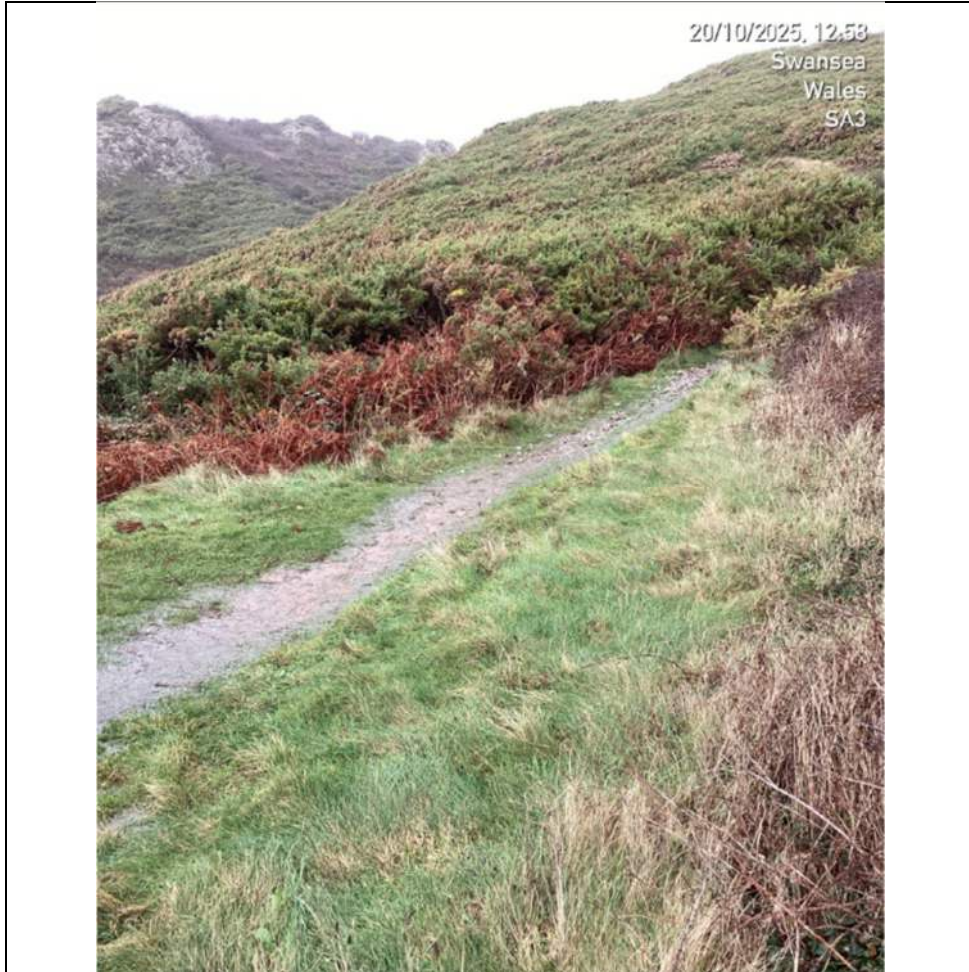
Flow of discharge down the footpath, leading toward rocks (bay)

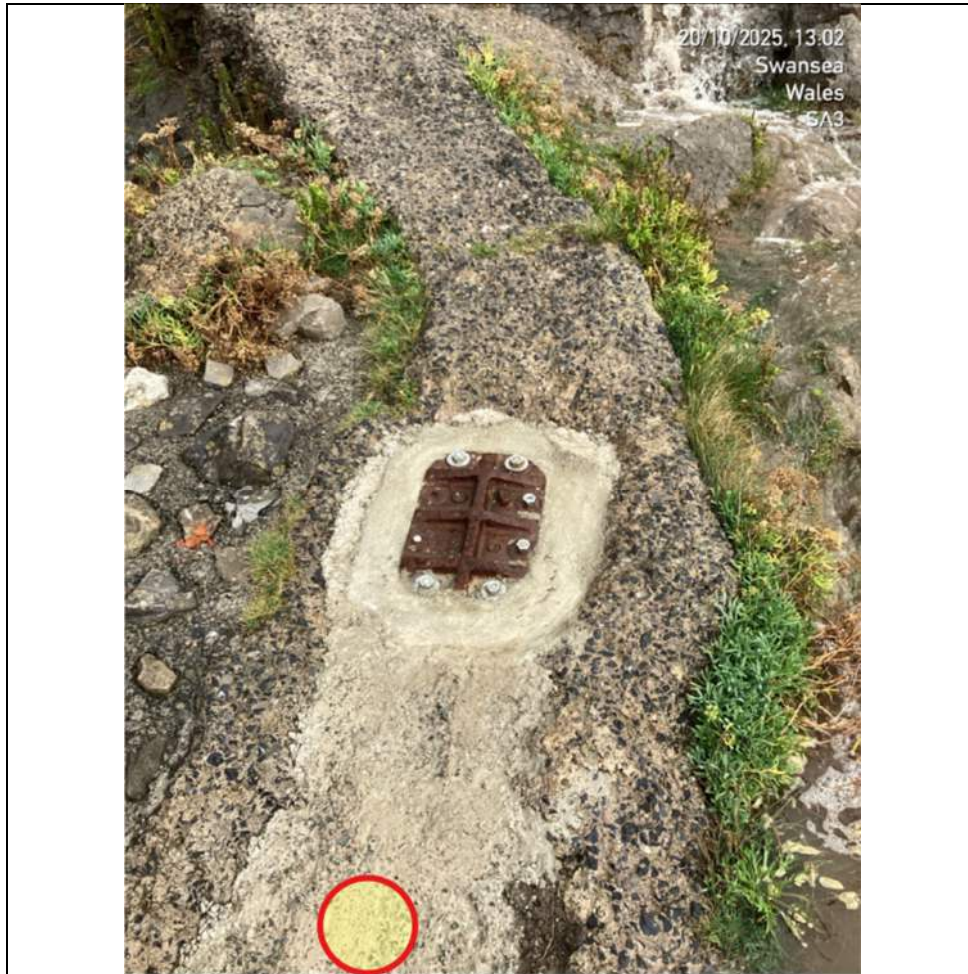
Hatch-plate d/s from discharge on footpath. The highlighted spot indicates where the metal sampling pot was wedged in the line (approx. 1m d/s from plate)

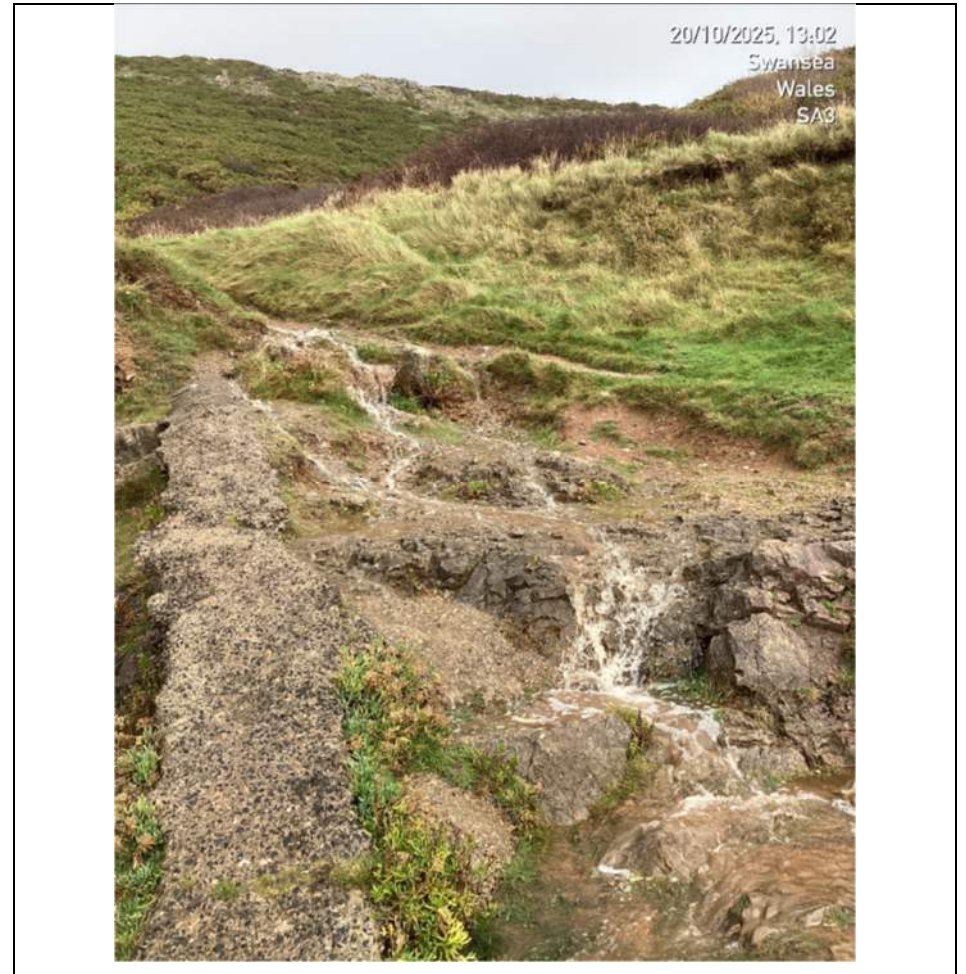
Direction of flow toward bay

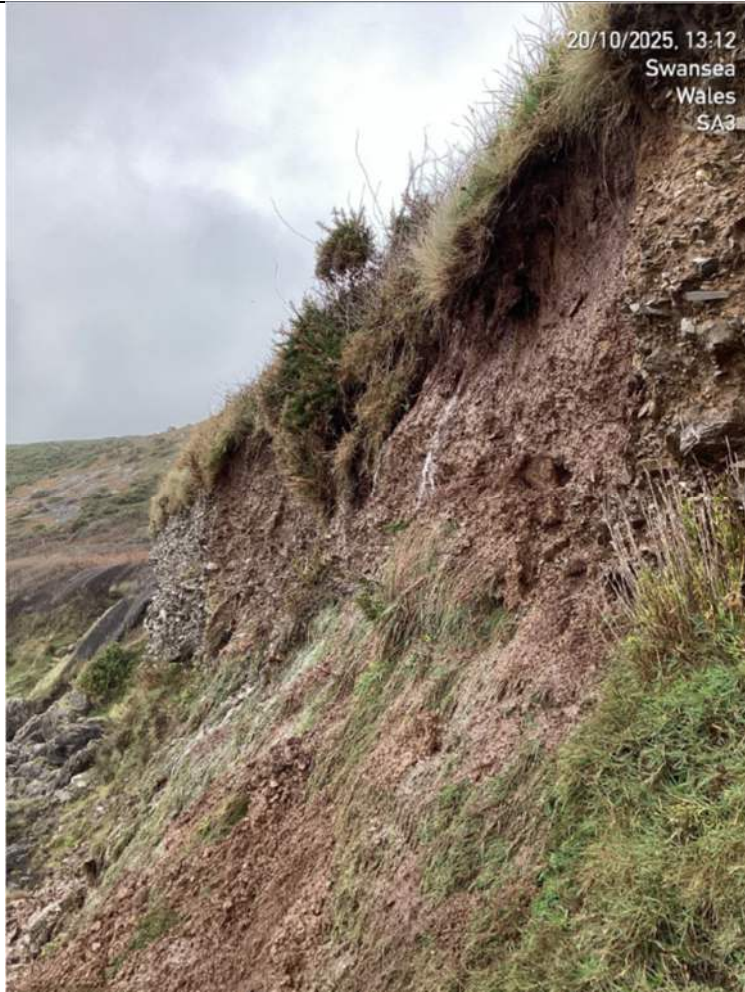
Flow emanating from the footpath bifurcated/filtered through sub-soil, leaching out as seen above.

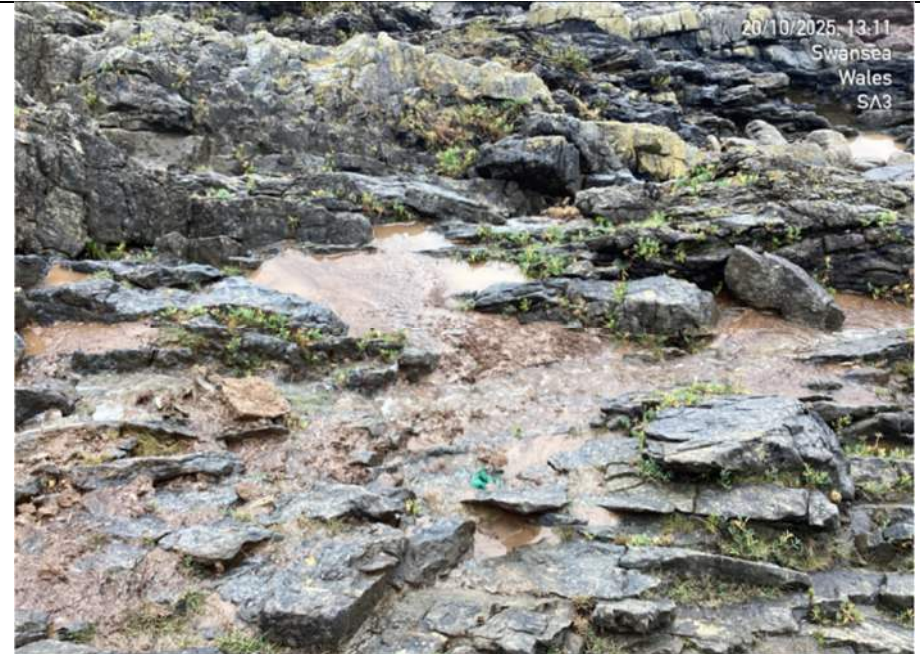
Sub-soil throughflow caused the muddy pools that can be seen above.

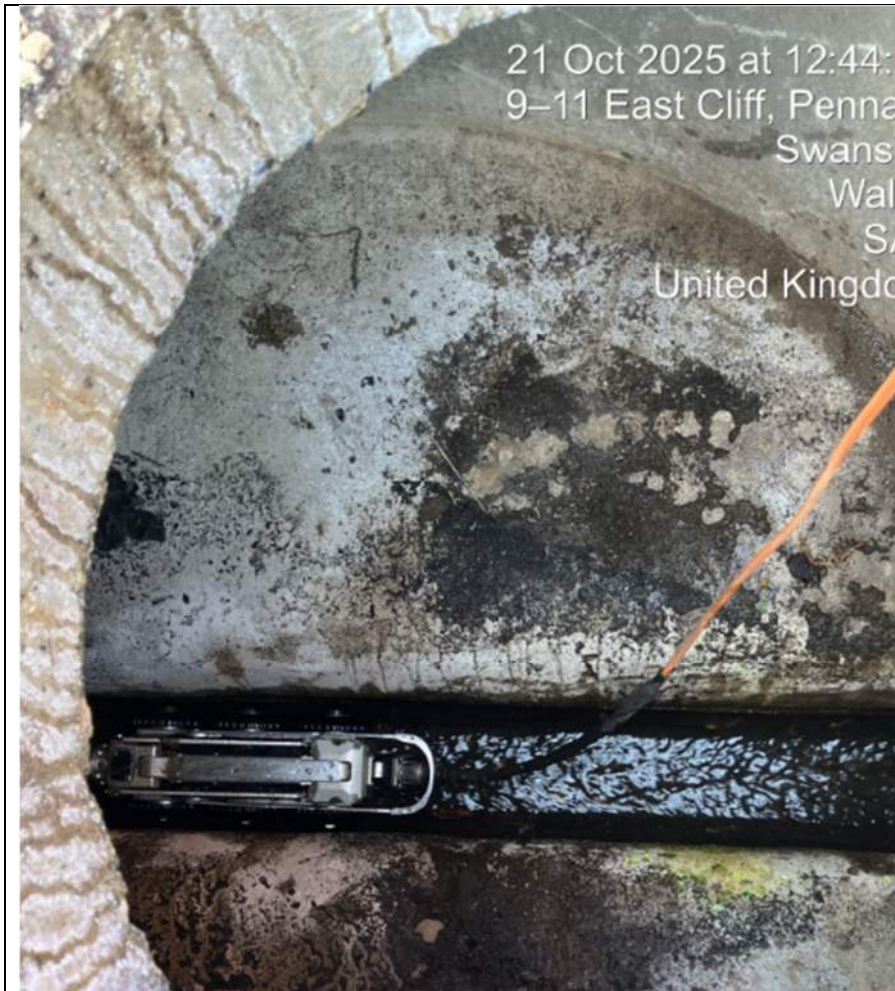
Uncharted m/h on grass verge next to Eastcliff Rd

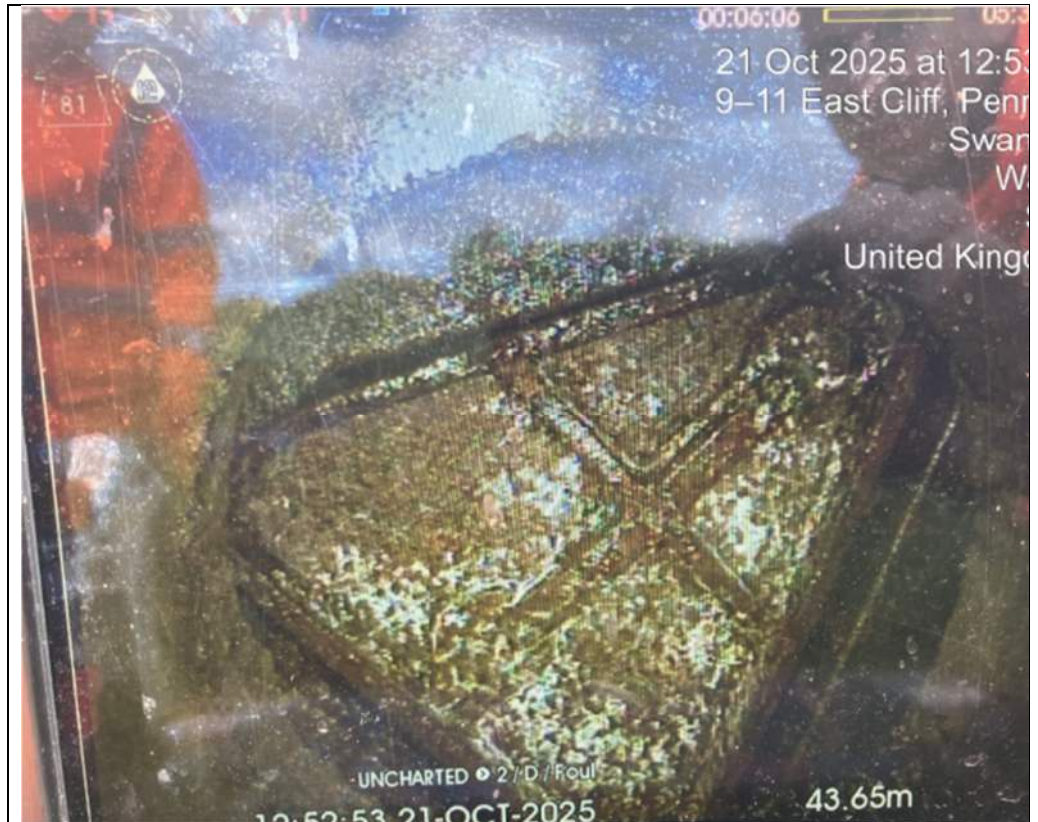
Buried chamber identified approx. 40m d/s (just before footpath begins steep descent)

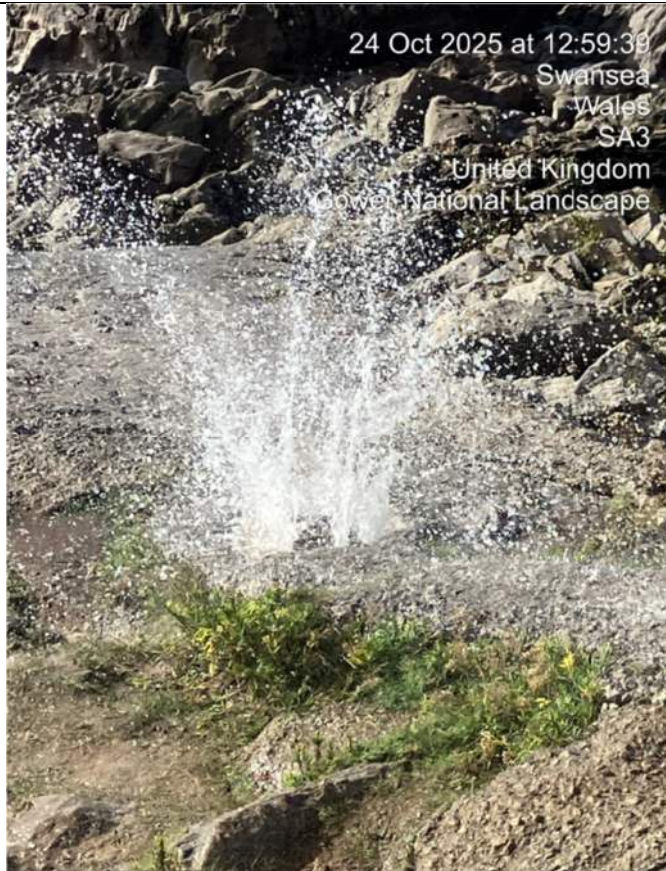
Once the pumps were switched back on, discharge escaped from the hatch due to lack of hermetic sea

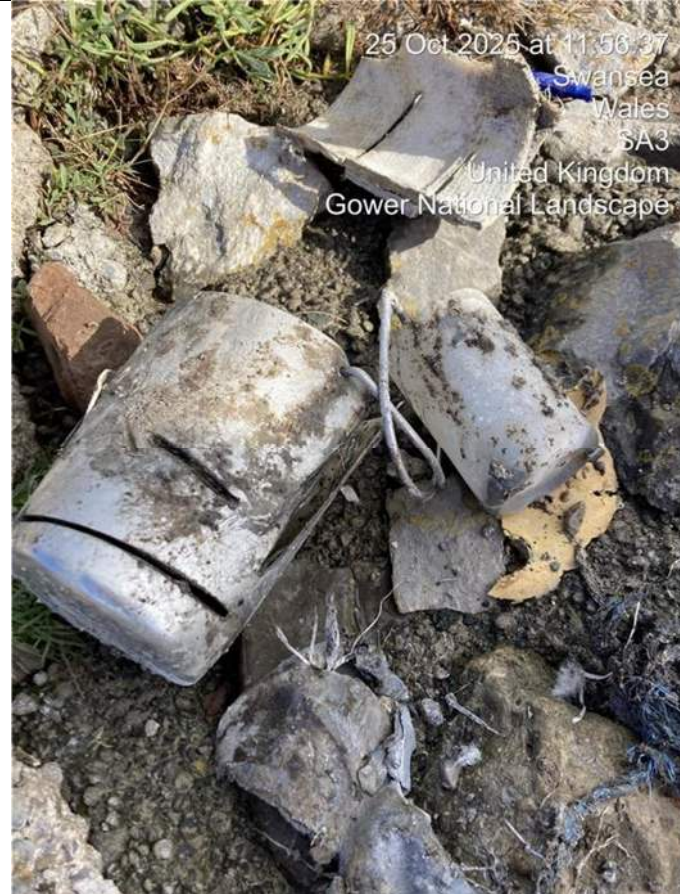
A large metal sampling pot (17cm x 11cm) was wedged within FE line. The plastic pot was lost during hatch-release, as it was used to scoop out standing water from the hatch.

Action taken (5)	25/10/25 - Task raised to dig-down and expose line to remove obstruction. Metal sampling pot was found to be cause of blockage (a smaller, plastic sampling pot was retrieved that was lost down line during CCTV work, however this was not the cause of the blockage). Temporary repair instated as full repair was not possible at time.
Action taken (6)	Full repair scheduled: patch-liner with protective concrete covering.

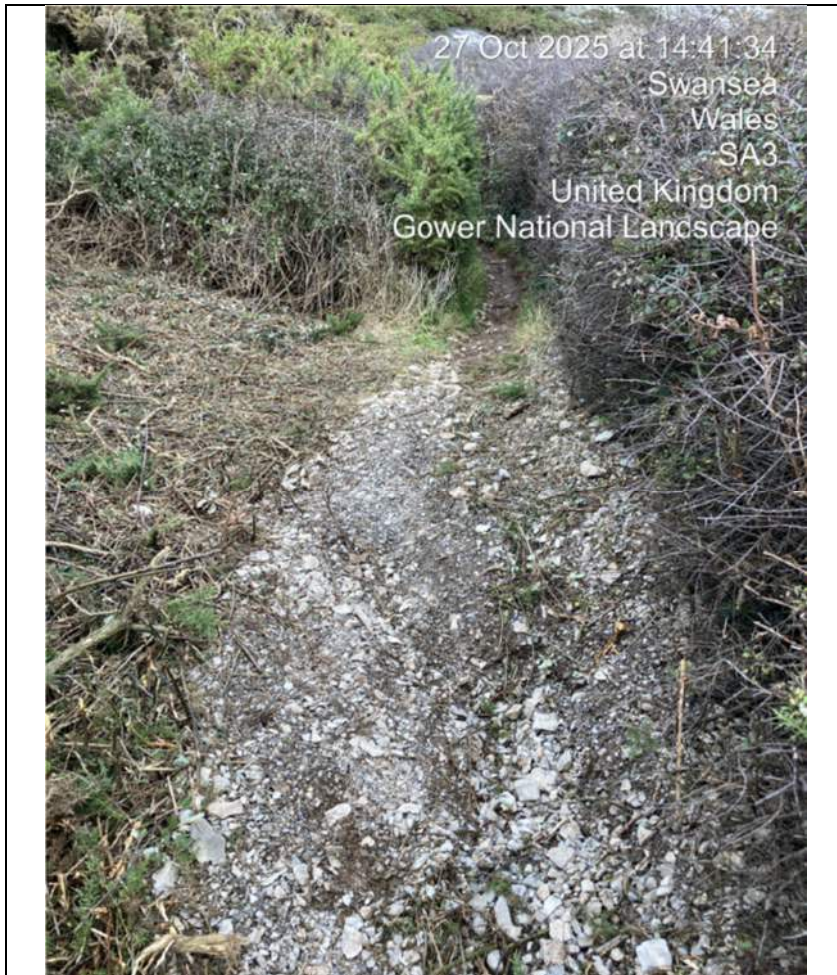
Following the removal of the metal sampling pot on 25/10/25, discharge ceased

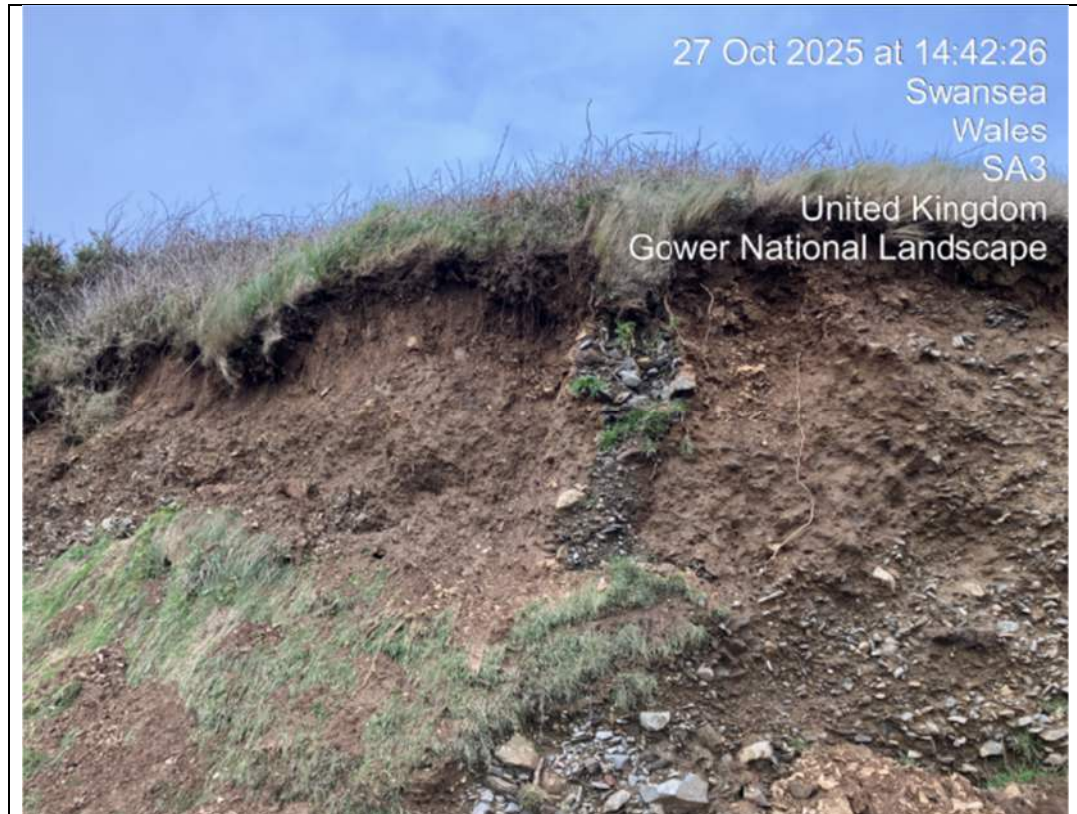
Following the removal of the metal sampling pot on 25/10/25, discharge ceased
