# PENRHOS SUBSTATION

## Site Walkover Summary

794-ENV-GDE-21696  
Penrhos Substation  
1  
15 April 2025

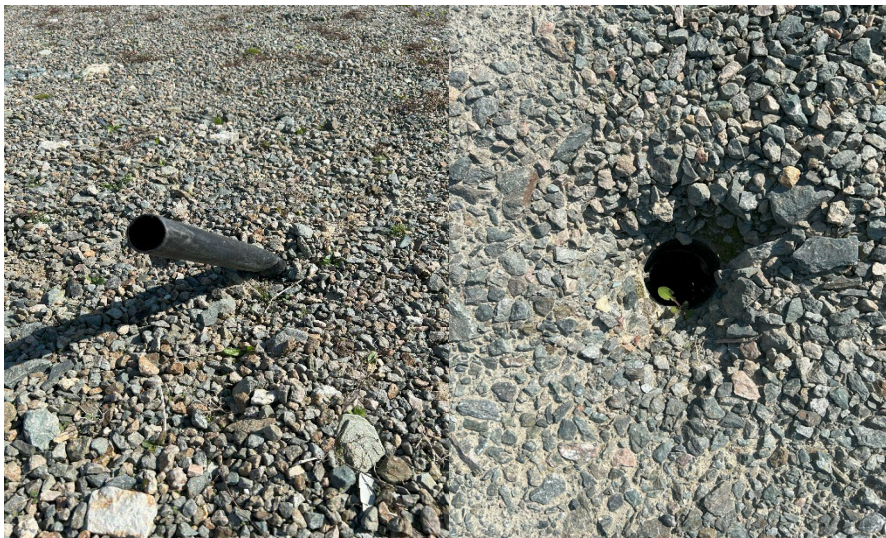
#### Picture 1: Boreholes on the substation compound

1a - Bent borehole

1b - Silted borehole

investigation was to identify and inspect any remaining installations to see if they could be repurposed for further monitoring. Picture 1 shows the only two installations identified during the walkover of the original substation site. Picture 1a shows a monitoring well which has been damaged by the previous demolition works at the compound. The angle of the bend in the pipe did not facilitate the procurement of a water level measurement. Picture 1b also shows a borehole which is intact at the surface. This borehole was, however, filled with sediment from a depth of 51cm below ground level (bgl) and therefore water level data was not able to be collected.

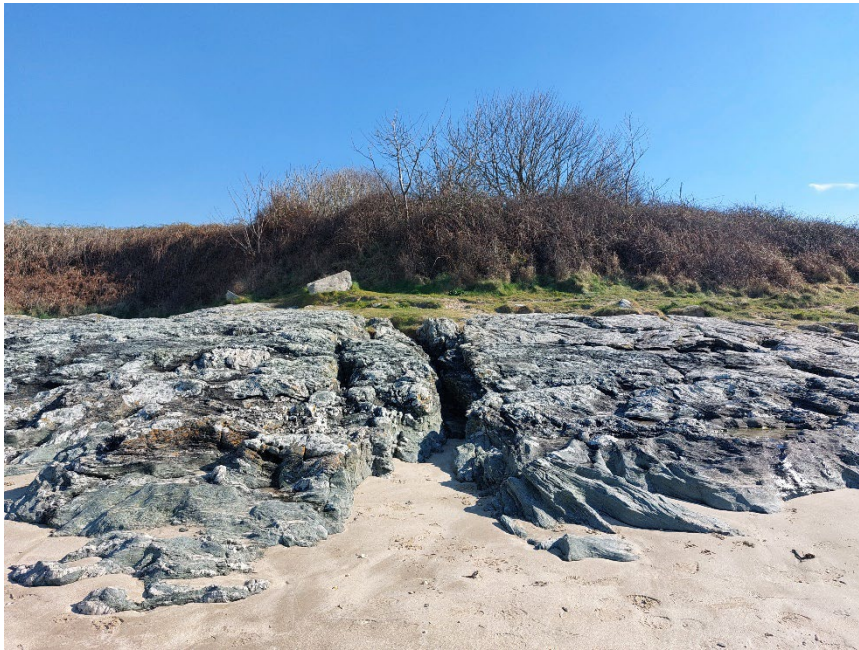
- 3.8 An exposed outcrop of the local bedrock was viewed at L7, at the northern end of Penrhos coastal park. The bedrock was observed to be comprised of competent but highly eroded, fractured schist, as shown in Picture 2.
- 3.9 Picture 3 depicts a close-up image of the bedrock texture. The rock texture is foliated, and the matrix is fine grained and crystalline. The high degree of foliation with persistent green colouration, indicates a high proportion of planar phyllosilicate minerals, particularly chlorite. Localised areas with a higher density of quartz veining were common.
- 3.10 Preferential erosion of jointing and fractures was observed to be the primary form of porosity.

**Picture 2 Outcrop of local bedrock observed at NGR SH 27557  
81401 facing south**

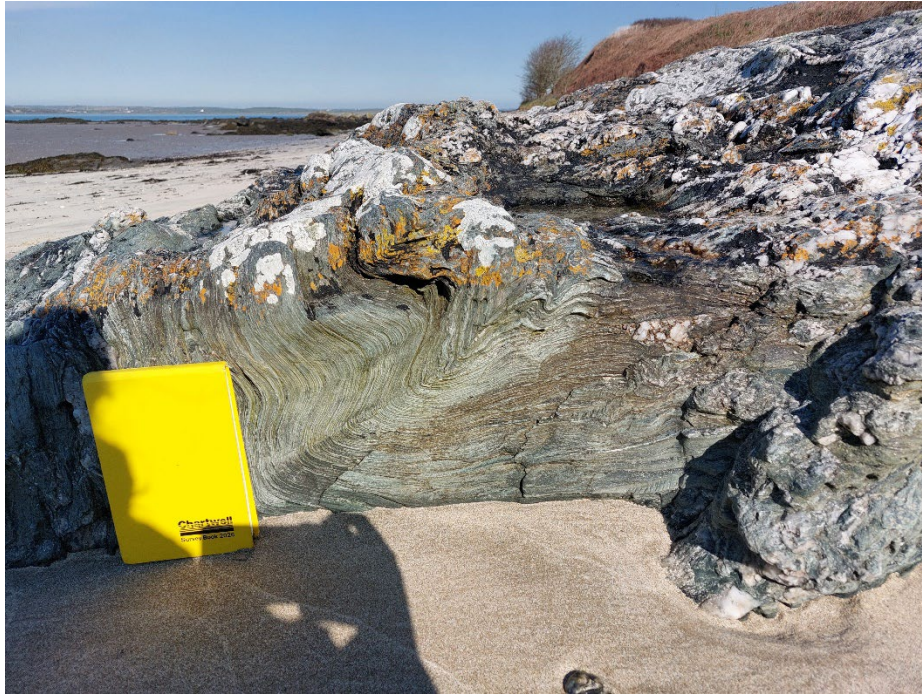
**Picture 3 Close up picture depicting bedrock fabric. Notebook for scale. NGR SH 27557 81401**

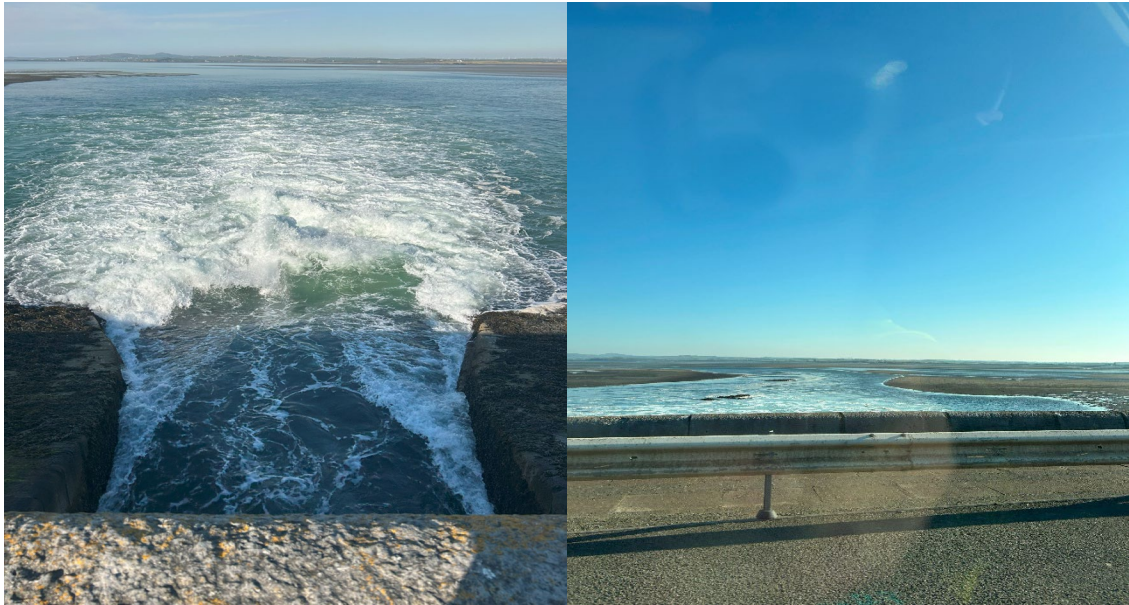
- 3.11 Surface water drains were observed to be present at regular intervals along Holyhead Road which runs along the northeastern side of Stanley Embankment.
- 3.12 Photographs were taken facing northeast from the embankment at NGR SH 27874 80162. Picture 3a was taken at approximately 3pm on the 1<sup>st</sup> of April and depicts flow conditions at the Stanley Embankment resulting from the falling tide passing through the embankment just after high tide. Picture 3b was captured on the 02/04/25 at 08:48 am on the rising tide shortly after low tide. Tidal fluctuations were observed to be in the range of 2-3m.

5a Embankment through-flow at high tide conditions

5b Embankment through-flow at low tide conditions

**Picture 4: Embankment through-flow at high and low tide, facing north. NGR SH 27874 80162 Photos were captured at approx. 3pm 01/04/25 and 08:48 am 02/04/25 respectively.**

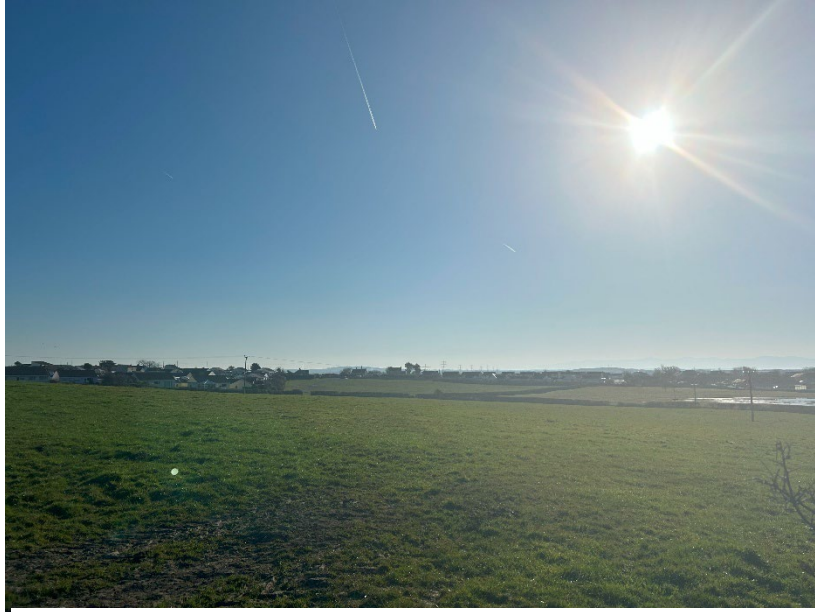
- 3.13 During the site induction, the RPS personnel were advised that a bull was present in the field at L10. Subsequently, no attempt was made to access the field. Picture 6, facing NEE depicts the terrain along the proposed cable corridor from the gate at NGR SH 28612 79859. Ground conditions were observed to be dry with some slight dew and moisture on the grass. The soil was noted as appearing to have a low clay content and the field well drained. Terrain in the field was observed to slope from northwest to southeast.

**Picture 5: Location 10, facing east, taken at NGR SH 28612 79859**

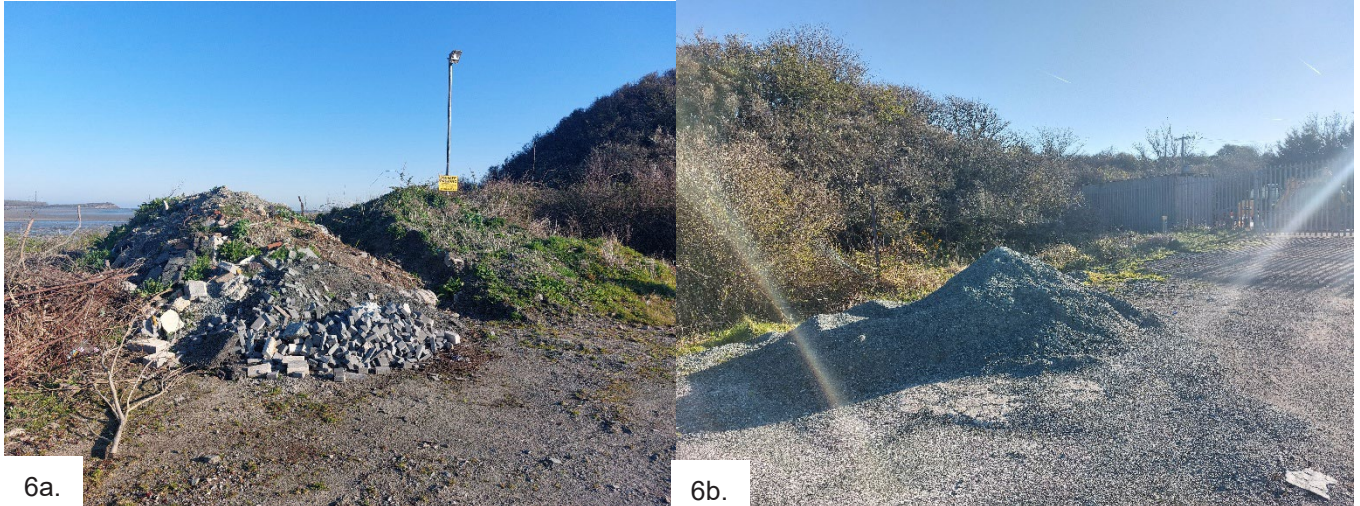
- 3.15 L9 is the point where the cable corridor moves from the North Wales Expressway, across Derwyn Garage, onto agricultural land. The existing cable runs under the car park of the garage; up a slight are of inclination and onto agricultural land. Picture 6a and Picture 6b depict spoil heaps and aggregate mounds which were observed in the carpark at NGR SH 28504 79856

**Picture 6: Spoil heap (6a) and aggregate mound (6b) in the carpark of Derwyn garage**

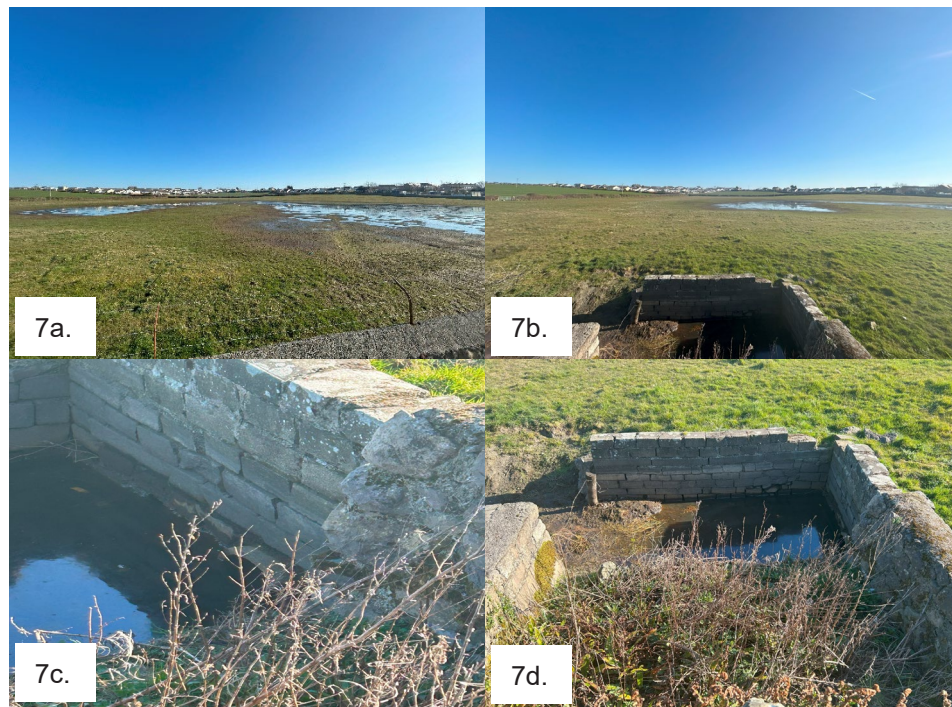
**Picture 7: Ponding and drainage features at Location 10, facing north**

- 3.16 L13, situated at NGR SH 27557 81401, was selected for investigation due the area exhibiting very poor drainage conditions. The area is downgradient of the alignment of the proposed cable corridor and is situated at an elevation of 4-5mAOD. The field was severely waterlogged, despite persistent dry weather conditions, with a large area of ponding (see Picture 7a). A drainage ditch was present along the southern boundary (Picture 7c & d), which connected to a culvert. Flow in the ditch appeared stagnant. It is not currently known where the culvert leads.

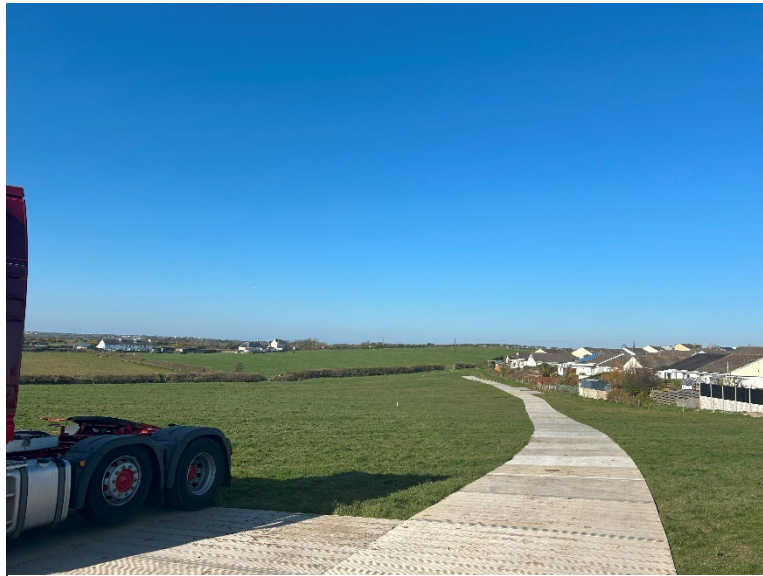
- 3.17 L11 & 12 lie to the west of Gorad Road. As detailed in Table 1, L11 and L12 were selected as locations of investigation in order to observe the ground conditions along the land between Delwyn Garage and Gorad Road that falls within the red line boundary for the cable corridor. L11 and L12 were located in the same field. The circumference of the field was walked and no discernible change in ground conditions was observed. Ground conditions were observed to be dry with a fine sandy, slightly clayey soil texture.
- 3.18 During the visit track matting was being laid down across this field for the purposes of ground investigation. Waterlogging was not observed to be present at L11 or L12. The field slopes southwest, towards Location 9. Picture 8, taken at L12 facing southwest depicts the site.

**Picture 8: Location 12, facing west NGR SH 28996 79909**

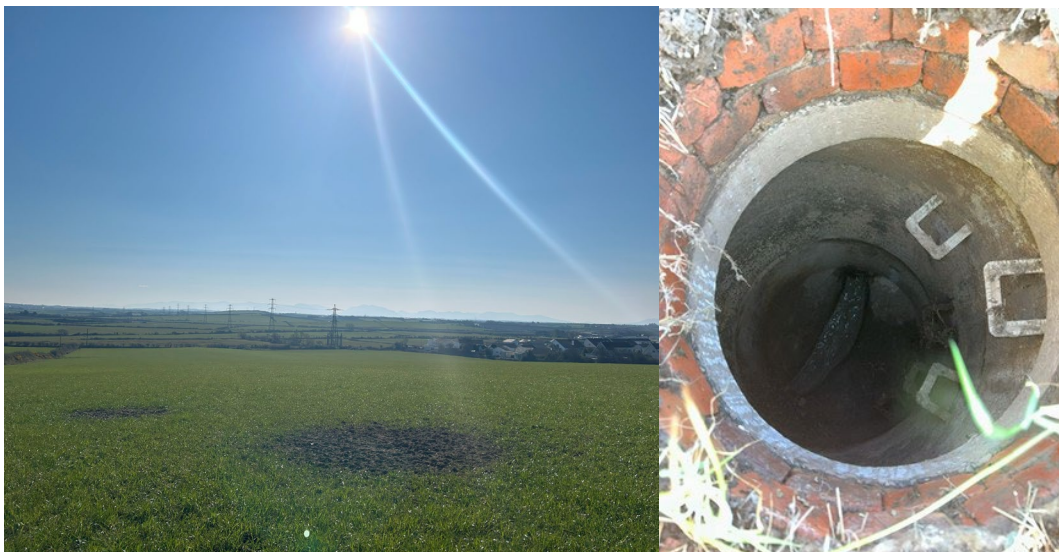
**Picture 9: Location 14 ground conditions and drainage feature.**

- 3.19 L14 lies halfway between Gorad Road and the point of grid connection at tower EV86. This field slopes eastwards, towards the pylon. Track matting was also being laid here during this visit (See SW16, Appendix B). Ground conditions in the field were generally dry asides from at the lower lying, eastern edge of the pasture where waterlogged ground conditions and wetland vegetation species were observed (See SW19, Appendix B).
- 3.20 Drainage ditches were observed at SW19 running along the eastern and southern boundaries respectively. Minimal water was observed in these ditches which were heavily vegetated.
- 3.21 A subsurface drainage feature, potentially a sewer was observed at NGR SH 29079 79911. The manhole cover had been displaced from the surface and the opening had been covered with

9a – NGR SH 29079 79911 Facing southeast, tower EV86 can be seen in the distance

9b - Subsurface drainage feature observed at NGR SH 29079 79911

temporary plastic matting for health and safety purposes. As shown in Picture 9b, an inspection of the hole revealed an access ladder down to a small sewer where brown water was observed running NW to SE.

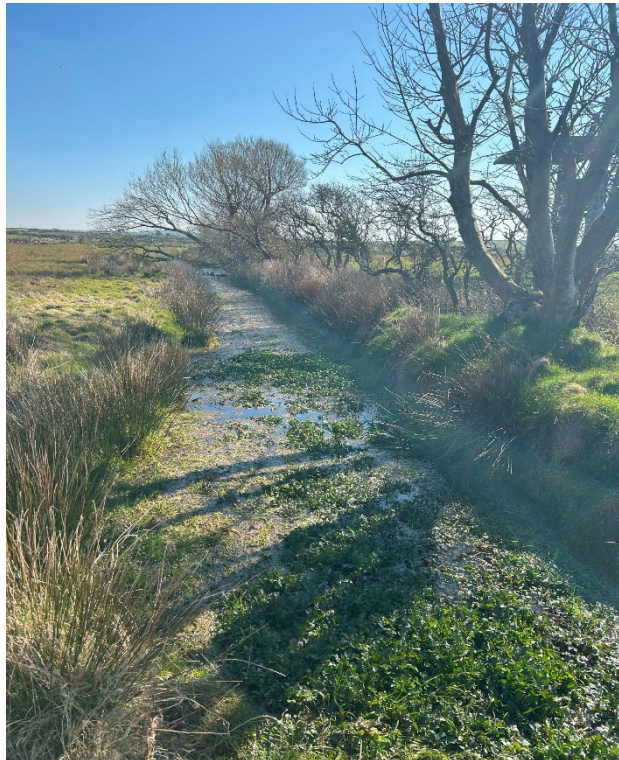
- 3.22 L15, as shown in Picture 10, is a mapped surface water feature immediately to the north of tower EV86. Flow was inferred to be to the east from local mapping, but no directional flow was observed in person. The drain was observed to be approximately 2m wide with unknown depth. Surrounding ground conditions suggested the area was frequently waterlogged.
- 3.23 The field immediately to the south, containing tower EV86 (see SW20, Appendix B), was not observed as being waterlogged despite being exceptionally flat. Ditches were present along all boundaries however to facilitate site drainage. The ditch along the eastern boundary (see SW21, Appendix B), contained a large volume of water but was stagnant. The condition of the ditch along the northern boundary was similar.

**Picture 10: Field drain photographed at NGR SH 29357 79855, facing east.**
