## Compliance Assessment Report CAR\_NRW0049595

**Permit being assessed:** WB3797TG

For: STP AT CELTIC MANOR RESORT, held by The Celtic Manor Resort

**Type of assessment carried out:** Site Inspection, Reason: Routine.

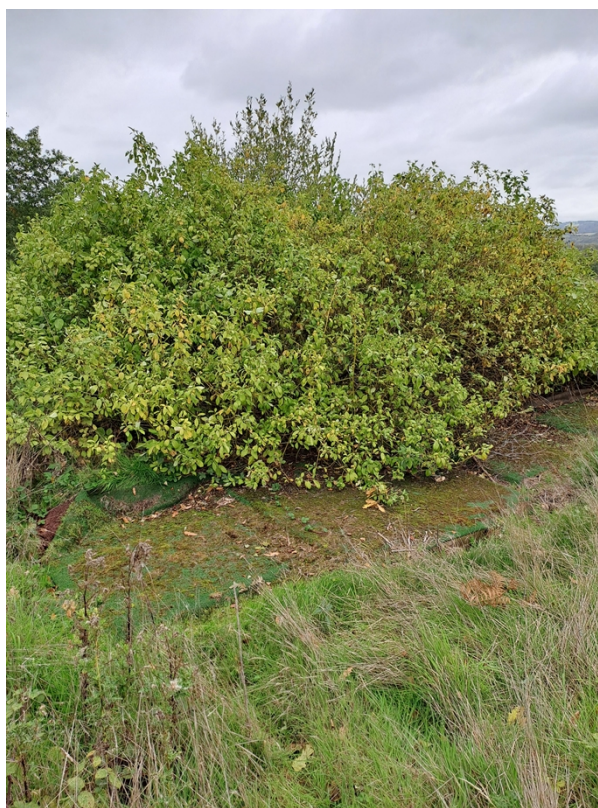
General access to the treatment system and chambers was acceptable, with some overhanging vegetation present and a section of false grass placed over the inspection chambers to provide a visual barrier for the site's customers. While we were able to access the chambers without hinderance, I request that the vegetation is managed to ensure future access is maintained. This is actioned below. Regarding the false grass placement, I understand the desire to implement this visual improvement, however I advise that the condition of these visual barriers be assessed continually to ensure access is not compromised. Please see the advisory comments section where this is recorded. These observations are evidenced in Figure 1.

Figure 1 – General site conditions as observed during the visit.

4. Undertake clearance of excess vegetation around the treatment system chambers to ensure continued access. Evidence shall be provided to NRW on completion.

1. Continually assess the condition of the false grass used as a visual barrier for the treatment system chambers to ensure access is not compromised.

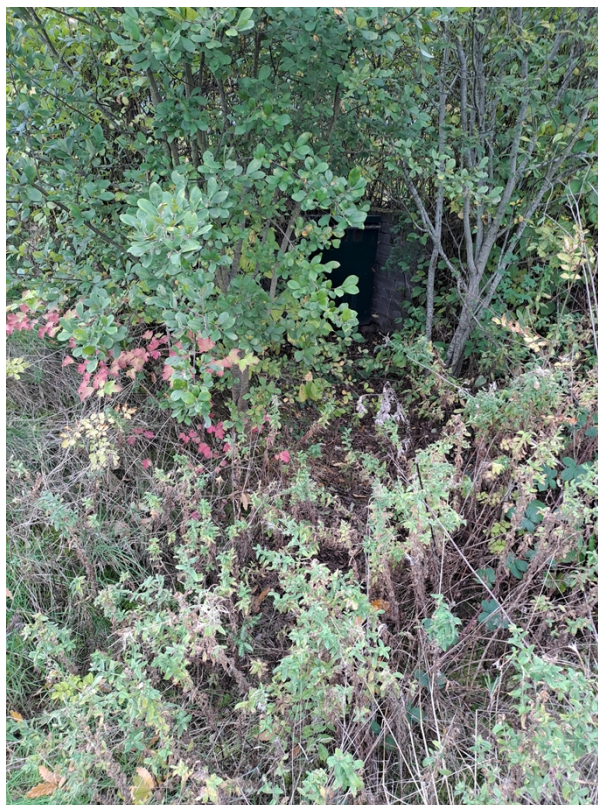
While the above access was acceptable, the system's control box was not. As seen in Figure 2, vegetation growth hindered easy access by operators and could become worse if not properly maintained. As a result, I have issued a C4 breach to reflect the conditions

Figure 2 – The condition of the system control box access as observed during the visit.

Access to the system's control box was hindered by vegetation growth. While not completely inaccessible, it shows a lack of management in line with the permit conditions and as such has been scored accordingly.

5. Clear the vegetation around the control box to improve access. Evidence shall be provided to NRW on completion.

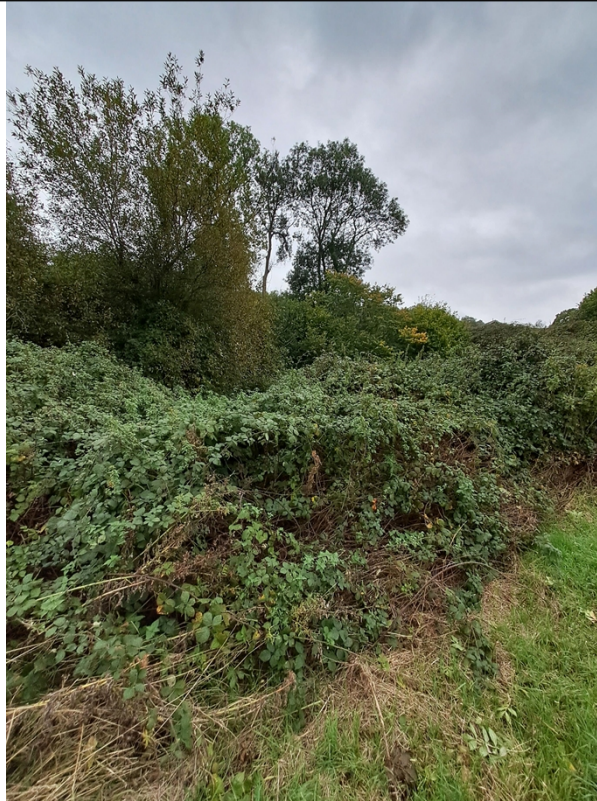
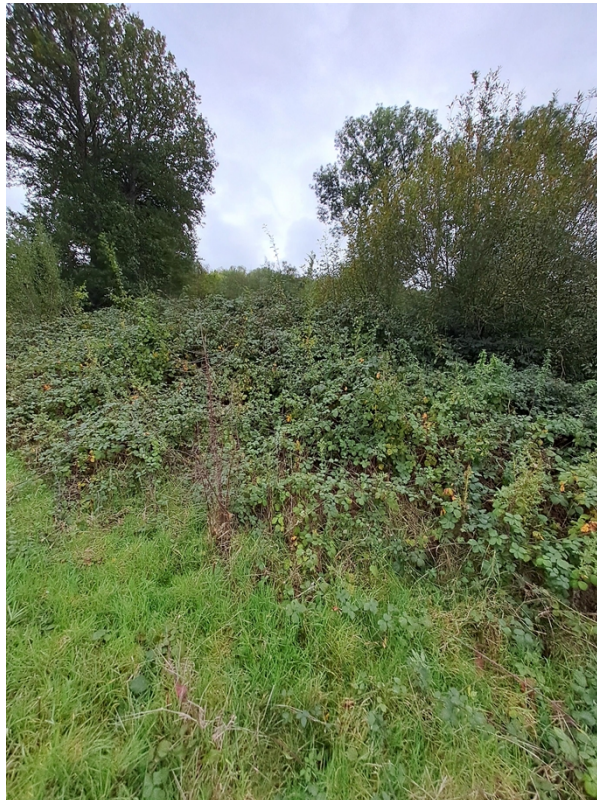
On inspection, it was clear that the location where the discharge/sample point are permitted to be located was heavily overgrown, making access to either impossible, as seen in Figures 3 and 4. The closest I could get to the outlet was ~5m away, which made a visual inspection unfeasible. I explained to SW that I would be issuing a C3 breach for access to the sample point due to condition 3.3.1 stating that “*permanent means of access shall be provided to enable sampling/monitoring to be carried out*”. Details of this breach and the requisite actions to improve access are outlined below.

Figure 3 – The location of the sample/discharge point hindered by overgrown vegetation as observed during the visit.

Figure 4 - The location of the sample/discharge point hindered by overgrown vegetation as observed during

Access to the sample/monitoring point was not possible during the visit due to excessive vegetation growth. This is a clear breach of the permit requirements and as such has been breached accordingly.

6. Clear the vegetation around the sample/discharge point to enable access for monitoring purposes. Evidence shall be provided to NRW on completion.

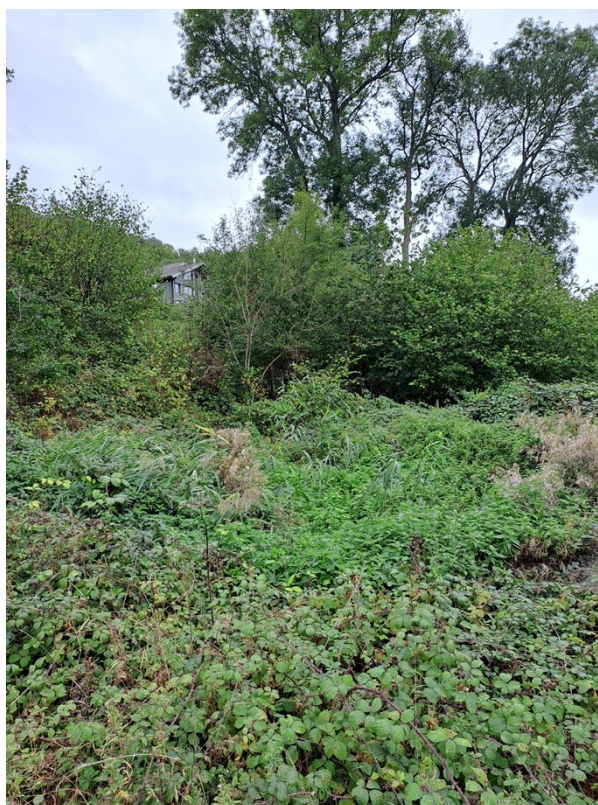
The reed bed (listed to be located in the vicinity of the sample/discharge point) was also observed to be overgrown and inaccessible, with minimal reed growth present (Figure 5).

While I have requested a history of the management of this reed bed, I can advise that maintaining access and ensuring no other vegetation takes hold within the reed bed itself will be vital in maintaining the long term viability of the system. I have issued a C4 breach for the condition of the reed bed to reflect the observations made. An action has been set to clear the reedbed of vegetation, as outlined below.

Figure 5 – The reed bed as observed during the visit.

It is clear that the reed bed is not fit for purpose, with minimal growth present and access hindered by excessive vegetation overgrowth. This has been scored accordingly. An improvement programme will be needed to rectify the issues observed.

3. Provide the management history of the reed bed and any maintenance undertaken attempting to establish effective growth and treatment.

7. Clear the reed bed of excess vegetation to promote healthy reed growth. Evidence shall be provided to NRW on completion.

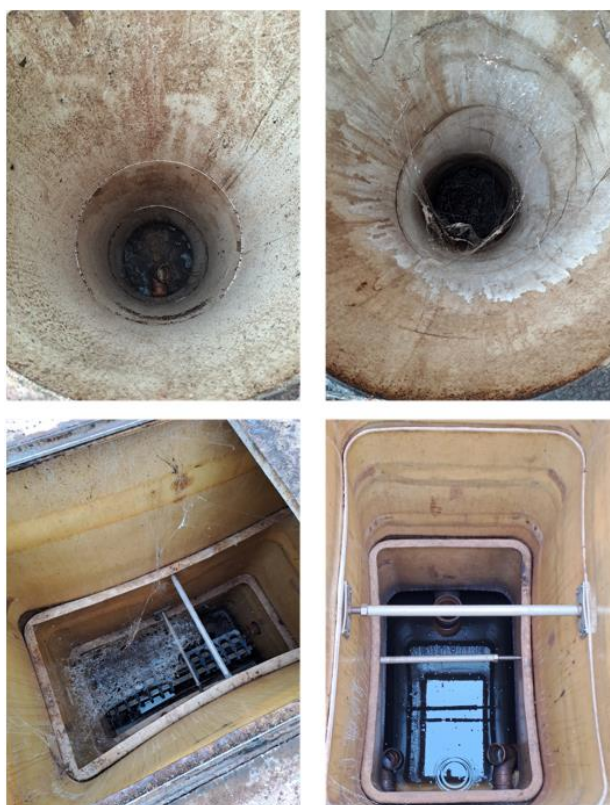
1. Primary chamber – The condition was as expected, not overly full and the inlet pipe was clear of obstructions. The chamber walls were in a good condition. I requested information on when the last de-sludge was undertaken and the requisite transfer notes as evidence. This is actioned below.
2. Settlement chamber – As above, condition was acceptable with good chamber wall integrity and solid matter was not passing forward to the last two chambers. Evidence of de-sludge is requested in conjunction with the primary chamber.

3. Aeration chamber – The aeration system was working as designed with good circulation in progress. Chamber walls were fine with no apparent cracks or defects present. No excessive solid material or odours was observed.
4. Final effluent chamber – Chamber wall integrity was fine with no solid material or odour present and the effluent appeared clear in quality. The outlet pipe was clear of obstructions.

Figure 6 – The effluent chambers as observed during the visit.

From top to bottom, left to right: Primary chamber, Settlement chamber, Aeration chamber, Final effluent chamber.

8. Provide details and evidence (in the form of waste transfer notes) on the most recent cleaning/de-sludge of the sewage treatment system.
