Compliance Assessment Report for: CAR_NRW0049869

Permit number	BL7108IM	Operator name	Tata Steel UK Ltd
----------------------	----------	----------------------	-------------------

Site name	Port Talbot Steelworks
Site address	Port Talbot Steelworks, Port Talbot, SA13 2NG
Type of assessment	Site Inspection

Date of assessment	17/10/2025	Time in	10:00	Time out	13:30
---------------------------	------------	----------------	-------	-----------------	-------

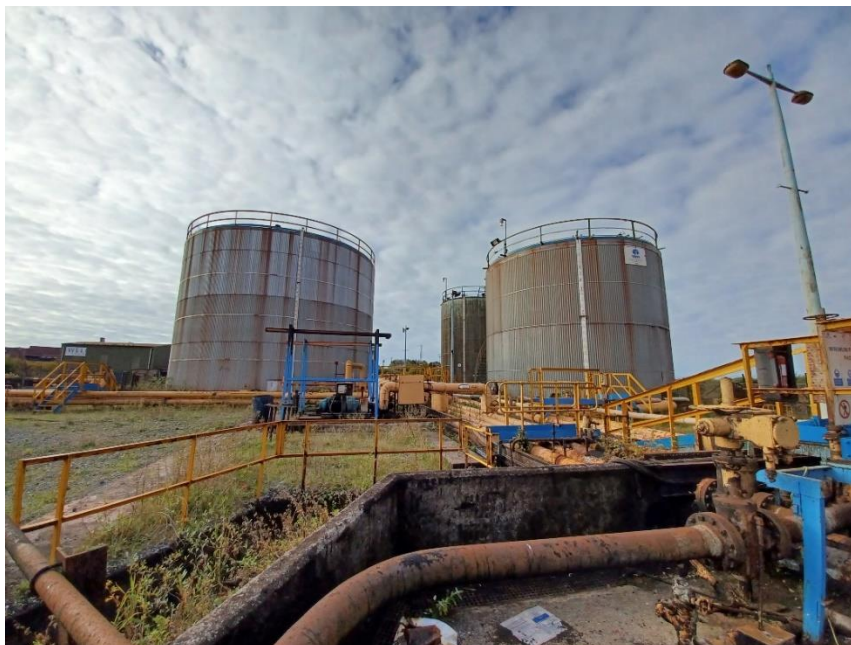
Image 1: View of the Pheonix Oil Tank Farm

TSUK informed NRW that the vessels (and associated pipework) within the POTF had been emptied and cleaned in preparation for the commencement of decommissioning works. The works area is located within the curtilage of the ABP leased land, and consequently TSUK outlined that they intend to clear this area within the next year.

During the inspection, NRW officers noted evidence of a loss of oil within the POTF “bund”. TSUK confirmed this had occurred during the decommissioning of the connecting pipework, caused by a small quantity of residual product remaining within the pipework. Absorbent granules had been deployed to mitigate the spill; however, these had not been recovered.

TSUK have previously identified that the base of POTF “bund” comprises porous substrate materials – including chippings, sand and slag – which are unlikely to provide adequate containment. TSUK must ensure that a suitable ground investigation is undertaken if it intends to surrender the land currently occupied by the POTF.

Action - CAR_NRW0049869. A1:

TSUK to ensure the deployed absorbent granules are recovered and disposed of in an appropriate manner.

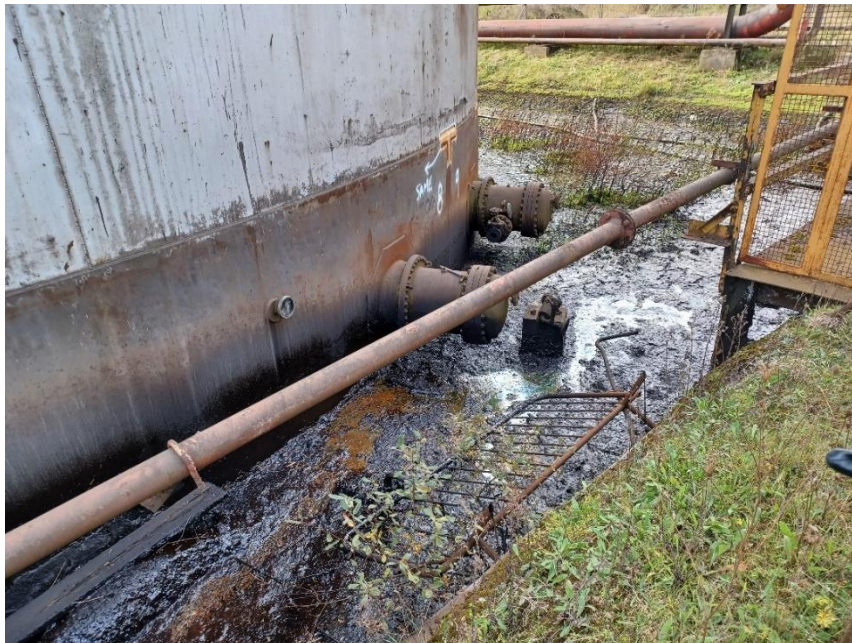
Image 2: Accumulation of hydrocarbon contaminated sludges (visual perspective) around the north-western face of the South Tank

The containment measures associated with the South and North Tanks within the MGT works area appear to consist of earth bunding, the base construction and integrity of which remains uncertain, as confirmed by TSUK at the time.

NRW were informed that Runtech Ltd has been unable to access the sump associated with the earth bund for over 11 months, and consequently the earth bund had not been emptied throughout this period. NRW also noted that the bund was devoid of rainwater. Whilst acknowledging that 2025 has been particularly dry, NRW does consider that sufficient rainfall had occurred in the lead-up to the visit to reasonably expect some accumulation of water within the curtilage of the bund. This raises concerns about the retention capability of the containment measures associated with the North/South Tank, suggesting that in the event of a catastrophic vessel failure (particularly in the case of the South Tank which is said to hold 900,000litres of polluting liquid), its contents may not be effectively contained and ultimately will be lost to ground. NRW understand that the North Tank contains 1.5m – 3.0m of sludges awaiting recovery/disposal.

TSUK has failed to provide safe access points to the sump associated with the earth bunding of the North/South Tanks within the MGT works area. This omission has the potential to impede the contractors (and TSUK) from implementing mitigation measures should a catastrophic vessel failure involving a polluting substance have occurred. This constitutes a breach of permit condition 1.1.1, and consequently a non-compliance score of C2 has been allocated under compliance criteria IR1A – General Management.

Additionally, concerns were raised about the presence of sludge with visible oil contamination near the northwestern side of the South Tank, which obscured the visibility of the tank's base in that area. TSUK informed NRW within the Opening Meeting that the South Tank had recently benefitted from thickness and weld testing in order to ascertain its condition. It was noted that the majority of the base appeared to have been cleaned, possibly to facilitate this inspection. However, this appears not to be the case for northwestern face (in the vicinity of the sampling point), suggesting this section may not have been fully inspected. The source of the oily sludge is unclear, with a failure of the vessel or spillages during sampling both being viable sources.

Action - CAR_NRW0049869. A2:

TSUK is to provide access to the drainage sump associated with the North/South Tank. Once completed, evidence is to be provided to NRW by the action deadline. Going forward, TSUK must ensure that all drainage sumps associated with bunds/vessels onsite are accessible at all times.

Action - CAR_NRW0049869. A3:

TSUK is required to safely remove all contaminated sludges from around the base of the South Tank, with particular attention to the area surrounding the sampling point. Evidence is to be submitted to NRW once completed.

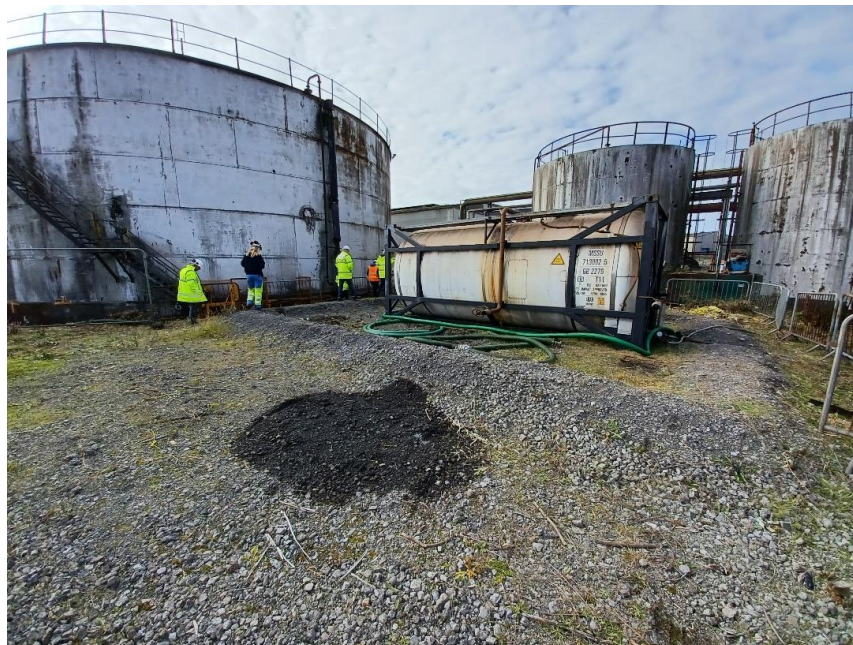
Image 3: Backup oil tank situated within an unlined earth bund, evidence of oil losses outside the curtilage of this earth bunding.

NRW Officers also inspected the mobile steel tank located within the MGT works area. This vessel, currently serving as a backup oil tank, is also proposed to support the cleaning process of the North/South Tanks, something which TSUK has committed to complete by 2027.

Inspection of the current containment measures for the backup oil tank revealed that the unlined earth bunding does not meet the standards outlined in CIRIA C736. Additionally, hydrocarbon staining from historic losses were observed both inside and outside the curtilage of the rudimentary bund. Valves were also found to be left unlocked, increasing the risk of accidental or unauthorised activation and potential further losses to ground. The compliance implications of this insufficient secondary containment relating to the backup oil tank are considered in later sections of this CAR form.

Action - CAR_NRW0049869. A6:

TSUK is to commission a review of their secondary containment measures associated with vessels within the Million Gallon Tank works area (and others as identified by TSUK). This review is to be undertaken by a suitably competent person, with a report generated that will be submitted to NRW as evidence. The report must clearly identify containment deficiencies and include a detailed improvement plan to address the issues.

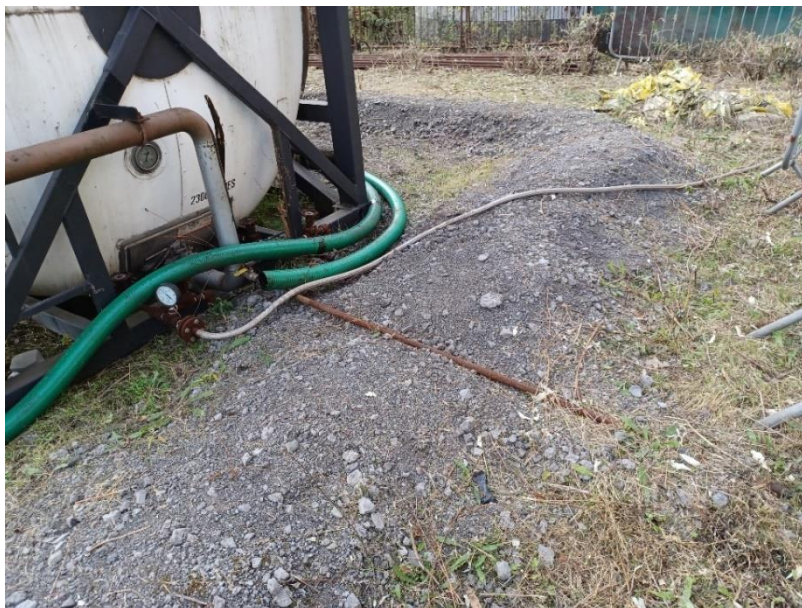
Image 4: Small offtake pipework from the outlet of the back-up oil tank, seen to discharge into the North Tank earth bund.

NRW Officers also noted a small offtake pipe, which was seen to discharge into the earth bund associated with the North Tank. The Runtech Operative was unclear on the purpose of this pipework, and from initial observations and the positioning of the offtake (which was left unlocked), NRW is concerned that this will allow oil to be discharged to ground.

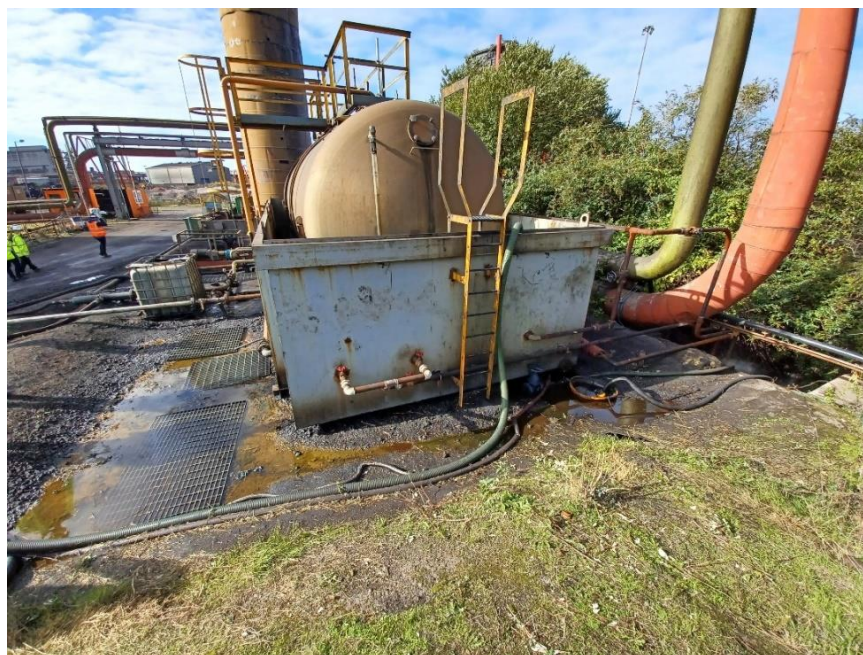
Image 5: Side view of PC1/PC2, oil contaminated surface water within the confines of the "tertiary" containment

NRW Officers inspected the PC1/PC2 asset which constitutes the processing component of the facility. The containment measures for PC1/PC2, including associated pipework consist of raised steel bunding around the primary vessel, surrounded by lined earth bunding that provides a level of tertiary containment. While a liner is present beneath the earth bund, NRW is uncertain of its containment capability with visible sections of the buried liner showing signs of degradation upon inspection. Additionally, auxiliary equipment (i.e. valves, pumps and coupling points) are housed within dedicated drip trays. These were seen to contain a quantity of free-phase oil/rainwater.

Several pipework penetrations were noted through the steel bunding associated with the primary vessel, including an outlet valve which is used to manually dewater the bund. This method of dewatering increases the likelihood of free-phase oil being discharged. The Runtech Operative informed NRW that the bund was emptied on a weekly basis, and is reliant on the Operative visually detecting oil within the discharge to prompt its cessation. From this information, NRW considers this indicative of inadequate management systems in place for the Oil Processing Facility, and this is something that must be reviewed by TSUK.

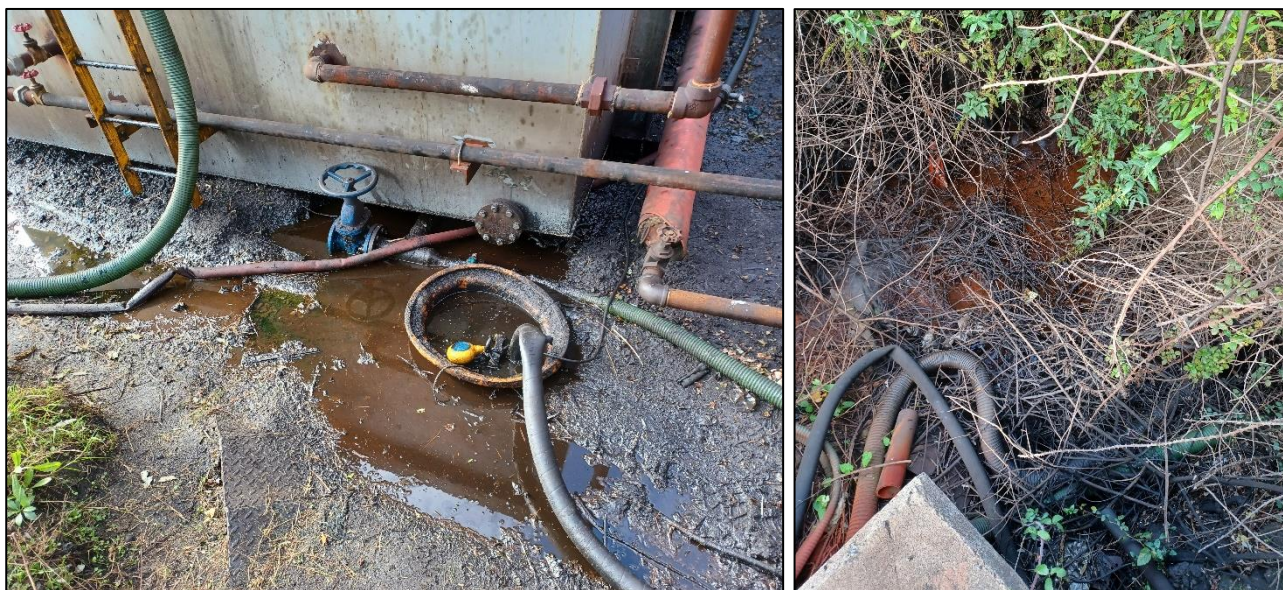
Images 6 & 7: Sump within the tertiary containment area, outlet observed as entering ditch to rear of the bund.

The housekeeping in the area was generally poor, with clear evidence of historic oil staining both inside and outside the curtilage of the earth bunding. Furthermore, significant pooling of contaminated (oily) water was noted along the north-eastern containment boundary (as illustrated in Image 5 above). NRW Officers also noted pooling from beneath the raised steel bund associated with PC1/PC2 which may indicate the presence of a structural failure on the base.

The tertiary containment appeared to be drained via a makeshift sump, fitted with a float activated sump pump, the outlet of which was noted as entering an adjacent ditch (///pizzeria.fuss.interview), positioned behind the asset. Inspection of this ditch from a nearby concrete plinth showed visible signs of contamination being present. The Runtech Operative outlined that this ditch feeds into the drainage network for the Site, however there has been no information submitted to NRW to support this statement. Furthermore, NRW is uncertain on the retention capability of the ditch, and consequently all discharges into this feature must be considered to ground until proven otherwise by TSUK. Similarly to the outlet valve for PC1/PC2, NRW were informed that the control of hydrocarbon discharge to the ditch is reliant on visual detection by the Operative, which is not considered a robust or compliant control measure.

NRW is also concerned that the installation of the makeshift sump may have compromised the integrity of liner associated with the tertiary containment. If this liner is damaged, this would provide a direct viable pathway for contaminants (specifically hydrocarbons in this case) to migrate to ground. Containment measures must adhere to the CIRIA 736 (2014 – *Containment systems for the prevention of pollution; secondary, tertiary and other measures for industrial and commercial premises*) standards and NRW's "How to comply" guidance. TSUK must ensure compliance with permit condition 3.2.3.

The direct discharge of a potentially polluting substance to ground is a contravention of permit condition 3.1.1, consequently a non-compliance score of C2 has been allocated under compliance criteria IR3A (3) - Emissions to Land.

Additionally, the root cause of the permit breach above is considered to be the failure to have sufficient management systems and training in place regarding operation of the Oil Processing Facility. This is a contravention of permit condition 1.1.1, and consequently a non-compliance score of C2 has also been allocated under compliance criteria IR1A – General Management.

Action - CAR_NRW0049869. A4:

TSUK is to immediately cease all discharges of potentially polluting liquids into the drainage ditch located behind the PC1/PC2 asset. TSUK must then provide evidence to NRW that all contents within this ditch are routed to the site's effluent treatment system, as previously claimed by the Operative. Until this is submitted, the drainage ditch is not to be used for any further discharge activities.

Action - CAR_NRW0049869. A5:

TSUK is to review their management systems and procedures relating to the activities at the Oil Processing Facility. The outcome of this review is to be submitted to NRW as evidence.

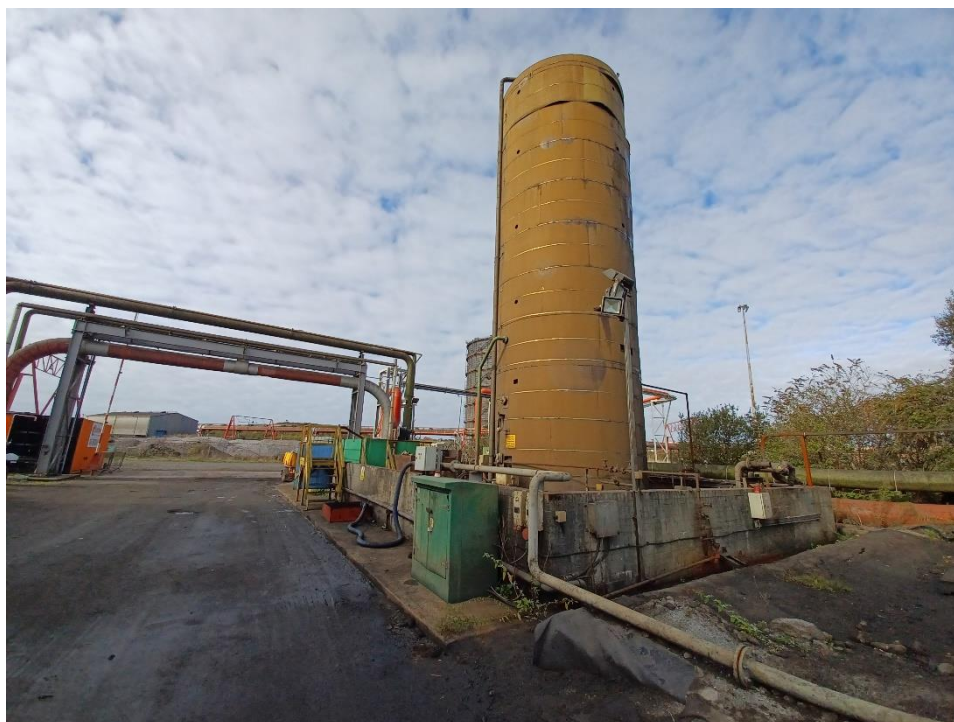
Image 8: View of Latex Tank

NRW Officers also inspected the Latex Tank, which is used as a storage vessel for the Oil Processing Facility. Numerous deficiencies were noted during the inspection that outlined that the containment measures associated with the Latex Tank were not in-line with the required standards outlined by CIRIA C736. These include, but are not limited to the following key observations:

- **Bund Construction:** The bund is of masonry brickwork construction, appearing to be two bricks in depth. It is unlikely to be reinforced, which increases the risk of catastrophic failure in the event of surging following vessel rupture.
- **Impermeability:** No impermeable coating was observed on the internal face of the bund. Over time, mortar joints may become porous, potentially allowing contaminants to escape.
- **Structural Integrity:** Linear cracks identified in the render between bricks on the southern and eastern walls.
- **Jetting Risk:** The notable height of the tank increases the risk of jetting should a puncture occur.

Furthermore, NRW Officers had concerns over evidence of oil/water seepage from around the base of the Latex Tank. It was unclear during the inspection whether this was resulting from failure of the primary vessel, or due water ingress behind the damaged insulation layer for the tank. Please be advised that the ingress of rainwater or salt behind the

insulation layering can potentially accelerate corrosion of the primary vessel. TSUK should factor this into their tank inspections and maintenance schedules.

Deficiencies regarding secondary containment measures were identified on all inspected assets. TSUK has failed to ensure that adequate containment measures are in place to prevent the risk of losses to the environment, should a catastrophic failure occur. This is a contravention of permit condition 3.2.3, and due to the number of deficiencies identified, a non-compliance score of C2 has been allocated against criteria IR3B - Emissions of substances not controlled by emission limits.

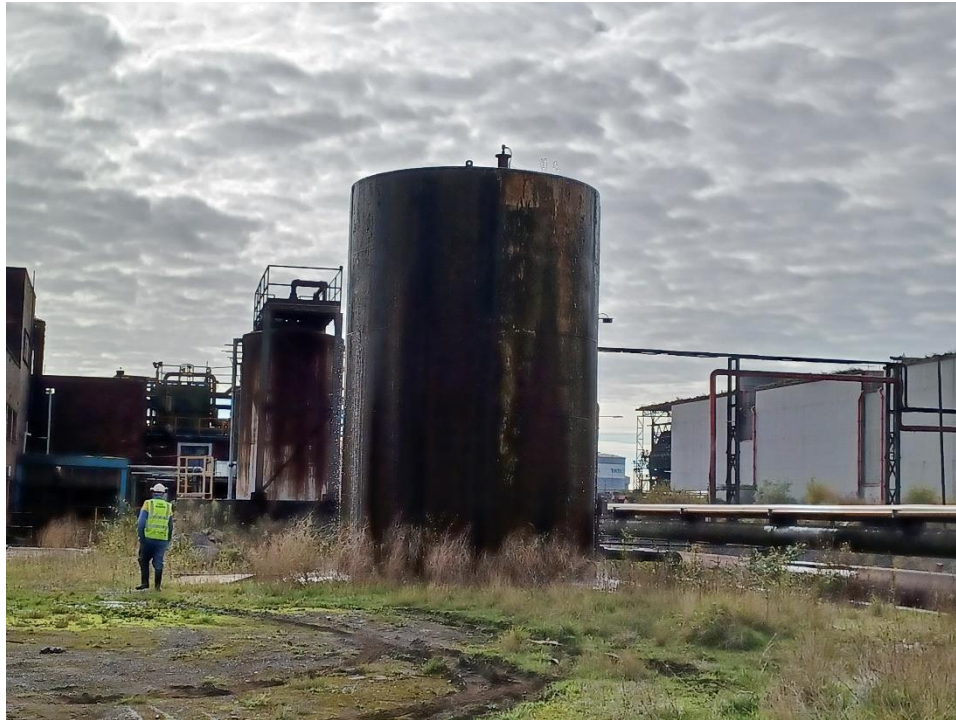
Image 9: Overflowing tank associated with Energy Department

During the visit, NRW Officers noted that an asset believed to be associated with the Energy Department of TSUK was overflowing. From onsite discussions, it was unclear how long this asset had been left to overflow and what the purpose for the water usage was.

The observed overflow of the asset associated with the Energy Department represents an inefficient use of raw materials, specifically water in this case. This is contrary to permit condition 1.3.1a, which requires the operator to use raw materials and water efficiently, consequently a non-compliance score of C3 has been allocated against criteria IR1D - Efficient use of raw materials.

Action - CAR_NRW0049869. A8:

TSUK is to cease the discharge of water into the overflowing tank immediately (action completed).
