| | | <p align="center"><b>NETWORK RAIL</b></p> <p align="center"><b>Visual Examination</b></p> | | | | | | | | | | |
| ELR: LLA | | Contract Mileage: 002m 1353yds 61.5chs | | | | | | Struct Ref: 2 61.5 | | | | |
| Structure Name: 3'06" brick arch with tidal flap | | | | | | | Route: Wales | | | | | |
| Any Hidden Parts: Yes | | | | Observed Under Load: No | | | | Exam Date: 15/04/2025 | | | | |

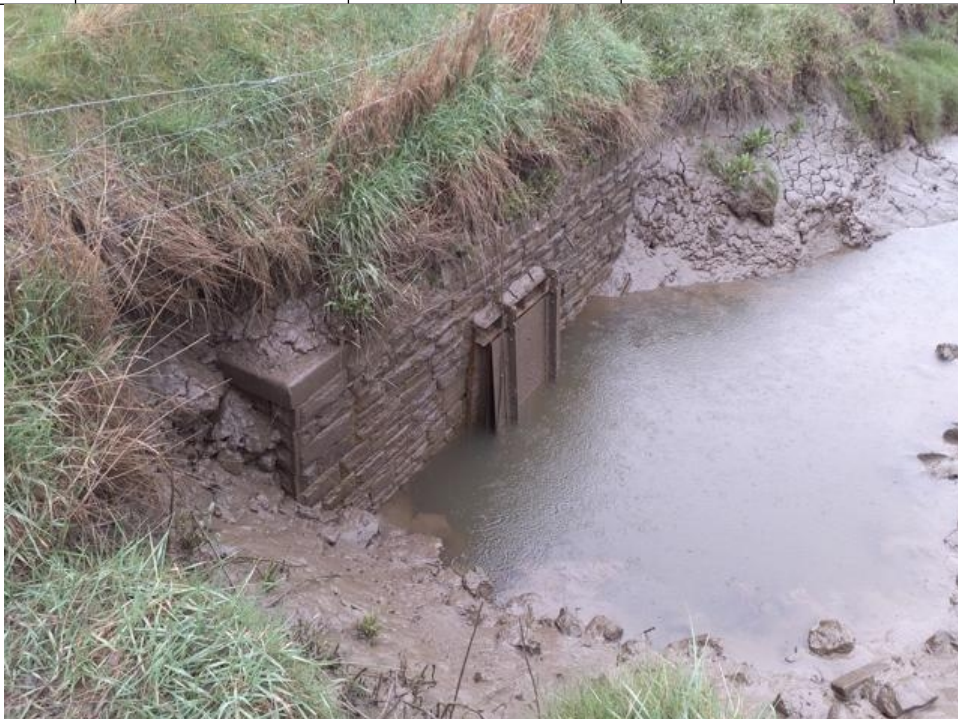
Photo Index: 8

| <p><b>STATUS OF PREVIOUSLY RECORDED SIGNIFICANT DEFECTS and STATUS OF RECOMMENDATIONS MADE AT PREVIOUS EXAMINATION</b></p> <p>Defect No: 2<br/> Description: Open Joints/ Deteriorated Mortar and Isolated Loose Masonry.<br/> Location: D/S Headwall, ABT's and Soffit.<br/> Status: Viewed from a position of safety only. Appears to be NFD.<br/> Recommendation appears to have not been actioned.<br/> Recommendation From Previous Year: Yes. Rake out and repoint joints and loose masonry.<br/> Photo: 2</p> <p>Defect No: 6<br/> Description: Missing Bolts.<br/> Location: D/S Headwall Flap Support.<br/> Status: No missing bolts could not be seen when viewing the tidal flap from a position of safety.<br/> Recommendation does not appear to have been actioned.<br/> Recommendation From Previous Year: Yes. Replace flap valve framing including missing bolts.<br/> Photo: 2</p> <p>Defect No: 8<br/> Description: Decayed Timber Support (Lintel?) and Loose Stones Above.<br/> Location: Within BAR Approximately 9m From D/S Elevation.<br/> Status: Cannot determine. Barrel could not be viewed due to no safe access to the upside elevation and only viewing the downside elevation from a position of safety.<br/> Recommendation From Previous Year: Yes. Replace timber lintel.<br/> Photo: 1 &amp; 2</p> <p>Defect No: 9<br/> Description: Deteriorating Flap Valve Framing.<br/> Location: Flap Valve to D/S Headwall.<br/> Status: Compared to the photo evidence in the previous visual report, the overall condition of the Tidal Flap appears to have no further deteriorated.<br/> Recommendation From Previous Year: Yes. Replace flap valve framing including missing bolts.<br/> Photo: 2</p> <p>Defect No: 10<br/> Description: Area of Developing Scour.<br/> Location: Below D/S Tidal Flap.<br/> Status: Cannot determine. Not viewed due to water level at the downside at the time of exam.<br/> Recommendation From Previous Year:<br/> Photo: 1 &amp; 2</p> <p>Defect No: 12<br/> Description: Debris.<br/> Location: Throughout.<br/> Status: Cannot determine due to no safe access at either elevation.<br/> Recommendation From Previous Year: No.<br/> Photo: 1 &amp; 2</p> <p><b>PREVIOUSLY UNRECORDED (NEW) DEFECTS</b><br/> None</p> <p><b>ADDITIONAL COMMENTS</b><br/> None</p> | | |

Description: Defect 2

| | | <p align="center"><b>NETWORK RAIL</b></p> <p align="center"><b>Visual Examination</b></p> | | | | | | | | | | |
|---|---|---|---|---|---|---|---|---|---|---|---|---|
| 1 | Rake out and repoint open joints and reset loose masonry. (281798) | Downside headwall, Abutments and Soffit | 4.0 | 1yr | 1 unit | 3 | 3 | E 9 | Hand Pointing | | | |
