Bund Inspections

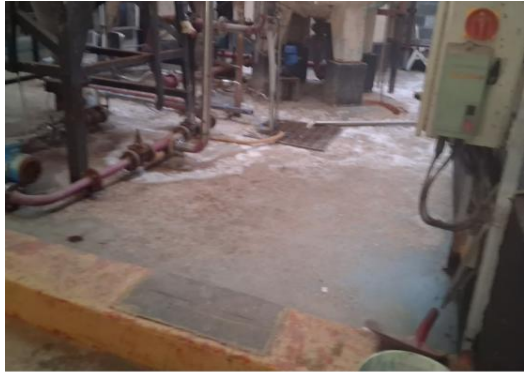
Bund No.	Name	Location	Construction Material	Sufficient capacity ⁽¹⁾	Outlet (yes/no)	Testing	Observations	Inspection date	Corrective Actions
B1	Viscose storage bund	North end RTTM	Reinforced concrete	Yes	No	6 monthly Visual Inspection as per procedure VCL/EMS/007 (water tested if necessary)	<p>Bund walls have been raised and new floor surface has been laid. Bund wall and bund surface have been coated with a chemical resistant paint (3 layers).</p> <p>Bund surface is washed down every shutdown.</p> <p>Bund can contain 110% of T1.</p> <p>Bund provided with sump for submersible pump.</p> <p>Floor needs levelling – metal studs in ground exposed and trip hazards.</p> <p>Hazmat and sink left in bund.</p> <p>Photo of Bund:</p>

15.12.25	<p>Floor trip hazards need to be removed.</p> <p>Hazmat suit to be removed from bund.</p>
B2	Caustic storage bund	North end RTTM	Reinforced concrete	Yes	No	6 monthly Visual Inspection as per procedure VCL/EMS/007 (water tested if necessary)	<p>Caustic transfer pumps are positioned within the bund and will be submerged in the event of a failure of tank integrity.</p> <p>Tools are stored in the bund.</p>	15.12.25	Tools to be properly stored.

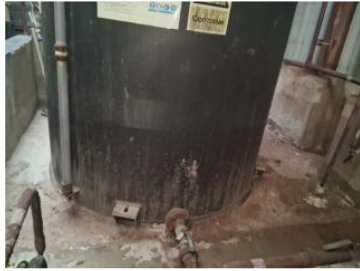
Bund No.	Name	Location	Construction Material	Sufficient capacity ⁽¹⁾	Outlet (yes/no)	Testing	Observations	Inspection date	Corrective Actions
							<p>Excess solid caustic on pipework.</p> <p>Photo of Bund:</p>

<p>Caustic to be removed from pipework.</p> <p>(Pipework is to be replaced in 2026).</p>
B3	Acid bund	North end RTTM	Reinforced concrete	Yes	No	<p>6 monthly Visual Inspection as per procedure VCL/EMS/007 (water tested if necessary)</p>	<p>Acid transfer pump are positioned within the bund and will be submerged in the event of a failure of tank integrity.</p> <p>Bund floor and wall repaired and painted with chemical resisted paint in March 2005</p> <p>No outlet present</p> <p>The overflow pipe of the effluent day tank which contains 32% caustic, is routed to a 205 lt drum to collect any spillages.</p> <p>Slight damage to bund wall.</p> <p>Chisel left in bund, broken concrete present in bund,</p> <p>Photo of Bund:</p>

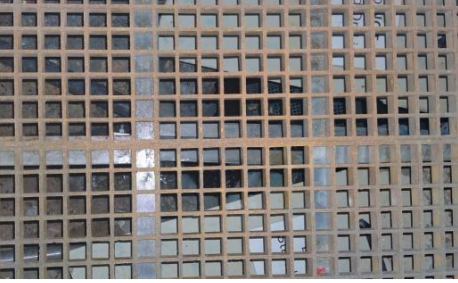
<p>Photo of Sump:</p>

Bund No.	Name	Location	Construction Material	Sufficient capacity ⁽¹⁾	Outlet (yes/no)	Testing	Observations	Inspection date	Corrective Actions
			of acid resistant reinforced concrete coated with acid resistant epoxy paint.				<p>IPPC improvement programme reference number 3 To be improved by 01.12.09, South end only</p> <p>Bund wall painted during summer shutdown 2010.</p> <p>Only roof above reelers is now old style roof, rest is new roof, fibreglass coated on the inside.</p> <p>New section of bund wall has been constructed along side existing wall along side storage tanks and setting bath make-up tank. New gulley alongside RTTM has been installed in Summer '17.</p> <p>Scrap steel in bund.</p> <p>Floor is poor under tanks 1 and 2.</p> <p>Photo of Bund:</p>

B4	RTTM bund	RTTM	South part of RTTM is made from reinforced concrete, the north part of RTTM is made	Yes	No	<p>6 monthly Visual Inspection as per procedure VCL/EMS/007 (water tested if necessary)</p>	<p>Reports automatically to effluent treatment sump by a level controlled submersible pump</p> <p>Poor surface around setting bath and tank 1. South end of bund has been repainted. Repair to gully was carried out in Nov '06.</p> <p>Bund cleaned after each production run.</p>	15.12.25	<p>Scrap steel to be removed with next metal scrap load.</p>

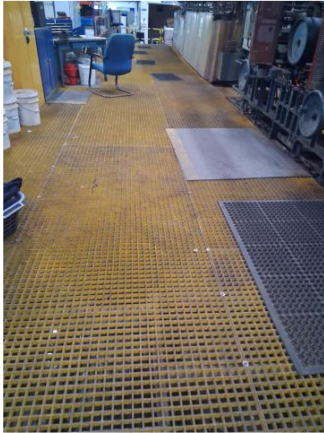
B5	Printing bund	Printing area	Reinforced concrete	Yes	Yes	6 monthly Visual Inspection as per procedure VCL/EMS/007 (water tested if necessary)	<p>Overflow of printing sump reports to preservative preparation sump under gravity followed by automatic transfer to RTTM bund by a level controlled submersible pump.</p> <p>Overflow from printing sump to preservative sump (under gravity).</p> <p>Bund cleaned in 2016</p> <p>Photo of Bund:</p>	15.12.25	-

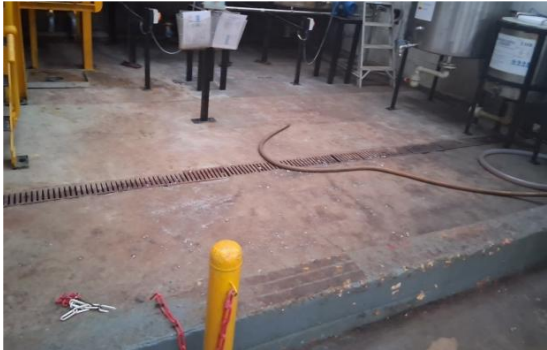
B6	Preservative preparation bund	Preservative area	Reinforced concrete	Yes	Yes	6 monthly Visual Inspection as per procedure VCL/EMS/007 (water tested if necessary)	<p>Reports to preservative preparation sump under gravity followed by automatic transfer to RTTM bund by a level controlled submersible pump</p> <p>Preservative transfer and circulation pumps are positioned within the bund and will be submerged in the event of a failure of tank integrity</p> <p>Small crack in floor, however doesn't appear to leak. Crack lies higher than drainage sump.</p> <p>Gulley to ink room should be closed however a spillage never occurred.</p> <p>Trailing flexi hose is a trip hazard</p> <p>Photo of Bund:</p>

15.12.25	Flexi Hose to be properly stored.

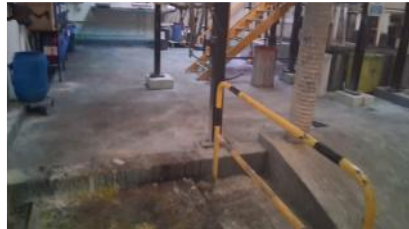
B7	Pigment preparation bund	Pigment area	Reinforced concrete	Yes	Yes	6 monthly Visual Inspection as per procedure VCL/EMS/007 (water tested if necessary)	Reports to effluent treatment sump under gravity Contains toy grade pigments and are non toxic. Bund is accessible by trolley via a ramp 24.08.05 – Small crack along length of floor No outlet present Outlet to effluent sump. Trailing flexi hose is a trip hazard Photo of Bund:

15.12.25	Flexi Hose to be properly stored.
B8	Scrubber	Yard	Reinforced concrete	Yes	No	6 monthly Visual Inspection as per procedure VCL/EMS/007 (water tested if necessary)	Caustic transfer and circulation pumps are positioned within the bund and will be submerged in the event of a failure of tank integrity Reports to spent caustic tower (which is located in the scrubber bund) by a automatically operated level controlled submersible pump 24.08.05 – Slight erosion at base of bund wall Bund located outside	15.12.25	-

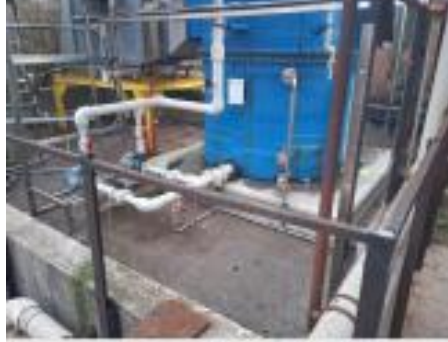
Bund No.	Name	Location	Construction Material	Sufficient capacity ⁽¹⁾	Outlet (yes/no)	Testing	Observations	Inspection date	Corrective Actions
							<p>No outlet present Transfer of solution via submersible to spent caustic tank.</p> <p>Bund regularly cleaned. Improvement programme going on at present.</p> <p>Photo of Bund:</p>

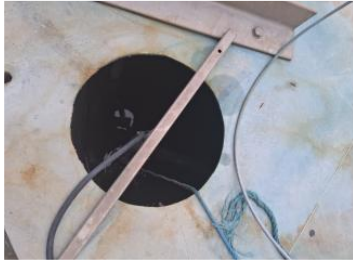
B21	Outer treatment bund (caustic dosing)	Yard	Concrete	Yes	No	6 monthly Visual Inspection as per procedure VCL/EMS/007 (water tested if necessary)	<p>Can store 250 lts</p> <p>No roof present</p> <p>Sump Image:</p>
