Compliance Assessment Report CAR_NRW0046223

Permit being assessed: AB0064101

For: PONTNHIR STW PONTNHIR NEWPORT, held by DWR CYMRU CYFYNGEDIG

Type of assessment carried out: Site Inspection, Reason: Routine.

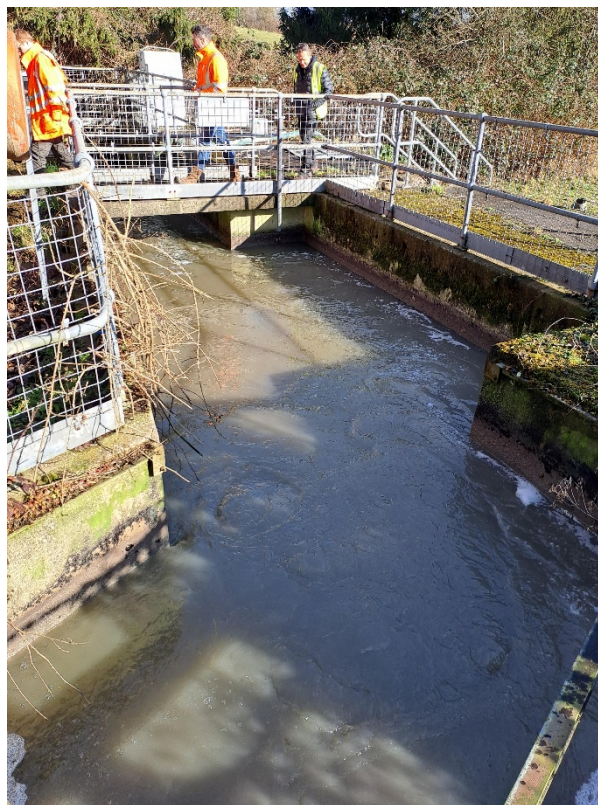
We began our inspection of the Primary Treatment site at the entry point of effluent from the inlet works. At the time of the visit it was clear of any large particulates and was not excessively odorous or concentrated, as seen in Figure 1.

Figure 1 – The effluent as it enters the primary treatment site at the time of the visit.

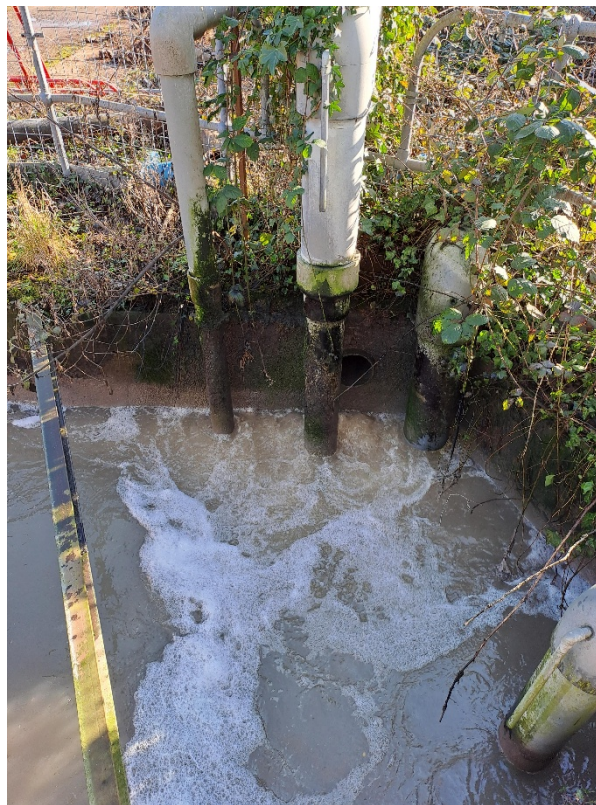
In addition to the effluent received from the inlet works it was also stated that there is a secondary input at this location via a pipe from Star Villas, a housing/industrial estate some 370m to the South of the site, which is transported to the treatment works via a separate pumping station. While this additional input appeared clear and was not altering the visual composition of the effluent (see Figure 2), it does not pass through the inlet works and as

such is not accounted for in the inlet monitoring, only the final discharge monitoring. It was not indicated by DCWW operators during the visit that the flow volume from this input was recorded. This raises concerns as the monitoring system doesn't capture the true volumes being transported to and treated on site. As a result, it is unclear whether the site is compliant with conditions pertaining to treatment volume and as such efficiency. I have not been able to find an amended/consolidated permit which indicates that this secondary input is regulated and legal. As such I have actioned that DCWW confirm if flow monitoring is conducted on this secondary input and how its inclusion does not breach effluent volume conditions.

Figure 2 – The white pipe seen is where effluent discharge from Star Villas enters the treatment works without flow monitoring capturing the volume.

No breaches were confirmed during this inspection. However, the secondary input from Star Villas raises concerns regarding effluent volume, flow monitoring and capacity. As a result, I have included an action to confirm the monitoring details on the input, the response to which will be assessed and based on the information available will be scored if the nature of the input breaches any of the associated permit conditions.

1. Confirm if flow monitoring is conducted on the Star Villas secondary input and how its inclusion does not breach treatment volume conditions.
Deadline: 22/01/2026

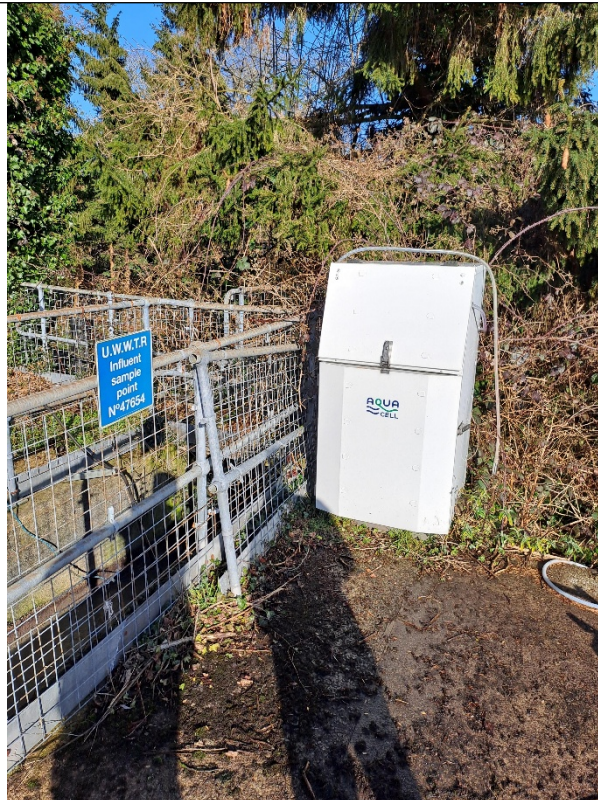
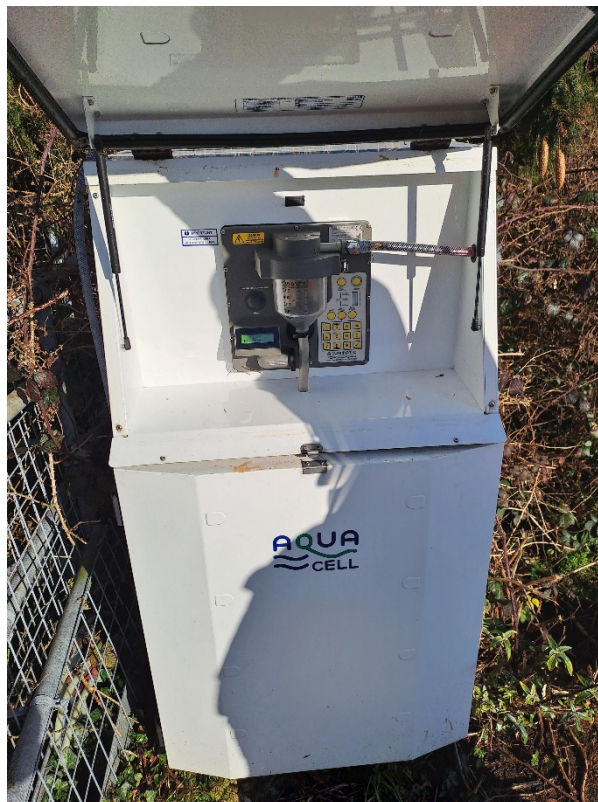
The crude sewage sampling point (fixed UWWTD) was observed to be in place at the point where effluent enters the treatment system (Figures 3 and 4). It was stated to be an autosampler which takes a representative sample 12 times a year i.e. monthly readings. This sampling, at the time of the visit, was last completed in January 2025, with results available from DCWW if requested. From this point the effluent is pumped to the primary settlement tanks to begin treatment.

Figure 3 (Top) – The location of the crude effluent sampling point.

Figure 4 (Bottom) – The internal system of the sampling point at the time of the visit.

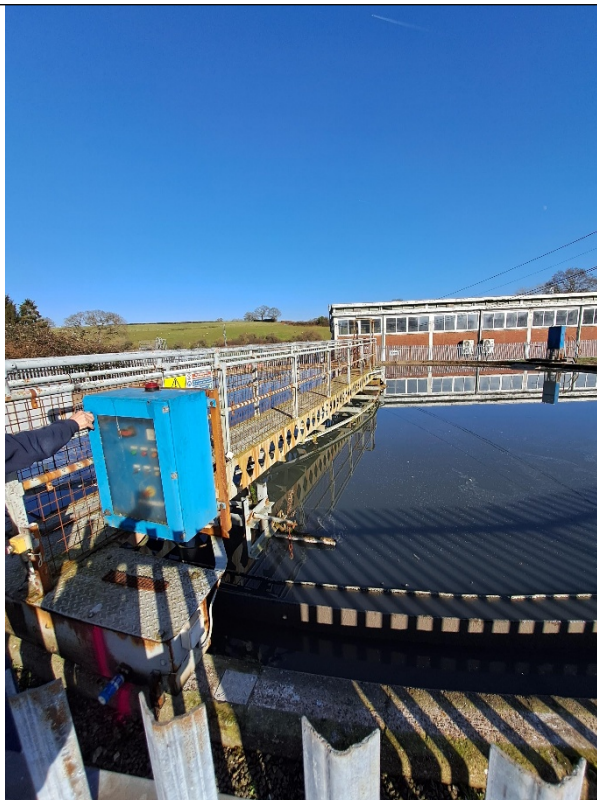
Settlement Tank 1's bridge appeared to not be in operation on first inspection. When investigated by DCWW operators it was clear that a metal plate on the chamber wall (as seen in Figure 5) was catching on the bridge and restricting it from rotating. I noted this as an action for DCWW to address as soon as practicable. The scum boards and baffle in Tank 1 appeared to be in good condition and working as designed, as seen in Figure 6.

Figure 5 (Top) – Settlement tank 1 where the metal plate restricting the bridge rotation can be seen on the chamber wall.

2. Maintenance – ensure settlement tank 1's bridge rotates freely and that no obstructions are restricting it.
Deadline: 22/02/2026
3. Maintenance – address collapsed and leaking baffles in primary settlement tanks 2 and 4.
Deadline: 22/02/2026

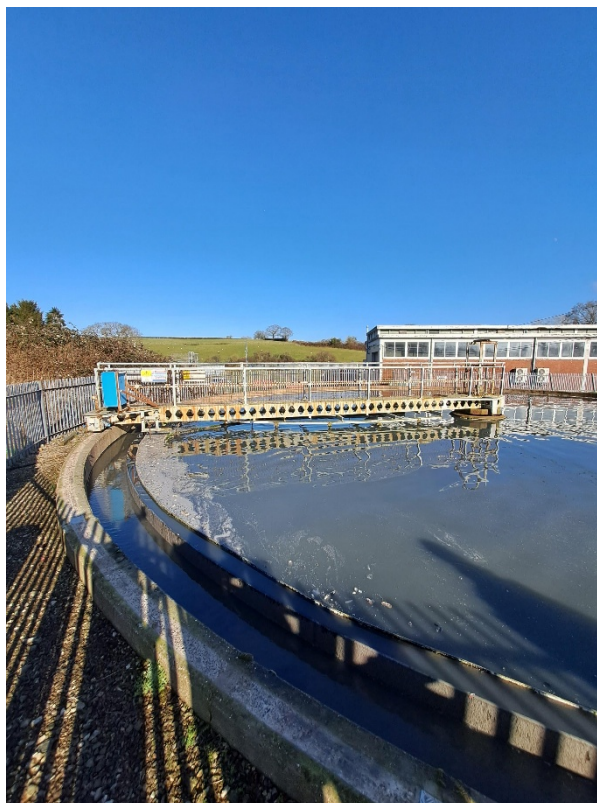
Figure 6 (Bottom) – The general condition of Settlement tank 1 at the time of the visit.

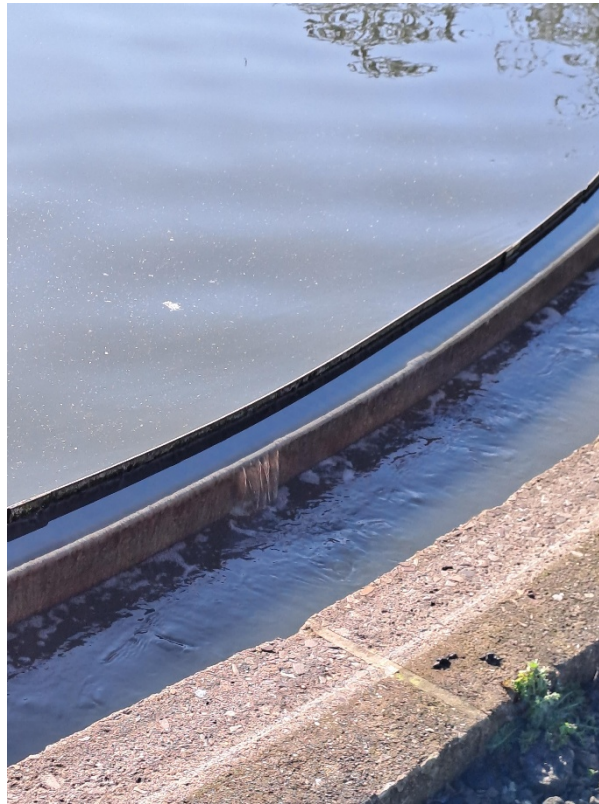
Settlement Tank 2 was in slightly worse condition at the time of the visit. The scum board was overtopping in places (Figure 7) and a baffle had collapsed in one section (Figure 8). I actioned for this to be a maintenance priority for DCWW operators.

Figure 7 (Top) – Settlement Tank 2's scum board overtopping.

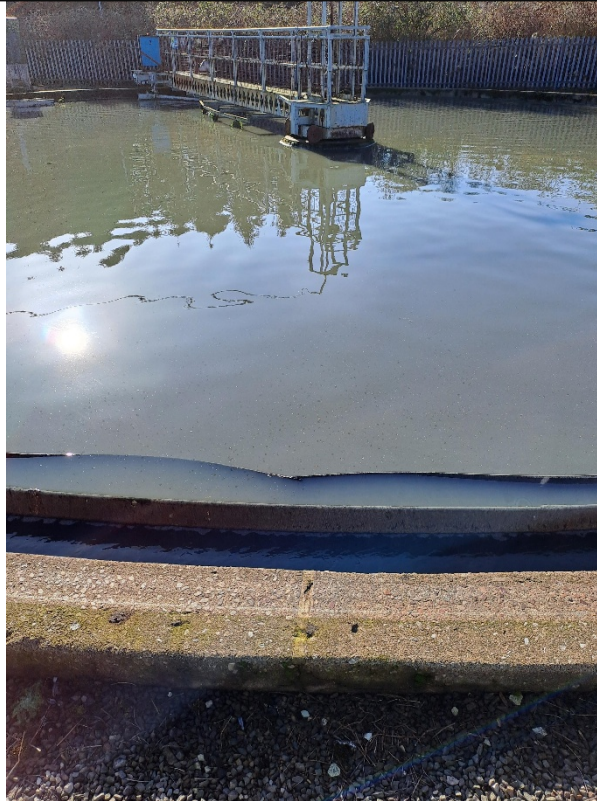
Figure 8 (Bottom) – A section of Settlement Tank 2's baffle where it has collapsed.

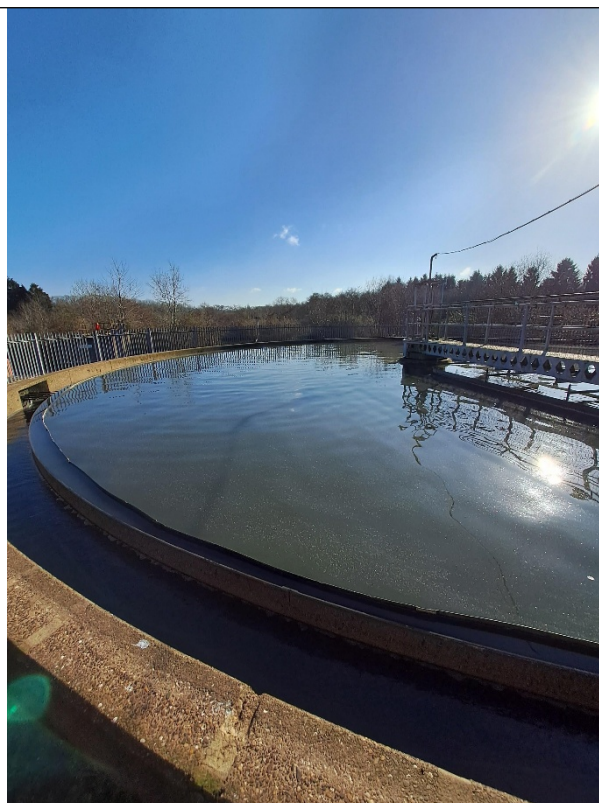
Settlement Tank 3 was in good condition with baffles and scum boards intact. There was some surface scum present but not excessive. These observations are evidenced in Figure 9.

Figure 9 – Settlement Tank 3 as observed during the visit.

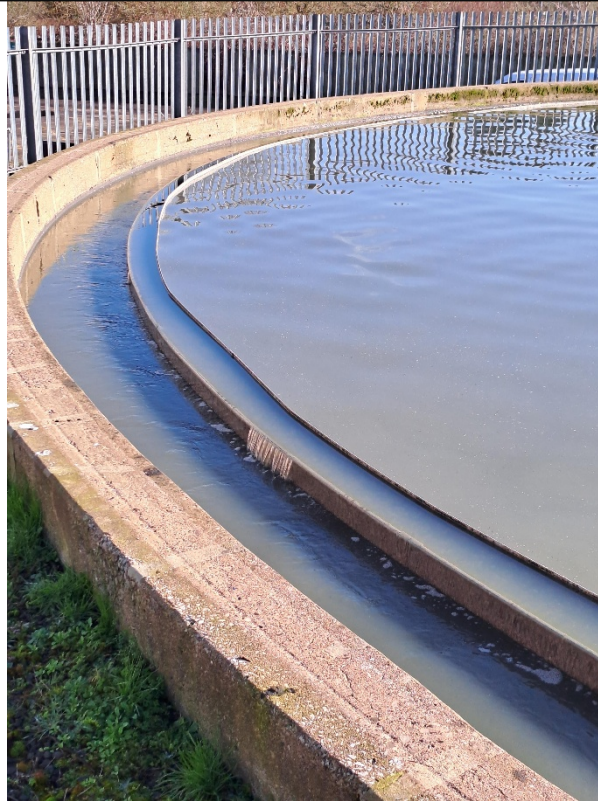
Settlement Tank 4 displayed similar defects as Tank 2 with baffle breaches in some parts (Figure 10) but overall no major issues noted (Figure 11). As previously noted, a verbal action was given to address these minor maintenance issues. The auto de-sludge was in operation on Tank 4 during the visit, operating as designed. It was noted that the solids/sludges are separated and sent on to Nash WwTW for further treatment.

Figure 10 (Top): Settlement tank 4 baffle breach as observed during the visit.

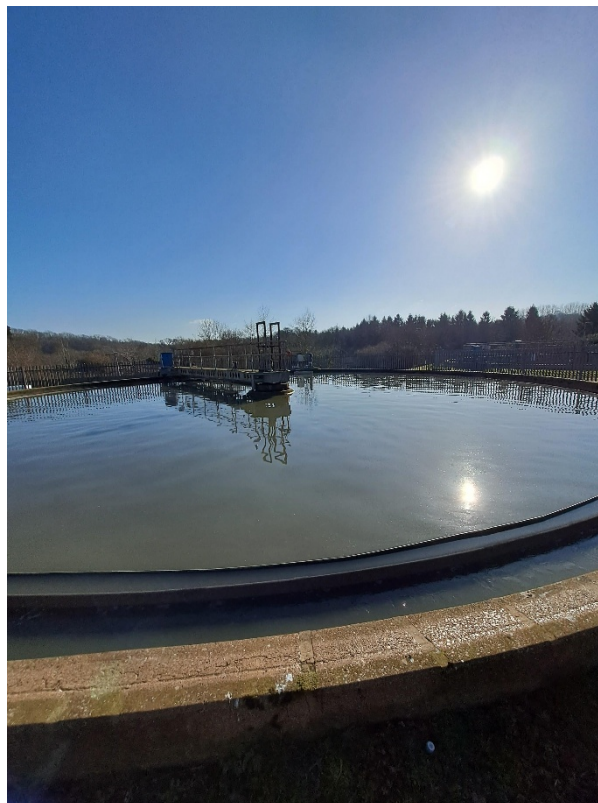
Figure 11 (Bottom): General condition of Settlement tank 4 as observed during the visit.

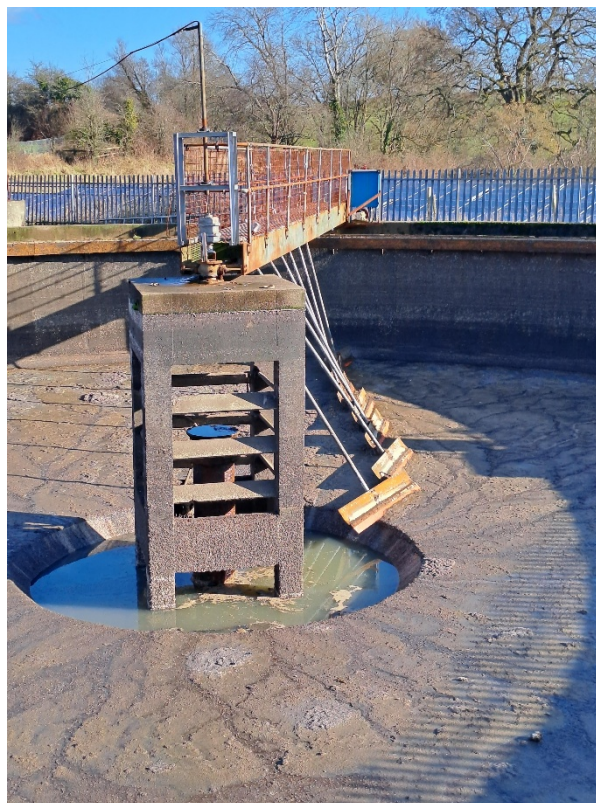
Settlement Tank 5 was not in operation during the visit and had been drainage down for maintenance. It was noted that the main maintenance priorities were to replace the drive and baffles. When questioned if DCWW submitted an OPNOT for this work, the operators stated they weren't sure and assured that they will check and inform NRW as soon as possible.

Figure 12 – Settlement Tank 5 drained down for maintenance at the time of the visit.

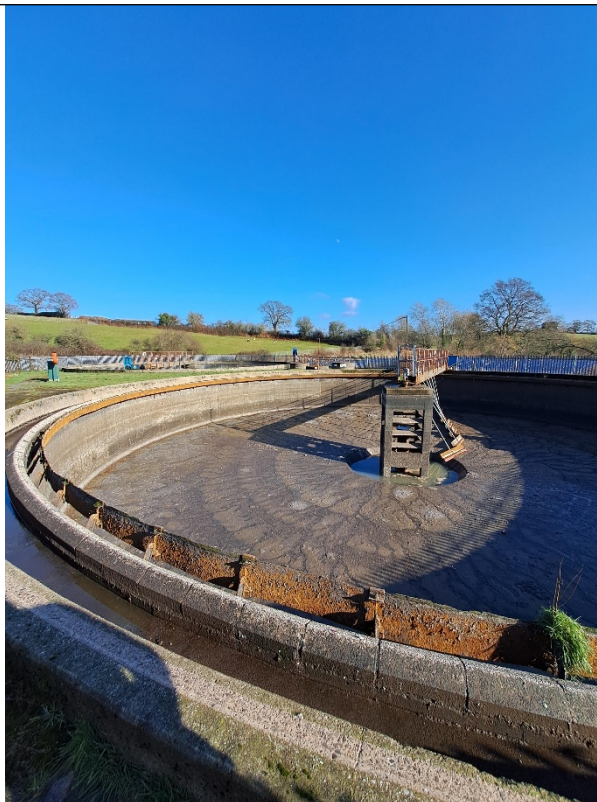
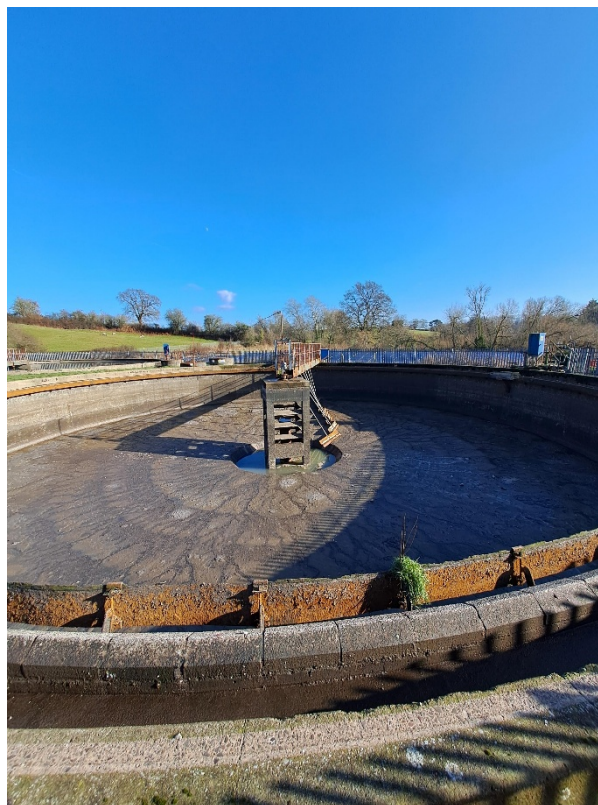
As the tank was empty, this was a good opportunity to assess the components that could not be seen on the other tanks and gauge the general maintenance of the infrastructure (Figure 12). The scrapers and bridge looked to be in good condition with no excessive wear. The baffles were very rusty and compromised in several places (Figures 13 & 14), but as this was noted as a maintenance priority by DCWW no action will be set by NRW.

Figure 13 (Top) – Baffles of Tank 5 showing considerable rust and defects, but maintenance scheduled by DCWW to rectify.

Figure 14 (Bottom) - Baffles of Tank 5 showing considerable rust and defects, but maintenance scheduled by

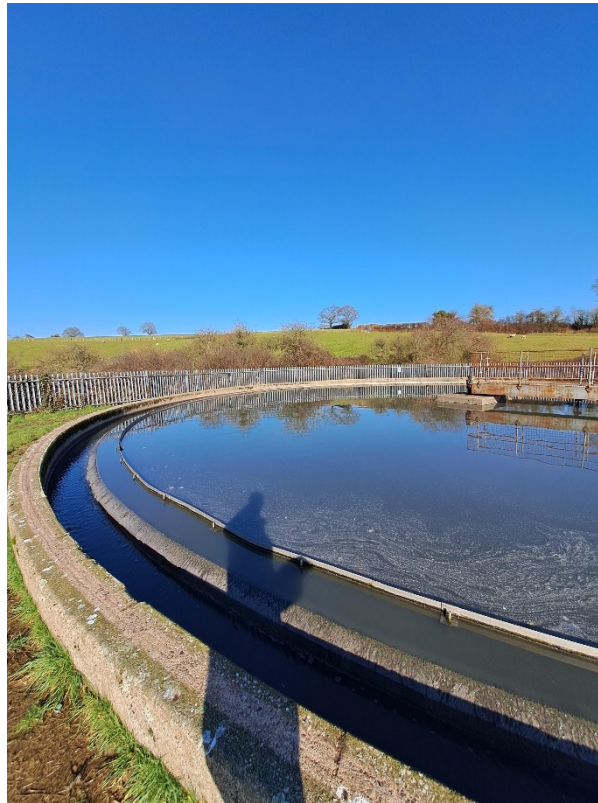
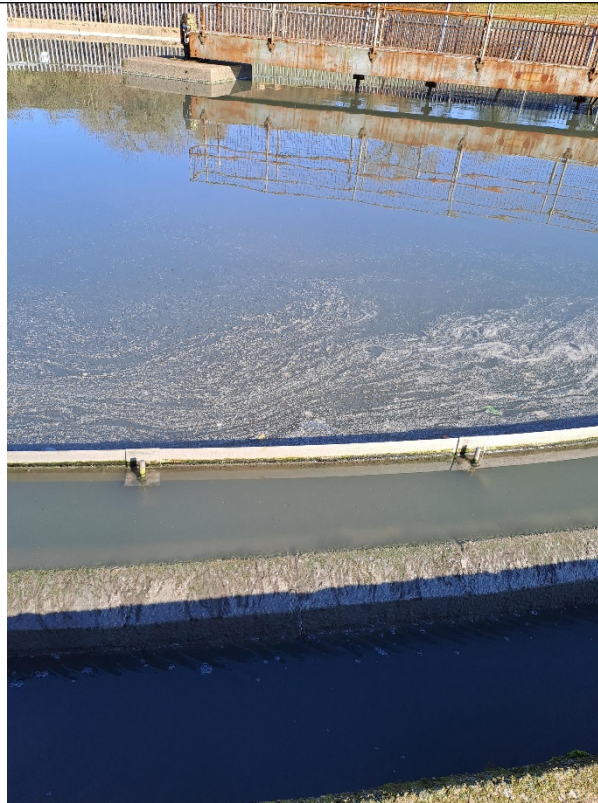
Settlement Tank 6 was in good working order with the baffles and scum boards in very good condition (Figures 15 & 16) as they had been replaced recently by DCWW. No issues noted at the time of the visit.

Figure 15 (Top) – Condition of Tank 6 as observed during the visit.

Figure 16 (Bottom) – Tank 6 baffles in very good condition.

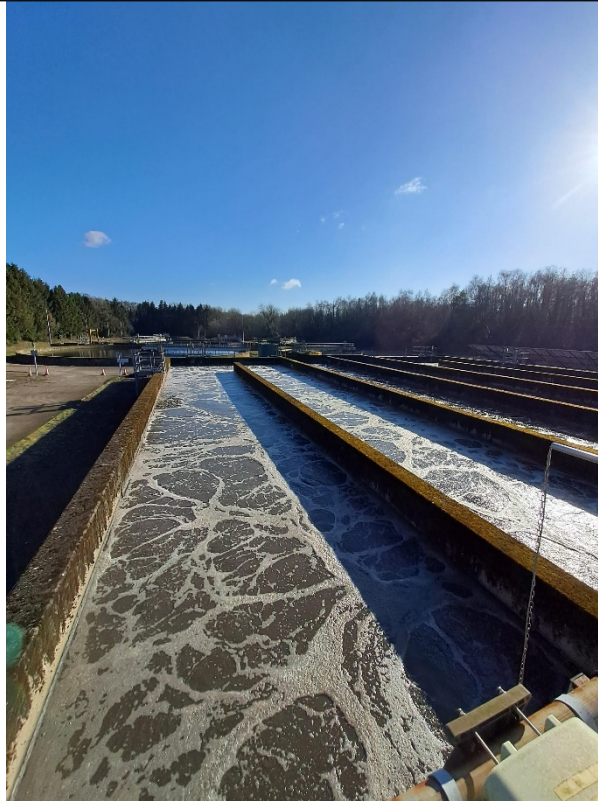
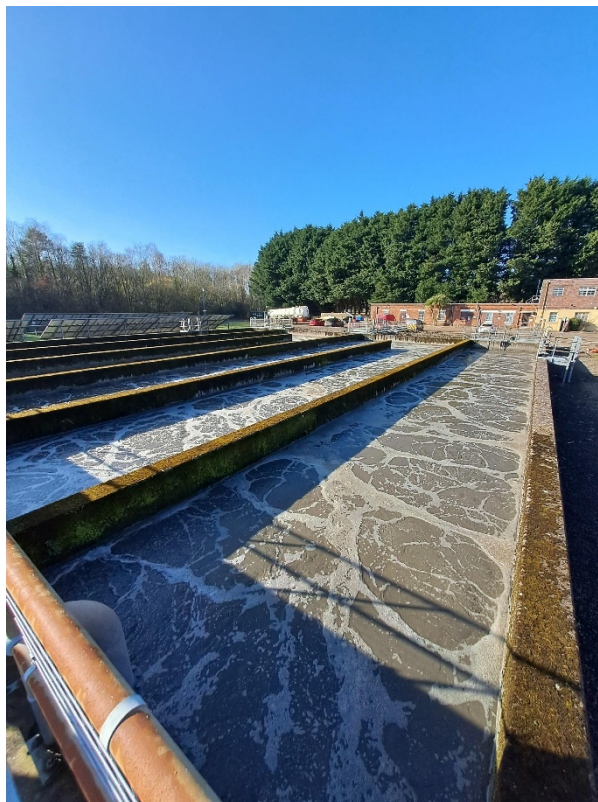
The secondary treatment/aeration lanes were inspected (2 tanks, 3 lanes in each) and found to be in a good working condition. There was no abnormal amounts of foam and the foam present was a white colour as expected as part of the requisite biological processes. There was no evidence of excessive solids observed at the time of the visit (Figures 17 & 18). It was stated that the Mixed Liquor Suspended Solids (MLSS) was last measured at 2000mg/l. This data can be requested from DCWW. Regarding planned maintenance, it was noted that the blowers need to be replaced. Two will be kept operational with two rental units to be utilised during the retrofit. I requested that this work be reflected with an OPNOT when undertaken.

Figure 17 – The aeration lanes as observed during the visit

Figure 18 – The aeration lanes as observed during the visit.

4. Reporting – Inform NRW via OPNOT when the retrofit of new blowers on the aeration lanes will/has taken place.
Deadline: 22/01/2026
5. Reporting – Inform NRW when Final settlement tank 3 is back in working operational order.
Deadline: Once complete (A six month deadline has been set for administrative purposes).

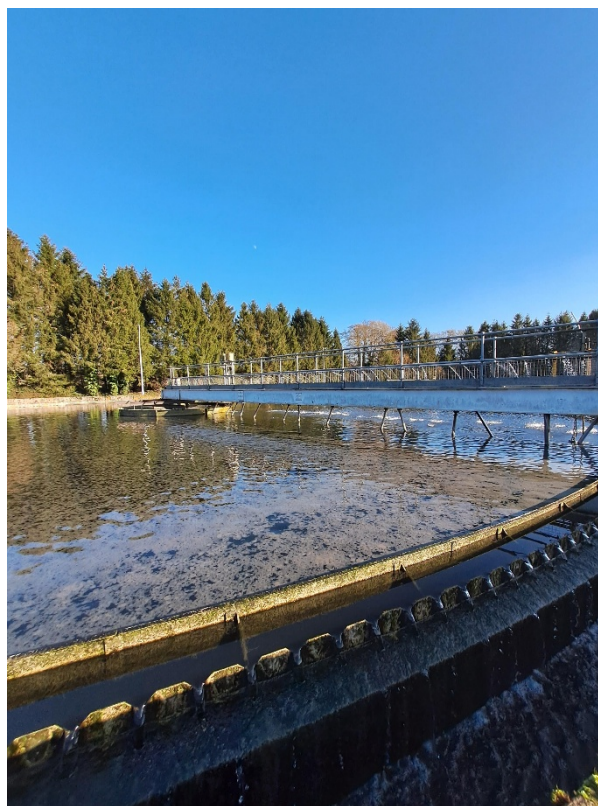
There are 4 final settlement tanks in total on site. 3 were operational during the visit. Overall there weren't any major issues observed. There was some surface scum present but this was explained to be "pin floc" and stated to be non-hazardous and breaks up without impacting suspended solids or chemistry of the final effluent. An example of this pin floc can be seen in Figure 19. There was no visible oil or grease observed. It was noted by DCWW that these final settlement tanks were retrofitted from the original primary settlement tanks. As such, they realistically shouldn't have/need the baffles and scum boards currently in place.

Figure 19 – An example of the pin floc observed in the final settlement tanks during the visit.

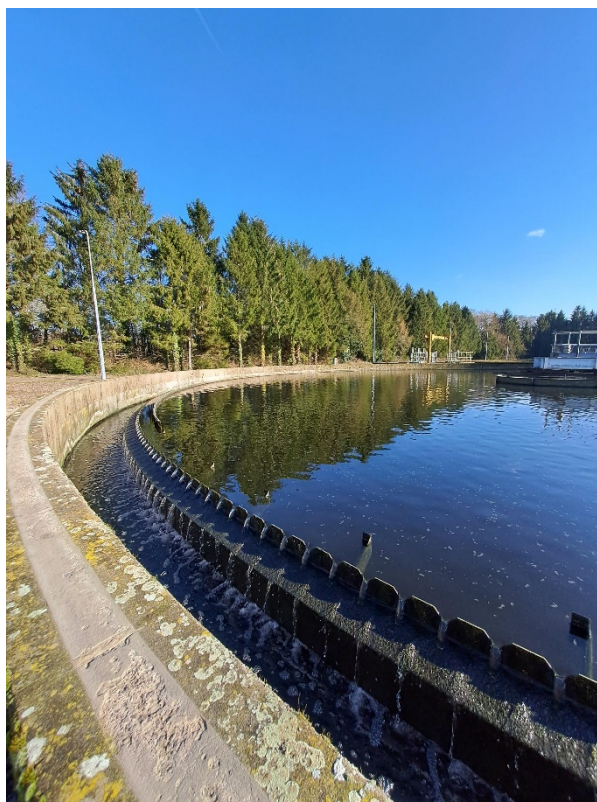
Tank 1 had good water clarity with some pin floc on the surface. No large solids were observed and treated effluent leaving tanks appeared to be (visually) very good. Figure 20 shows these observations.

Figure 20 (Top) – Final Settlement Tank 1 as observed during the visit.

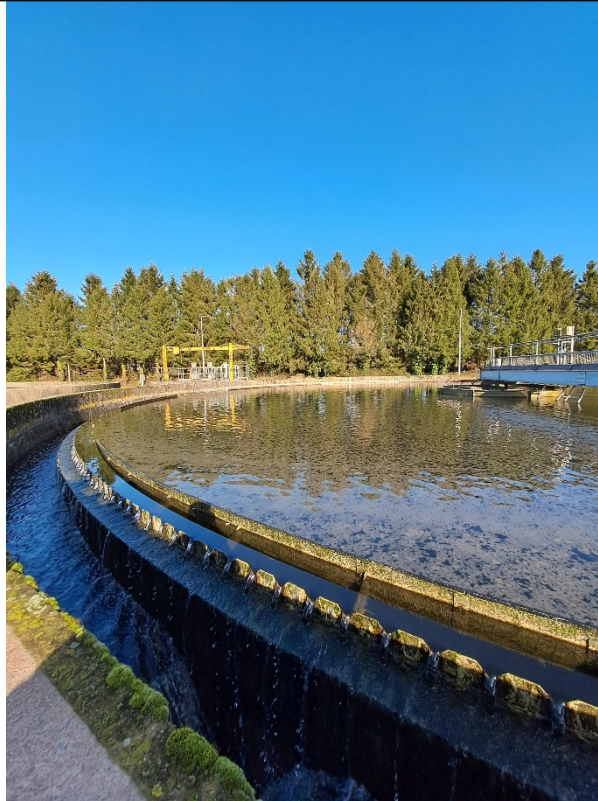
Tank 2 contained even more pin floc, but as stated previously, this was not a concern to DCWW and it was noted that the baffles act as a barrier, restricting the floc from breaking up in the effluent as it cascades out of the tanks. The water clarity leaving the tank was good. These observations can be seen in Figure 21.

Figure 21 (Bottom) - Final Settlement Tank 2 as observed during the visit.

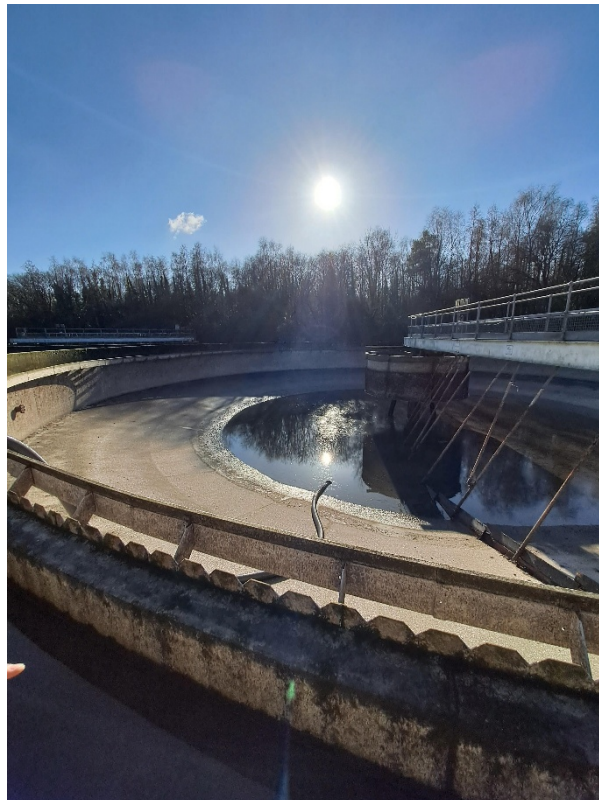
Tank 3 was empty during the visit due to an electrical fault in the bridge operation. When asked about timescales for remedying the issue it was stated that parts were on order but DCWW operators will check when this fix is scheduled to take place. Figure 22 shows the condition of tank 3 during the visit.

Figure 22 (Top) – Final Settlement Tank 3 as observed during the visit.

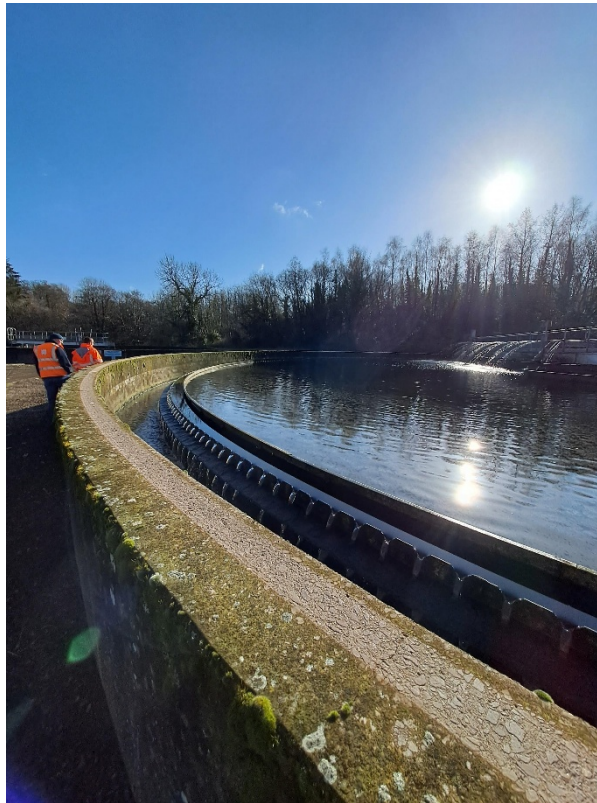
Tank 4 displayed similar pin floc as tanks 1 & 2, although not as extensive. The water clarity, although not as good at the other tanks, was still visually very clear. Figure 23 is evidence these observations.

Figure 23 (Bottom) - Final Settlement Tank 4 as observed during the visit.

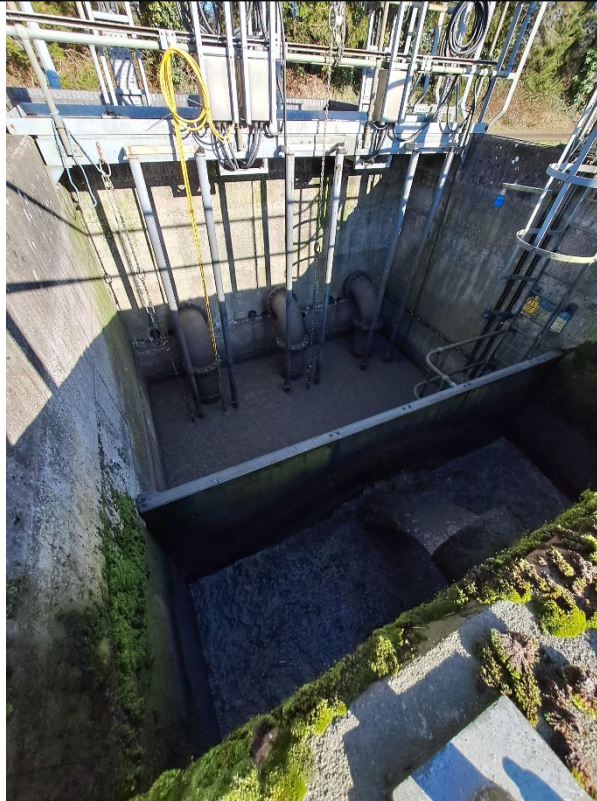
The return system for sludge from the final settlement tanks was observed (Figure 24). No issues were noted from the visual inspection. As noted previously, these sludges are sent to Nash WwTW for further treatment.

Figure 24 – The sludge return system as observed during the visit.

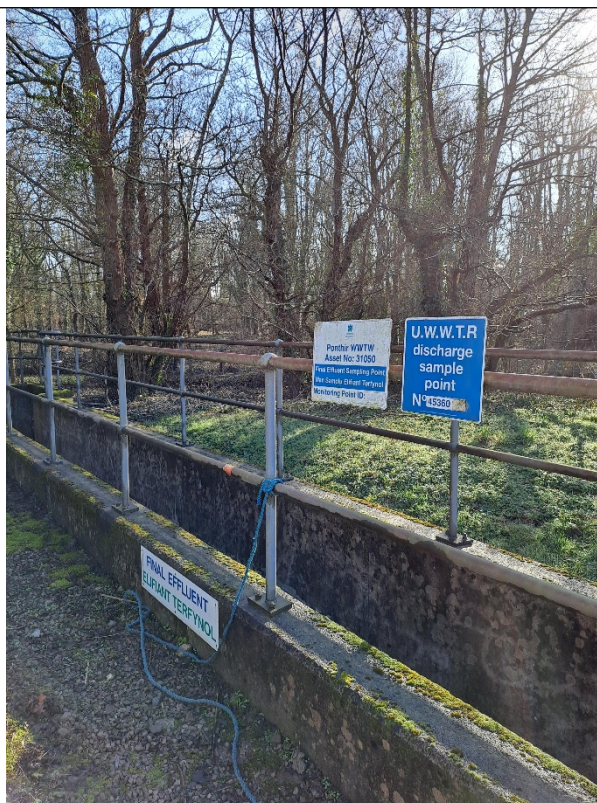
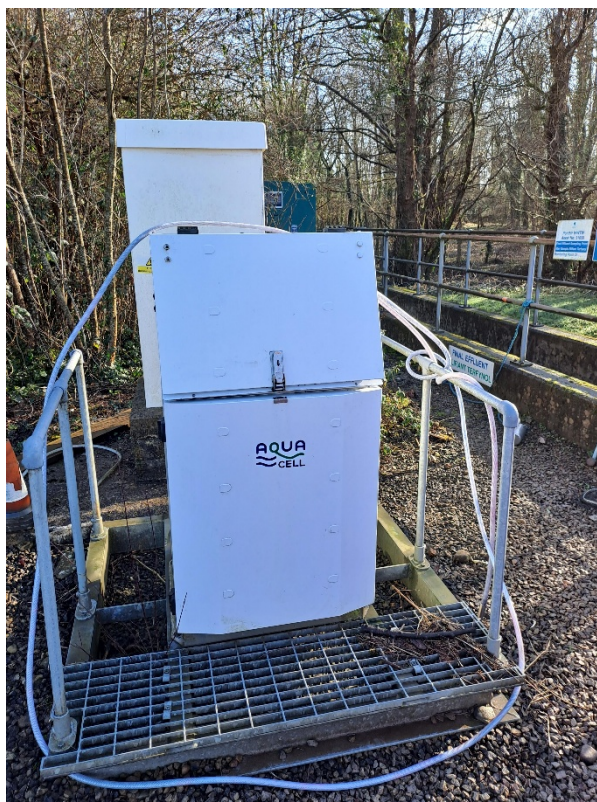
The final effluent sampling point and UWWTD auto samples are in the listed location and are clearly labelled, as seen in Figures 25 and 26. The UWWTD holds an appropriate MCERTS certification (valid until 07/12/2027). The sampling regime allows for a representative sample to be taken via a bucket from the final effluent flume which is well mixed. A representative data set for sampling analysis will be requested to assess treatment efficiency. The flow measurement device (telemetry) is in place, operational and the read out is visible, as seen in Figure 27. At the time of the visit the final effluent was discharging at a rate of 405.3l/s.

Figure 25 (Top) - The final effluent sampling point, clearly labelled.

Figure 26 (Bottom) - UWWTD auto samples in the listed location.

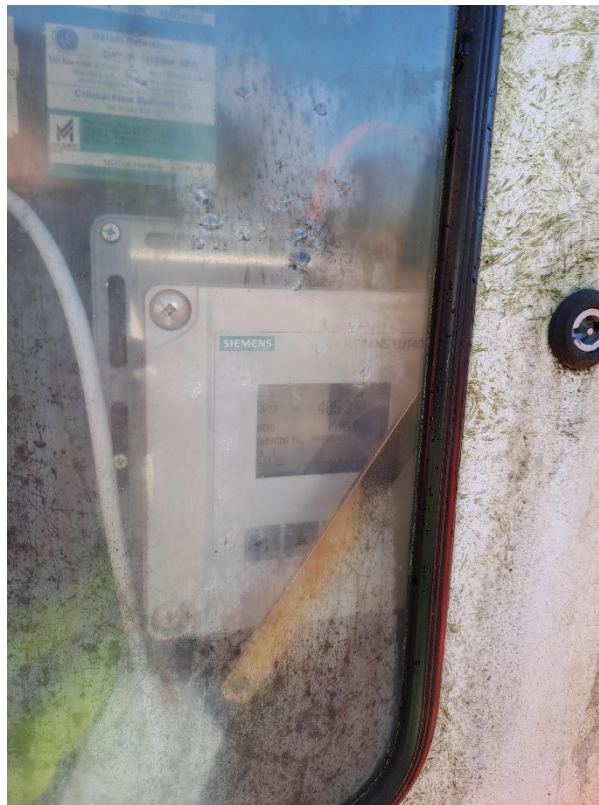
Figure 27 - The flow measurement device, visible and in operation.

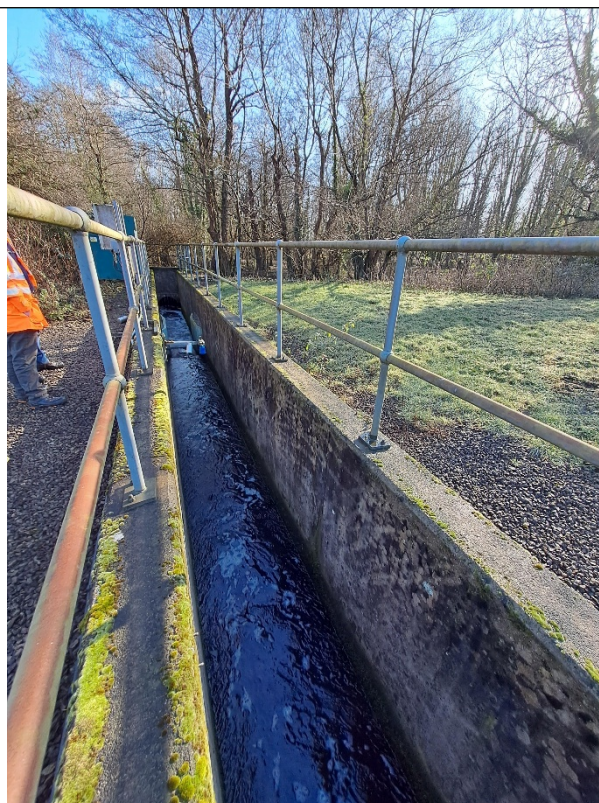
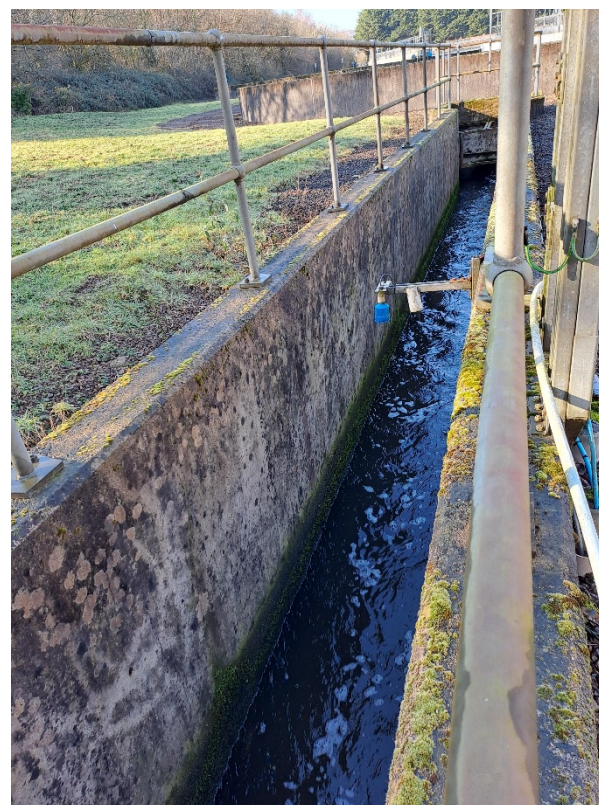
The final effluent flume/channel was clear of debris and fungus, with sensor heads also free of debris, as seen in Figures 28 and 29. EDM monitors were described to be in place on the storm effluent channels near the storm tanks, as assessed separately.

Figure 28 (Top) – Final effluent channel with monitors in situ.

Figure 29 (Bottom) – Final effluent channel with monitors in situ.

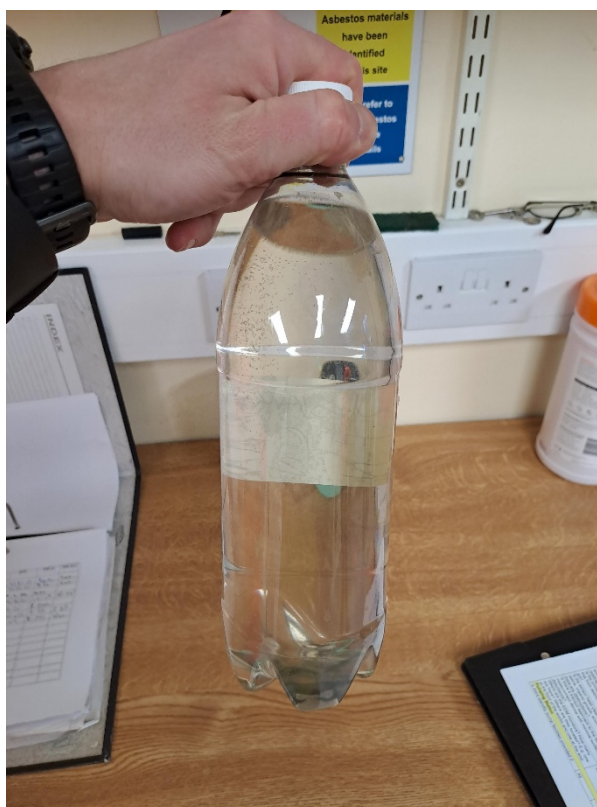
A brief tour of the laboratory and analysis facilities was given, where a representative example of a final effluent sample (taken by NRW officer E.Evans earlier that day) was observed. As seen in Figure 30, the effluent was of good quality with minimal discolouration and no visible solids present.

Figure 30 – Sample of the final treated effluent from the day of the visit.

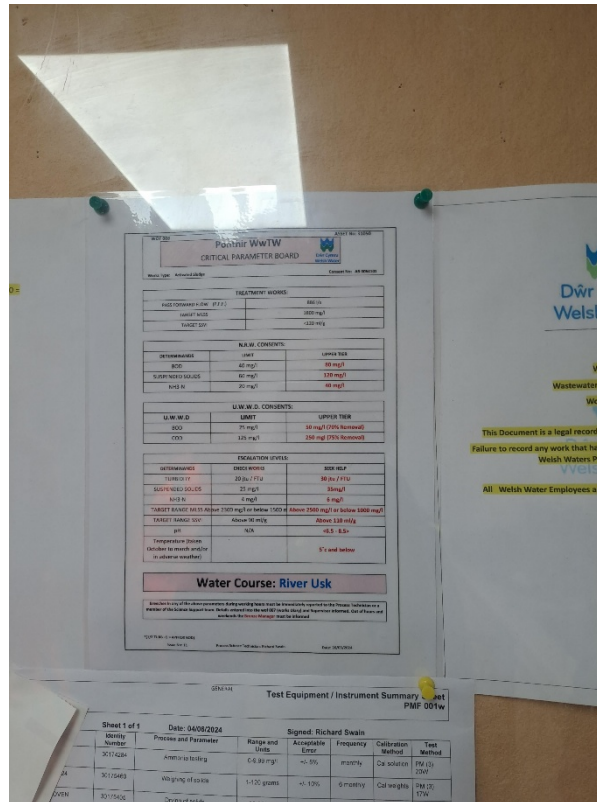
The critical parameter board was observed (Figure 31) which is backed up by an escalation process if an exceedance in effluent quality is detected. All tests listed are undertaken daily. The DCWW daily sample book was observed (Figure 32) with all results within consented limits for the day of the visit.

Figure 31 (Top) – The critical parameter board as observed during the visit.
