SWL24-380-01-WFS-02

**Point of Ayr Gas Terminal:
Water Features Survey**

Rev	Date	Description	Prepared by:	Approved by:
P01	30.01.2026	Initial Submission	George West	Mark Pickett
P02	10.02.2026	Update after Client comments	George West	Mark Pickett

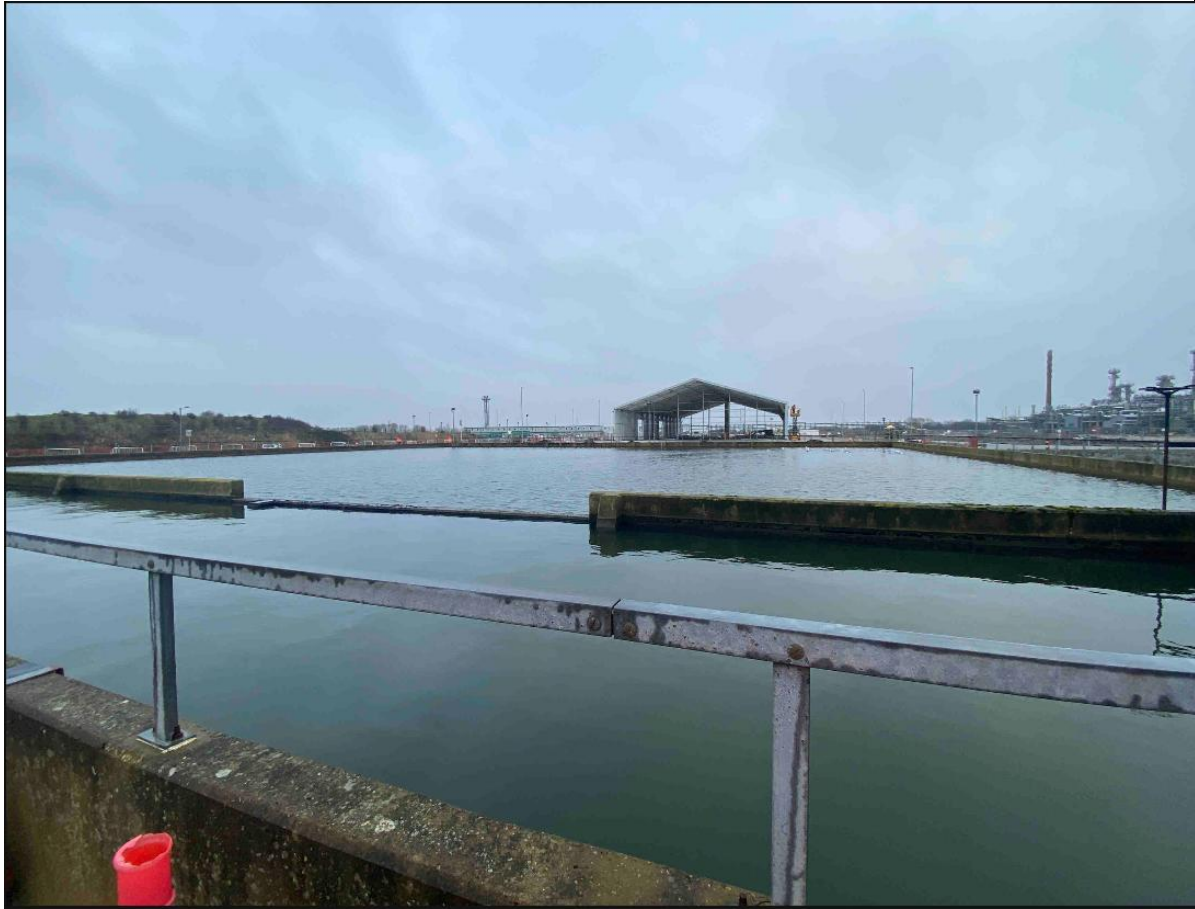
1, 2	Location L00 Directly on the site exists a surface water storage tank. This is to act as a flow through during dewatering works as all abstracted water will be pumped into the tank then subsequently pumped to the brook. This tank is approximately 50.0 m by 50.0 m.	Daily photographic record during de-watering
	3	Location L01 Directly on site there exists also a fire suppression water storage pool, this pool is bunded by a plastic liner and is approximately 120.0 m by 30.0 m. This pool can drain into the surface water tank at the discretion of the site operators. The pool is currently contaminated with PFOS/PFAS and thus would need to be treated before discharging.	Water treatment prior to discharge

Photograph 1: Location 00: Surface water collection tank. 50.0m by 50.0m

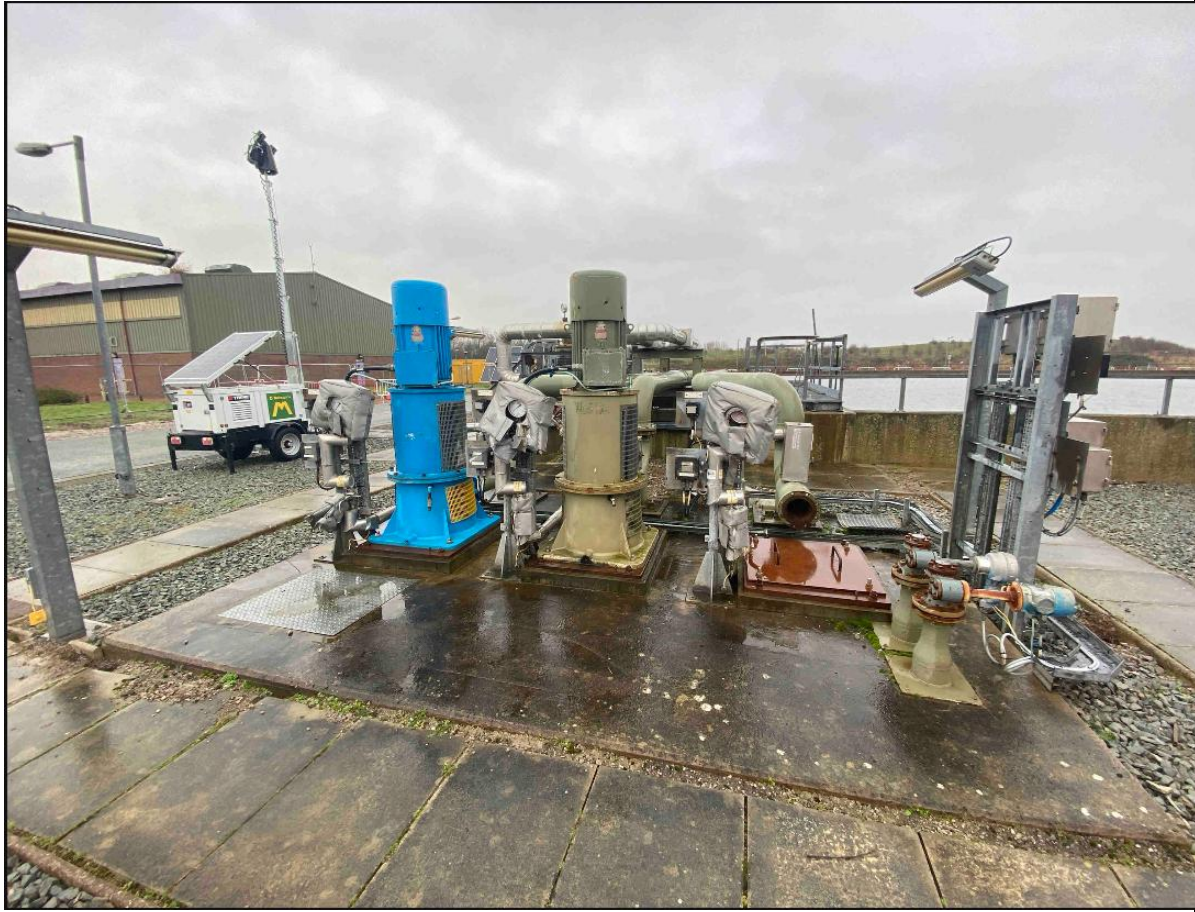
During the site walkover, the brook bordering the site was observed to be adequate to handle the abstracted groundwater, it is worth noting that due to the restrictions on site, all abstracted water from the dewatering will be discharged to an existing holding tank which subsequently discharges from the tank to the brook with a maximum flow of 50 m³ per hour at location W1. This limitation of discharge is due to the existing pumps maximum capacity.

Photograph 2: Location 00: Permanent installation pumps on site for the surface water storage tank (Maximum capacity of 50m³ per hour)

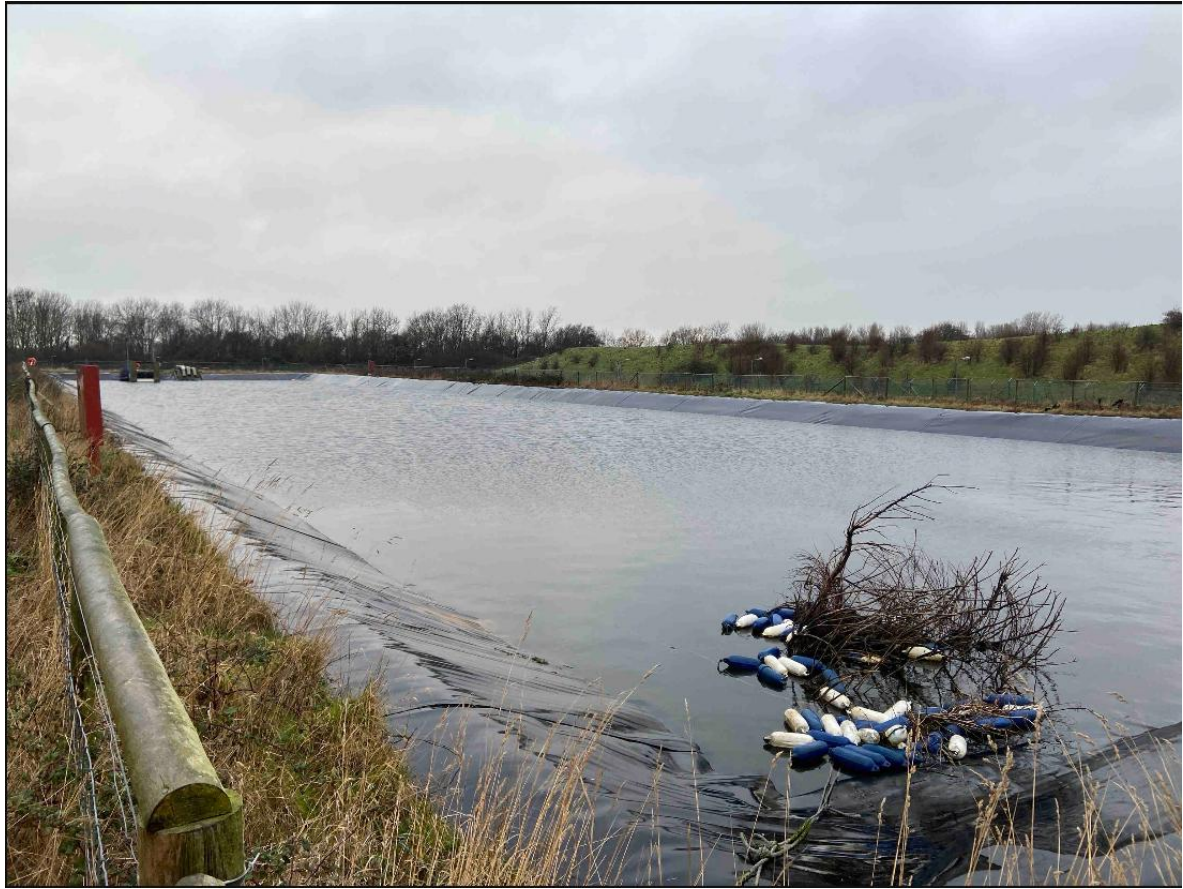
Photograph 3: Location 01: View of fire suppression water collection tank. This tank is connected to and can drain to the surface water collection tank. Currently it is cut off as it is contaminated with PFOS/PFAS. 117.0m by 30.0m

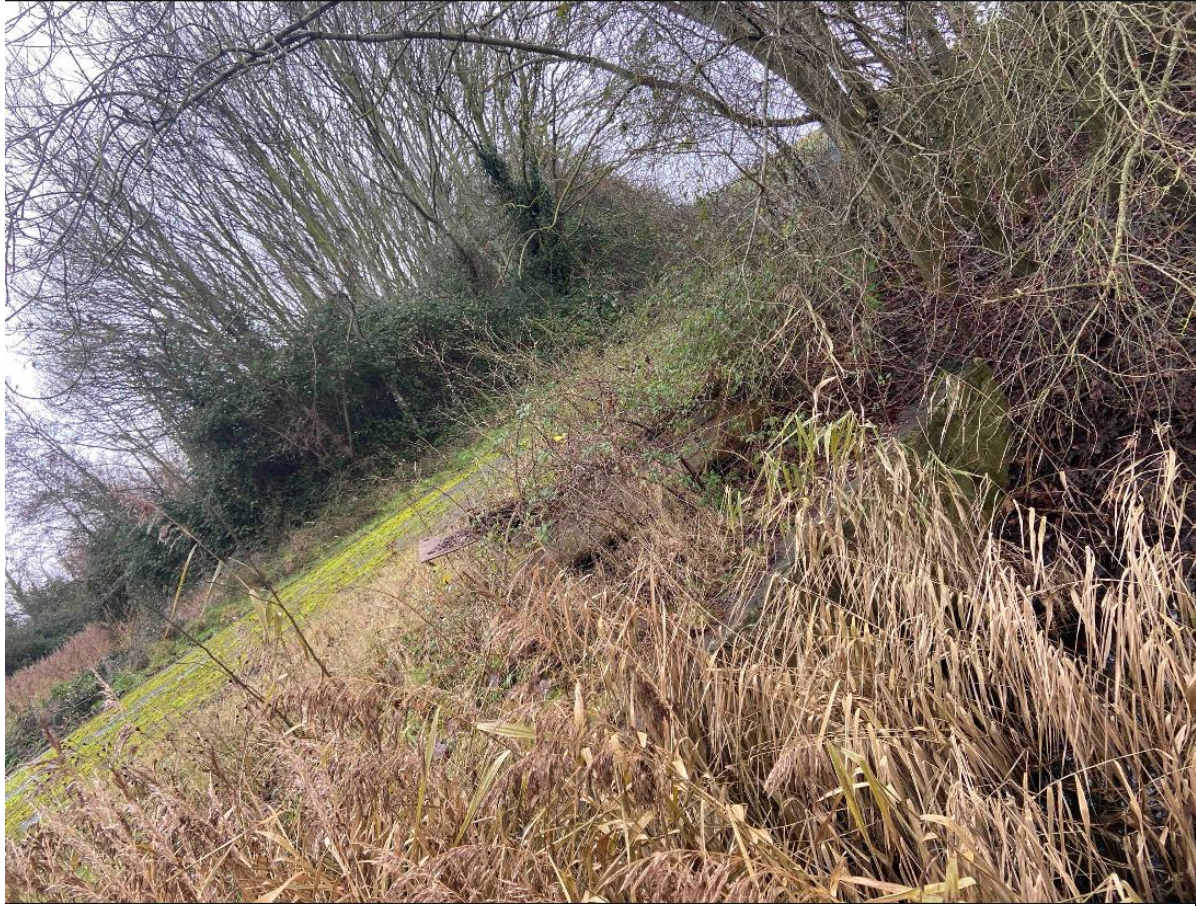
Photograph 4: Location 02: Culvert underneath historic roadway, this is upstream from the discharge. Culvert is 0.8m by 0.9m box tunnel. Photo taken facing East.

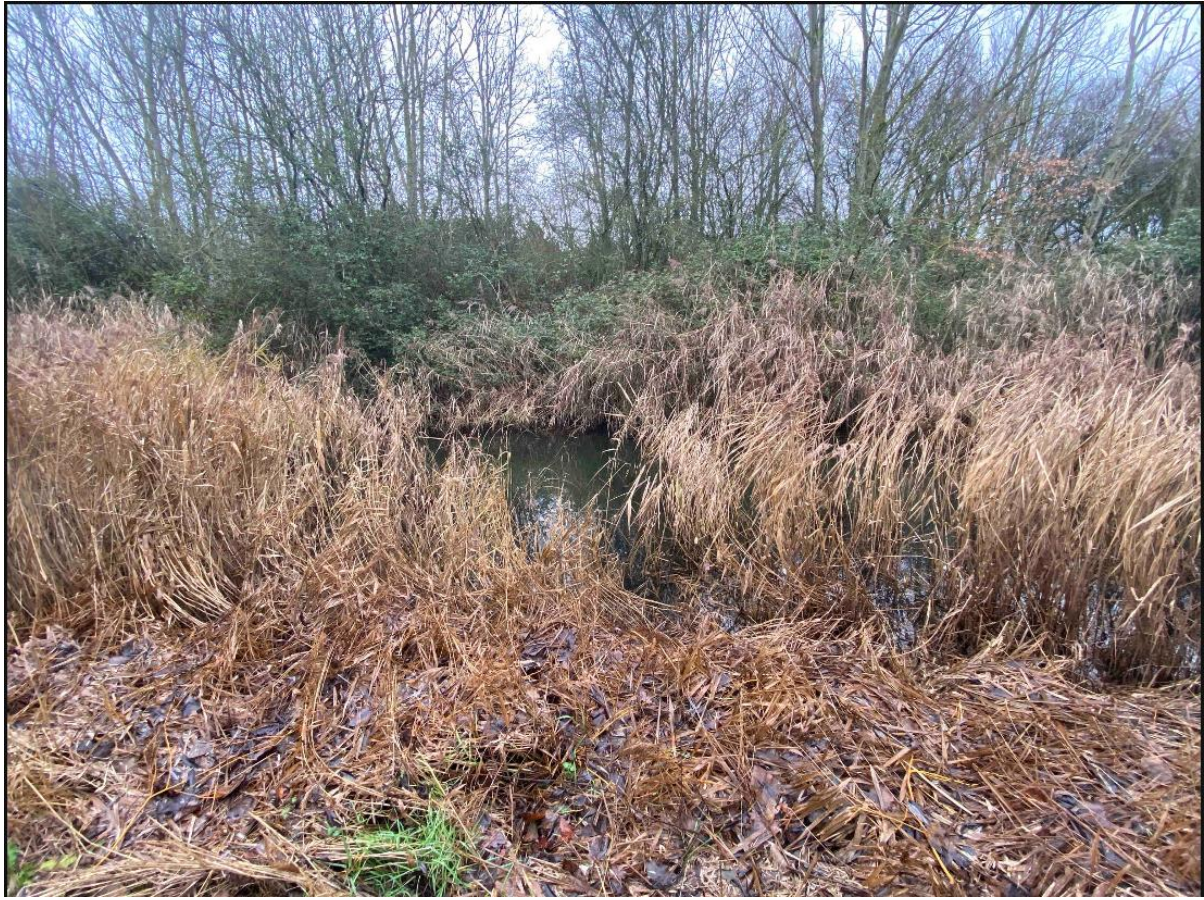
Photograph 5: Location 03: Talacre Brook, ~4.5m wide and ~1.8m deep, lots of reed growth. In photograph directly opposite is the discharge outflow from the surface water storage tank. No observable flow. Photo taken facing East.

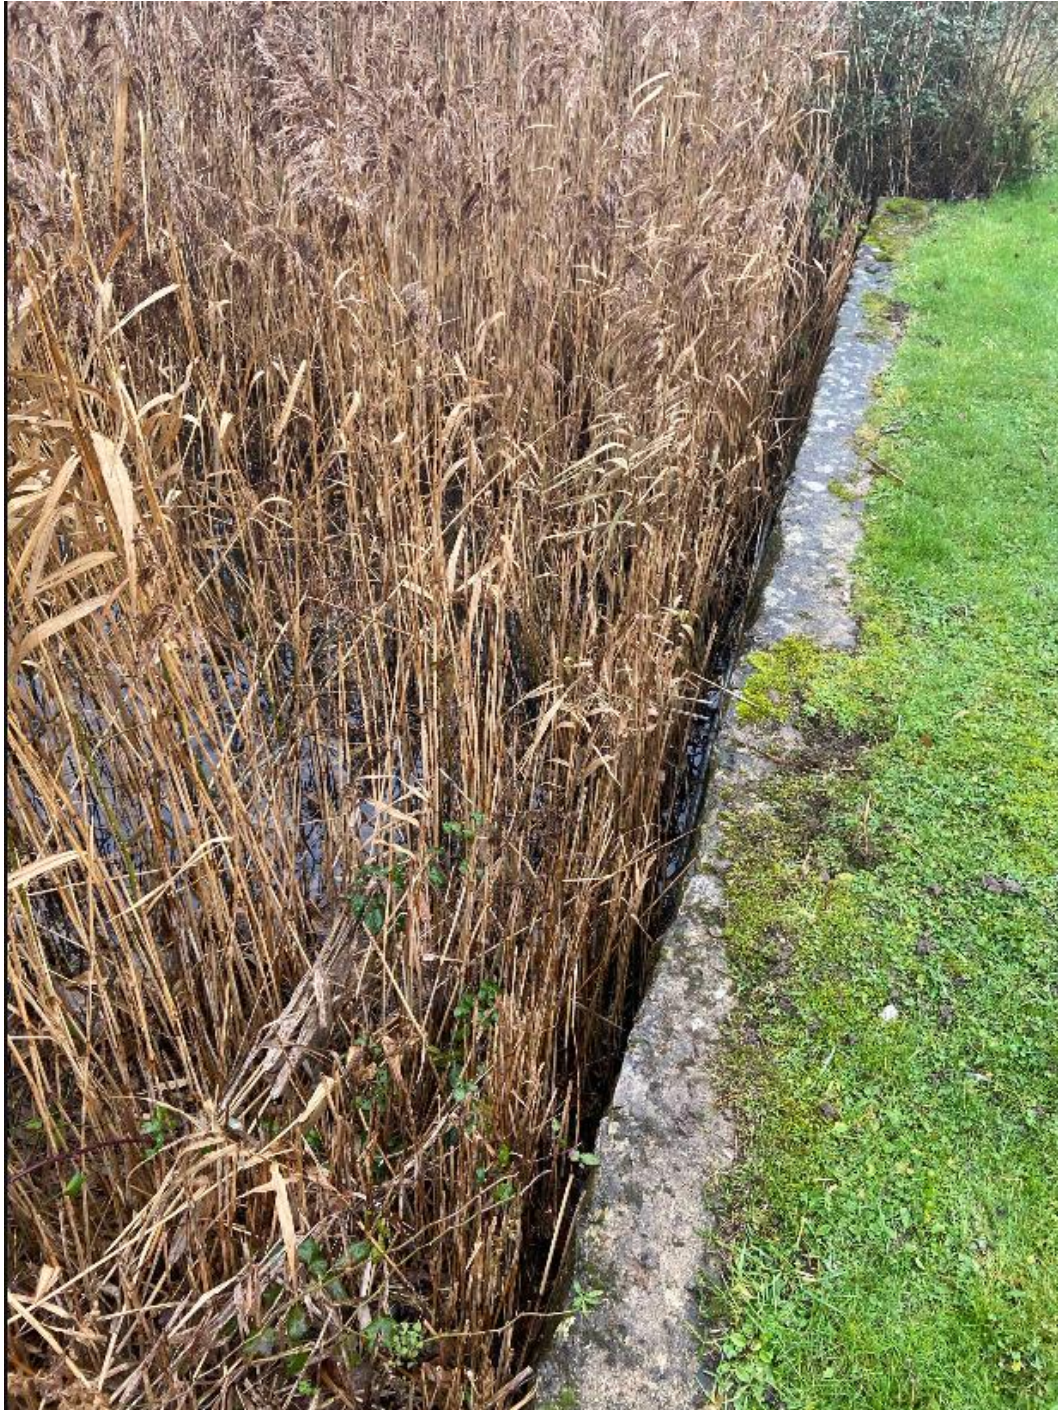
Photograph 6: Location 04: Box culvert under entrance roadway to gas terminal. Box is 1.4m by 0.7m. Brook is ~5.0m wide and ~1.5m deep with no flow observable. Photo taken facing East.

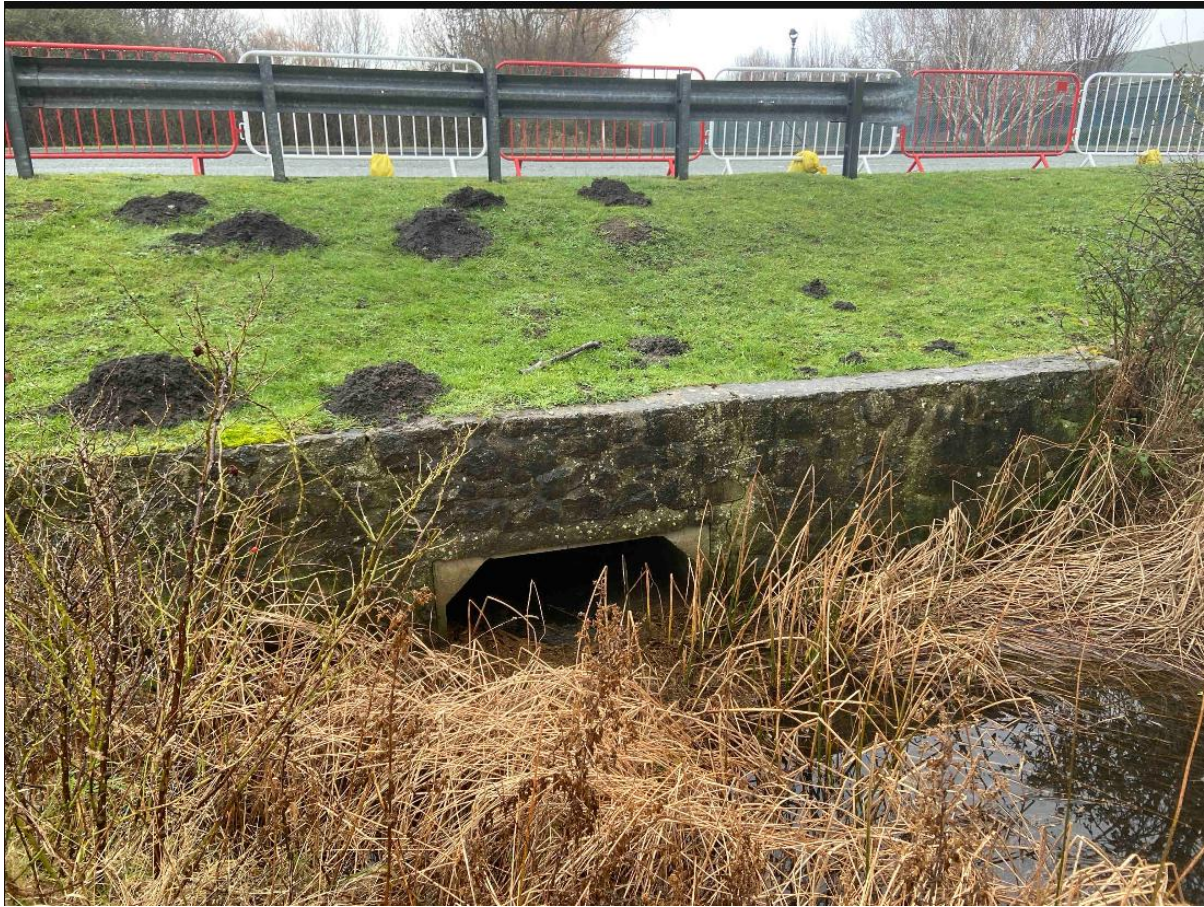
There is a pinch point on the southwest corner of the site where a roadway has been constructed maintaining the brook with a box culvert best shown in Photograph 7 (Appendix 1). The brook is approximately 2.0 m deep and 6.5 m wide at ground level. The box culvert under the roadway is 1.4 m by 0.7 m and forms a potential bottleneck, however it is clear and could support consistent flow through. On the base of the brook silt is observed, which is from the accumulation of fine sediments and may cause sedimentary caking that will negatively impact the soakaway rates and drainage potential of the ditch. This could be mitigated via dredging.

Photograph 7: Location 05: Box culvert outflow from entrance roadway for gas terminal. The culvert maintains the same shape as previous location. Box culvert is 1.4m by 0.7m and brook widens to ~6.5m wide by ~1.4m deep. No observable flow. Photo taken facing North.

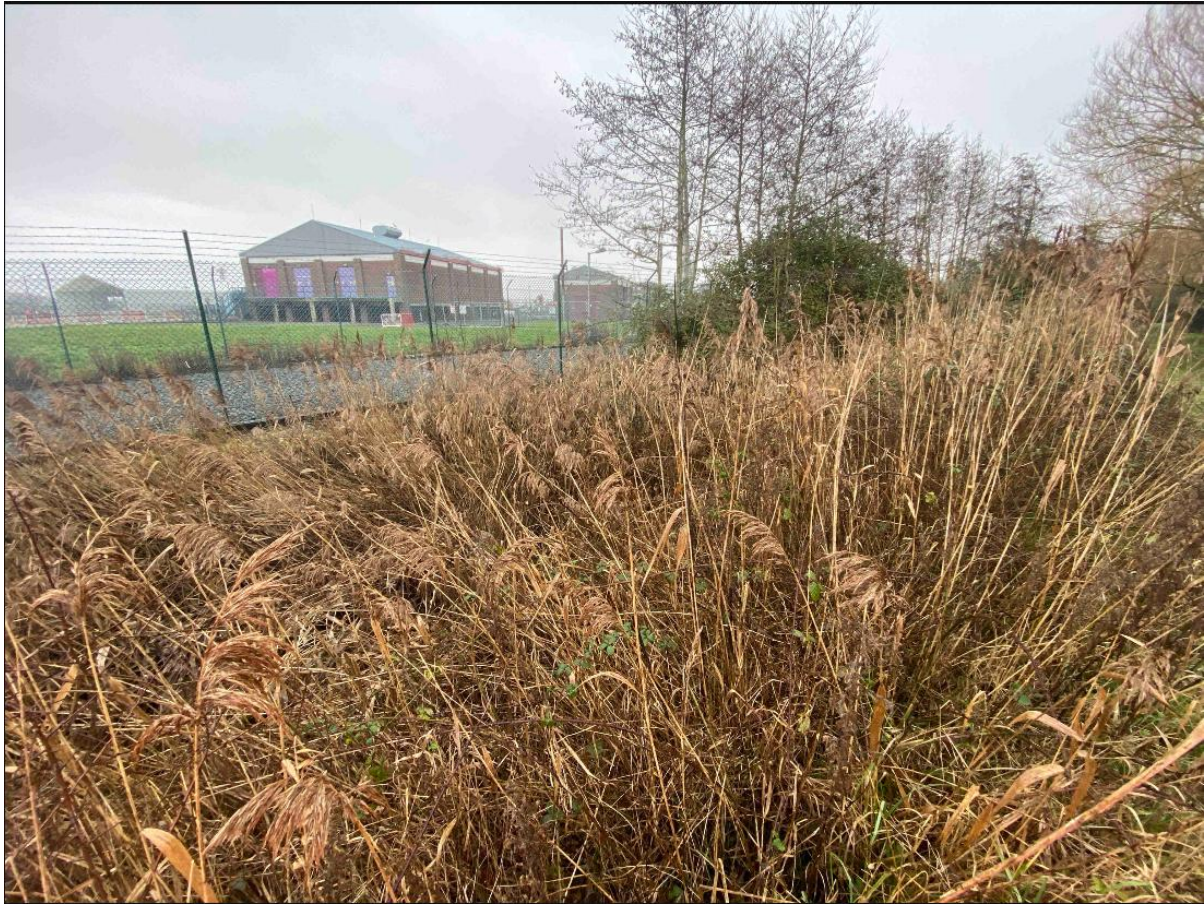
Photograph 8: Location 06: Talacre Brook continued, heavy vegetation with sections that have been piled with cuttings of trees and hedge material. The brook narrows and widens regularly with widths of: ~5.0m to ~2.5m. The depth remains consistent throughout at: ~1.5m. No observable flow. Photo taken facing NNE.

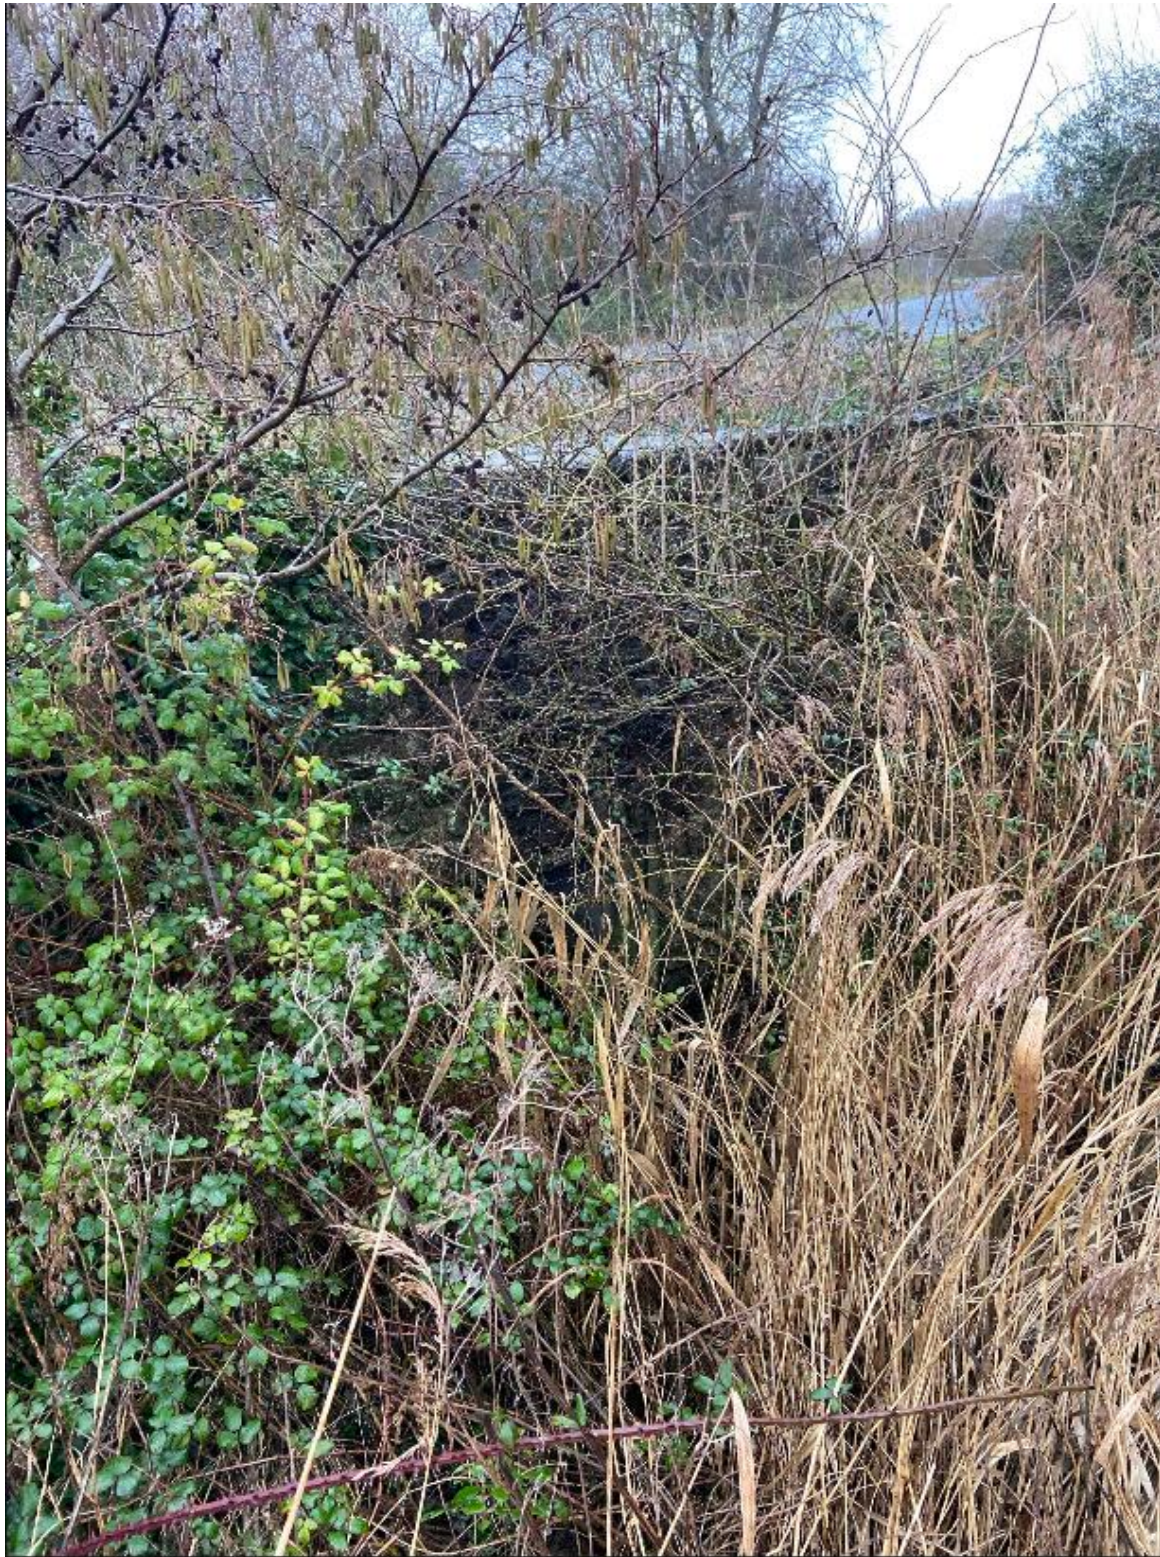
After passing underneath the entrance roadway, the brook continues around the south side of the site where it proceeds underneath a few more culverts with diameters of 0.7 m to 1.8 m. The smaller of these being directly next to the south side of the site (see Figure 5, L07).

Photograph 9: Location 07: Cobblestone culvert underneath historic road. The culvert is a pipe with a diameter of 0.7m. At this point Talacre brook is ~6.0m wide and ~2.0m deep with a low flow present. Difficult to photograph as heavy vegetation completely surrounding. Photo taken facing east.

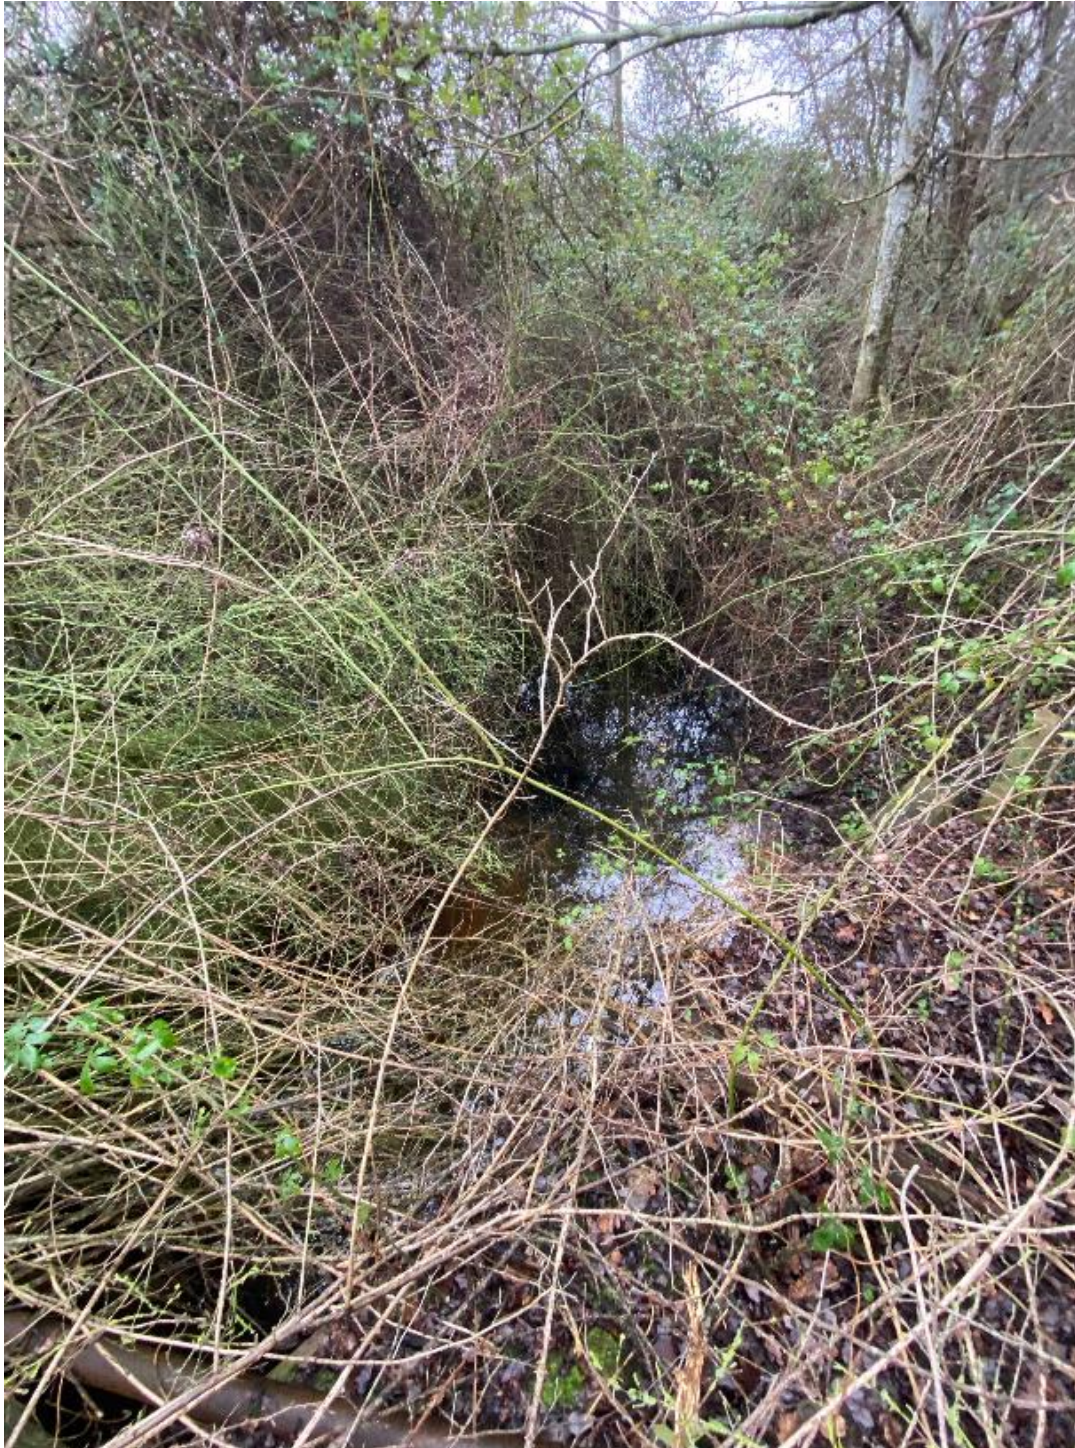
Photograph 10: Location 08: Talacre Brook meandering south due to concrete construction walls diverting it underneath a road via another culvert with a pipe (diameter 1.8m). The brook is ~6.5m wide and ~2.5m deep at this point. Photo taken facing north.

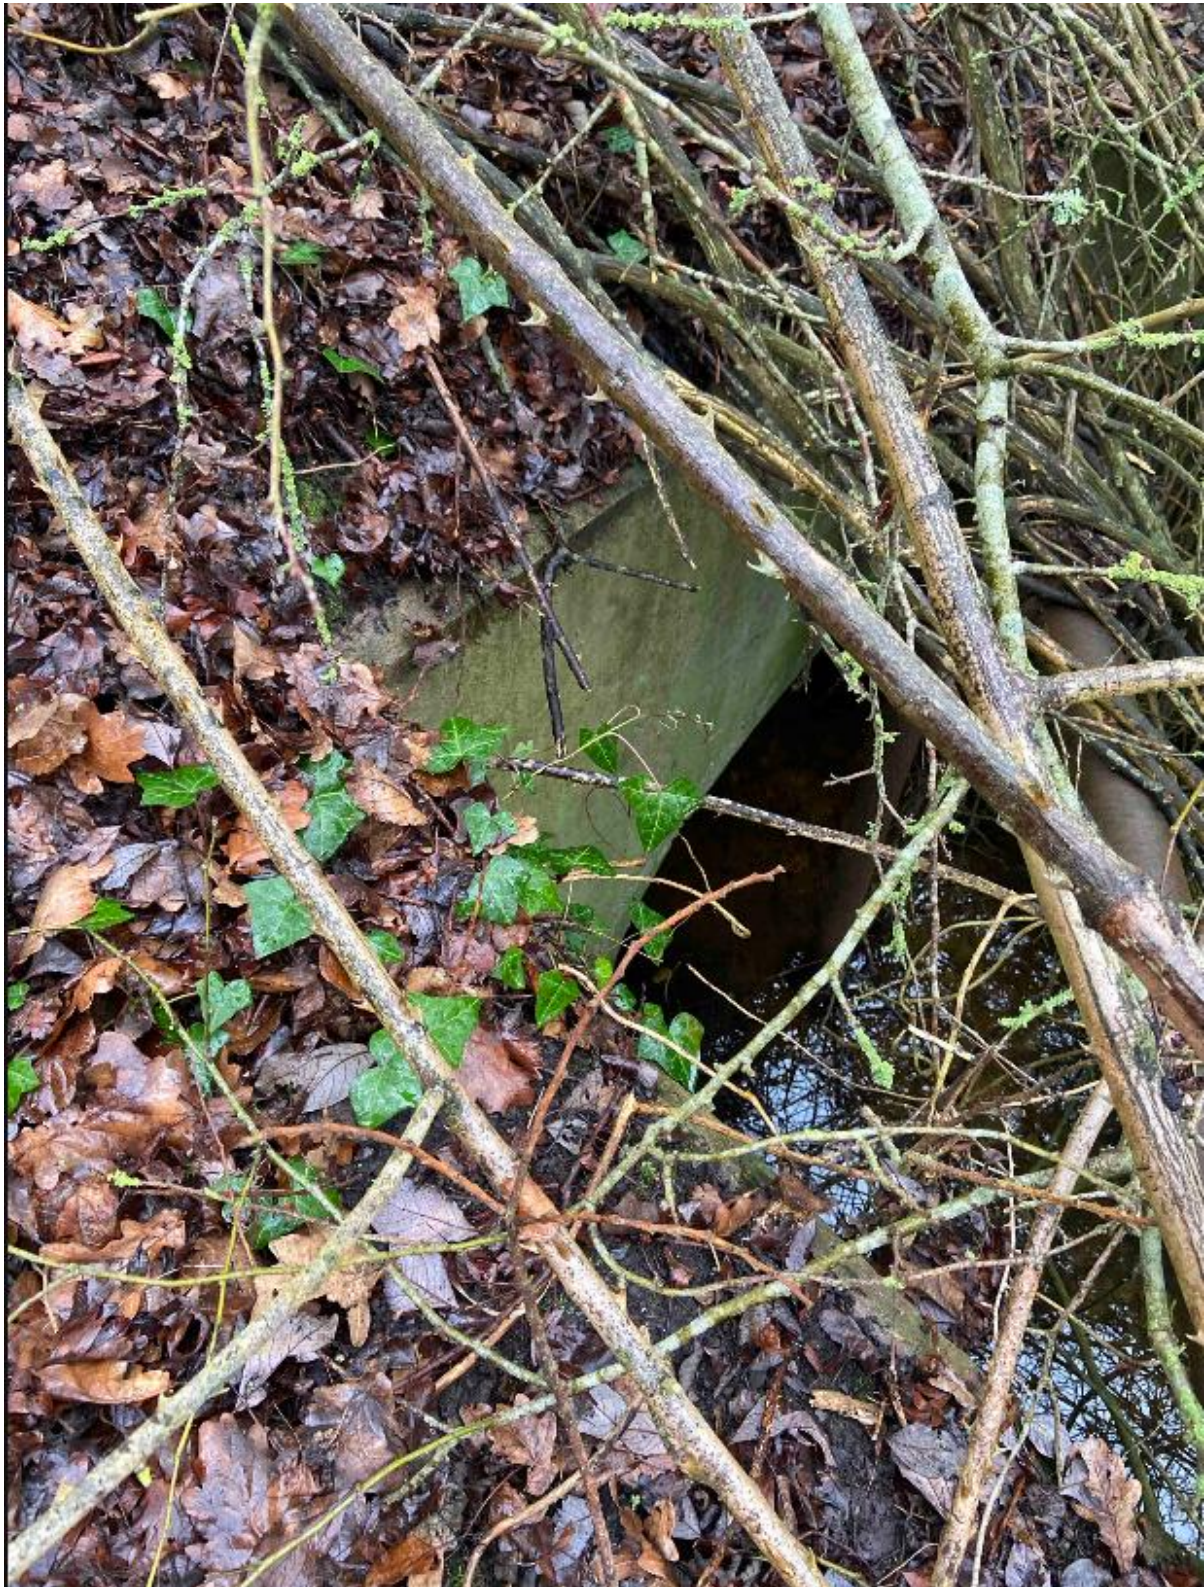
Photograph 11: Location 08: Previously mentioned in Photograph 10, this is the second culvert, which is 1.8m diameter.

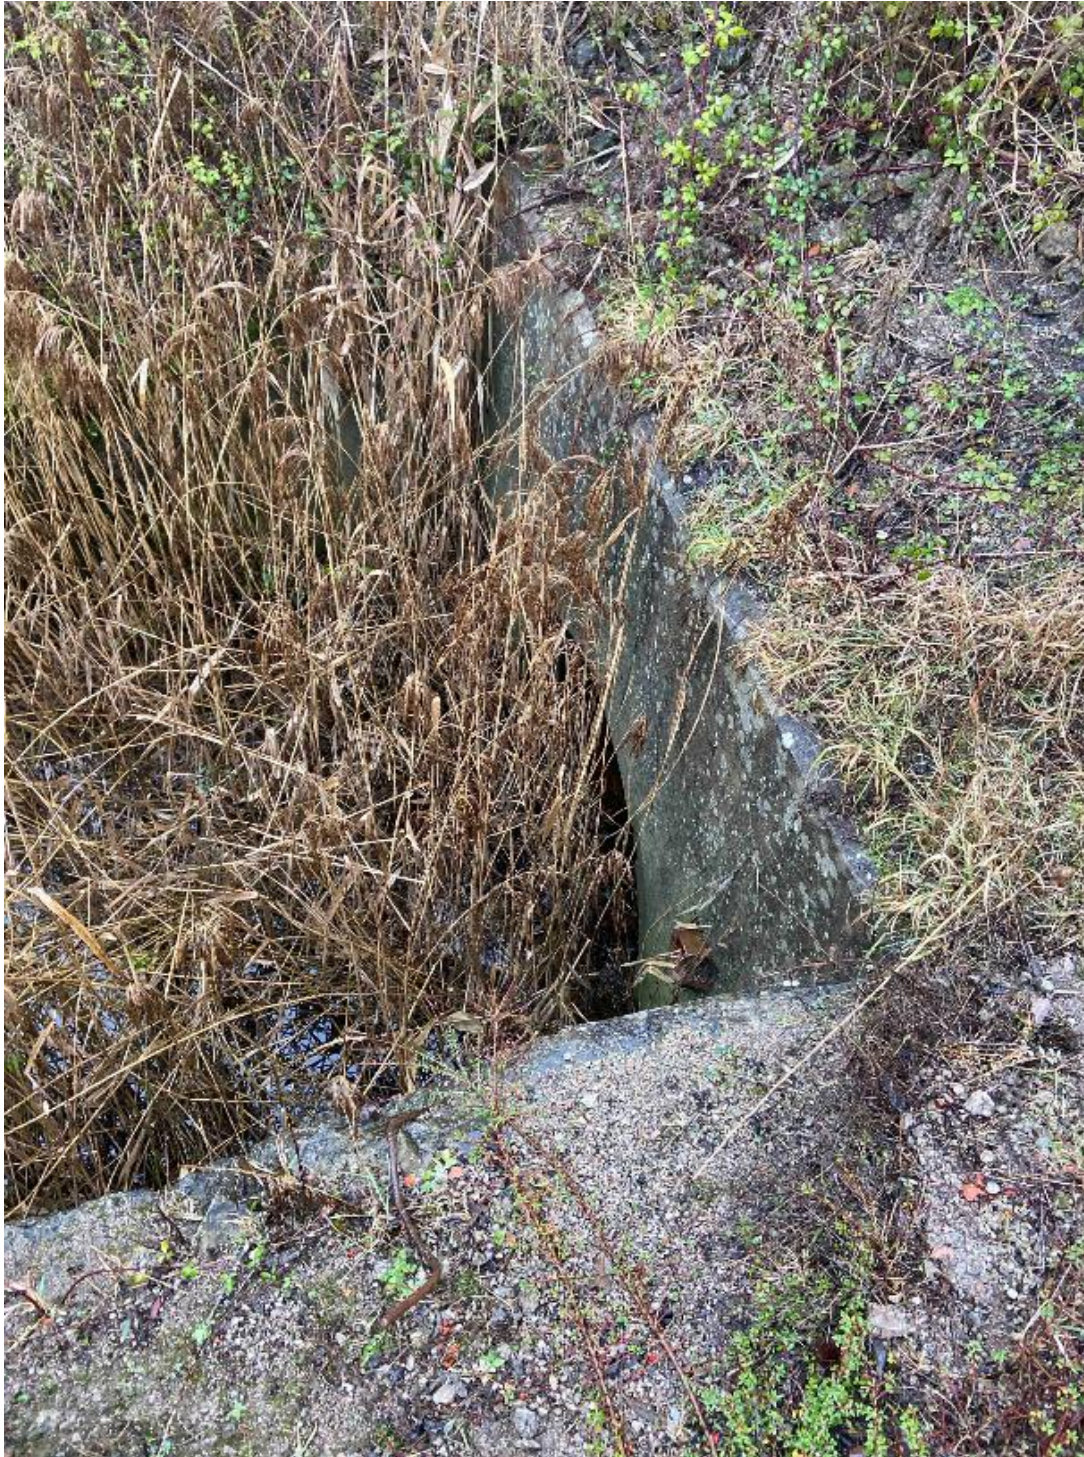
Photograph 12: Location 09: Outfall from culvert in Photograph 11, still with a diameter of 1.8m. The brook is built into a concrete channel here with a width of ~4.0m and a depth of ~2.5m. The brook then is directed into a drainage pipe that travels entirely underneath the old colliery, this pipe has a diameter of 1.5m at this entrance.

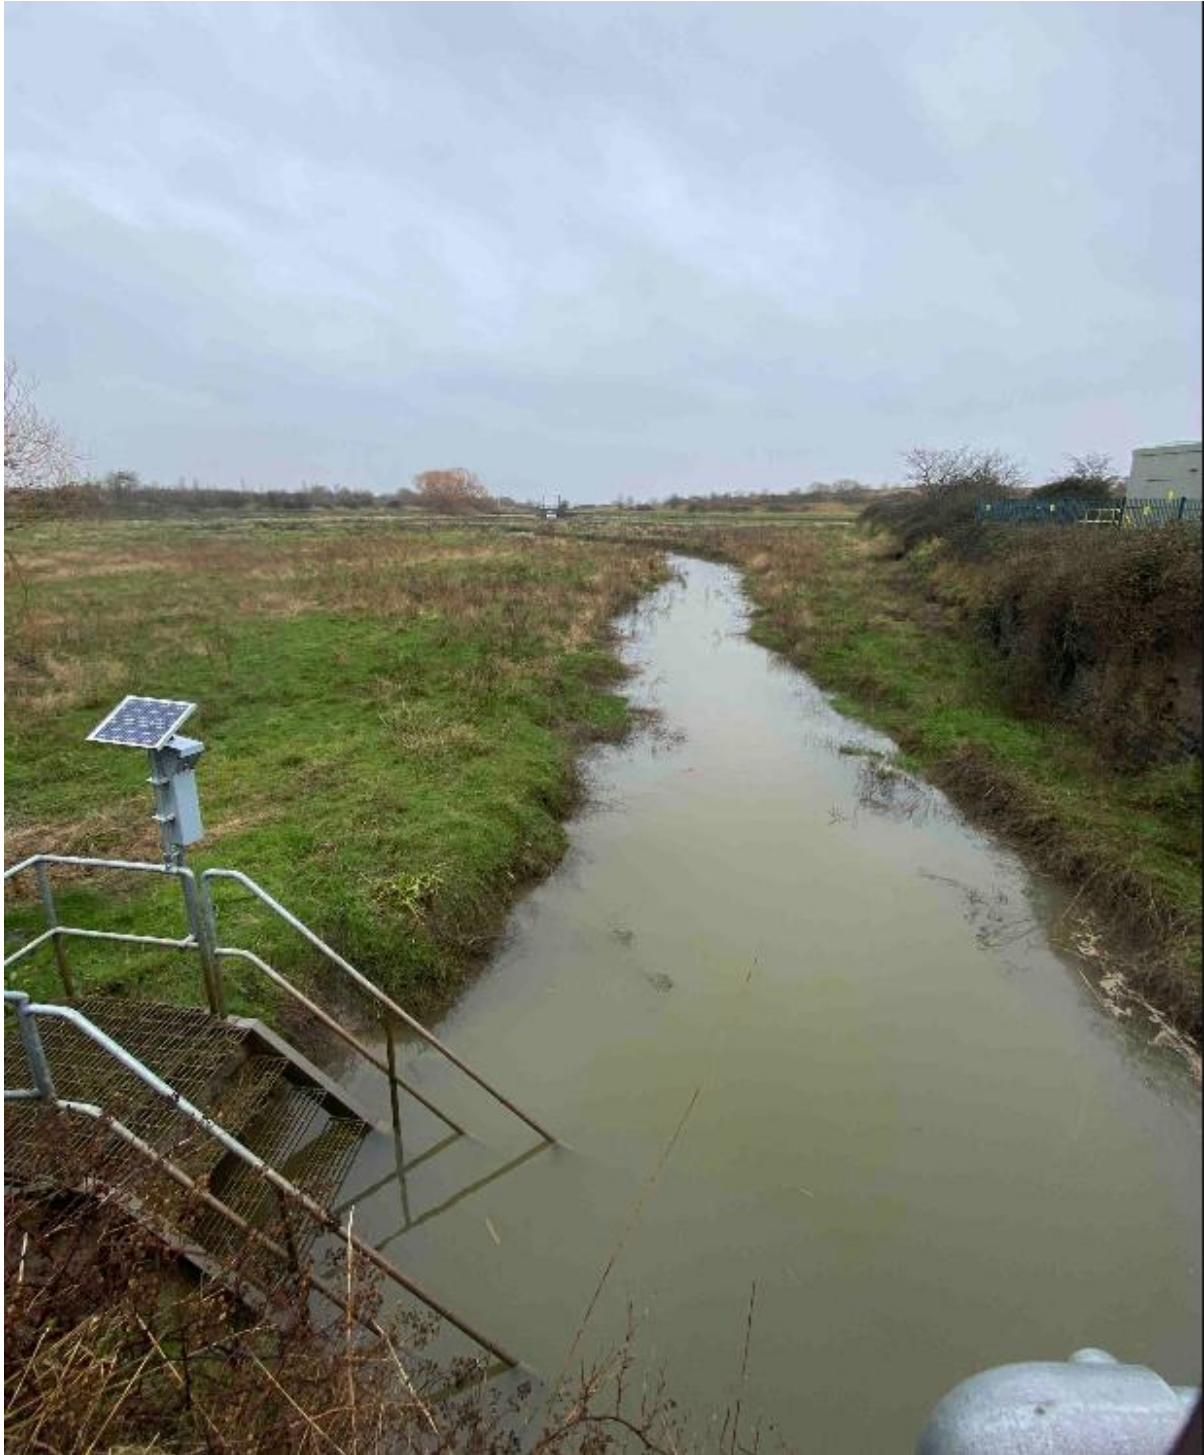
Photograph 14: Location 10: View of the outflow past the sluice gate from the lagoon. Channel is ~3.0m wide and ~1.2m deep. Photo taken facing East.

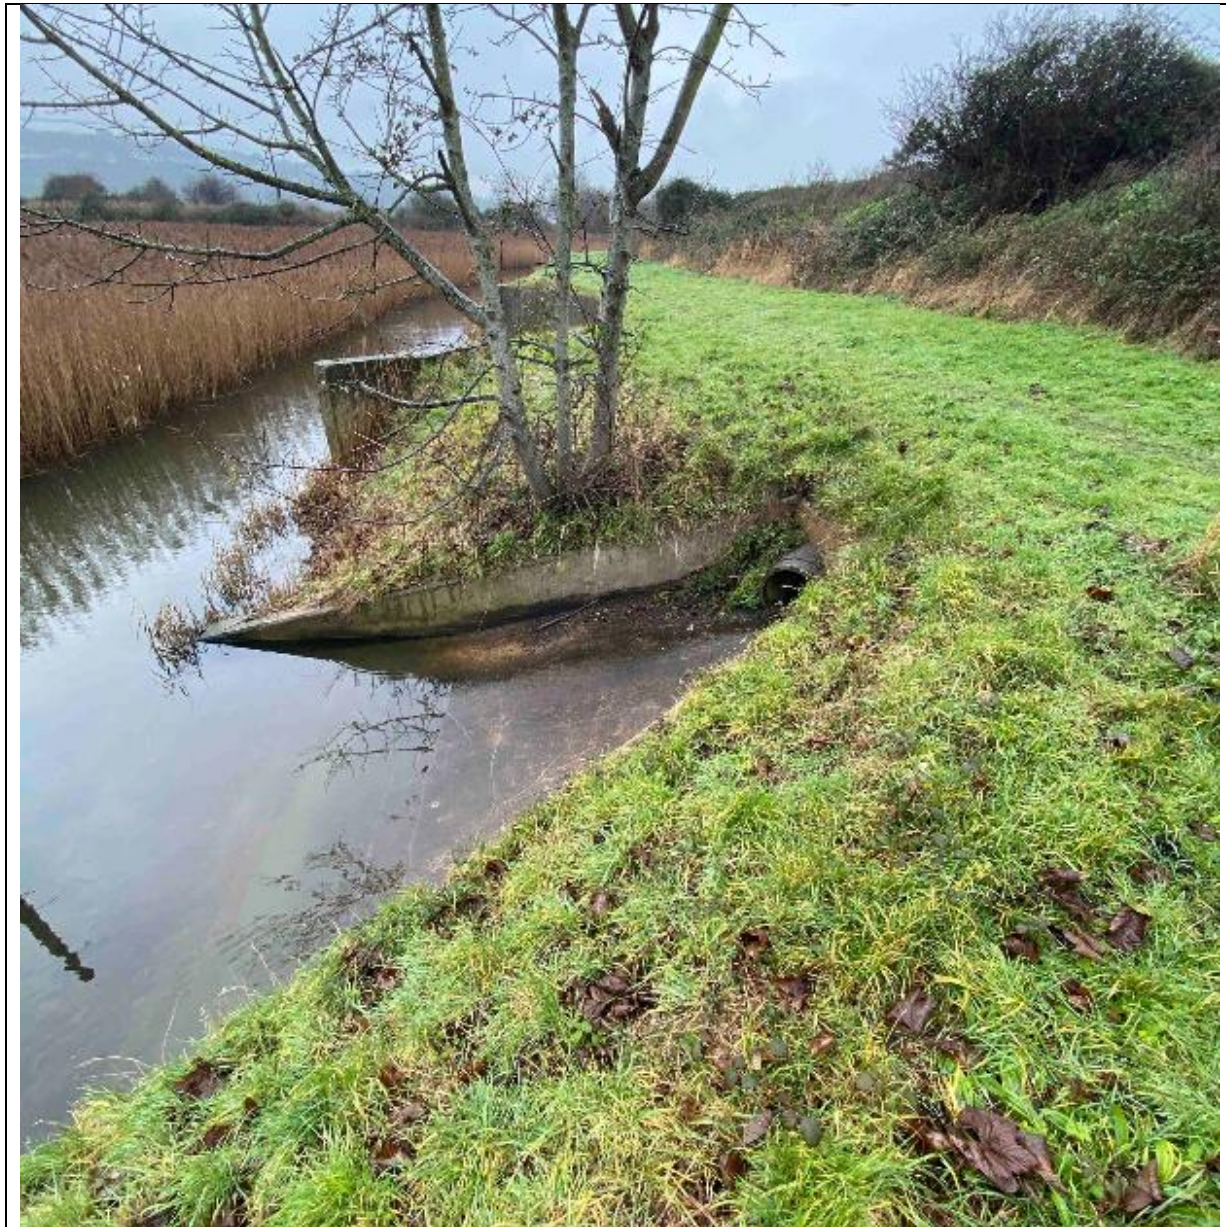
Photograph 16: Location 11: Discharge pipe outflowing to the lagoon, 450mm diameter pipe. No flow visible.

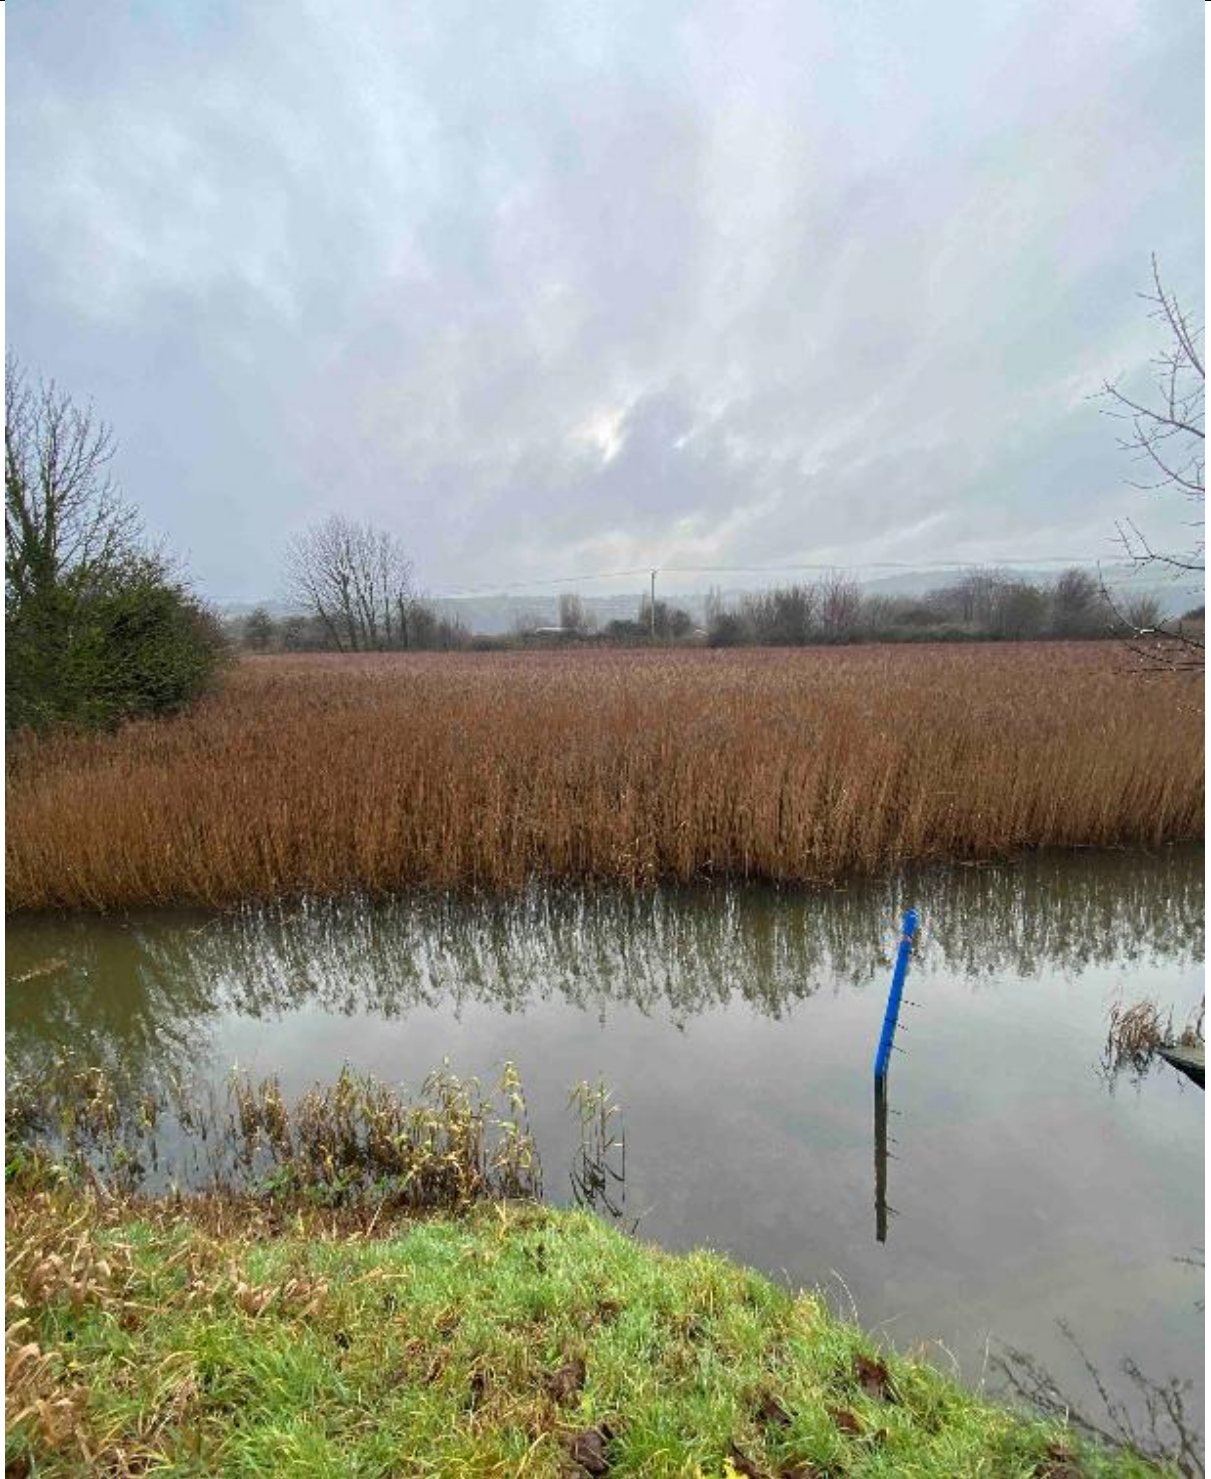
Photograph 17: Location 11: Fenland lagoon with reed vegetation, no flow observed. Photo taken facing South.
