SWL24-380-01-WFS-02

**Point of Ayr Gas Terminal:
Water Features Survey**

Rev	Date	Description	Prepared by:	Approved by:
P01	30.01.2026	Initial Submission	George West	Mark Pickett
P02	10.02.2026	Update after Client comments	George West	Mark Pickett

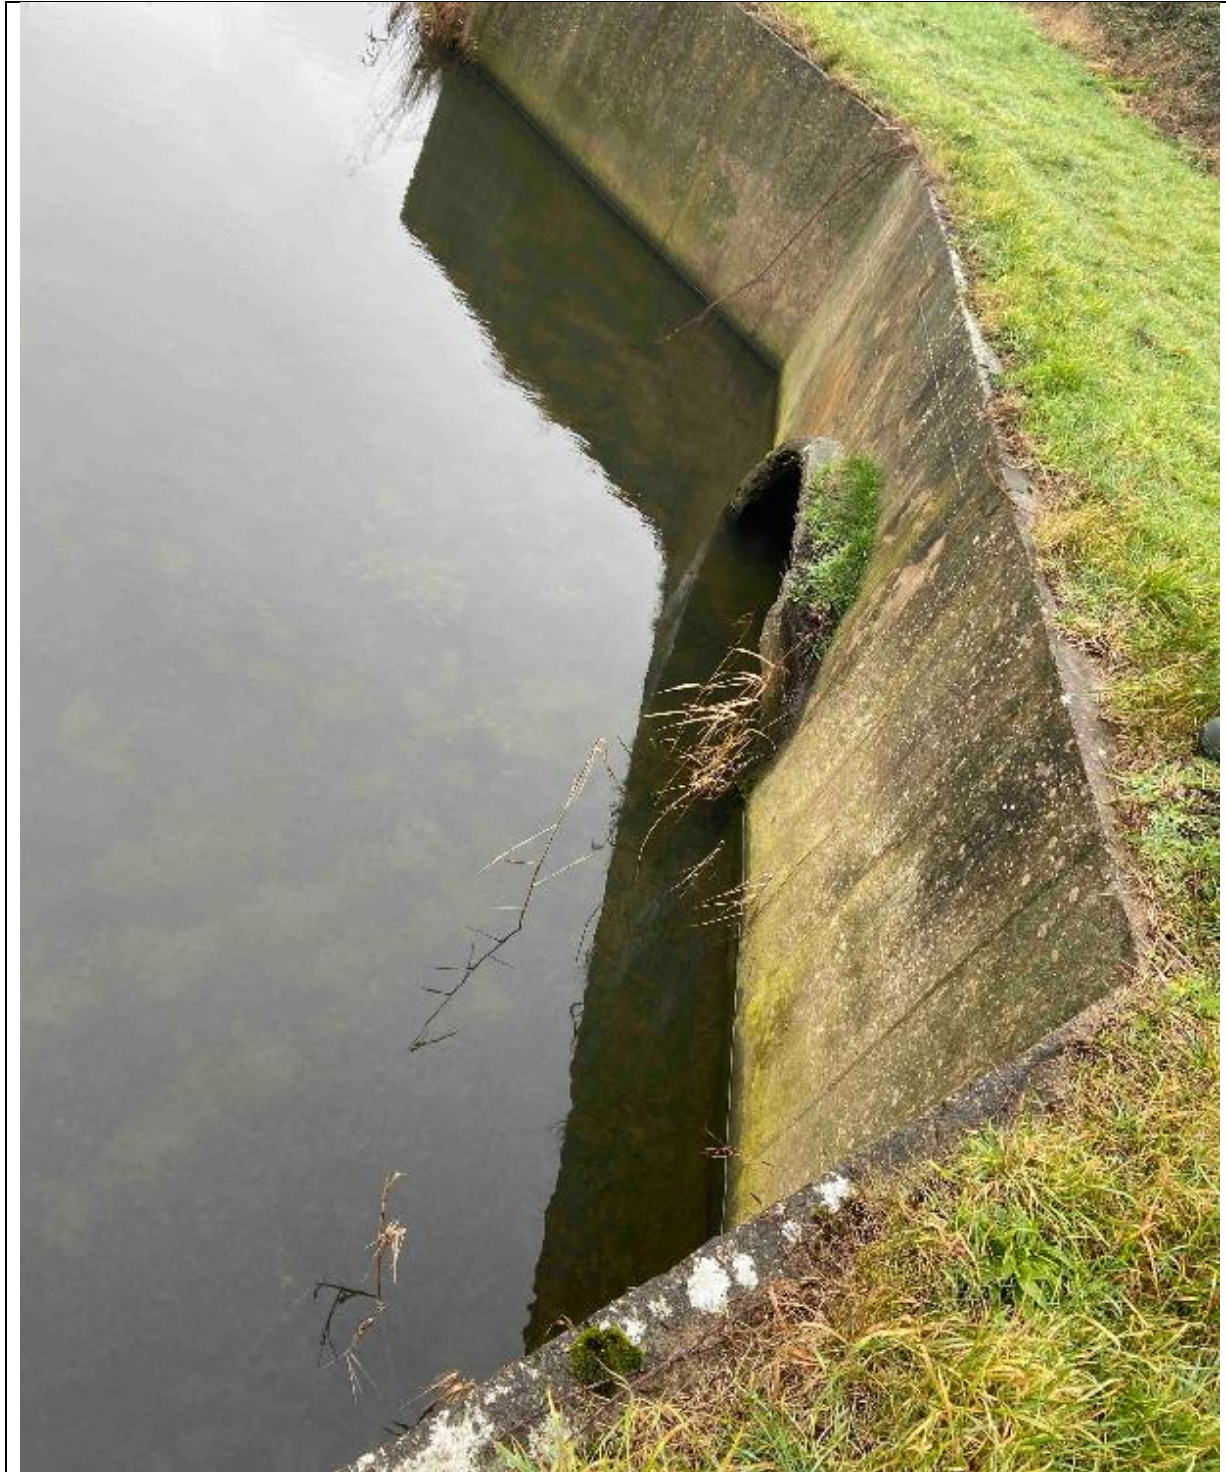
Photograph 18: Location 11: Discharge pipe to lagoon area with a diameter 1.8m, no flow visible.

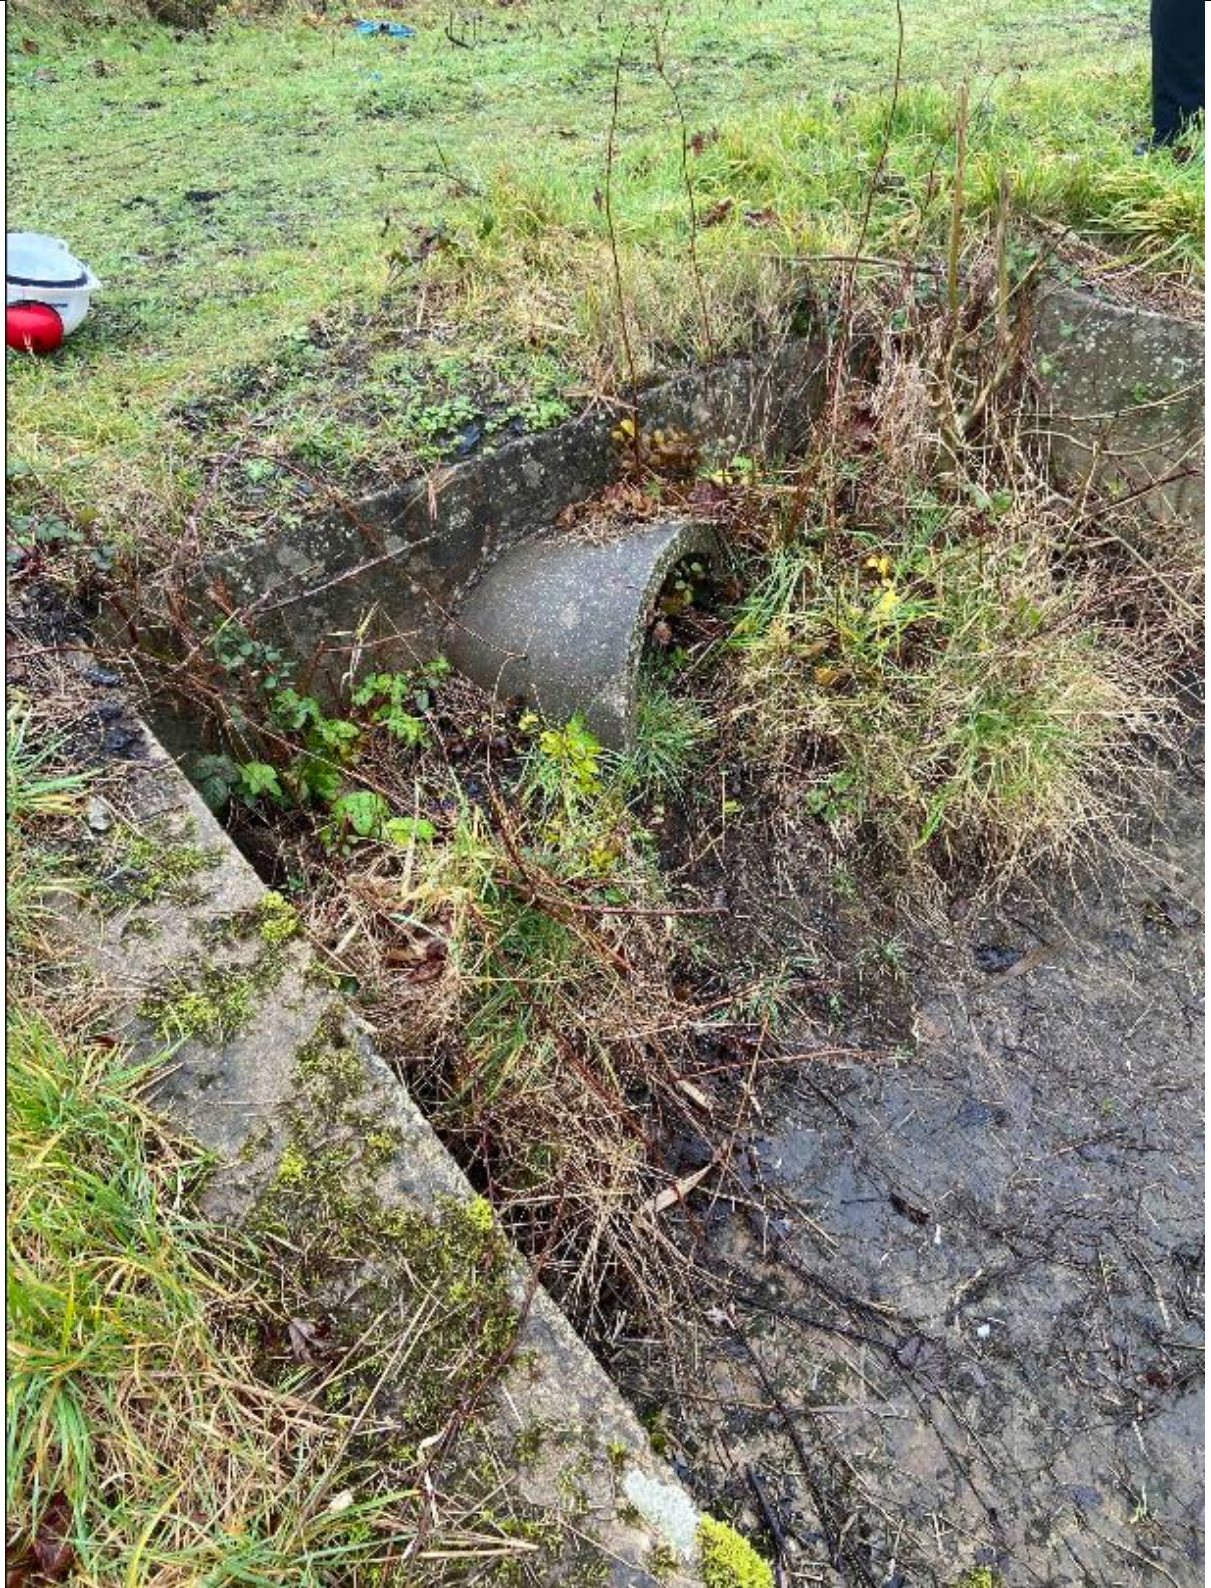
Photograph 19: Location 12: Discharge pipe for Talacre Brook, pipe 0.5m diameter. Covered with vegetation but still very slow flow visible.

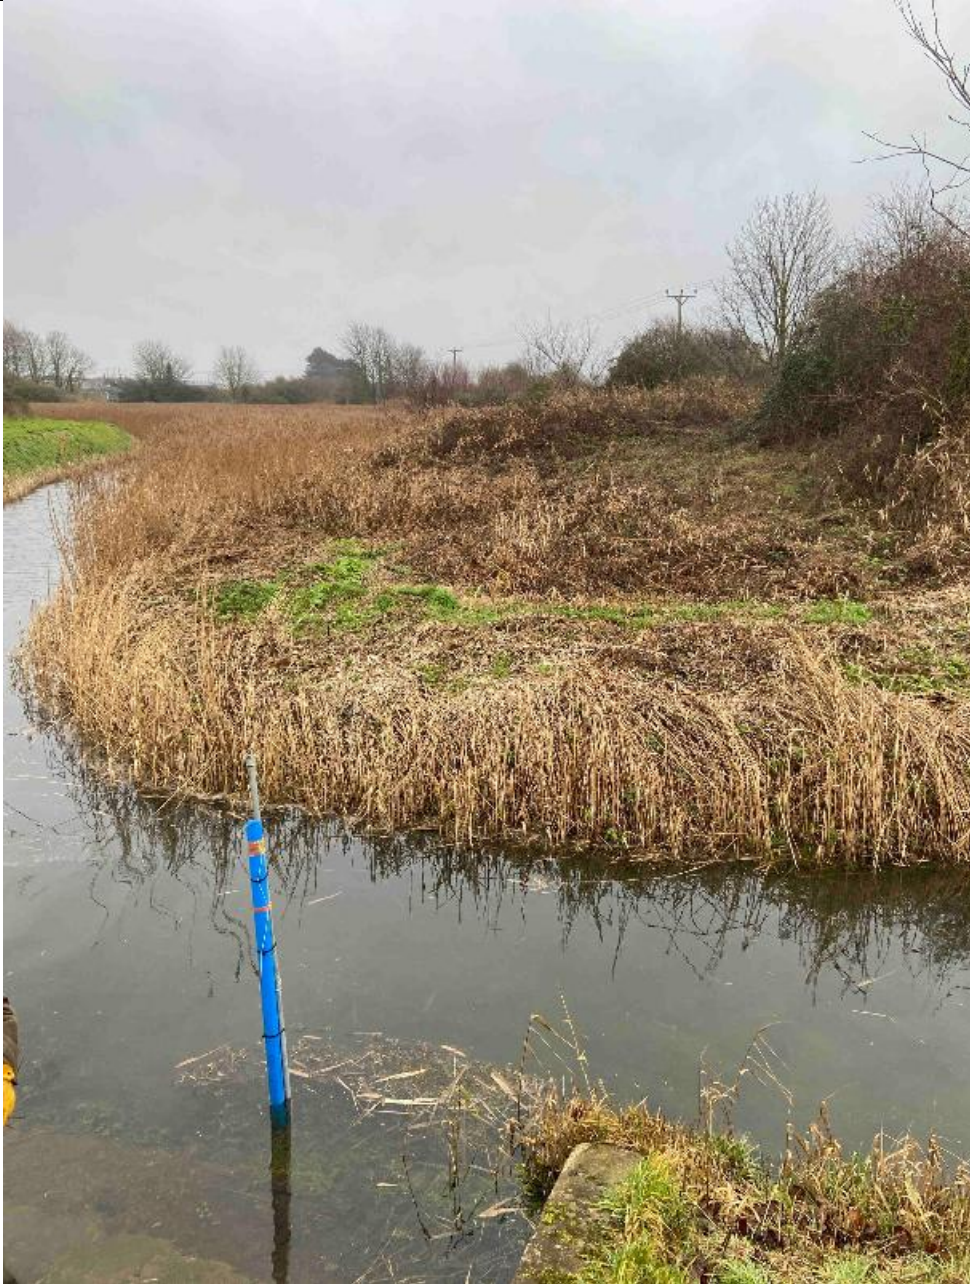
Photograph 20: Location 12: View of lagoon from the bank. This is the west end of the lagoon, where it narrows to a ditch which is ~3.0m wide and ~1.7m deep.

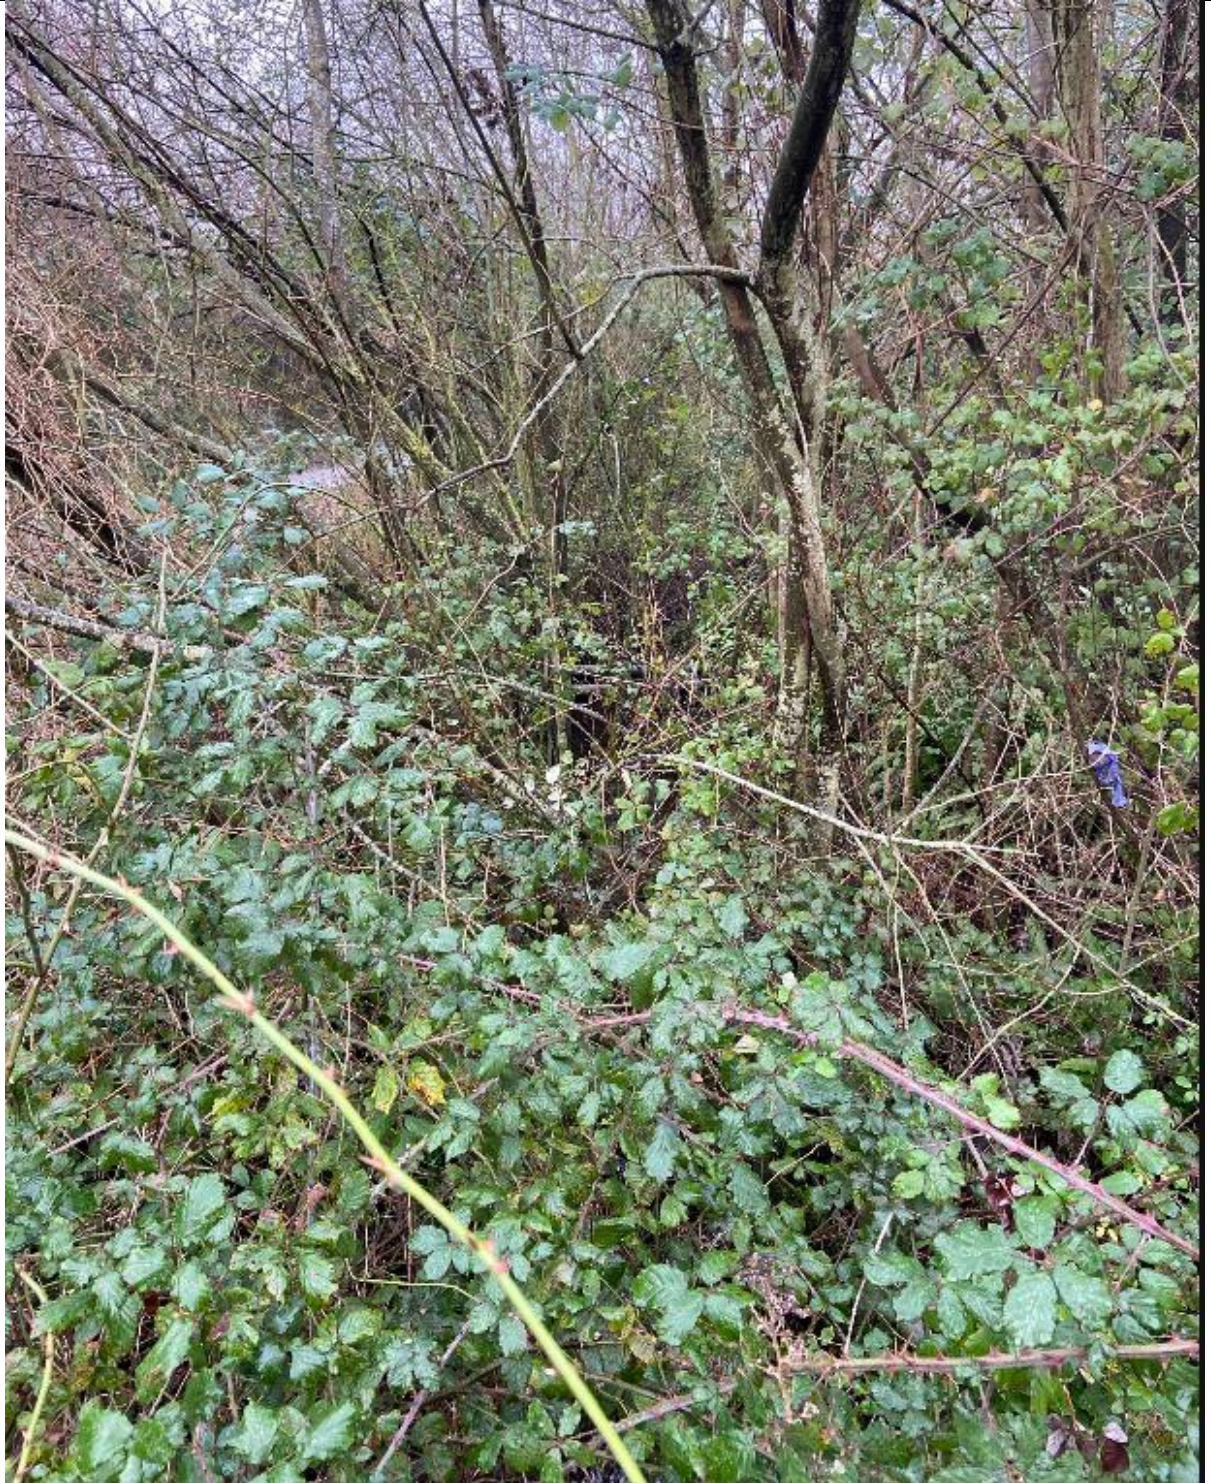
Feature(s)	Photograph ID	Notes	Action
	21, 22	Locations L13 and L14 Running parallel to Talacre Brook a little further south there is a drainage ditch that acts as the main drainage system for the gas terminals external car park. It measured approximately 2.0 m wide and 1.5 m deep. It is connected to Talacre Brook and discharges to the local lagoon.	none
	N/A	North of the site lie a couple ponds, one of which can be seen feeding Talacre Brook, however due to the flat landscape the flowrate is extremely slow. Back flow from the discharge of water is less of a concern as the brook has been observed flowing the opposite direction and due to the volume of the pond and the dimensions of the banks it is not a concern.	none
Springs	N/A	No springs were identified during the desk study or observed during site walkovers.	none
Conservation Sites	N/A	The desk study determined the site is not within a Special Scientific Interest (SSSI) zone or a Special Areas of Conservation (SAC). However, the immediate surrounding area is a SSSI so any discharged water cannot include pollutants and must be completely clean.	Water treatment prior to discharge

Photograph 21: Location 13: Overgrown drainage ditch acting as main drainage for the gas terminal exterior car park. Photo taken facing East.

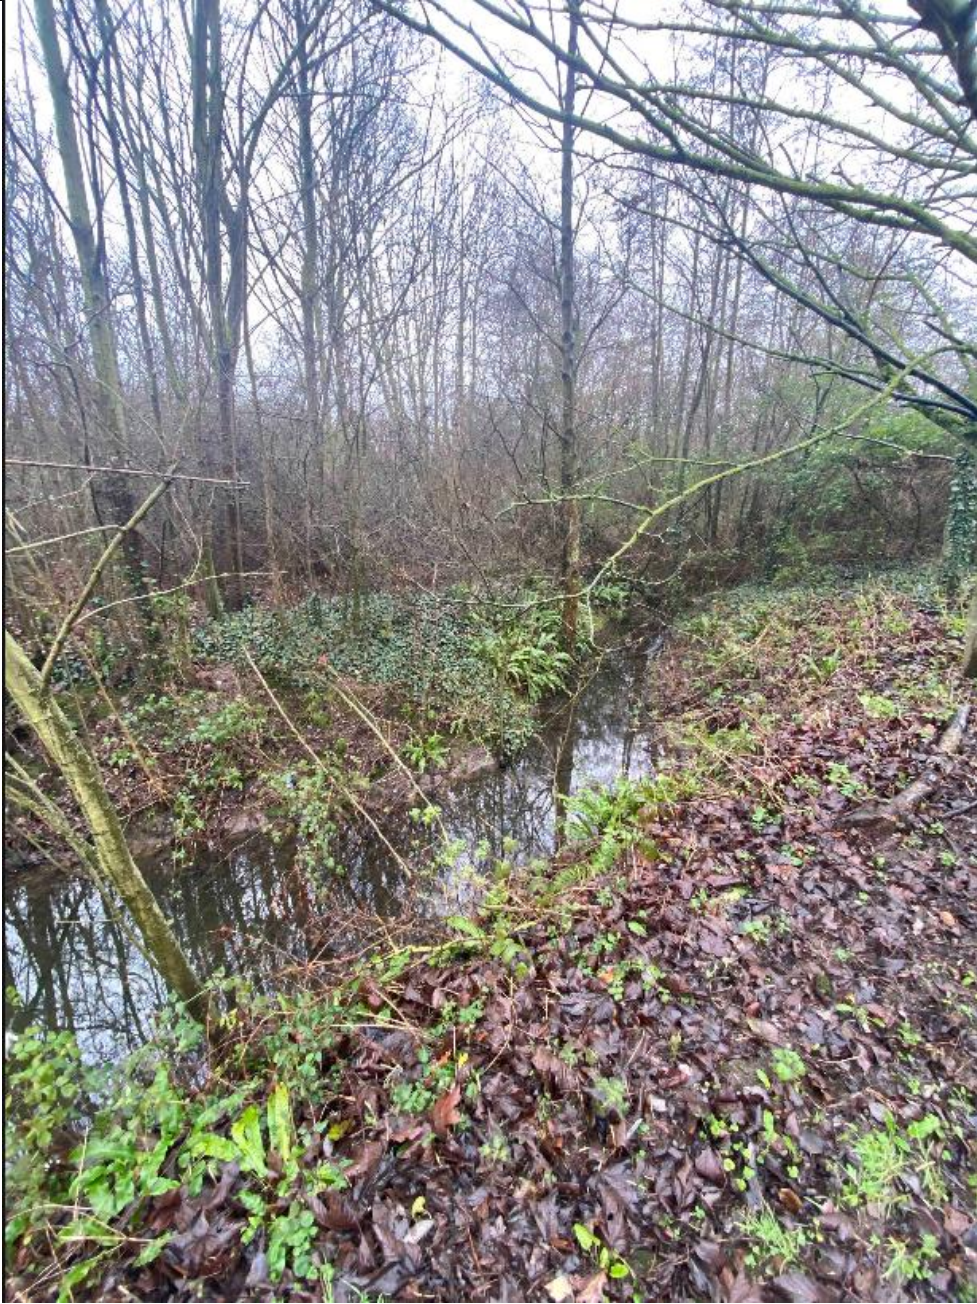
Photograph 22: Location 14: The same drainage ditch as previous location, no flow visible. Width of ~2.0m and depth of ~1.5m.
