## Compliance Assessment Report CAR\_NRW0050242

**Permit being assessed:** EP3698FL.

**For:** Nantycaws H C I Transfer & Treatment Facility, **held by:** CWM Environmental Ltd

**Type of assessment:** Site Inspection,

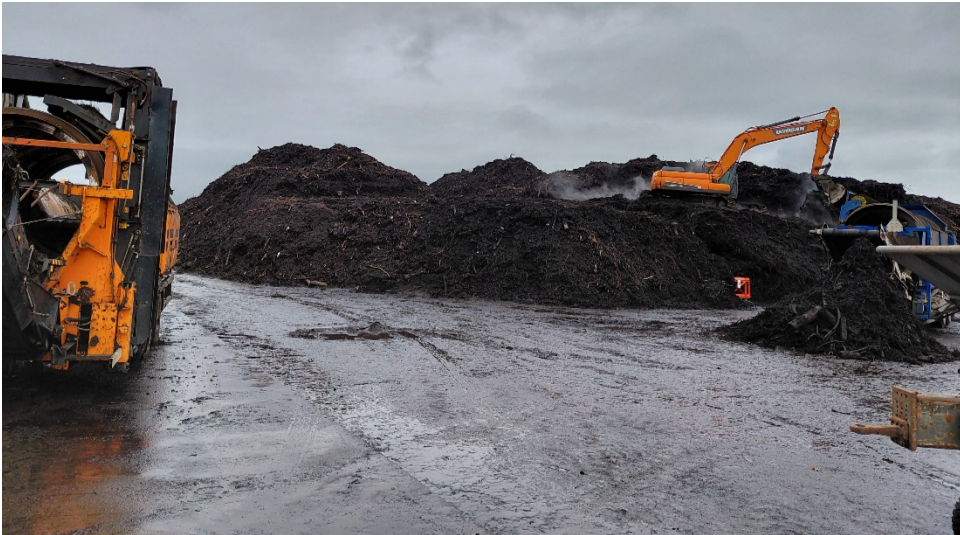
We acknowledge the significant progress made in reducing the green waste stockpile. However, full compliance with permit conditions regarding stockpile size and location has not yet been achieved. The site remains in breach of its permit and has not fulfilled the requirements of the Regulation 36 Notice, which expired on 31st October 2025. (Location shown on map below demarked by the purple arrow).

- Old Green Waste Stockpile:
  - Being split into 6 sections with firebreaks installed.
  - Height reduced to approx. 5m at the front; rear remains approx. 10m high.

*Figure 1 Photo showing large old green waste stockpile being reduced in height.*

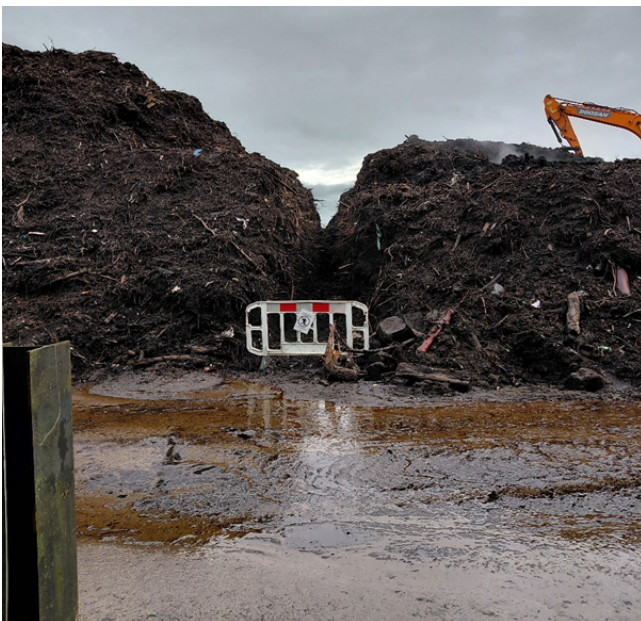
*Figure 2 Photo showing large old green waste stockpile being divided into rows.*

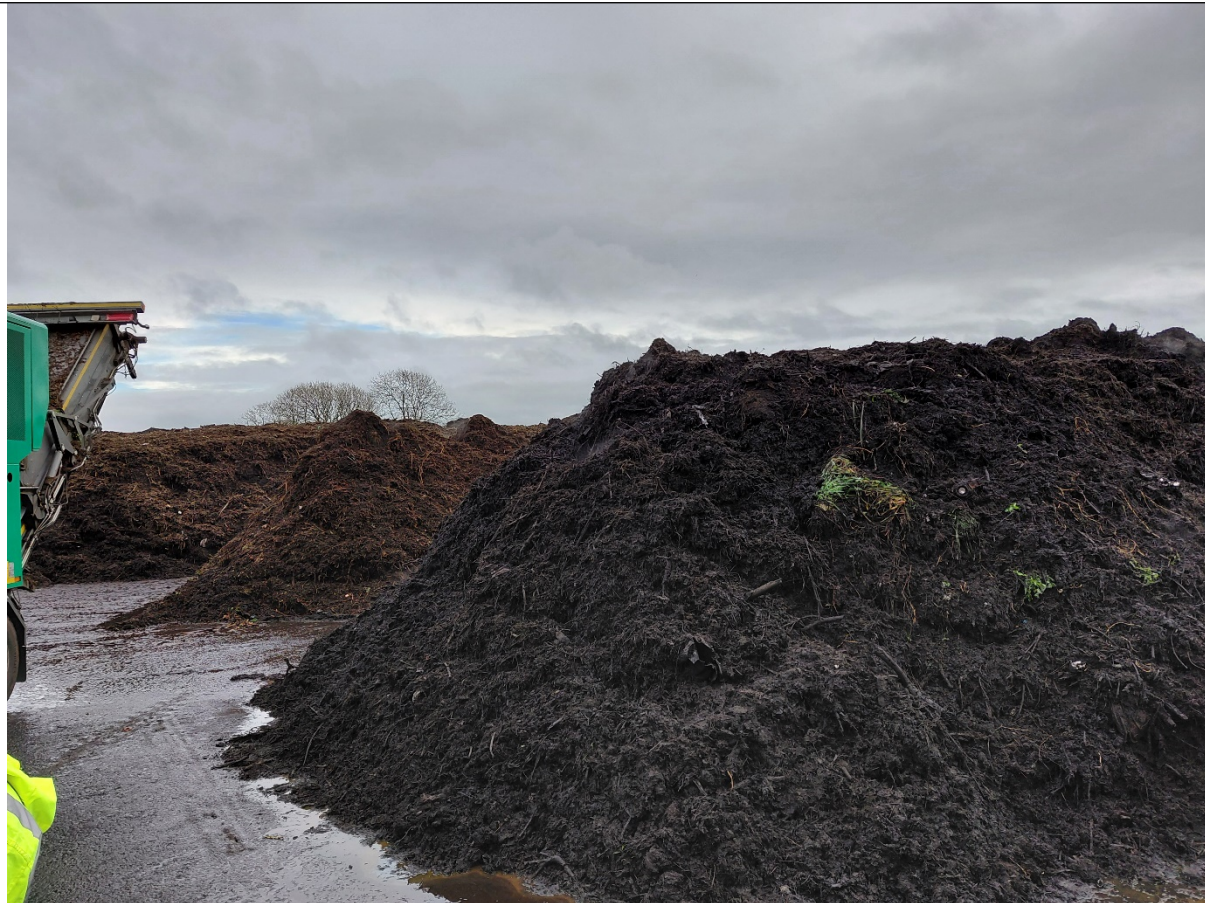
*Figure 3 Photo showing active windrows.*

Additionally, it was observed that the larger active windrow appeared to protrude past the concrete hardstanding. This is a cause for concern, as it presents a potential pathway for pollution to bypass the purpose-made sealed drainage system, undermining the site's containment infrastructure.

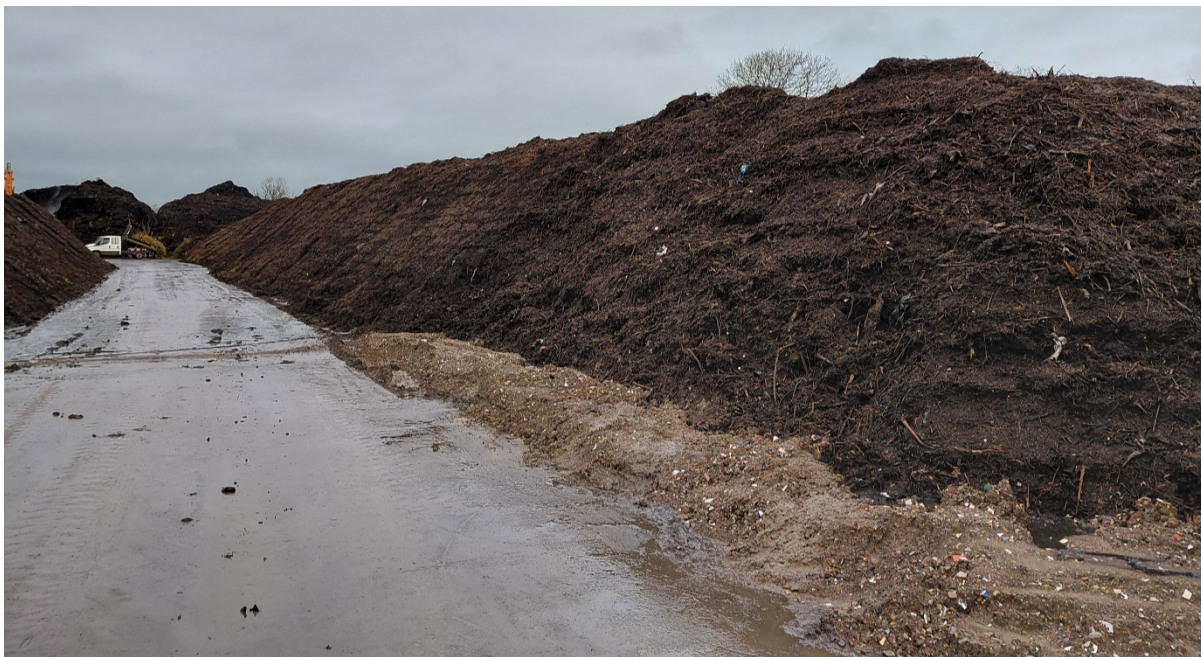
The operator stated that a concrete bump and bunding had recently been installed to divert runoff back toward the drainage system. However, this feature appeared inadequate and not fit for purpose, as it did not provide sufficient containment or diversion to ensure effective pollution control. (Location shown on map below demarked by the black arrow).

*Figure 4 Photo showing concrete bump and bunding to base of longest windrow.*

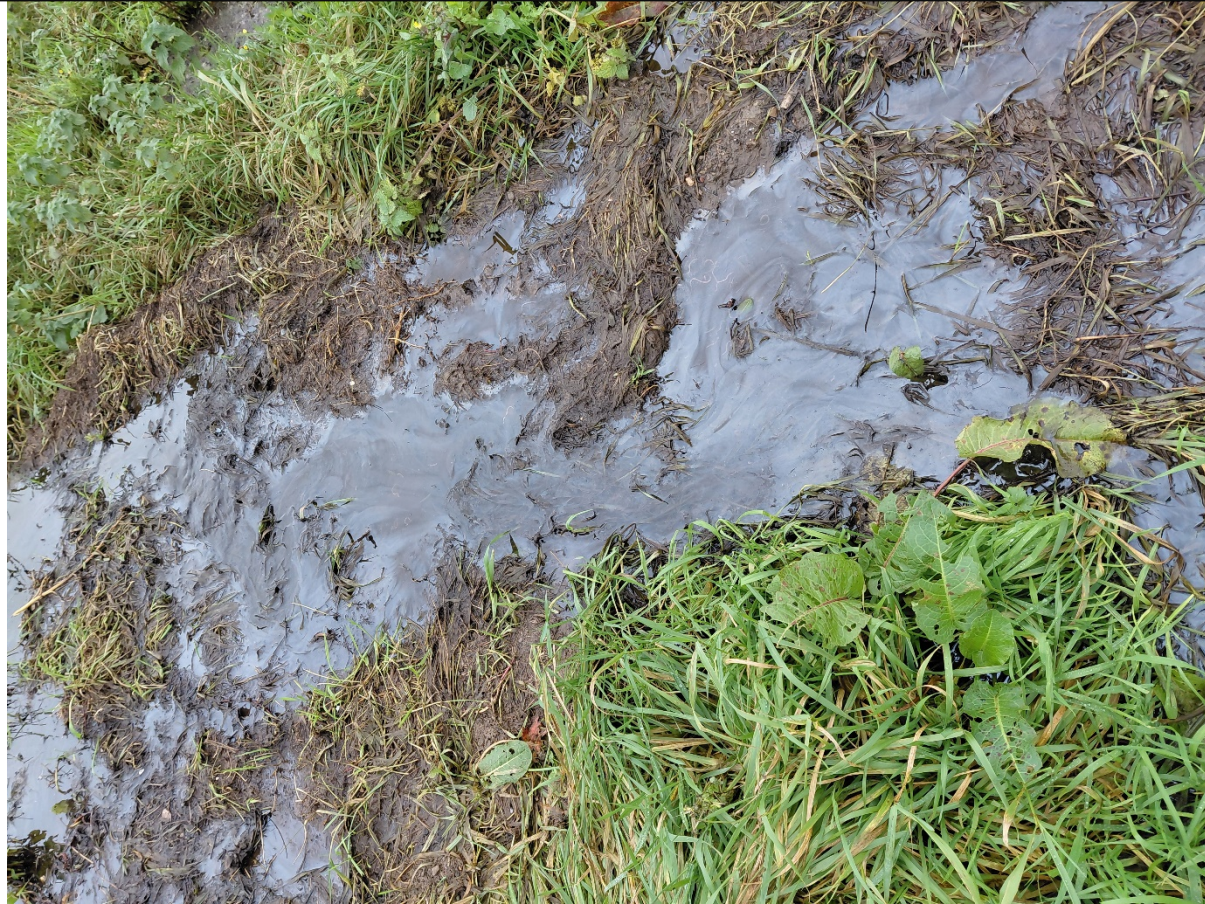
During the inspection, the soft ground surrounding the concrete pad was found to be saturated, with visible signs of water pooling. Notably, the pooled water exhibited a visible sheen, further increasing concerns regarding potential contamination. This level of saturation indicates that surface water is not effectively reaching the designated drainage system as intended by the site design. This raises concerns about the potential for pollution to migrate beyond the permitted site boundary. Additionally, the waterlogged ground conditions could hinder access for emergency response, including firefighting equipment. The visit followed after a period of heavy rainfall, which may have contributed to the observed conditions.

*Figure 5 Photo showing saturate ground surrounding the concrete pad. Water had a visible sheen.*

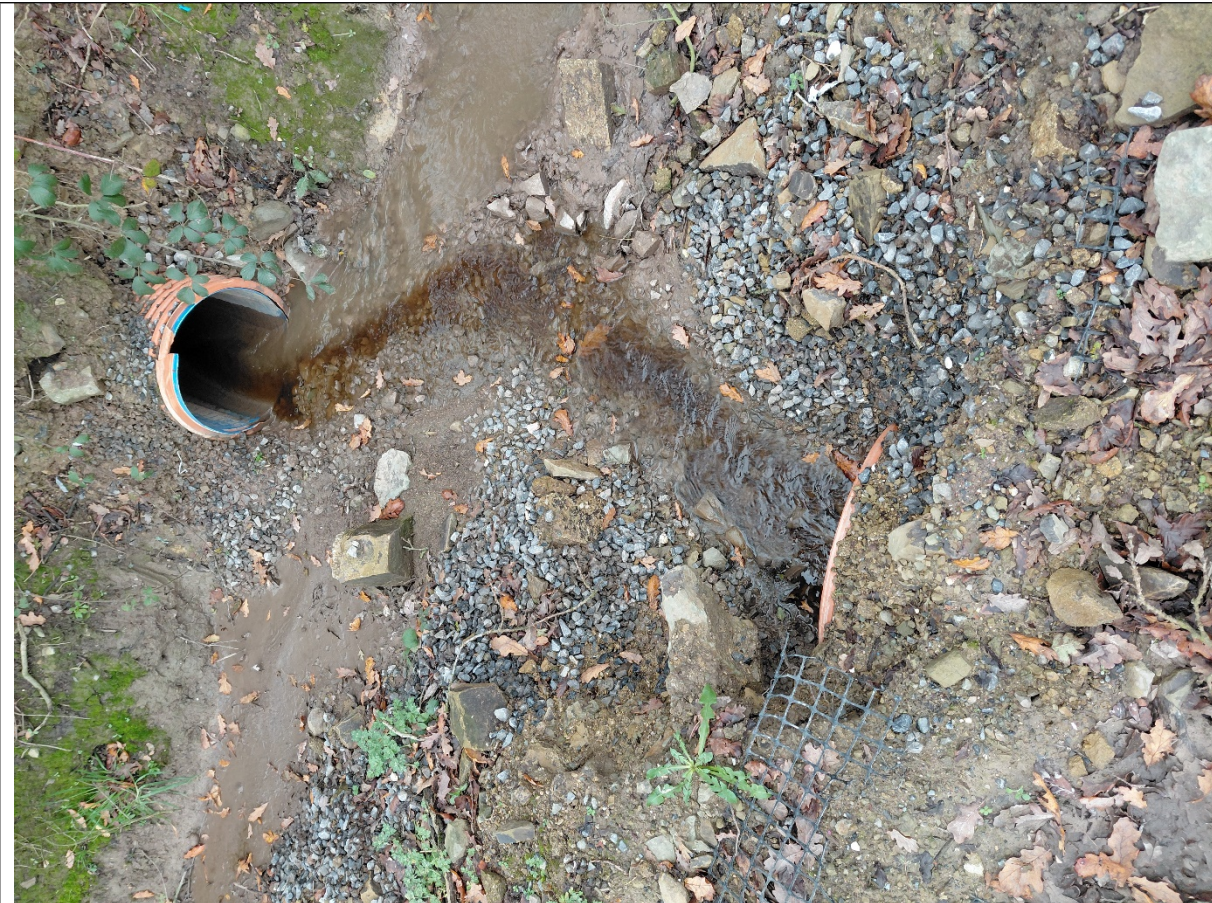
A pipe was observed emerging from under the newly constructed access road, and appearing to come from the direction of the lagoon adjacent to the compost facility. (This is denoted on the map below shown by the red arrow). The pipe was discharging very dark brown/black water into an open stream that tracked alongside to the landfill that was clearly distinguishable from the clear surface water in the drainage stream. Our understanding is that this stream is not included within the site's contained drainage system and may discharge to the local water course.

Figure 6 Photo showing unknown liquid discharging into open stream.

- Confirm the source of the discharge.
- Clarify the purpose of the pipe and destination of flow.
- Take immediate action to stop and prevent further contaminated discharges.

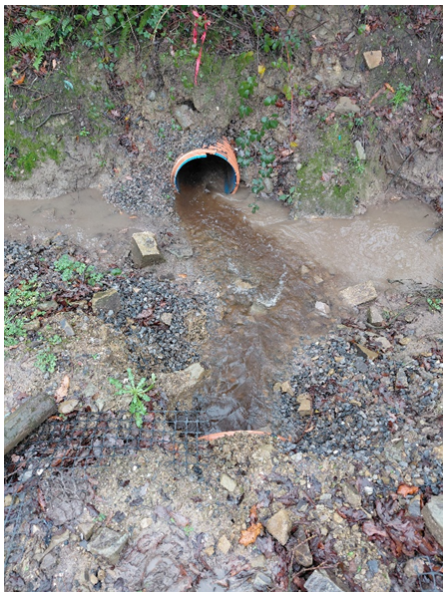
NRW attended the site on 12/11/2025 to collect water samples following concerns as identified on 07/12/25. During the visit NRW observed a failure in the containment bunding of the leachate lagoon for the composting facility. Leachate could be seen tracking through the compromised containment system and discharging into the wider site out of the permitted boundary. It is believed to have then entered what appears to be a land drainage pipe which discharges into a stream on the landfill site (Permit number CP3735PB).

*Figure 7 Photo above showing dark brown/black liquid emerging from pipe adjacent to compost leachate lagoon.*

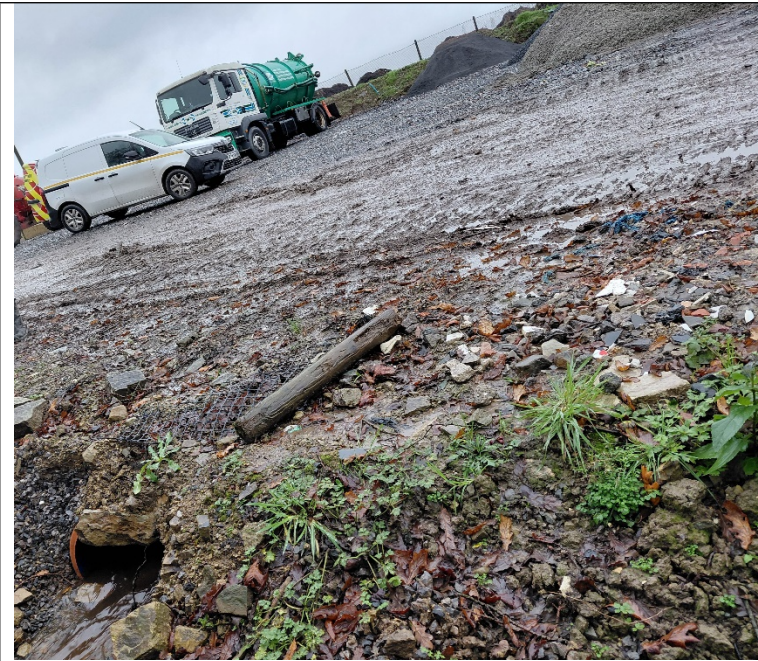
*Figure 8 Photo above showing pipe appears to run from direction of compost leachate lagoon showing in the background.*

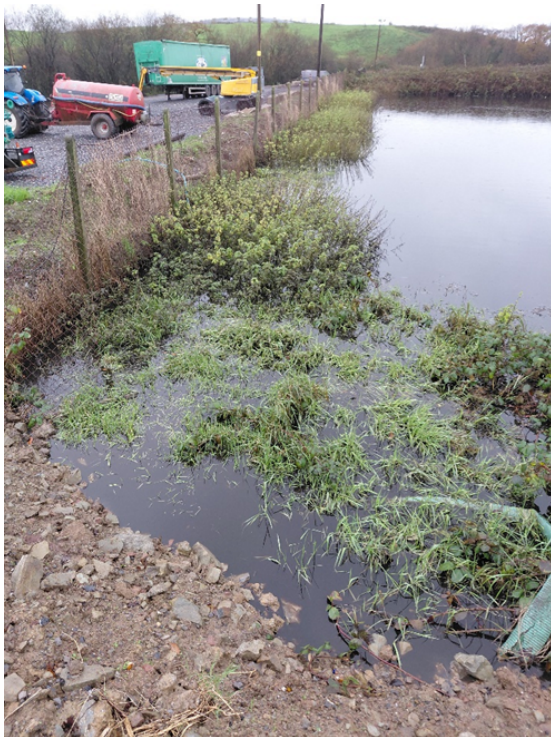
The lagoon water level was also very high, increasing the likelihood of overtopping and placing additional strain on the containment system. These issues indicate that the operator's inspection and monitoring programme is not sufficiently robust.

*Figure 9 Photo above shows very high level of dark brown/black liquid in leachate lagoon.*

Action: Pump down lagoon to safe operating level to prevent overtopping and reduce strain on containment. Providing evidence of pumping records, disposal documentation and before and after photos. Review procedures to account for seasonal variations in rainfall.

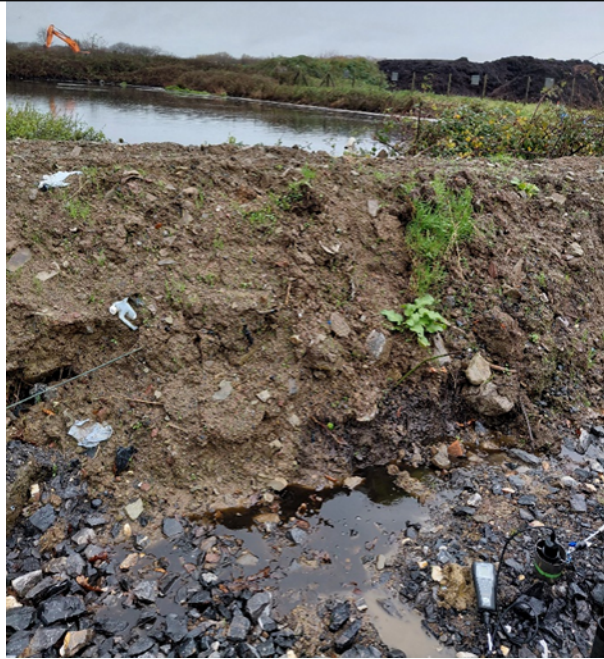
Failure: leachate lagoon containment system has failed.

*Figure 10 photo above shows high leachate level and breach of containment with dark brown/black liquid pooling outside containment.*

Action: Investigate leachate lagoon bund failure and repair compromised sections. Operator to confirm integrity of lagoon containment.

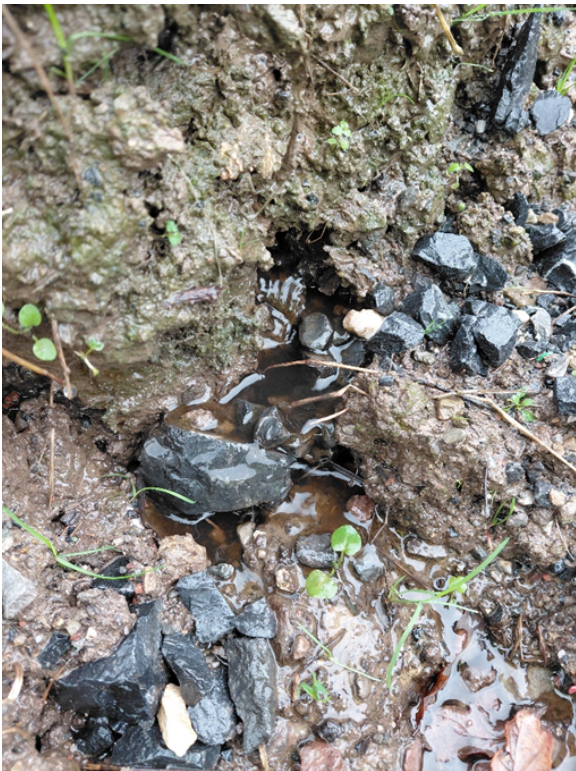
*Figure 11 Photo above shows dark brown/black liquid flowing through leachate lagoon containment.*

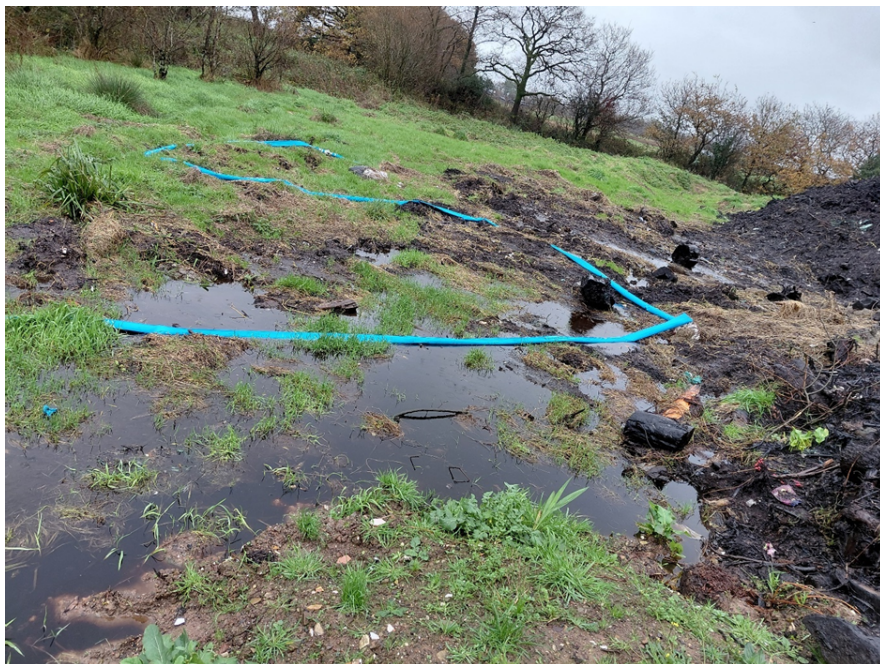
During the visit, the land was found to be highly saturated, indicating a possible failure of the containment system. Pooling of dark brown/black liquid was observed, and this liquid appeared to be flowing beyond the permitted site boundary into an adjacent field. Samples were collected and have been submitted for laboratory analysis. (Location shown on map below demarked by the blue arrow).

*Figure 12 Photo above showing dark brown/black liquid on land adjacent to compost pad.*

**Action:** Implement temporary measures to prevent off-site migration of pooled water (e.g., deploy spill booms/pads for sheen, sandbag bunds, temporary overland channels to designated drainage).

Regrade or hard-surface soft ground adjacent to the pad if required to prevent ponding and ensure positive drainage to the designated system. Install perimeter bunding/kerbs where required.

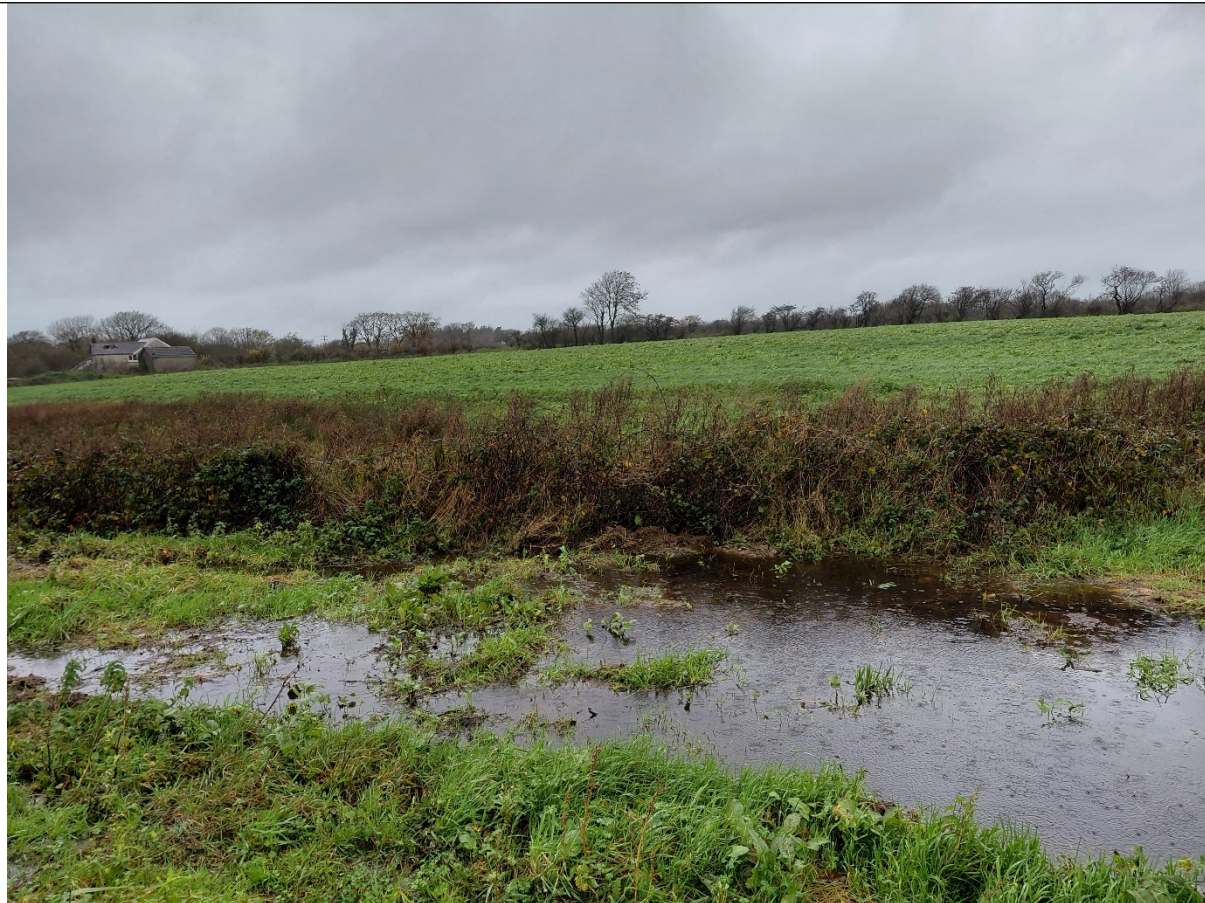
*Figure 13 Photo above further showing dark brown/black liquid on land adjacent to compost pad, flowing to adjacent field.*

Failure: Failure to detect saturation and discharge beyond the boundary shows the inspection regime is not robust.
