Poeton Industries
Poeton Cardiff Ltd.
283 Penarth Road
Cardiff
CF11 8UL

FAO: Mr. Jason Hamling
Report Reference: Audit of secondary containment measures at Poeton in Cardiff – January 2026
Report Ref. No: PR9965

GPT (UK) Ltd - Bund Audit Report

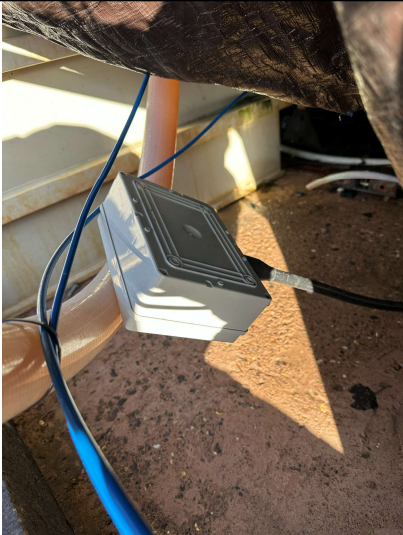
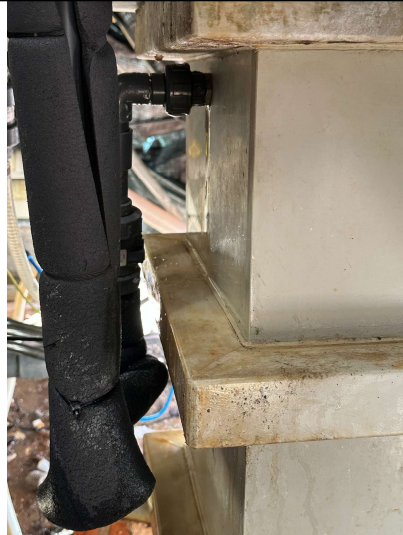
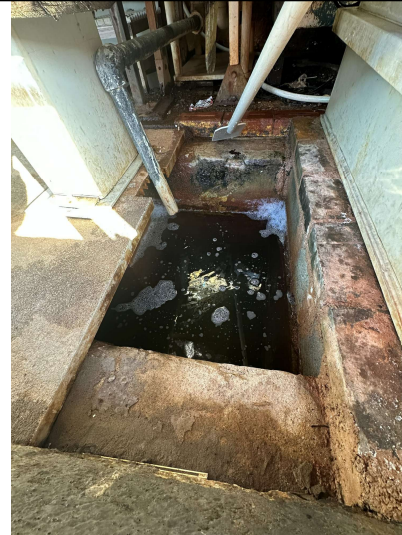
Image 7. Plastic channel liner detached from concrete and allowing water to escape containment.	Image 8. Unsealed cable ducting.	Image 9. Unsealed joint between bund floor and plastic sump liner.

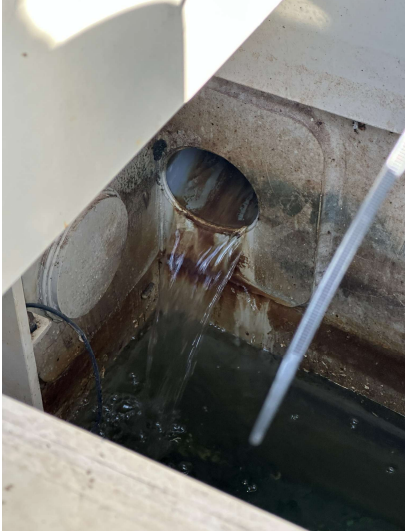
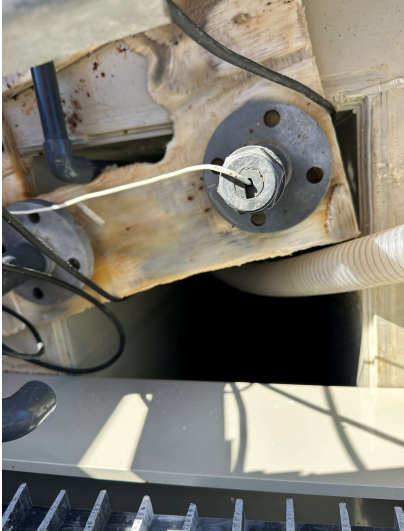
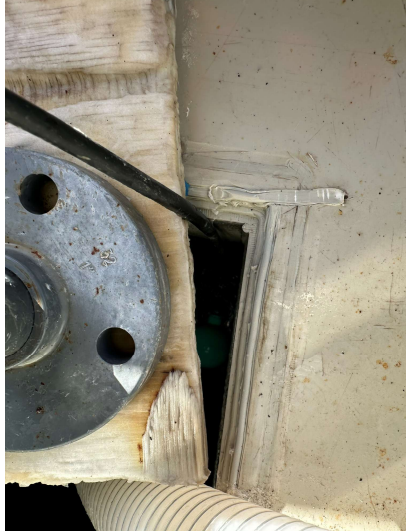
Image 1. Water inlet from process water being discharged by the warehouse.	Image 2. Corrosion to the plastic bracket housing the testing probes.	Image 3. Corrosion to the plastic bracket housing the testing probes.

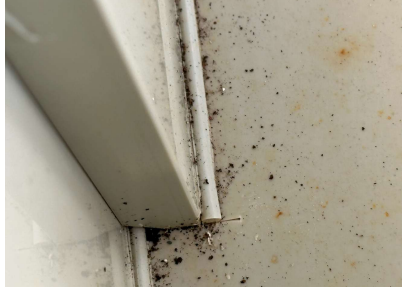
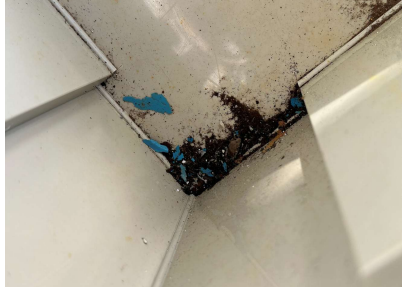
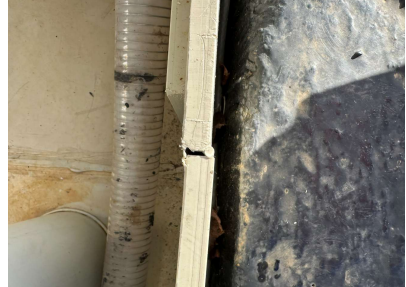
Image 4. Missing plastic welds and gaps visible at overlaps within the bunded area.	Image 5. Missing plastic welds and gaps visible at overlaps within the bunded area.	Image 6. Missing plastic welds and gaps visible at overlaps within the bunded area.

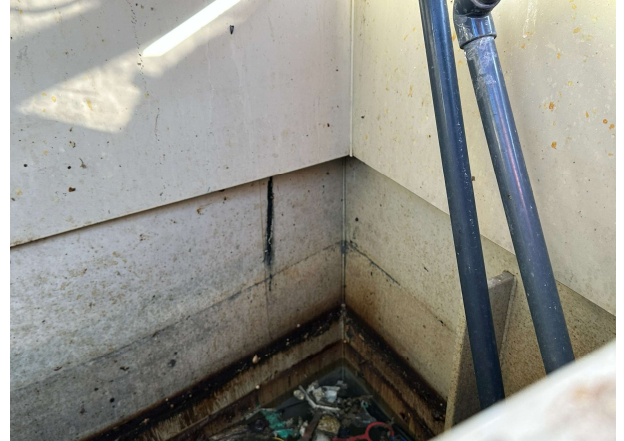
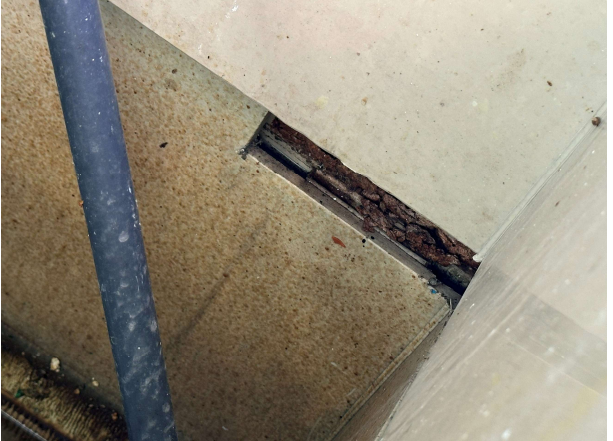
The chrome sump was not sealed to the main body of the bund and has the potential for water to rise and escape to ground should an equipment failure occur. Large holes and unsealed overlaps present a potential pathway for untreated water to escape containment.

Image 7. Plastic sump liner not attached to the main body of the bunded area with a significant gap visible between the two pieces.	Image 9. Large hole between the plastic sump liner and the bottom of the bunded area. Existing degraded brickwork sump visible.

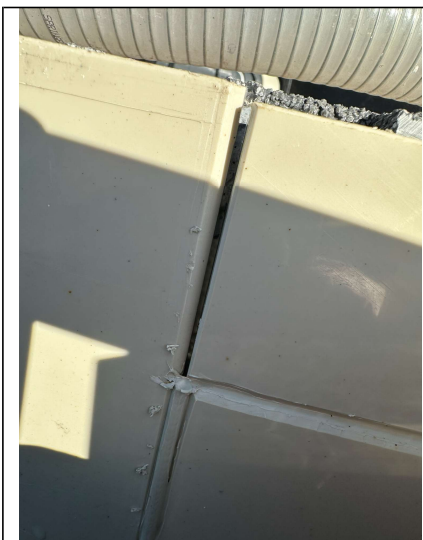
Image 10. Large gap visible between two joints forming the bund walls.

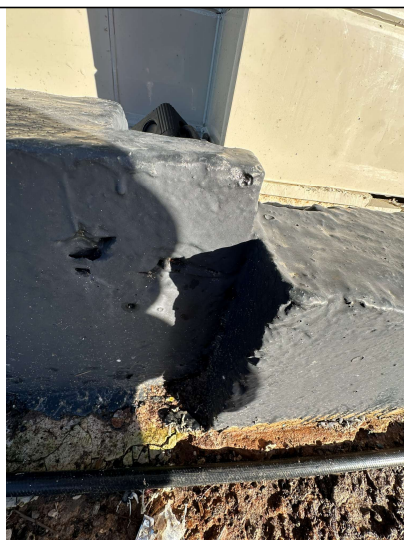
Image 11. Historic evidence of vehicular impact.

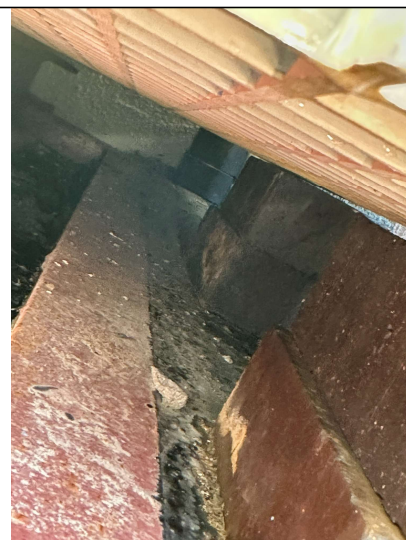
Image 12. Ancillary equipment held above the bunded area on bricks and plastic gratings.

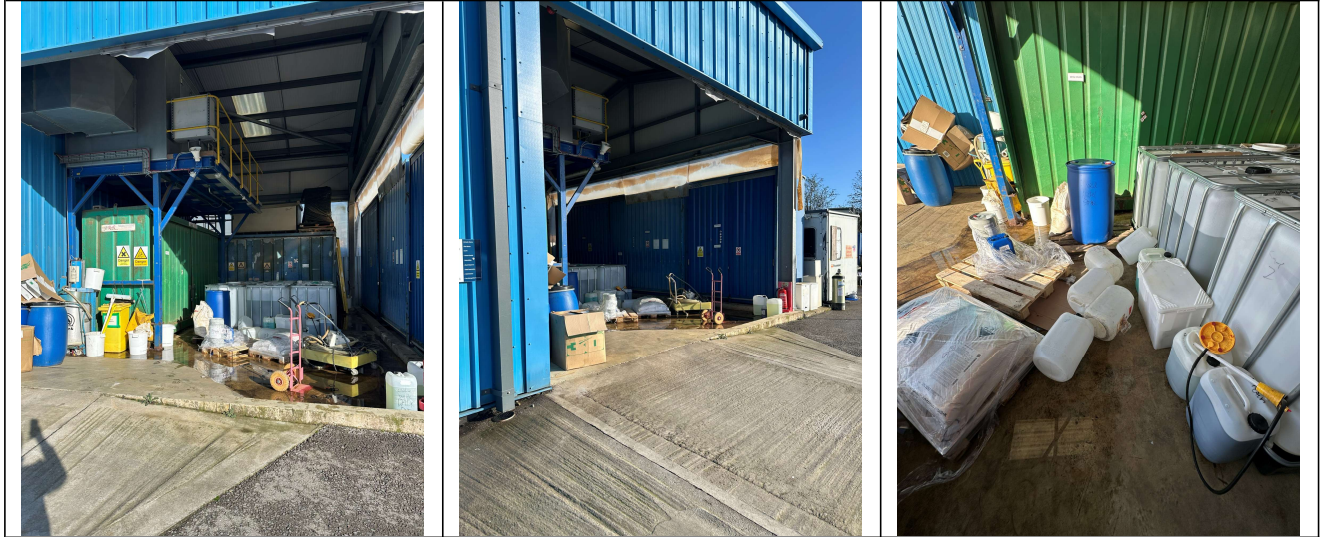
Image 1. External view of the secondary containment showing pooling of rainwater. Image 2. External view of the secondary containment showing access for forklift and/or site staff. Image 3. Empty and mixed chemical containers stored within the secondary containment.

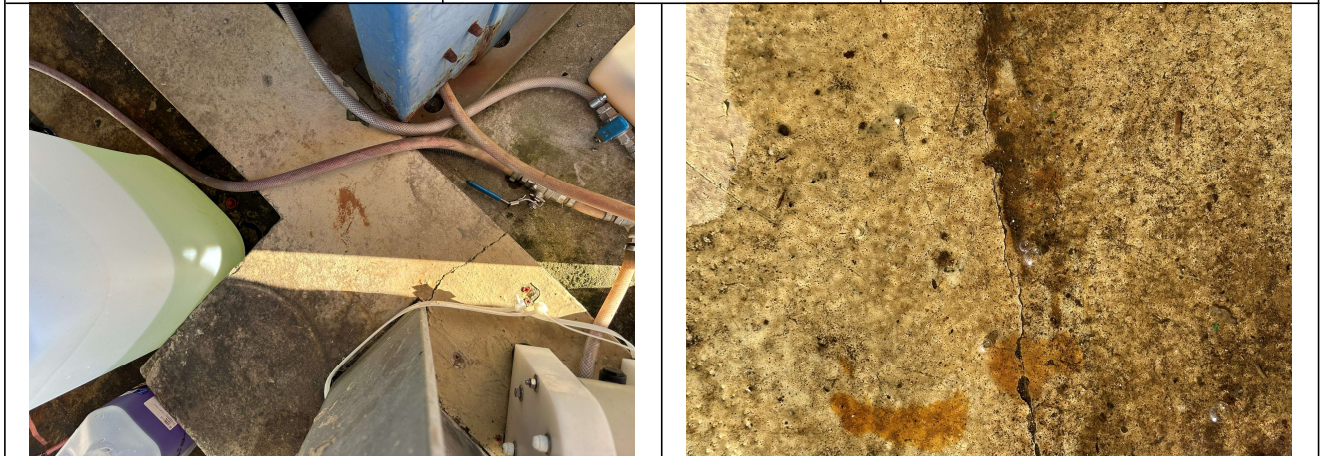
Image 4. Damage to the bund wall adjacent to the dewatering system. Image 5. Cracks to the bund floor are visible throughout the structure.

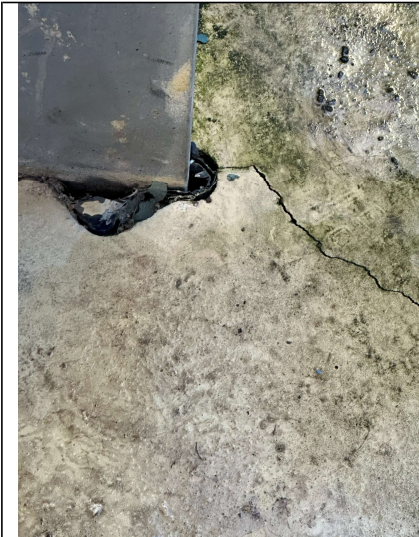
Image 6. Cracks to the bund wall to the rear of the concrete structure (rear, right hand side).

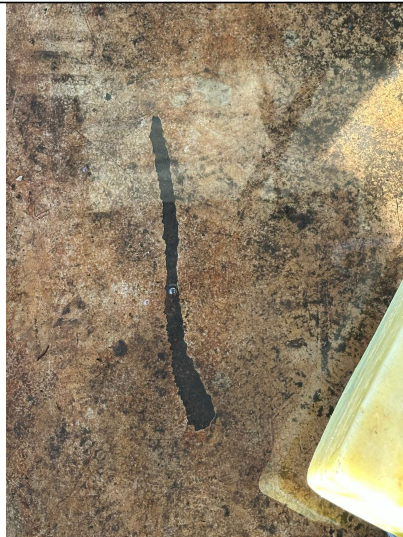
Image 7. Damage to the bund lining from scrpaing of forklift attachments or pallet truck.

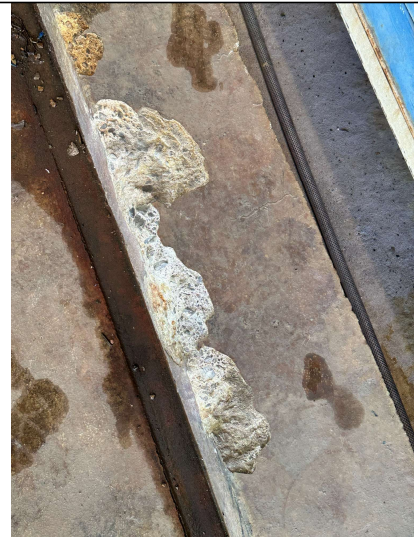
The bund is not protected from impact by vehicles and / or plant. There was some evidence of forklift impact from turning in a tight space. A ramp provides access to the bund but no specific protection is present.
Protected from Unauthorised Entry	Fail

Image 8. Damage to the bund wall from forklift impact (suspected wheels when turning).

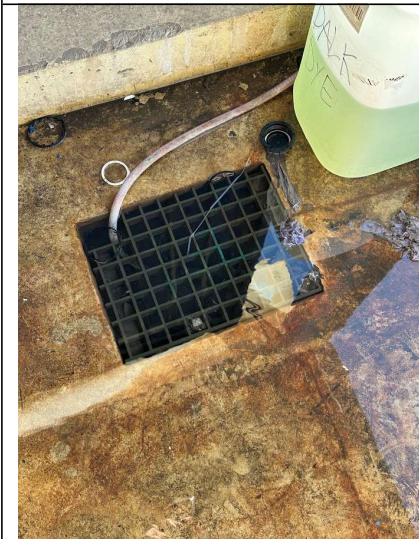
Image 9. Sump to the front of the bund which appears to be holding water.

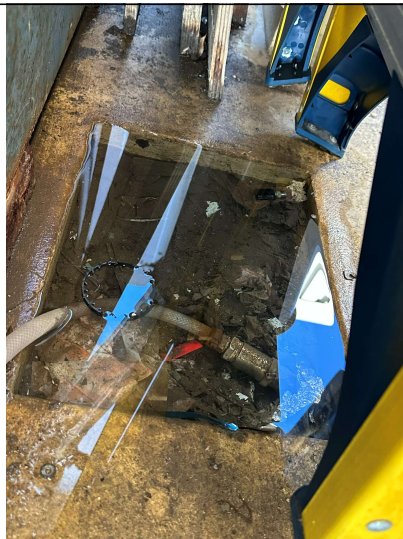
Image 10. Sump to the rear of the bund which is filled with silt and plastic debris.

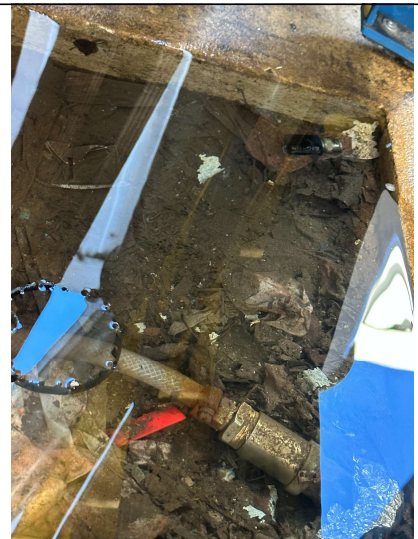
Image 11. Sump to the rear of the bund which is filled with silt and plastic debris.

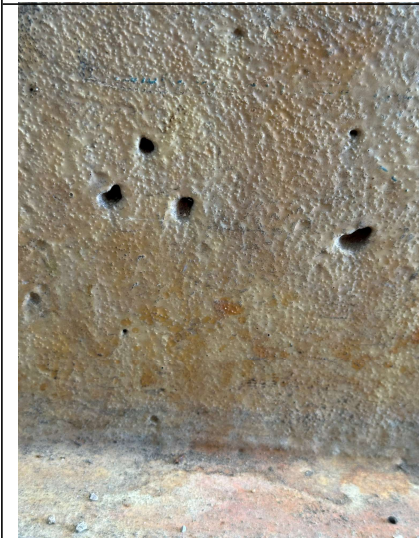
Image 12. Pitting / holes observed to the lining of the bund walls.

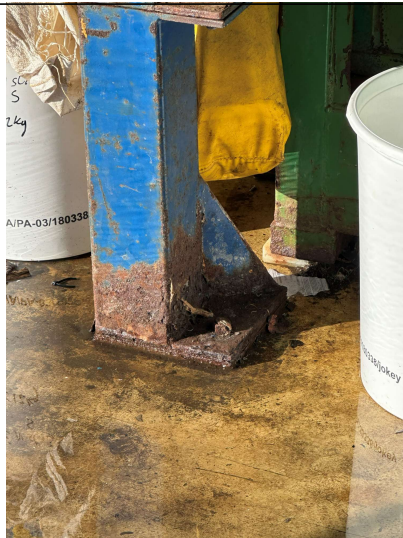
Image 13. Corroded steel supports which were submerged in rainwater.

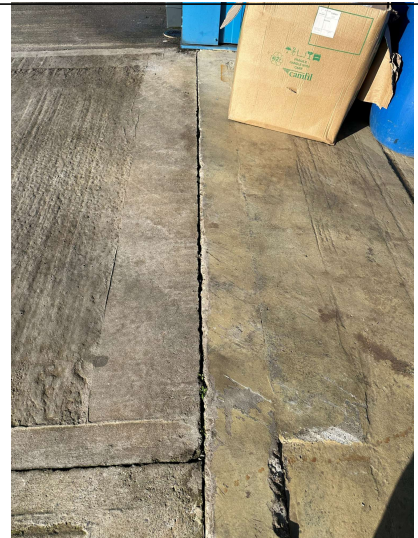
Image 14. Unsealed gap between the bund floor and the external concrete pad - pollutant pathway.

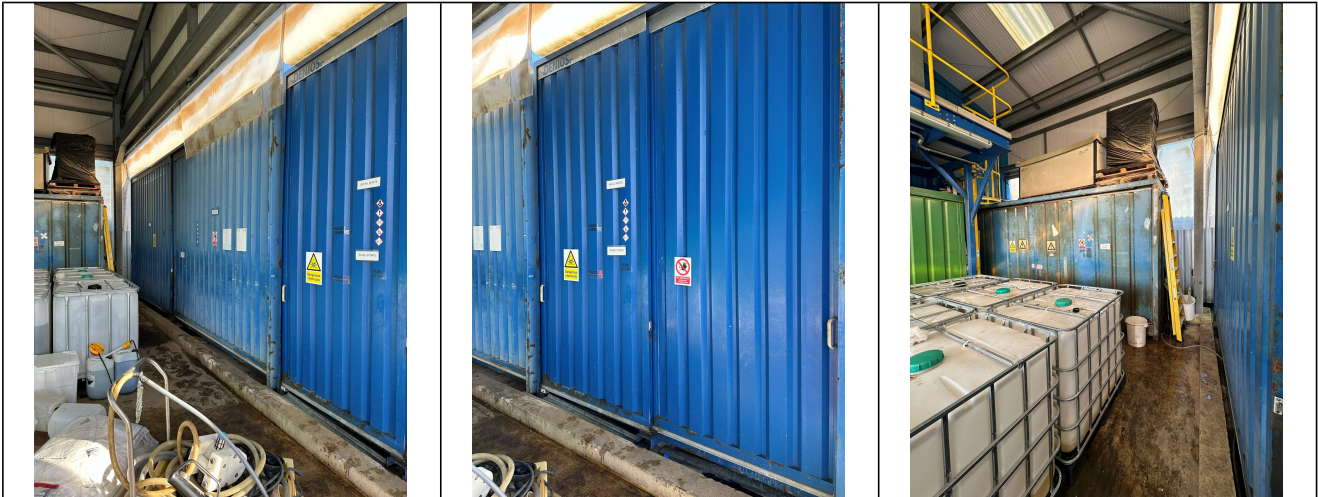
Image 15. Chemical storage cabinets which are external to the bunded area.

Image 16. Chemical storage cabinets which are external to the bunded area.

Image 17. The two chemical storage cabinets which should be used to prioritise liquid storage.

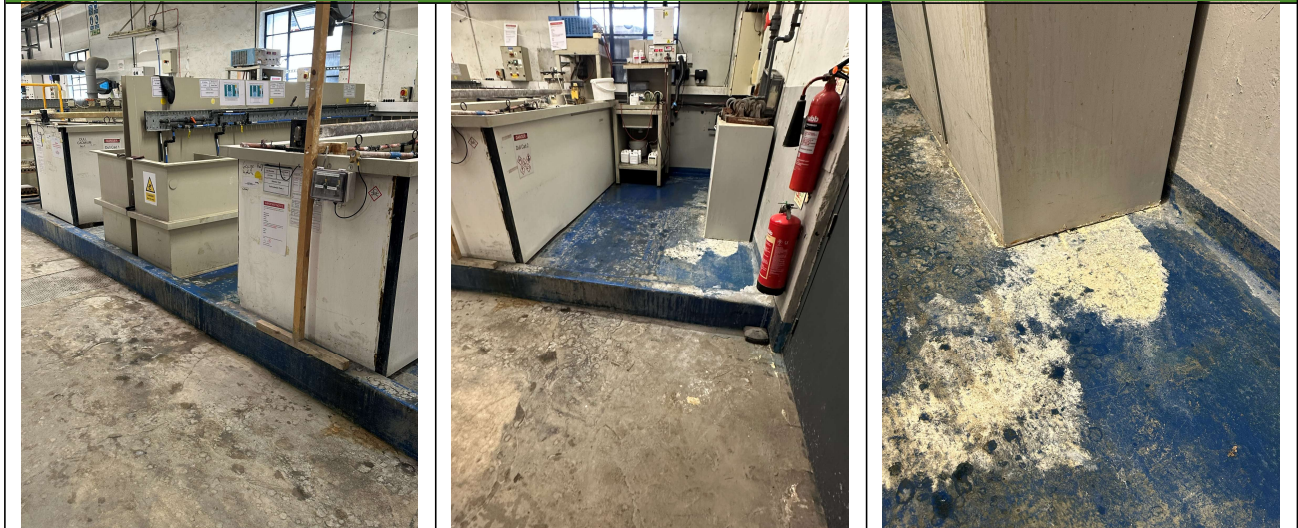
Image 1. View of the tanks held within the bunded area. Image 2. Storage area within the confines of the secondary containment. Image 3. Heavy chemical staining and corrosion noted to large areas of the bund.

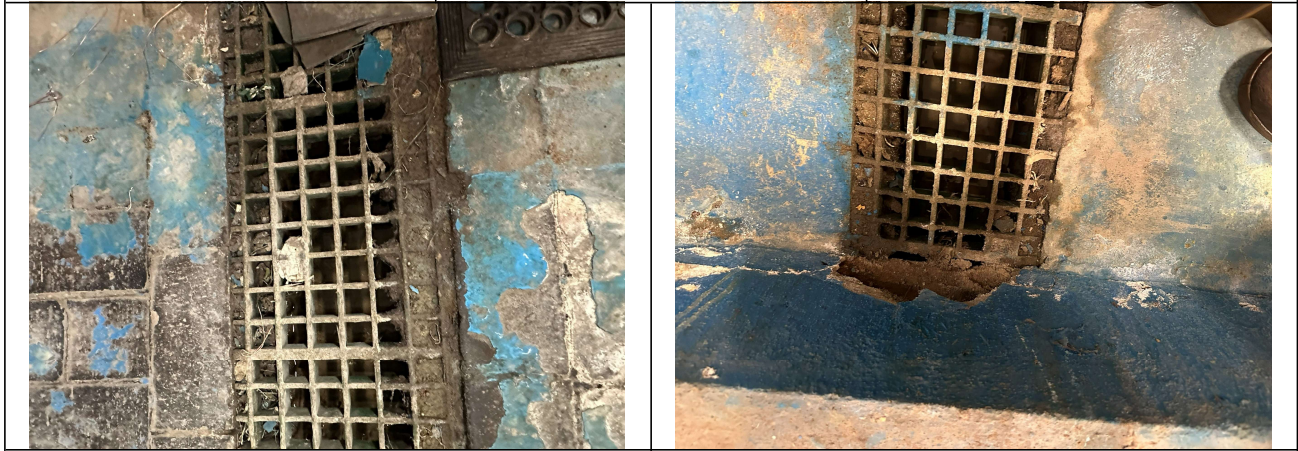
Image 4. Drainage channel passing through the warehouse floor and discharging to bund 2 (externally). Image 5. Drainage channel passing through the warehouse floor and discharging to bund 2 (externally).

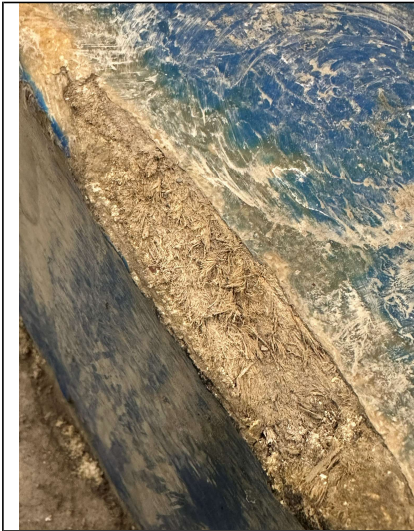
HIGH	The bund appears to be constructed from concrete blocks but it was noted that some of the block edges had been impacted by vehicles / plant exposing some fibrous material. The floor of the bund was heavily corroded from chemical spillages / drips.
Coating Condition (if applicable)	Fail

Image 6. Fibrous material exposed due to prolonged chemical exposure.

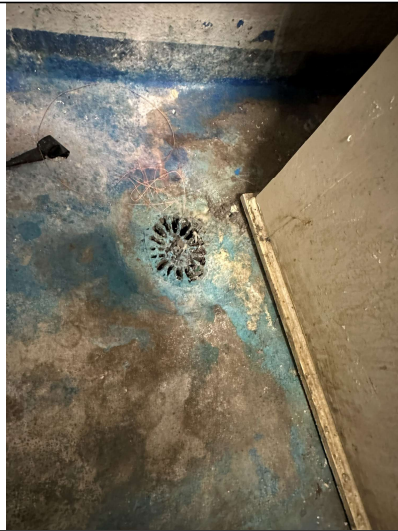
Image 7. Floor drain located within the confines of the bunded area.

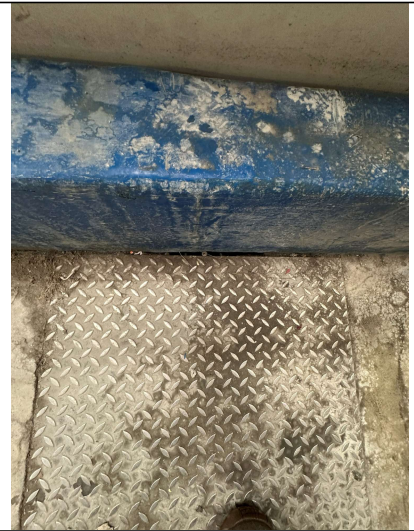
Image 8. Internal drainage channel running beneath the bunded area.

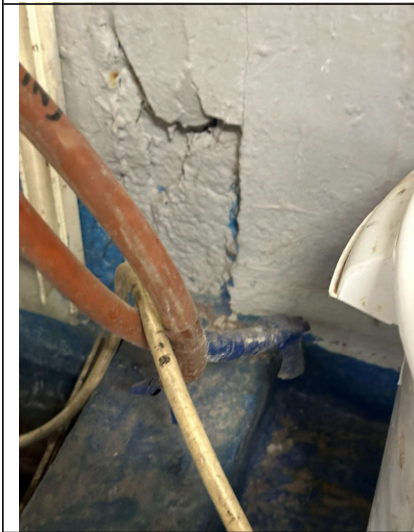
Image 9. Delamination of the render to the bund side of the internal wall.

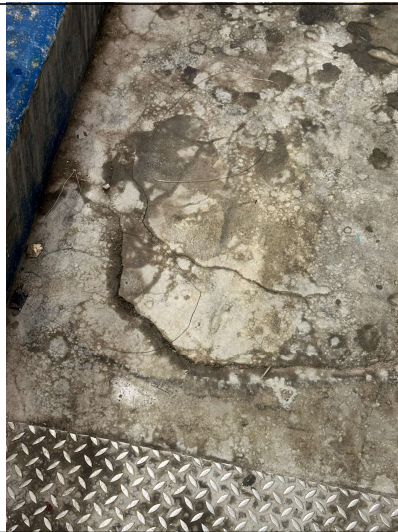
Image 10. Heavy chemical staining and damage to the warehouse floor. Many cracks visible.

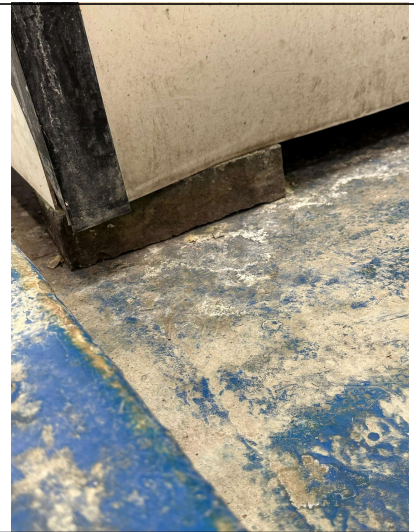
Image 11. One of the tanks within the bund which was positioned on acid-resistant engineering bricks.

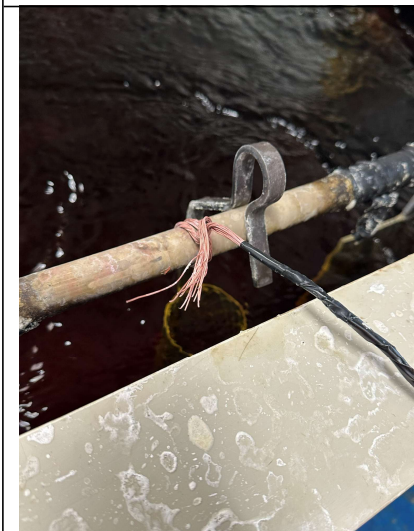
Image 12. Exposed copper cable above the chromium tank.

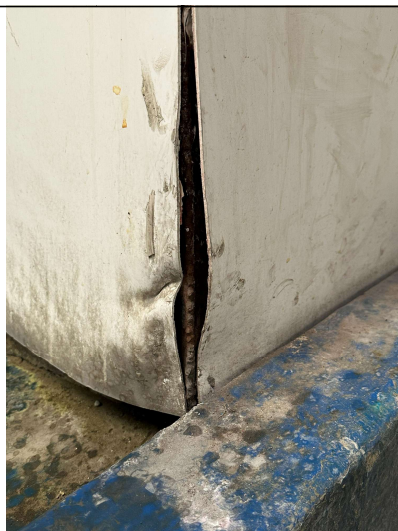
Image 13. Delamination of the tank decorative outer skin.

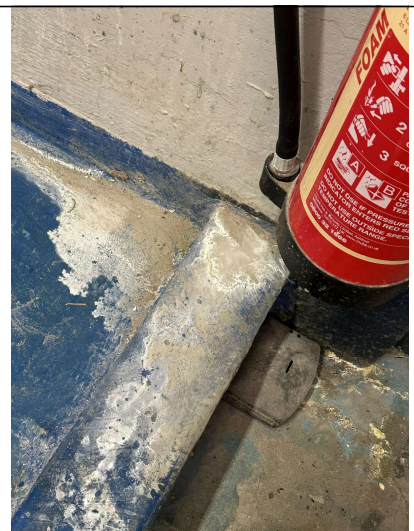
Image 14. Heavy chemical staining within / outside the bund and on top of the bund walls.
