## MWC0183N SITE PHOTOGRAPHS

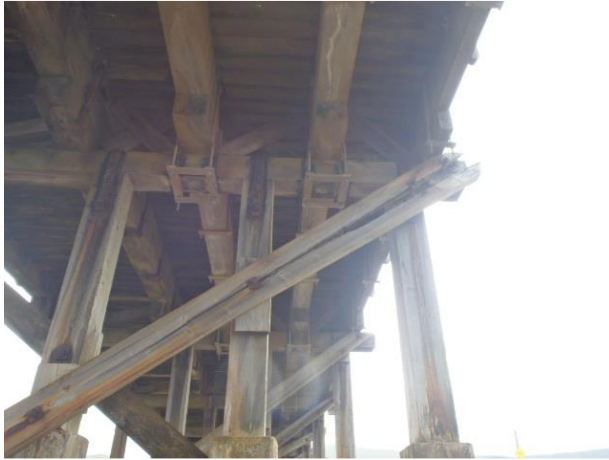
*Timber beam to be replaced*

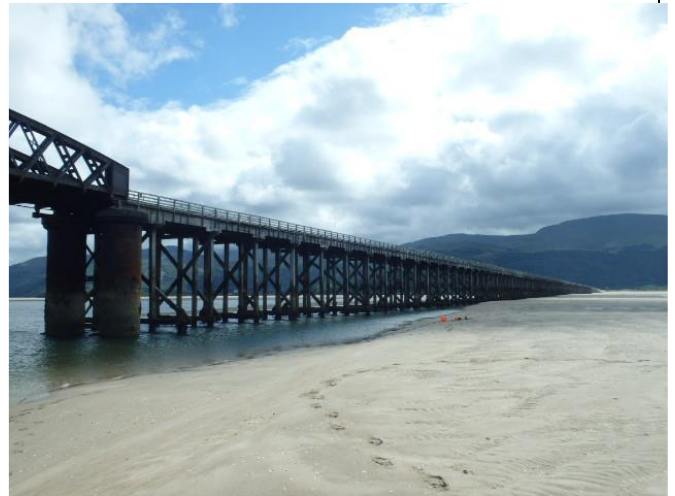
*View from the north side of the viaduct*

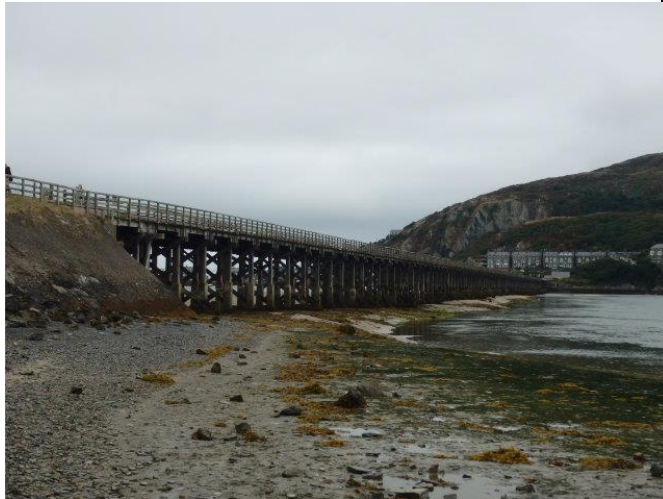
*View of access route for machines & personnel*

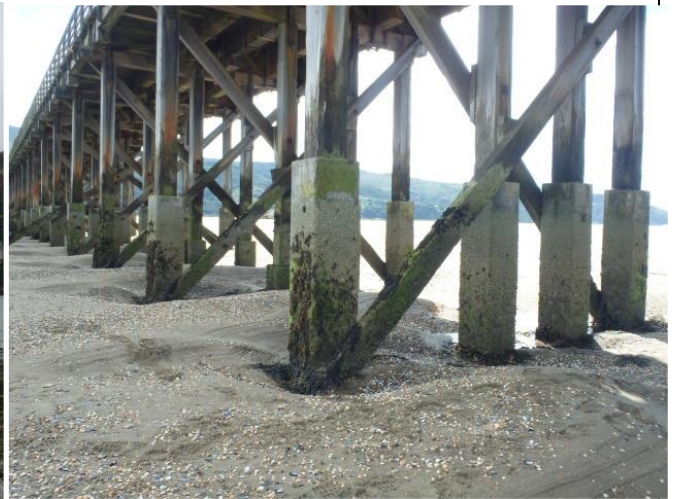
*Typical works area underneath structure*
