# MCERTS - EDM Inspection Report

## Henllan (North) WwTW

10 December 2025

Report No. CFS/ 19876v1

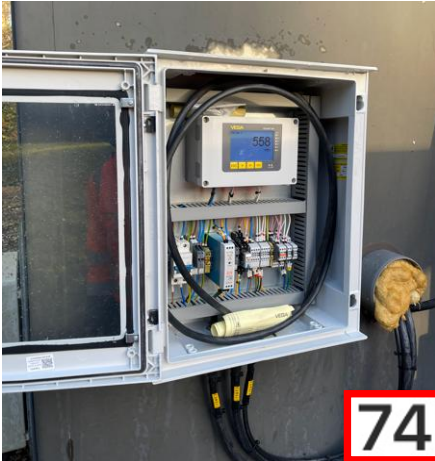
74383512

Level Monitor Display and Serial Number

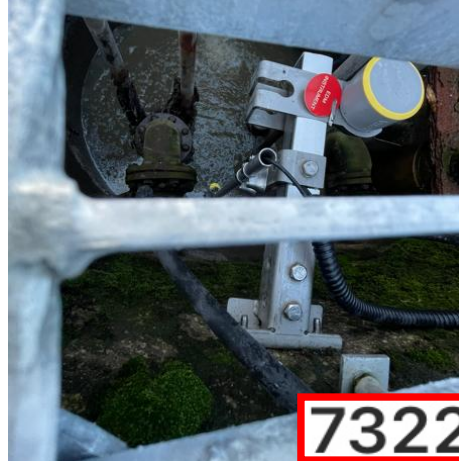
73229967

Level Sensor Location and Serial Number

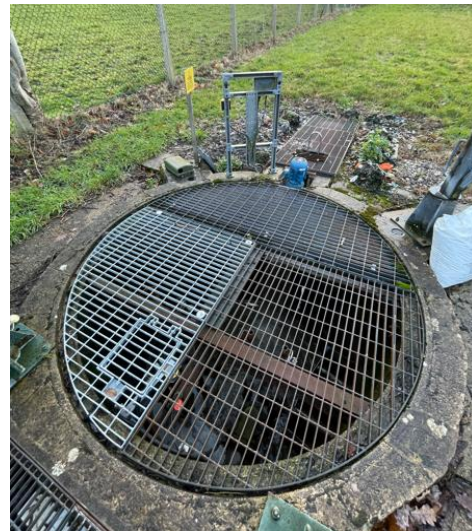
EDM Location

The EDM is located above the Pump sump storm overflow pipe

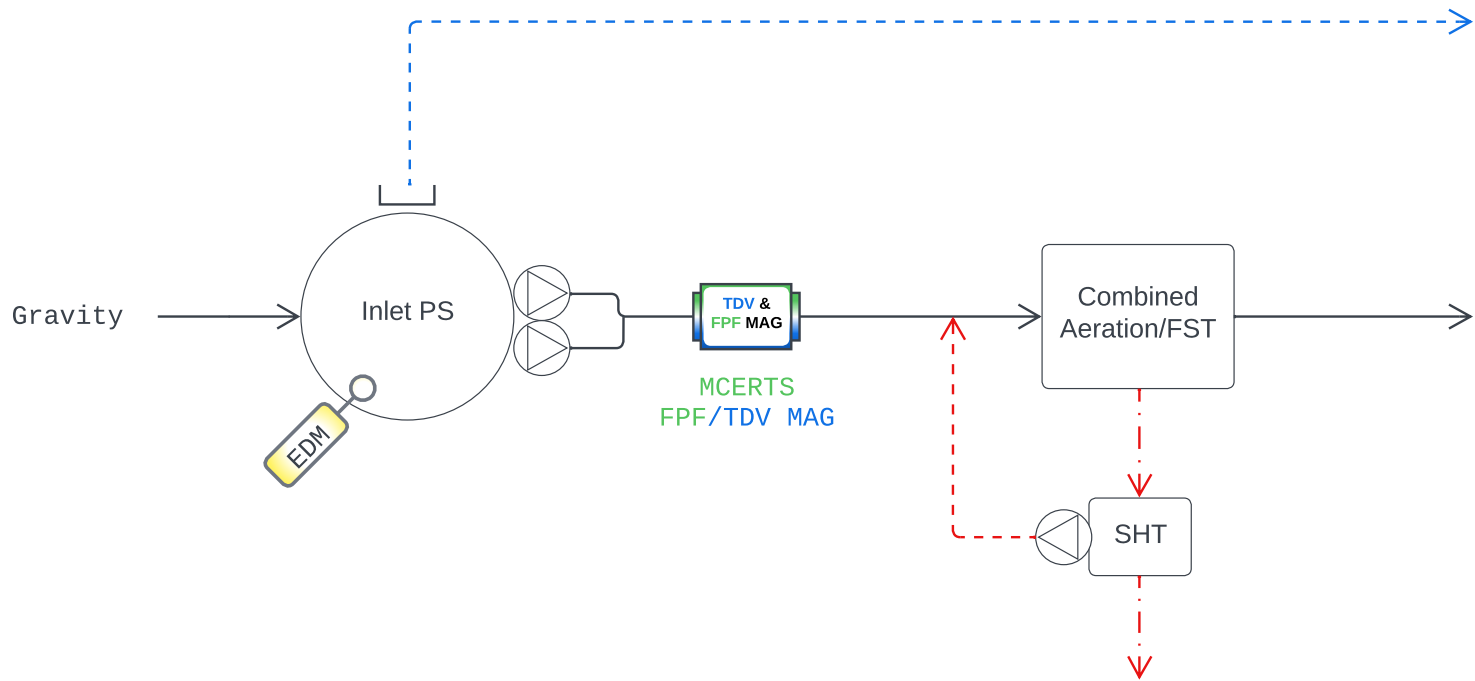
Process Diagram - Henllan WwTW

*Process interpreted from site visit and has not been confirmed*
