Compliance Assessment Report for: CAR_NRW0050376

Permit number	EPR/BX9471IU	Operator name	Tata Steel UK Limited
----------------------	--------------	----------------------	-----------------------

Site name	Trostre Works
Site address	Trostre, Llanelli, Carmarthenshire, SA14 9DS
Type of assessment	Site inspection

Date of assessment	13/01/2026	Time in	09:50	Time out	16:21
---------------------------	------------	----------------	-------	-----------------	-------

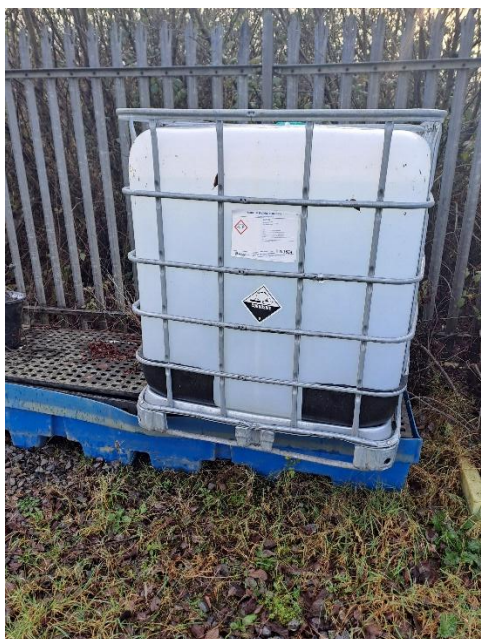
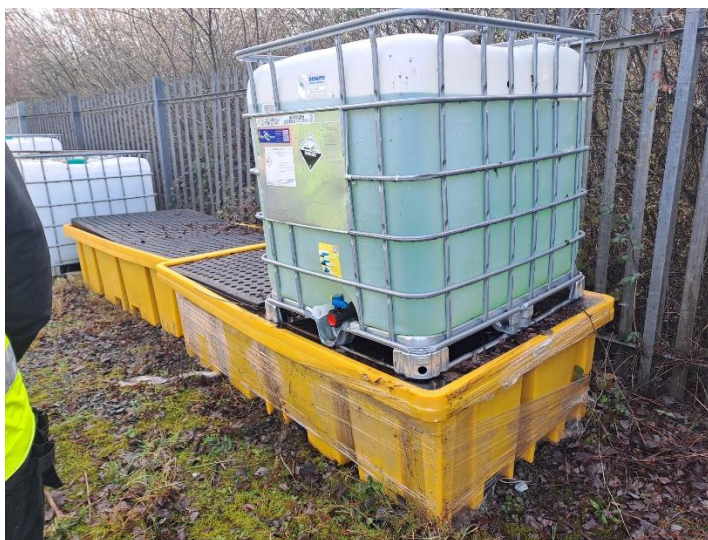
IBCs containing potentially polluting chemicals within the ETP area without adequate secondary containment were observed. This included bunds being full of rainwater reducing the containment capacity, structurally compromised (i.e. impact damage) and inadequately sized bunds in place (as shown by Images 1 & 2).

Within the IBCs, liquids including sodium hydroxide and sulphuric acid were being stored and were located with close proximity to the perimeter fence and surface water receptors. The IBCs were not located on an area of impermeable ground and therefore could be a direct pathway to soil, groundwater and/or the nearby surface water features south of the ETP.

Images 1 & 2 – IBCs with lack of appropriate containment.

Such substances, whose emission to water or land could cause pollution, were not suitably isolated from direct discharge to the environment or stored in an area that could effectively contain a spill or leak and therefore is a non-compliance with the permit.

Compliance assessment - The inadequate storage of potentially polluting chemicals is considered a breach of permit condition 3.2.3 - *“All liquids in containers, whose emission to water or land could cause pollution, shall be provided with secondary containment, unless the operator has used other appropriate measures to prevent or where that is not practicable, to minimise, leakage and spillage from the primary container.”*

A non-compliance score of C3 has been attributed to this permit contravention (against sub-criteria IR3B). NRW will escalate it's response and non-compliance scoring should such matters persist.

The operator must store all potentially polluting liquids with appropriate secondary containment and in a designated area, which is isolated from direct discharge to the environment to the extent where the storage area should be able to safely contain any spill or leak.

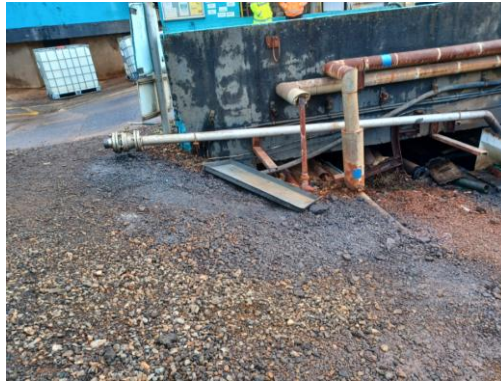
Image 3

NRW Officers also observed tankering operations being undertaken in the ETP involving the discharging of pumped effluent from the site back into the ETP. NRW shared concerns regarding the tanker connection points and pumping into the effluent flume/lagoons with a lack of appropriate containment measures in place. There were multiple connection points and evidence of spills to ground, therefore risk of pollution (Image 3). TSUK must review their tanker pumping operations and containment measures.

Compliance assessment – The tankering connection points (pipework) were not provided with secondary containment (or other appropriate containment measures) and therefore can also be considered a breach of permit condition 3.2.3. Connections points/pipework did not appear to be in a suitable contained area or within a sealed drainage system and a failure could result in a release onto land and/or into clean surface water systems.

The leakage of effluent onto unlined ground from tanker connection points is also considered a breach of permit condition 3.1.1 (*“there shall be no point source emissions to water, air or land except from the sources and emission points listed in schedule 3 tables S3.1 and S3.2”*). A non-compliance score of C3 has been attributed to this permit contravention (against sub-criteria IR3A(3) - Emissions to land). NRW will escalate its response and non-compliance scoring should such matters persist.

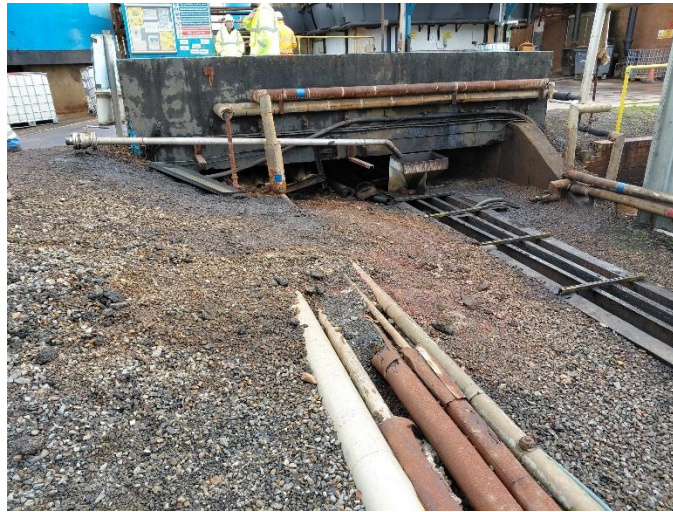
NRW Officers were also concerned with a collection of pipework within the ETP which appeared to be badly corroded and partly buried (Image 4). It is NRW's understanding that this area is made (permeable) ground and provides a potential pollution pathway to soil and groundwater

Image 4 corroded and partially buried pipework

TSUK/Veolia claimed some pipework in this area is redundant but also stated that some pipe runs were operational.

Action REF CAR_NRW0050376.10 - TSUK must investigate to determine which pipes are still operational and ensure they are appropriately protected from corrosion and/or damage. Where pipework is used to transfer potentially polluting liquids, secondary containment provision will need to be provided. The investigation outcomes must be submitted to NRW.

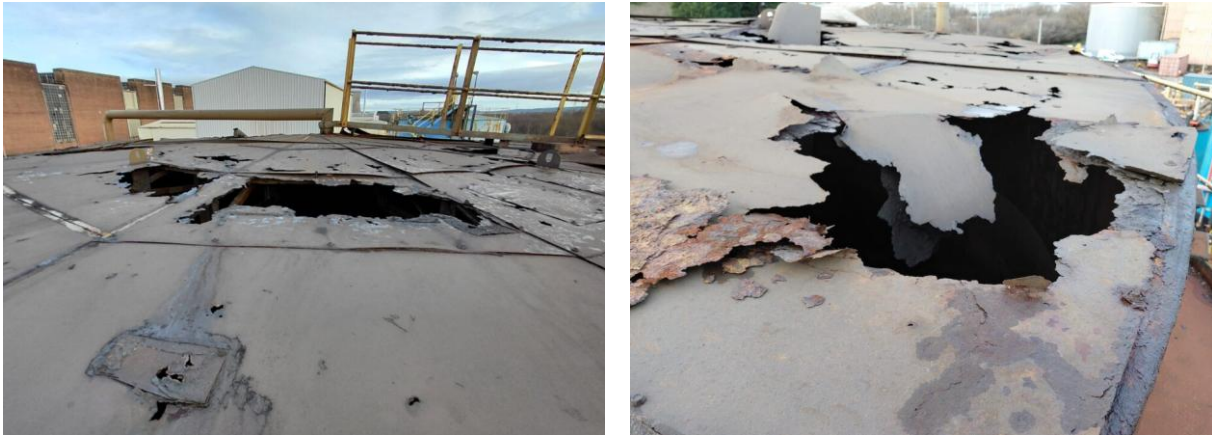
NRW Officers further inspected the chrome and waste oil tank areas of the ETP. NRW has concerns regarding the extent of corrosion observed on the roofs of several tanks but of immediate concern were the roof condition of the two waste oily effluent tanks within the ETP. Large sections of the roof were found to be severely degraded and entirely missing in some points. Whilst this may pose both a safety and environmental risk it also raises concerns about the site's general preventative maintenance programme of the ETP's tanks. This needs immediate investigation by TSUK to ensure that the structural integrity of the tanks has not been compromised.

Images 5 & 6 – corrosion on tank roofs

TSUK/Veolia have stated that this issue has been identified already and recorded on their risk register. However, NRW is concerned that the problem may have persisted for some time without corrective action being implemented. TSUK/Veolia must urgently review and assess the integrity of these tanks and ensure that the risk register accurately reflects the current situation and provide proposed timetable for remediation.

There is a concern that aging plant is not adequately being maintained and there could be potential general management failures. NRW has not assessed the root cause into the poor condition and maintenance of these tanks as part of this assessment and are now subject to ongoing investigation and will be determined at a later date.

Action REF CAR_NRW0050376.11 - TSUK to provide copies of the following documents:
