Compliance Assessment Report CAR_NRW0050816

Permit being assessed: BR9685IX.

For: Barry Silicone Plant, **held by:** Dow Silicones UK Limited

At: Cardiff Road, Barry, Vale of Glamorgan, CF63 2YL.

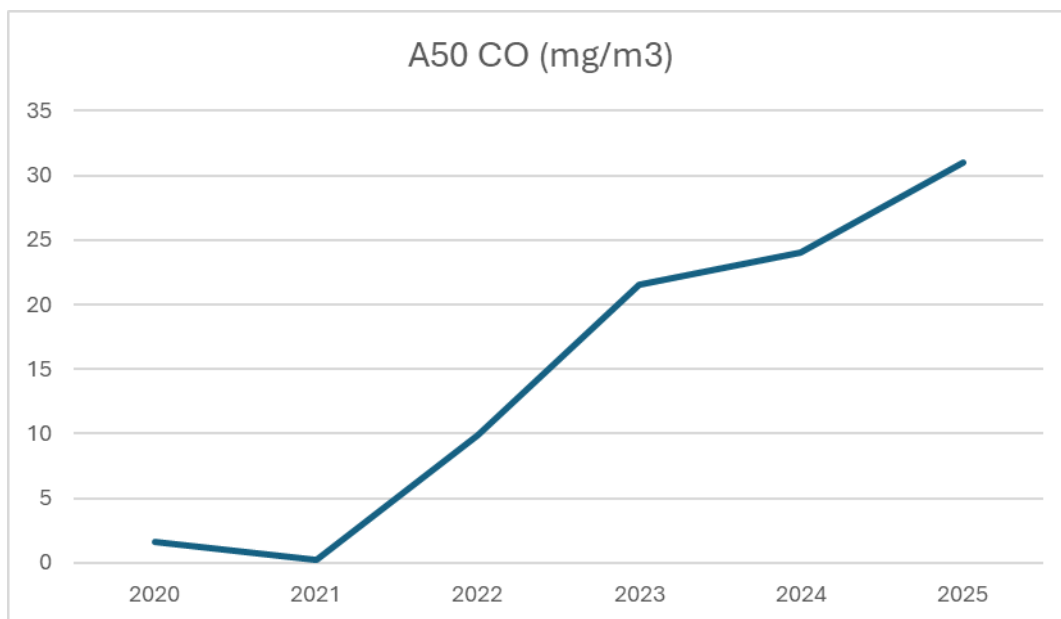
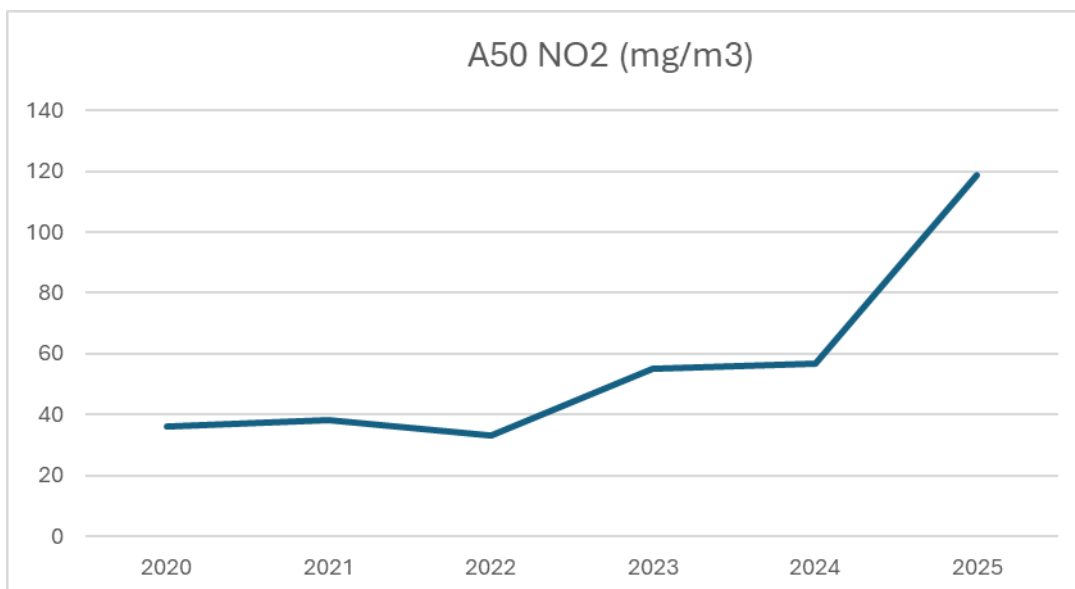
Both returns were received on time, and all monitoring results were found to be within their respective compliance limits. The A50 emission point, which is connected to the W957 Hydrogen Plant vent via

the 19 m stack, continues to operate within the permitted emission limit values for both carbon monoxide (CO) and oxides of nitrogen (as NO₂).

However, despite remaining compliant, the data show a gradual upward trend in emissions from A50 over the past five years. This emerging pattern will be raised and discussed in detail at the next compliance meeting, with a view to understanding the underlying causes and considering whether any operational, maintenance, or process-related adjustments may be warranted.
