# Executive summary: Churchstoke STW, Hall Bank, Churchstoke, SY15 6EN

## Incident Classification and Response Summary

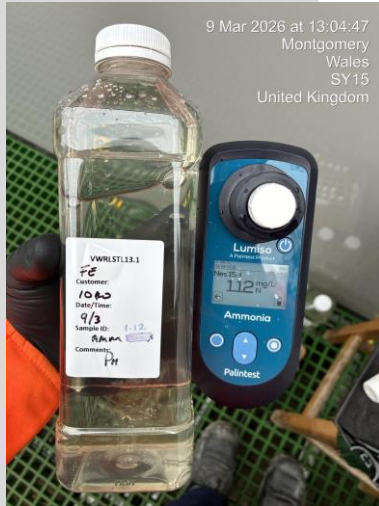
Ammonia reading  
1.12mg/l

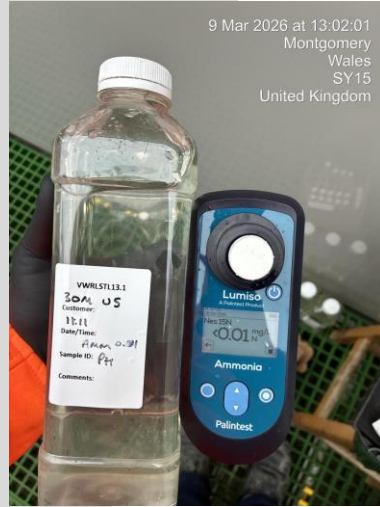
Ammonia reading at  
<0.01 mg/l

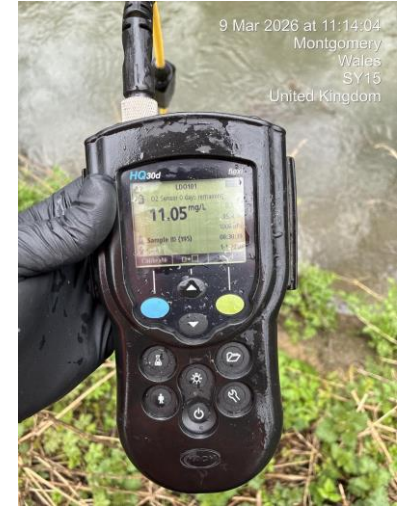
Dissolved Oxygen reading  
11.05 mg/l

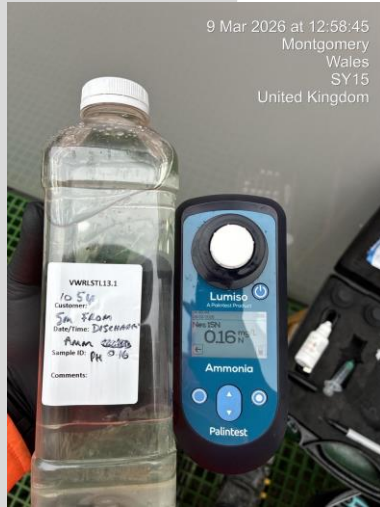
Ammonia reading at  
0.16mg/l

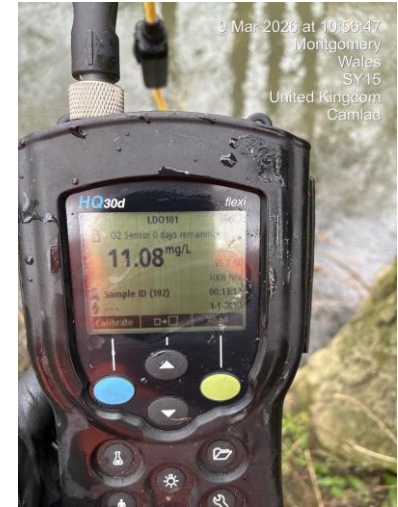
Dissolved Oxygen reading  
11.08 mg/l

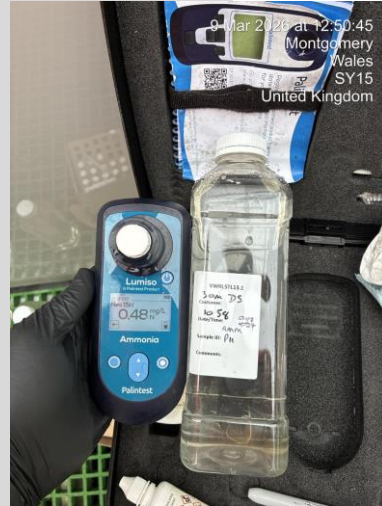
Ammonia reading at 0.42 mg/l

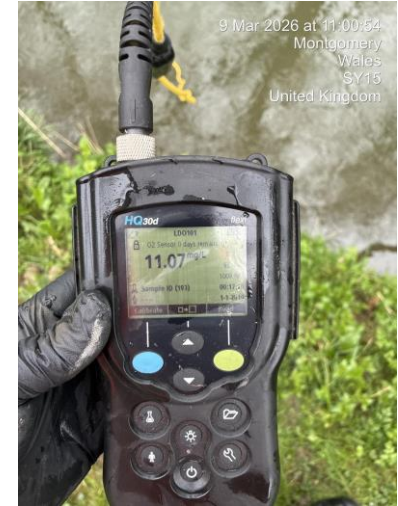
Dissolved Oxygen reading 11.07 mg/l

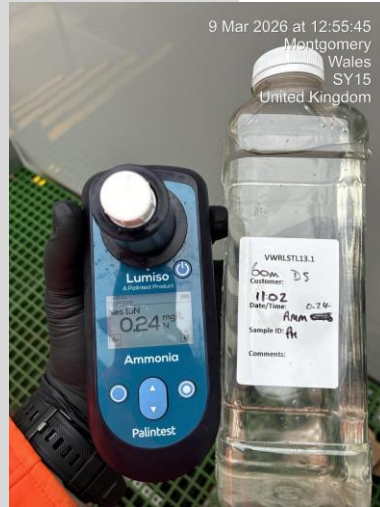
Ammonia reading at  
0.15mg/l

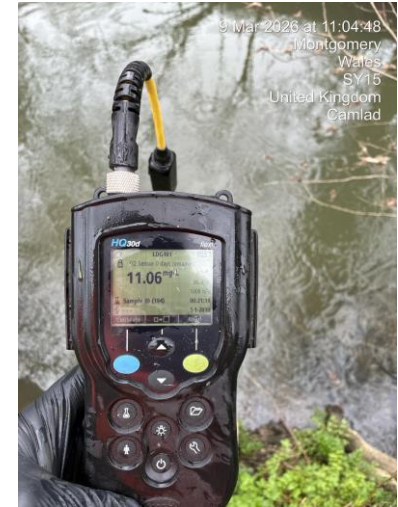
Dissolved Oxygen reading  
13.17mg/l
