## NOTE TO FILE

| Contract | Llanelltyd Sheet Pile Removal |
| Subject | Llanelltyd Sheet Piling Geomorphological Assessment |

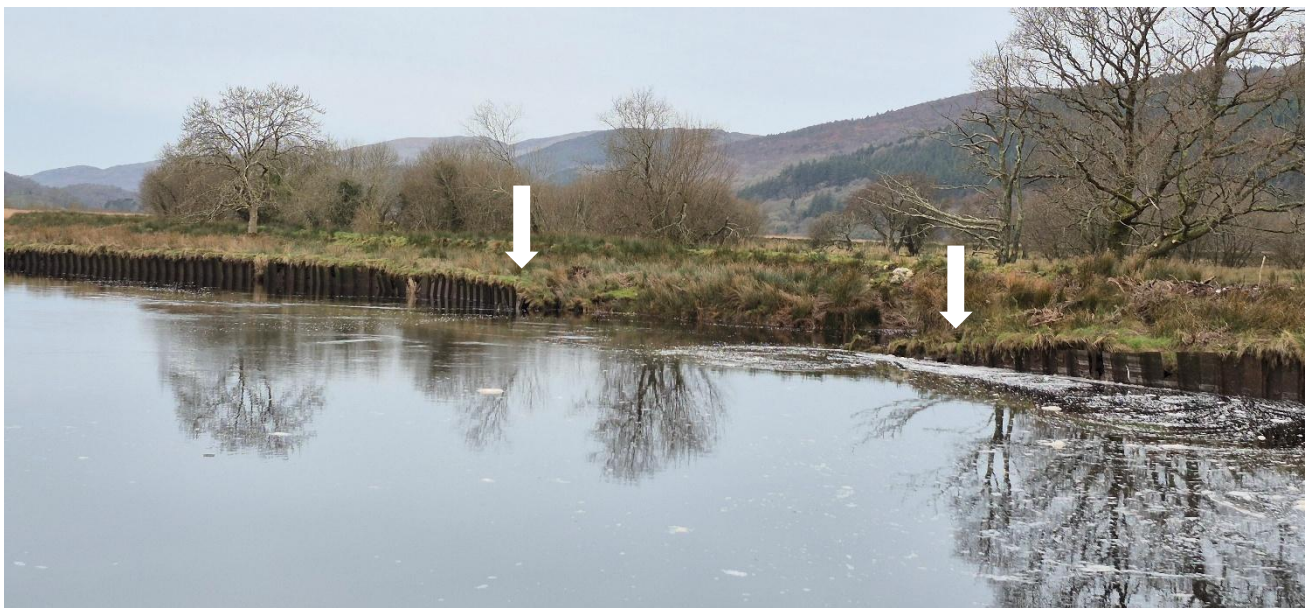
The site of interest consists of a 100m of sheet piling along the right bank of the Afon Mawddach, 30m of which has catastrophically failed. The sheet piling is located on the outside of a sharp 90-degree meander bend, with the worst failure in the sheet piling located just downstream of the apex of the bend (See Figure 3-1, Figure 3-2 and Figure 3-3).

Figure 3-1 Section failed sheet piling in the middle of the image between the white arrows (Left bank looking downstream)

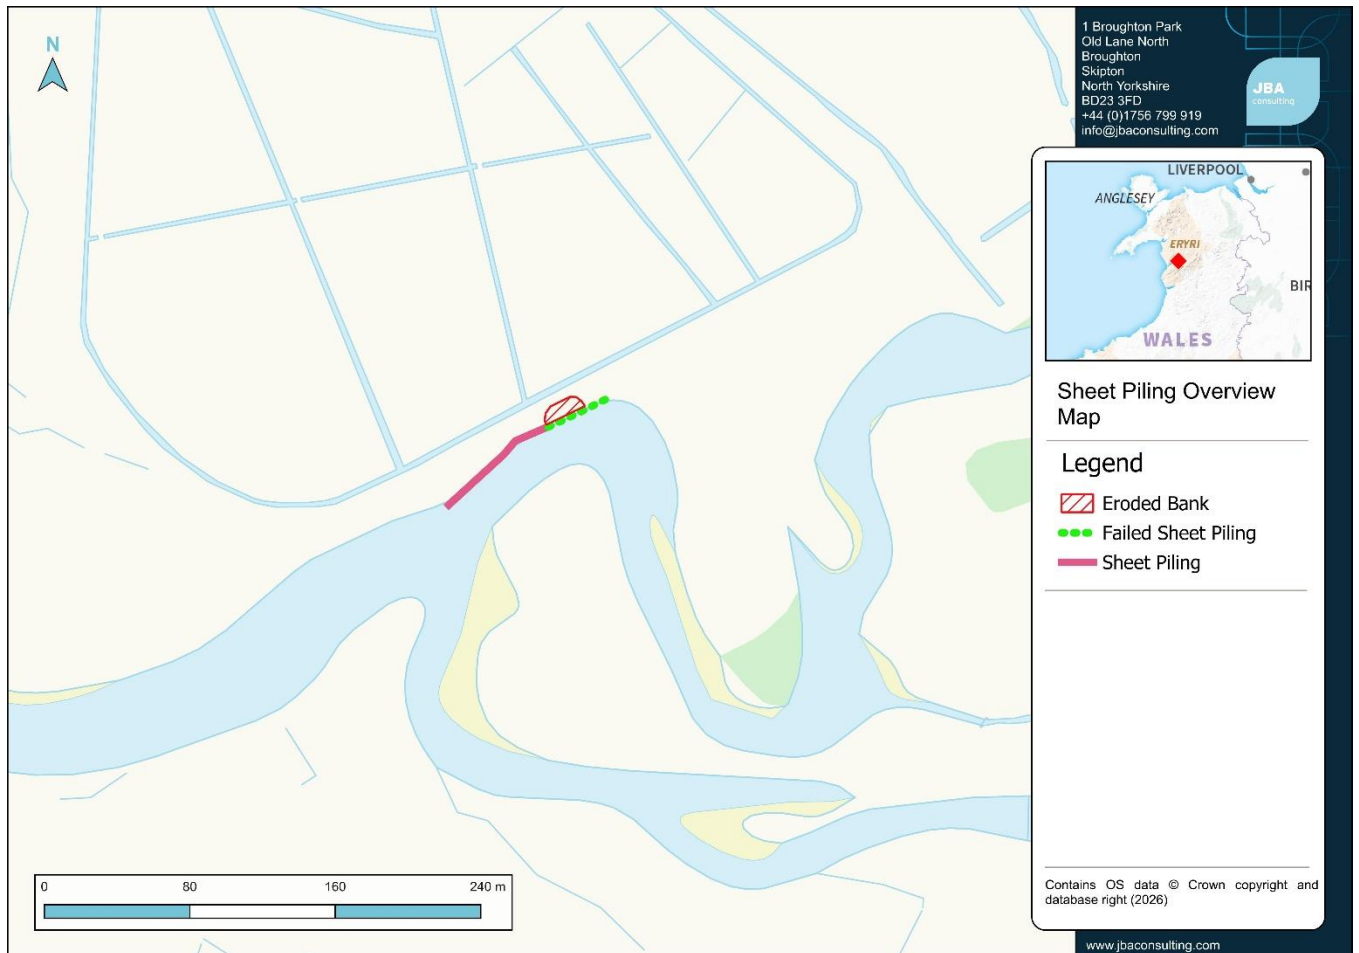
Figure 3-2 Map showing the positioning of the sheet piling, failed sheet piling and area of erosion

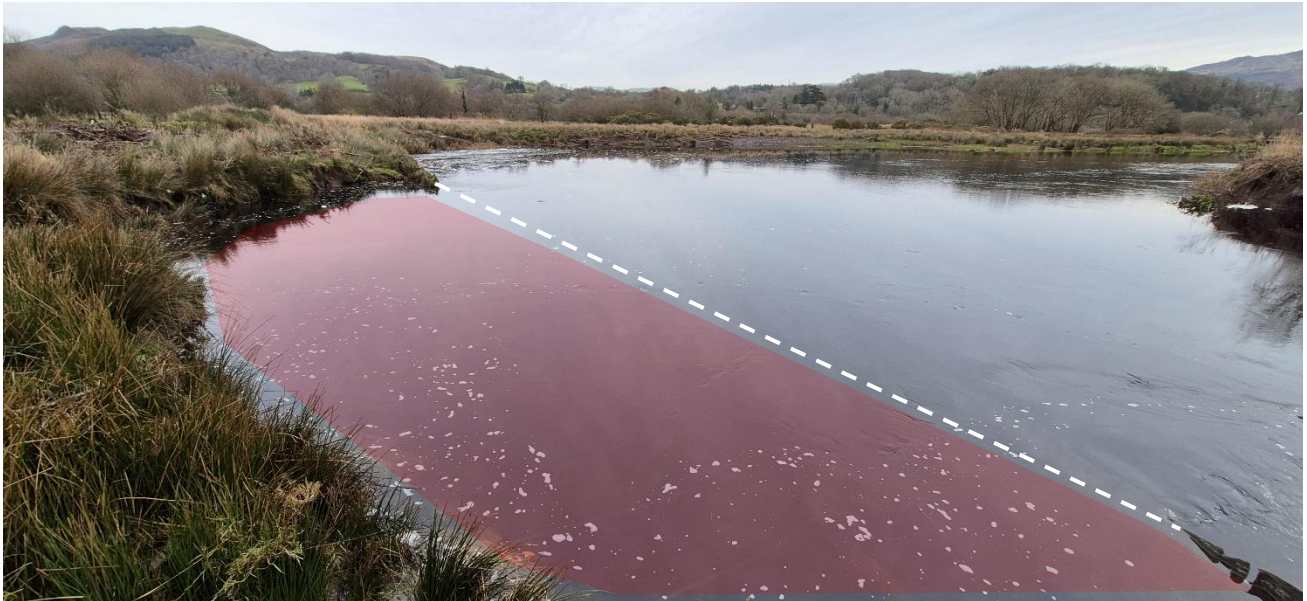
The failure of the sheet piling has left part of the bank exposed on a section of bend with the highest velocity flow; this has caused erosion of the bank between the sheet piling and the informal flood bund (see Figure 3-3). The flood bund had also suffered extensive erosion and was breached, but was temporarily repaired by the landowner. The erosion of the bank has left the tie-rod foundations of the sheet piling dangerously exposed in the river (see Figure 3-4), which are now underwater obstacles when the tide is up and pose a risk to people using the river for water sports.

Figure 3-3 Section of failed sheet piling and the extent of subsequent lateral channel movement and scour. White line represents where the existing bank line and sheet piling was, with the red area representing the extent of scour. (right bank looking upstream)

The sheet piling is likely to have originally failed due to a combination of deterioration/rusting of the sheet piling combined with high velocity helical flows on the outside of the meander bend. It can be inferred that the majority of erosion took place while the water levels were lower than when observed on site, suggesting that the toe of the sheet piling will have scoured out first leading to a failure of this section of the structure.

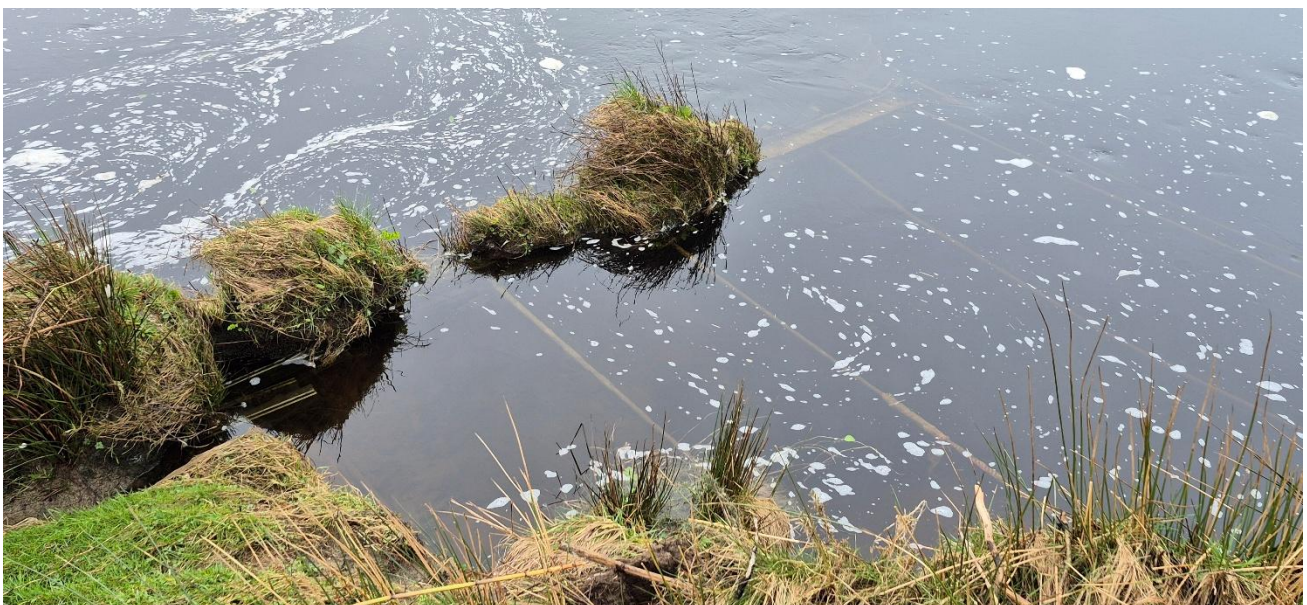
Figure 3-4 Foundation tie rods of the failed sheet piles still in place, just visible below the high tide (right bank looking downstream)

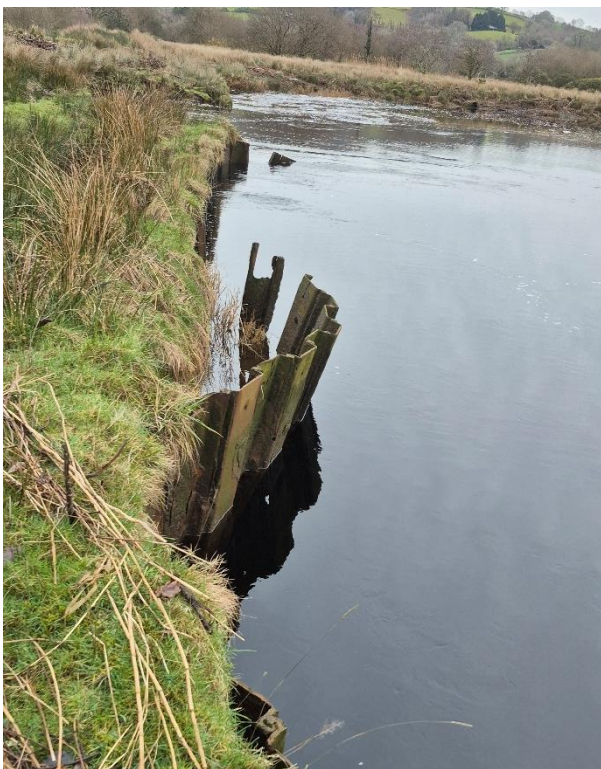
Figure 3-5 The downstream section of sheet piling beginning to fail (right bank looking upstream).

The downstream section of sheet piling was also visibly beginning to fail, with sections of it leaning out towards the channel as can be seen in Figure 3-5. This may have also been from the toe of the sheet piling starting to destabilise along with the metal work rusting.

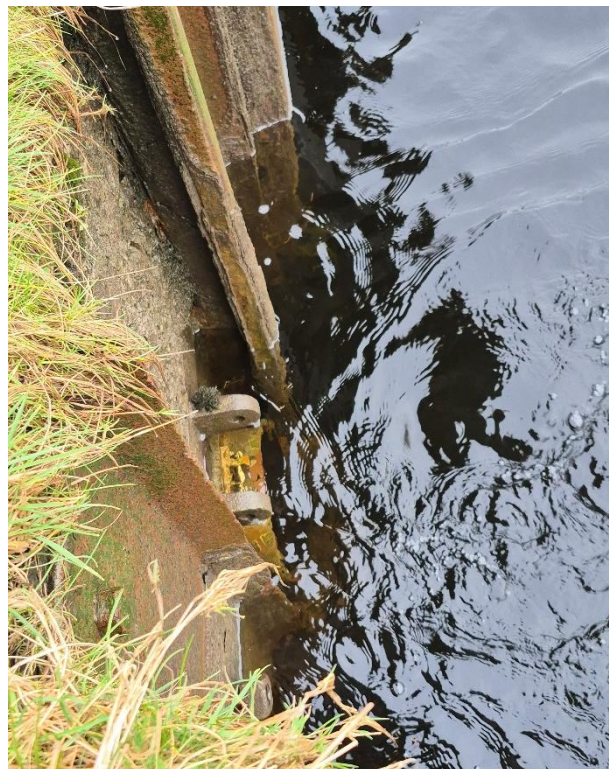
Figure 3-6 Outfall in the sheet piling missing a flap valve (right bank looking upstream).

There was also a surface water outfall present in the sheet piling. The outfall was discharging at the time of the visit with surface water from the farmland behind the flood embankment. The outfall was missing a flap valve (see Figure 3-6) meaning the water can flow back up through the structure at times of higher flows.

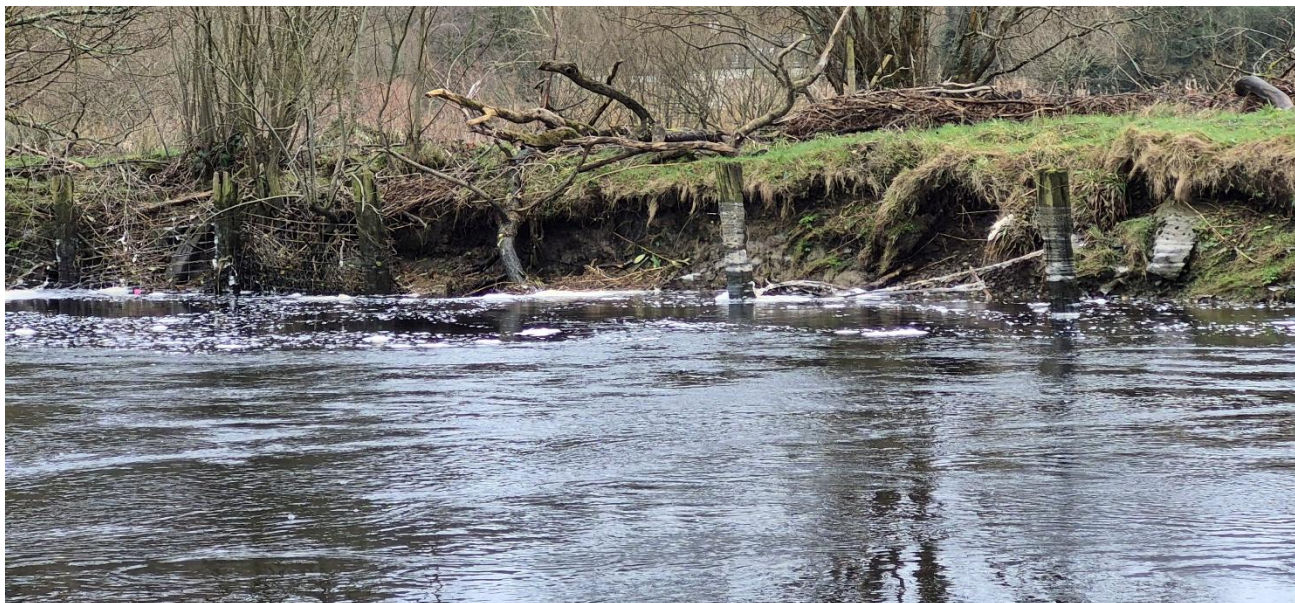
The channel is more disconnected from the floodplain than downstream, with generally higher and steeper banks observed in this section of the river. This upstream reach exhibited a significant amount of active erosion with bare banks visible throughout, that appeared to be relatively friable. One section of erosion of note was the section of bank between the Mawddach and the Wnion that showed evidence of full bank scour (see Figure 3-10). There are also the remains of a fence or potential failed bank protection along this section of bank, likely to try and stop the two rivers meeting. The banks appear relatively consolidated but have been subject to significant erosion suggesting a high energy environment.

Figure 3-10 Section of eroded bank face between the Afon Mawddach and the Afon Wnion. A fence/ failed bank protection is visible in the form of posts in front of the bank face

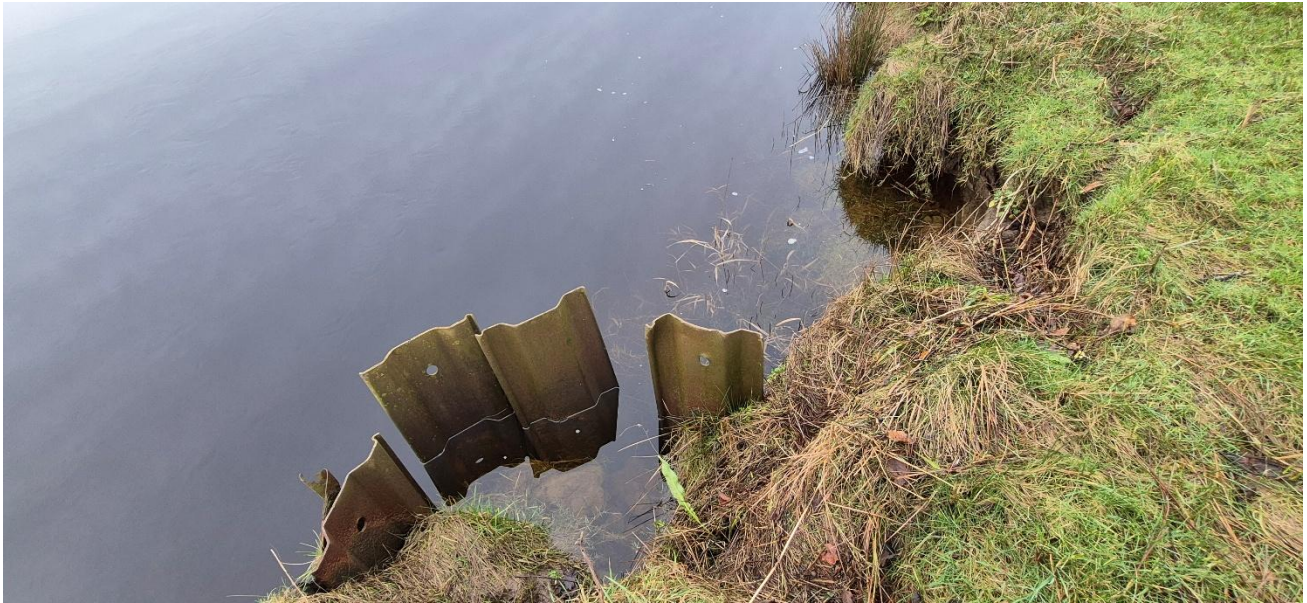
The Afon Wnion joins the Afon Mawddach immediately downstream of the site and was observed to have caused erosion along the left bank at the mouth of the Wnion and more crucially on the right bank immediately downstream of the 100m of sheet piling. This erosion has started to destabilise the other (downstream) end of the of the sheet piling leading to its deterioration and imminent failure (see Figure 3-11). Aerial imagery from 2006, shows that the bank here has retreated around 6-10m, due to the flow velocity out of the Wnion. This is also an increasing threat to the section of sheet piling that is yet to fully fail.

Figure 3-11 Evidence of basal scour and slumping causing deterioration and failure of the sheet piling at the downstream end of the site (right bank looking downstream)
