Compliance Assessment Report CAR_NRW0050734

Permit being assessed: BL7108IM.

For: Port Talbot Steel Works , **held by:** Tata Steel UK Limited

Type of assessment: Site Inspection,

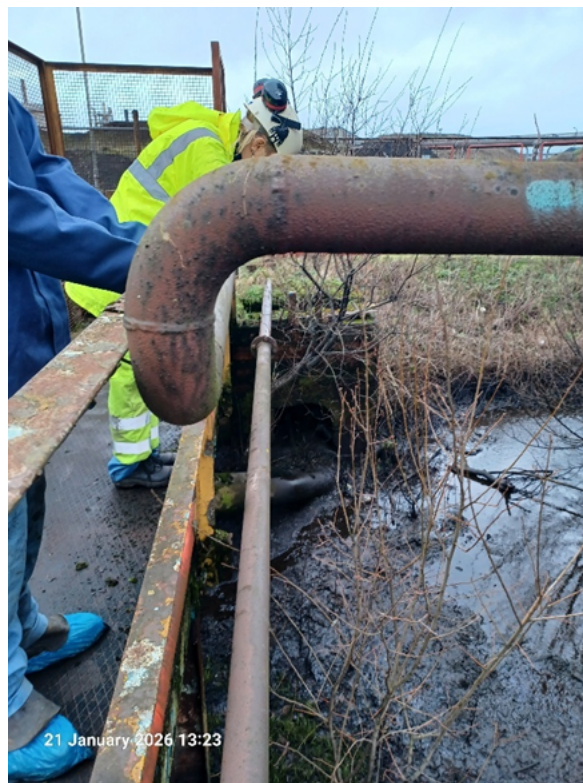
Image 1: Potential pathway outside of the earth bunding associated with the North/South Tank

During the inspection, NRW Officers identified a masonry brick built channel which appeared to encapsulate redundant pipework associated with the presumed former coupling point of the vessels. It is unclear from the surface whether this may provide a potential pathway for contaminants to exit the earth bund should a catastrophic failure occur.

CAR_NRW0050734.A5: TSUK should investigate whether there is a risk of contaminants leaving the curtilage of the earth bund associated with the North/South Tank in the event of a catastrophic failure. Once completed, the conclusion is to be submitted to NRW as evidence.

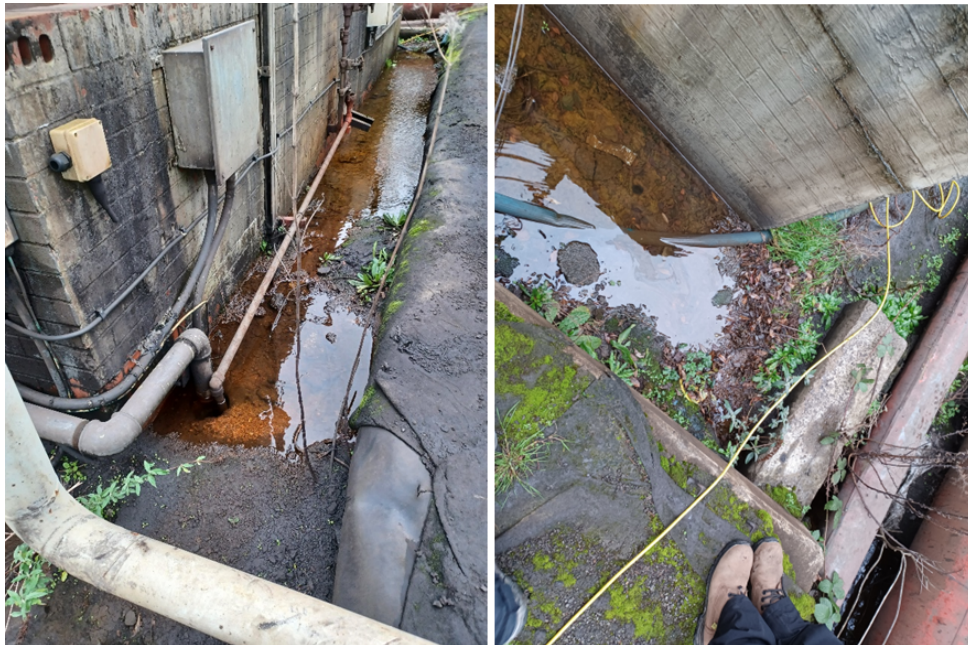
Image 2 & 3: Outlet pipe associated with Latex Tank appeared to be flooded, allowing for a release of water to ground behind the bund.

It was noted during the inspection that the outlet gully receiving water from the oil separator within the Latex Bund appeared to be blocked, resulting in an accumulation of surface water in the immediate vicinity of the drainage feature. NRW understands that the proposed arrangement is for surface water from the PC1/PC2 containment to be directed to this oil separator prior to discharge via this gully. TSUK must understand the connectivity of this drainage feature before they install this diversion, and will need to remedy the suggested blockage within the outlet pipework. Due to the design and class of the oil separator and activities undertaken within the bund, any discharge from the asset must enter the foul/effluent drainage network.

Due to this blockage, surface water was being discharged to ground to the rear of the Latex Bund. Furthermore, iridescence consistent with the presence of hydrocarbons was also observed upon the water surface. This constitutes an unauthorised emission to ground and is a contravention of permit condition 3.1.1. Consequently, a non-compliance score of C3 has been allocated against permit criteria IR3A(3) – Emissions to Land.

Additionally, the root cause of the permit breach above is considered to be insufficient management systems regarding operation of the Oil Processing Facility. This is a contravention of permit condition 1.1.1, and consequently a non-compliance score of C3 has also been allocated under compliance criteria IR1A – General Management.

CAR_NRW0050734.A6: TSUK must ensure, if they have not already done so, that the outlet gully associated with the Latex Bund is flowing freely. TSUK is also required to confirm the connectivity of this drainage feature before commissioning any works to divert surface water from PC1/PC2. This information must be submitted to NRW as evidence.

CAR_NRW0050734.A7: In addition to *CAR_NRW0050734.A3* TSUK must undertake a review of its management systems within the Oil Processing Facility to ensure that drainage infrastructure remains free-flowing at all times, thereby preventing any risk of surface flooding involving potentially contaminated water.

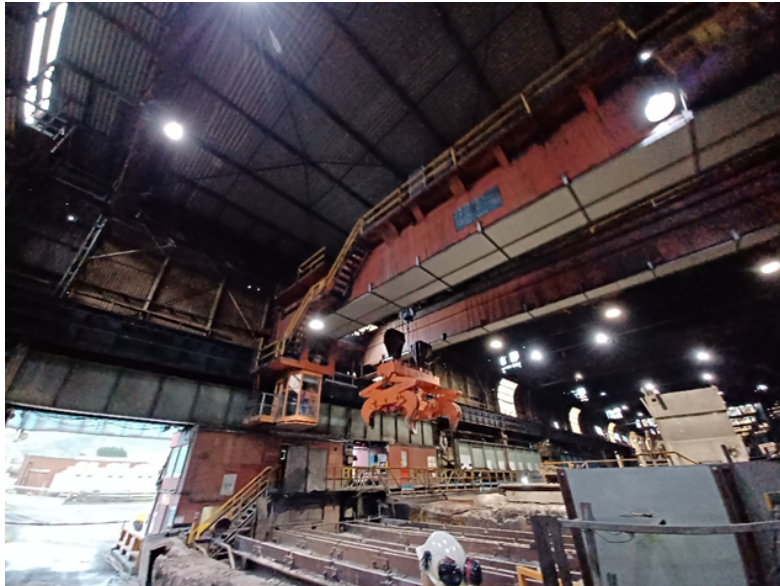
- TSUK has identified that the noise is originating from the *First Reduction Spur Gearbox* on the *Middle Outer Crane (AA146)*. The noise correlates with increases in torque and consequently, is exacerbated during instances of

- Due to the age and design of AA146, there is increased difficulty in sourcing suitable replacement parts.
- Remedial works are scheduled for the week commencing the 23rd of February 2026, with the refurbished gearbox component expected to be delivered on the 9th of February 2026.

Image 4: View of faulty Middle Outer Crane (AA146) associated with the Hot Rolling Mills

NRW Officers visited the area where the Middle Outer Crane (AA146) is located. This asset has been the subject of numerous noise complaints from the local community, as outlined in an earlier section of this CAR form. Although the crane was not in operation at the time of the visit, TSUK operated it upon request for the benefit of NRW.

CAR_NRW0050734.A1: TSUK is to confirm to NRW whether the remedial works on Middle Outer Crane (AA146) have been completed. If these works have not yet progressed, TSUK must provide an update outlining when the works are scheduled to be undertaken.
