NOTE TO FILE

JBA Project Code	2026s0165
Contract	Llanelltyd Sheet Pile Removal
Client	Natural Resources Wales
Day, Date and Time	17/03/2026
Author	James Nixon BSc MSc
Reviewer / Sign off	Natasha Todd-Burley BSc (Hons) PhD CGeog (Geomorph) FRGS
Subject	Llanelltyd Sheet Piling Geomorphological Assessment

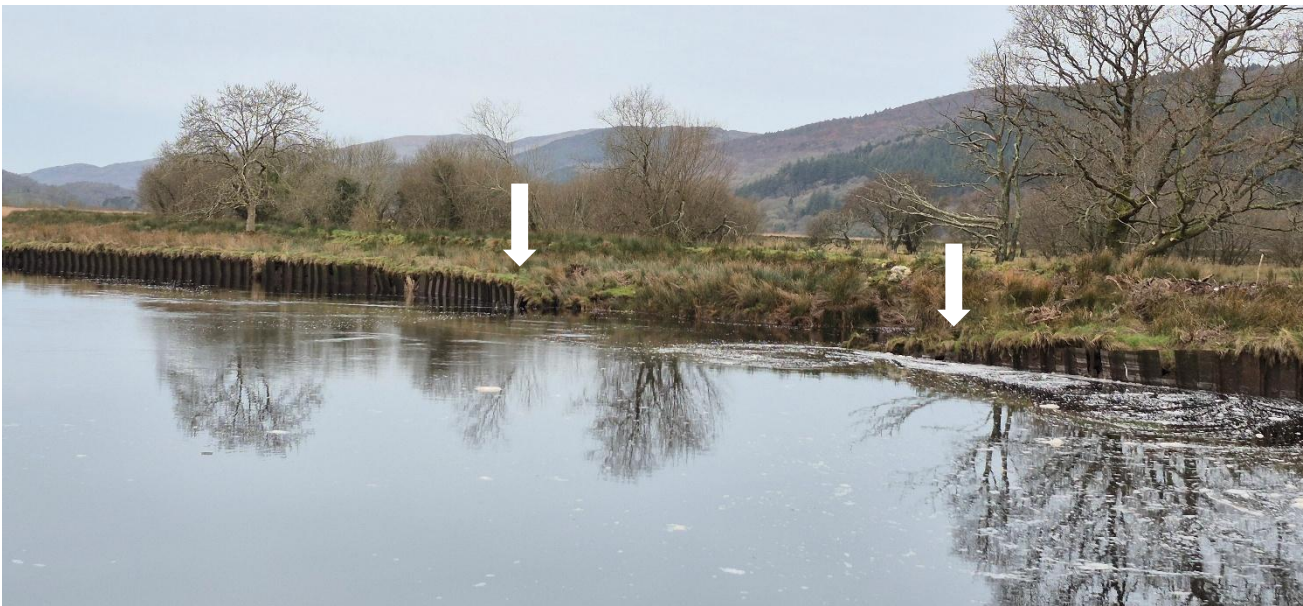
The site of interest consists of a 100m of sheet piling along the right bank of the Afon Mawddach, 30m of which has catastrophically failed. The sheet piling is located on the outside of a sharp 90-degree meander bend, with the worst failure in the sheet piling located just downstream of the apex of the bend (See Figure 3-1, Figure 3-2 and Figure 3-3).

Figure 3-1 Section failed sheet piling in the middle of the image between the white arrows (Left bank looking downstream)

The sheet piling is likely to have originally failed due to a combination of deterioration/ rusting of the sheet piling combined with high velocity helical flows on the outside of the meander bend. It can be inferred that the majority of erosion took place while the water levels were lower than when observed on site, suggesting that the toe of the sheet piling will have scoured out first leading to a failure of this section of the structure.

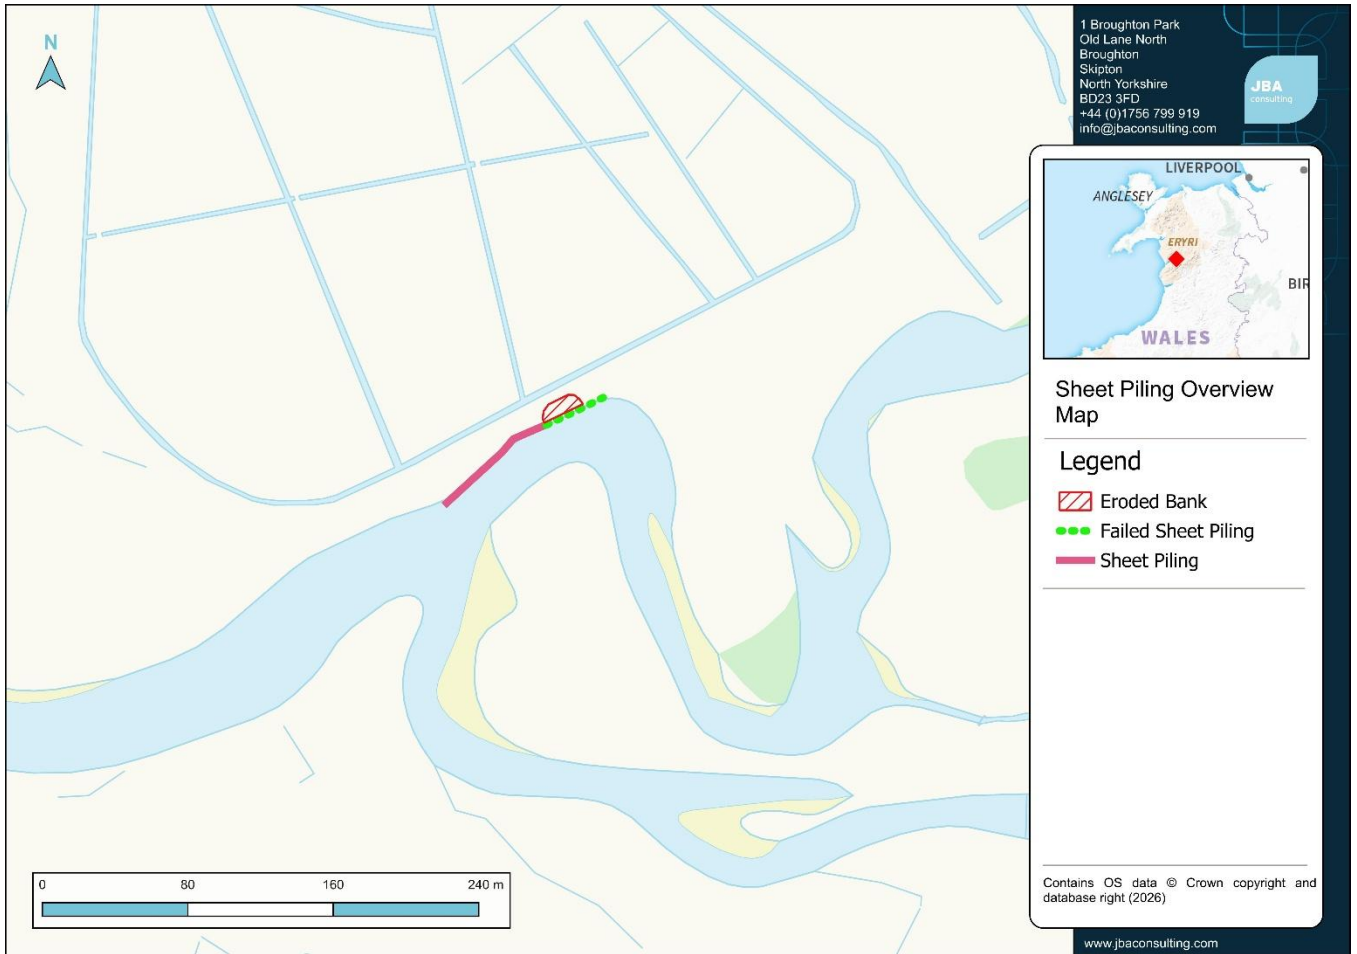
The failure of the sheet piling has left part of the bank exposed on a section of bend with the highest velocity flow; this has caused erosion of the bank between the sheet piling and the informal flood bund (see Figure 3-3). The flood bund had also suffered extensive erosion and was breached, but was temporarily repaired by the landowner. The erosion of the bank has left the tie-rod foundations of the sheet piling dangerously exposed in the river (see Figure 3-4), which are now underwater obstacles when the tide is up and pose a risk to people using the river for water sports.

Figure 3-2 Map showing the positioning of the sheet piling, failed sheet piling and area of erosion

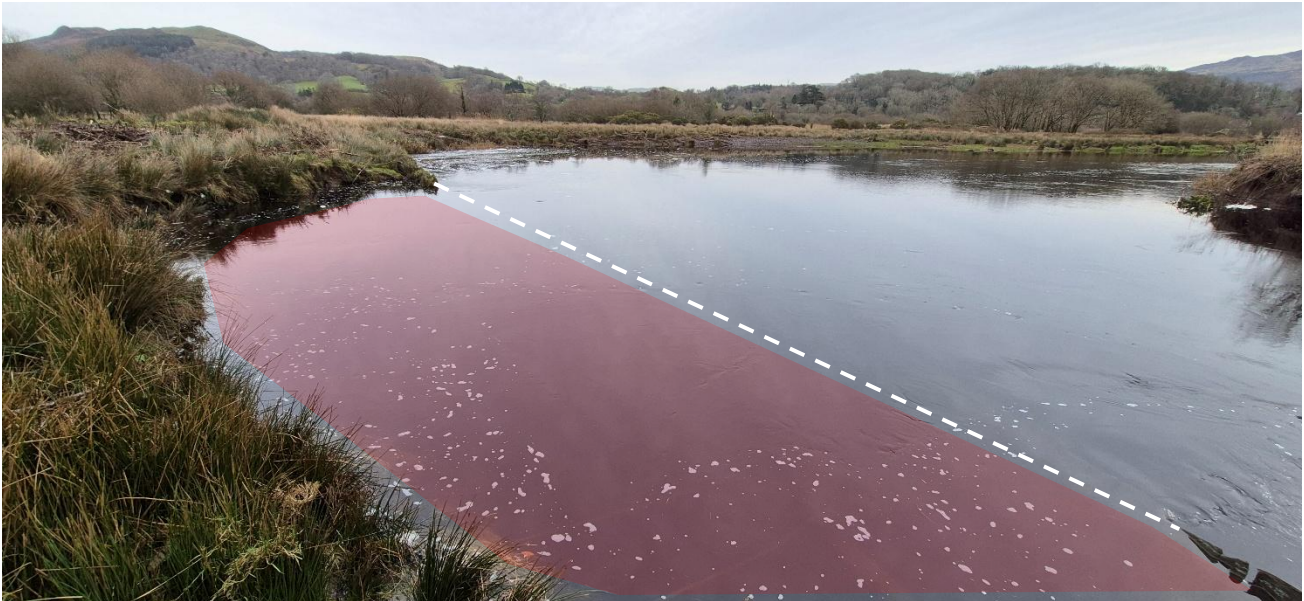
Figure 3-3 Section of failed sheet piling and the extent of subsequent lateral channel movement and scour. White line represents where the existing bank line and sheet piling was, with the red area representing the extent of scour. (right bank looking upstream)

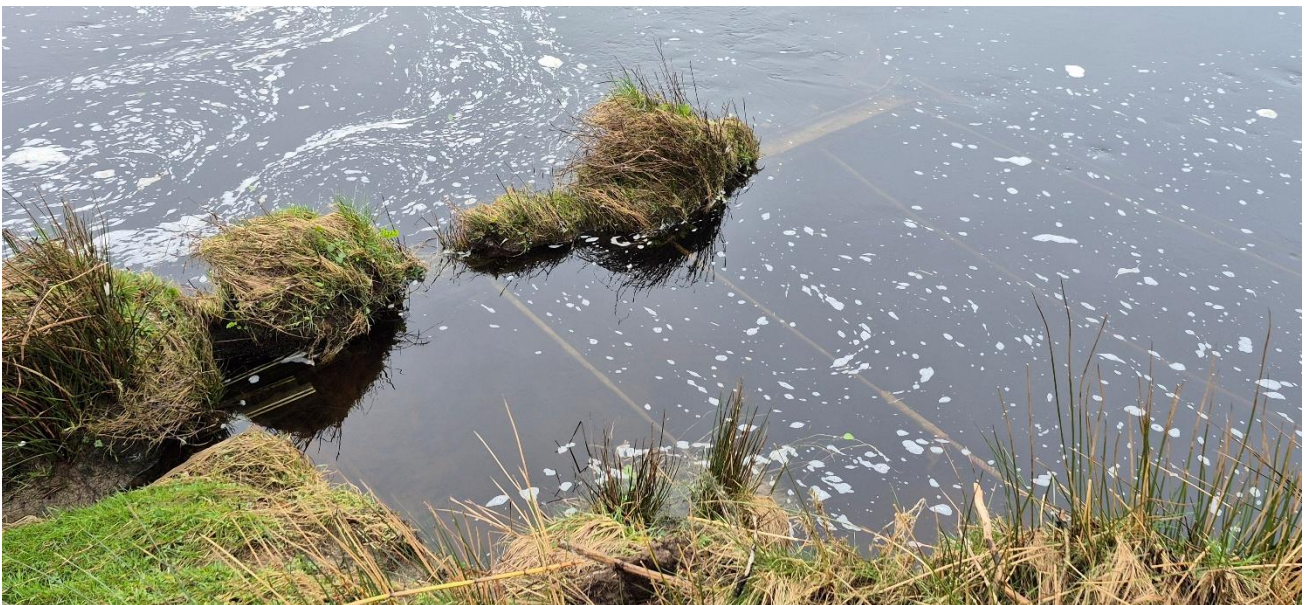
Figure 3-4 Foundation tie rods of the failed sheet piles still in place, just visible below the high tide (right bank looking downstream)

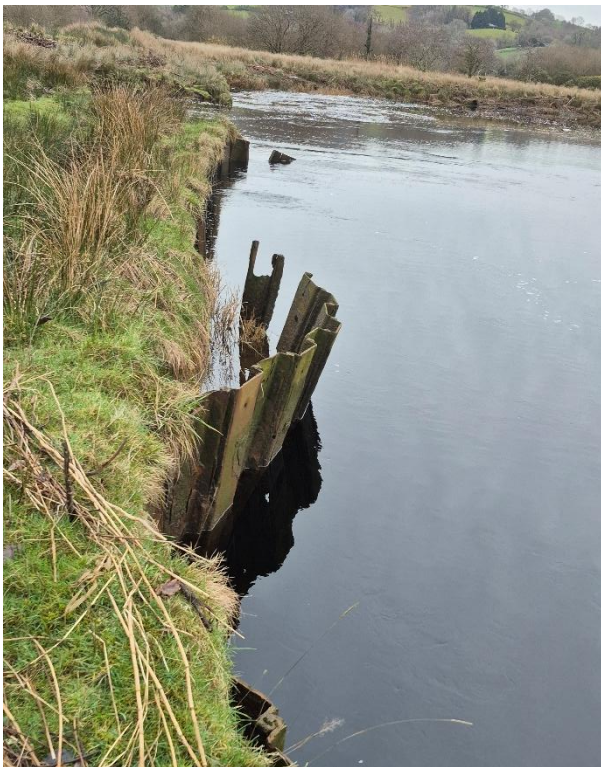
Figure 3-5 The downstream section of sheet piling beginning to fail (right bank looking upstream).

The downstream section of sheet piling was also visibly beginning to fail, with sections of it leaning out towards the channel as can be seen in Figure 3-5. This may have also been from the toe of the sheet piling starting to destabilise along with the metal work rusting.

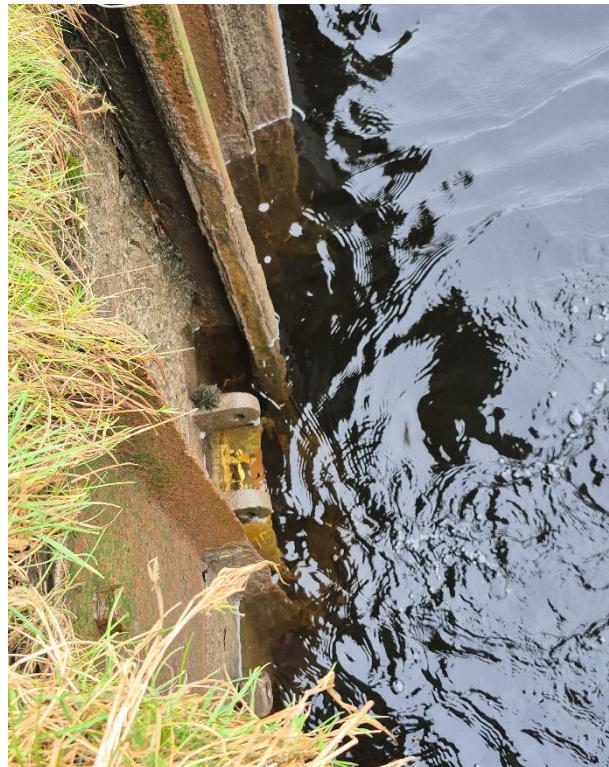
Figure 3-6 Outfall in the sheet piling missing a flap valve (right bank looking upstream).

There was also a surface water outfall present in the sheet piling. The outfall was discharging at the time of the visit with surface water from the farmland behind the flood embankment. The outfall was missing a flap valve (see Figure 3-6) meaning the water can flow back up through the structure at times of higher flows.

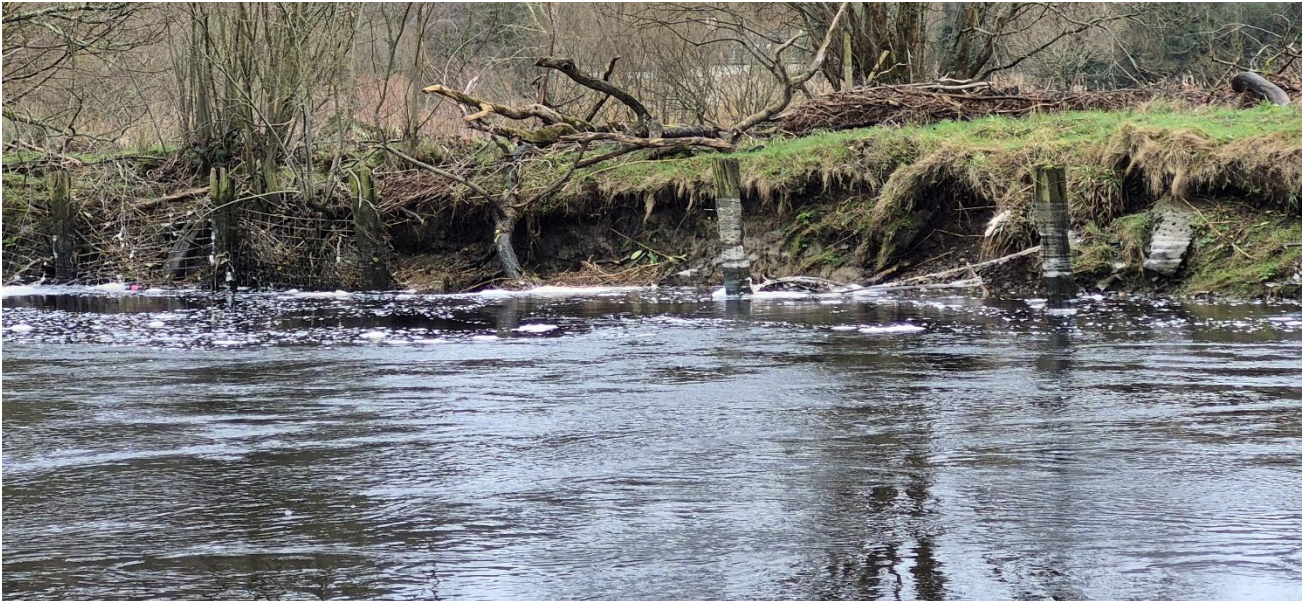
The channel is more disconnected from the floodplain than downstream, with generally higher and steeper banks observed in this section of the river. This upstream reach exhibited a significant amount of active erosion with bare banks visible throughout, that appeared to be relatively friable. One section of erosion of note was the section of bank between the Mawddach and the Wnion that showed evidence of full bank scour (see Figure 3-10). There are also the remains of a fence or potential failed bank protection along this section of bank, likely to try and stop the two rivers meeting. The banks appear relatively consolidated but have been subject to significant erosion suggesting a high energy environment.

Figure 3-10 Section of eroded bank face between the Afon Mawddach and the Afon Wnion. A fence/ failed bank protection is visible in the form of posts in front of the bank face

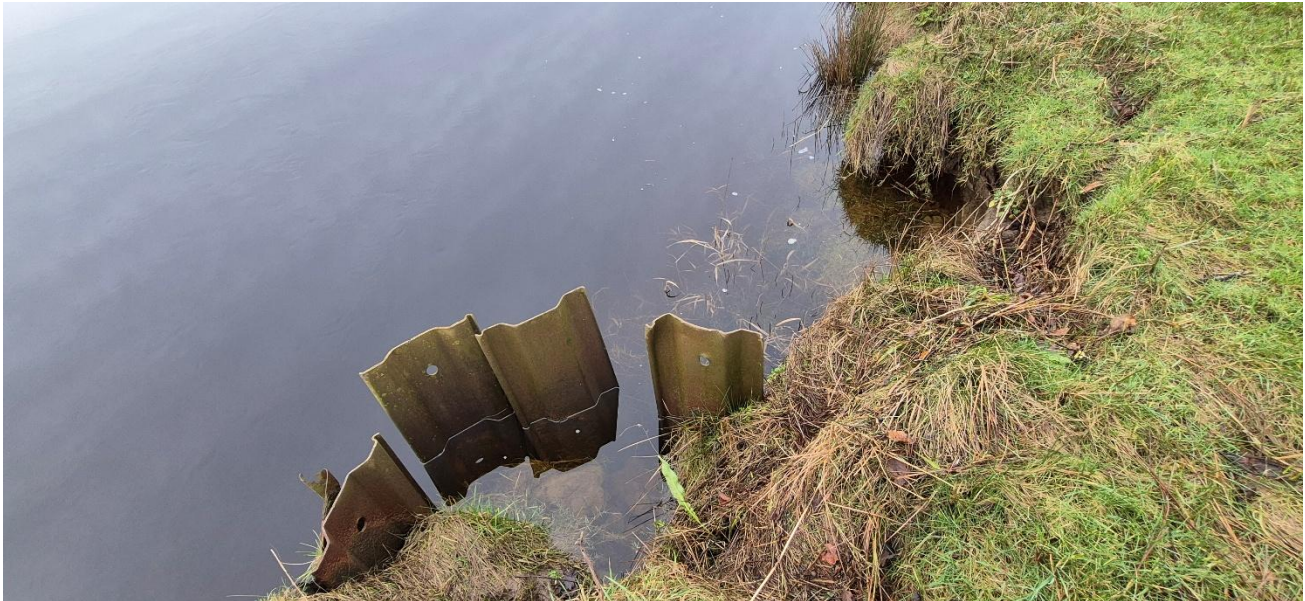
The Afon Wnion joins the Afon Mawddach immediately downstream of the site and was observed to have caused erosion along the left bank at the mouth of the Wnion and more crucially on the right bank immediately downstream of the 100m of sheet piling. This erosion has started to destabilise the other (downstream) end of the of the sheet piling leading to its deterioration and imminent failure (see Figure 3-11). Aerial imagery from 2006, shows that the bank here has retreated around 6-10m, due to the flow velocity out of the Wnion. This is also an increasing threat to the section of sheet piling that is yet to fully fail.

Figure 3-11 Evidence of basal scour and slumping causing deterioration and failure of the sheet piling at the downstream end of the site (right bank looking downstream)

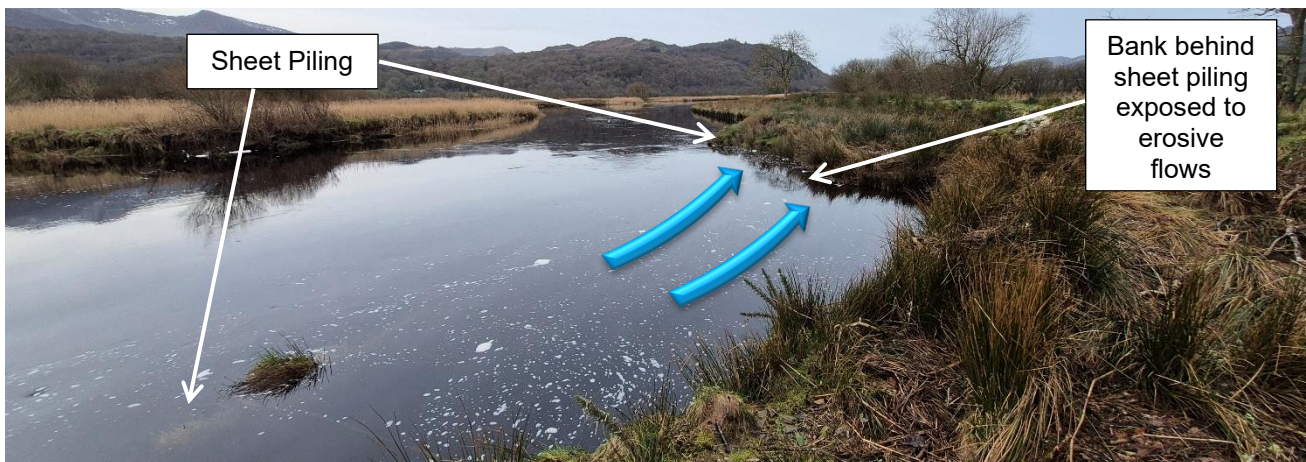
With this option, flow energy is still likely to be directed at a small section of bank, the only section without protection, meaning the flow is more likely to continue to quickly erode this part of the bank. In addition, the removal of the failed section will likely leave the section of bank behind the remaining sheet piling more exposed to erosive flows that are likely to outflank and erode the foundations of the sheet piling from behind (see Figure 4-1), resulting in a higher likelihood that this piling will rapidly fail as it is already deteriorating.

Figure 4-1 Shows how erosive flows can be directed to the bank behind the downstream sheet piling (flow is represented in blue arrows) (photo take from right bank looking downstream)
