## Compliance Assessment Report CAR\_NRW0052101

**Permit being assessed:** AN0235601

**For:** Hafod Quarry, **held by:** TARMAC TRADING LIMITED

**Parts of permit assessed:** Site drainage infrastructure

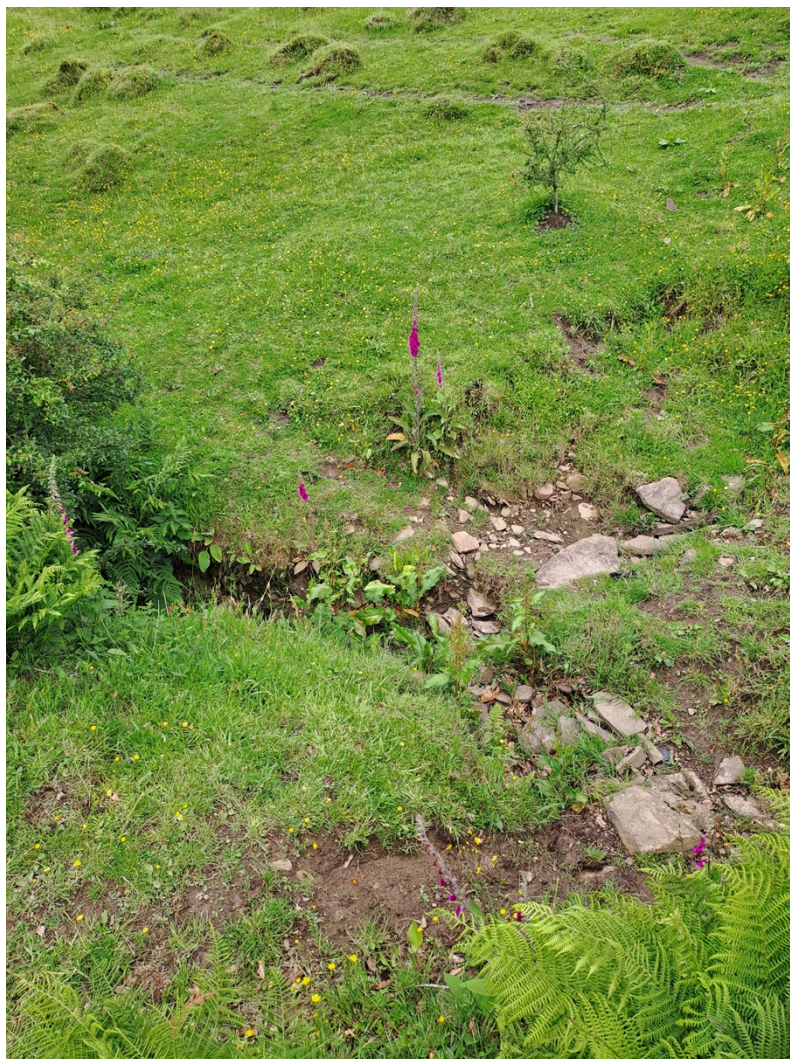
We began our site observations by following Nant Hafod Fach from the point where it emanates at ST299197172 then follow it downstream to identify any points where additional inputs could be transporting sediments into the watercourse. At the time of the visit there was no flow in the watercourse, as seen in Figure 1.

Figure 1 – The point where Nant Hafod Fach emanates and the start point of our site visit.

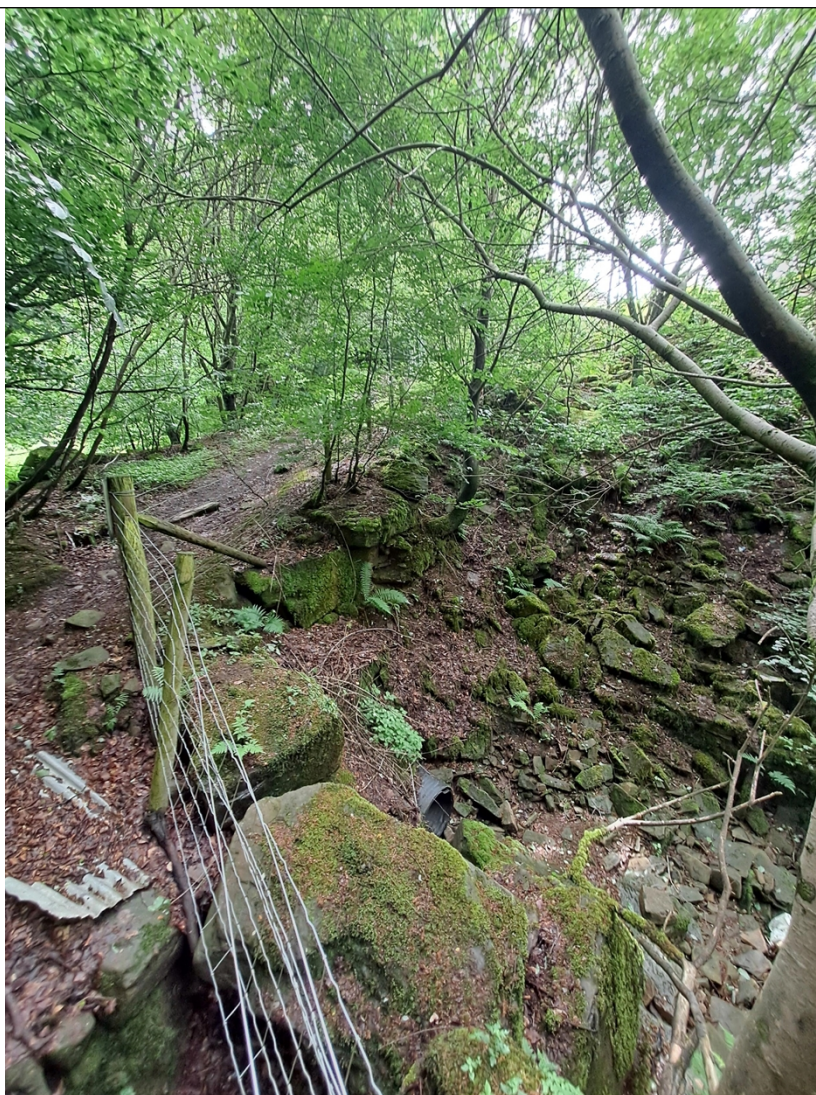
We walked downstream with LJ as far as where Nant Hafod Fach crosses the site boundary at ST226569953, however no input points were identified. At this point LJ left GS and I to retrieve their vehicle and to drive back to site, leaving us to inspect the remainder of the watercourse. There was still no flow in the watercourse at this point, as evidenced in Figure 2. It is key to note that it started raining moderately at this time.

Figure 2 – The point where Nant Hafod Fach enters the site. No flow at the time of the visit.

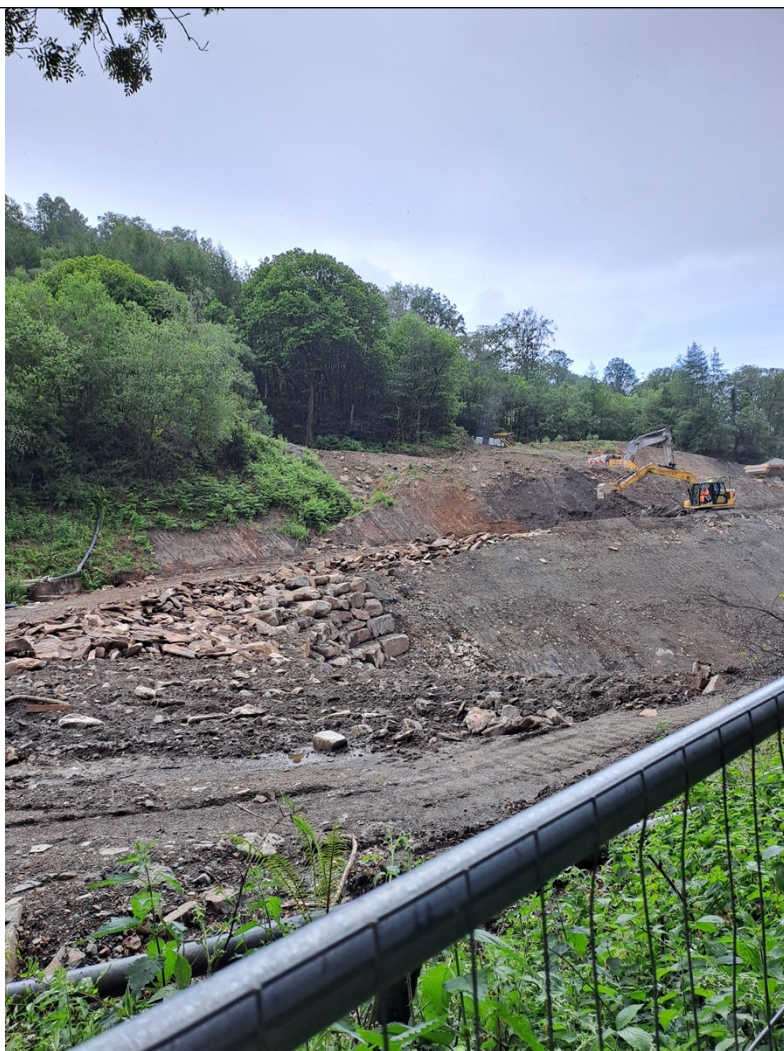
At ST2248496544 some of the site drainage infrastructure was visible, including the pipes transporting water between lagoons as well as the newly constructed settlement lagoon. It is noted that the volume of water being held in this lagoon was minimal at the time of the visit. These observations can be seen in Figure 3.

Figure 3 – Site drainage infrastructure as observed during the visit.

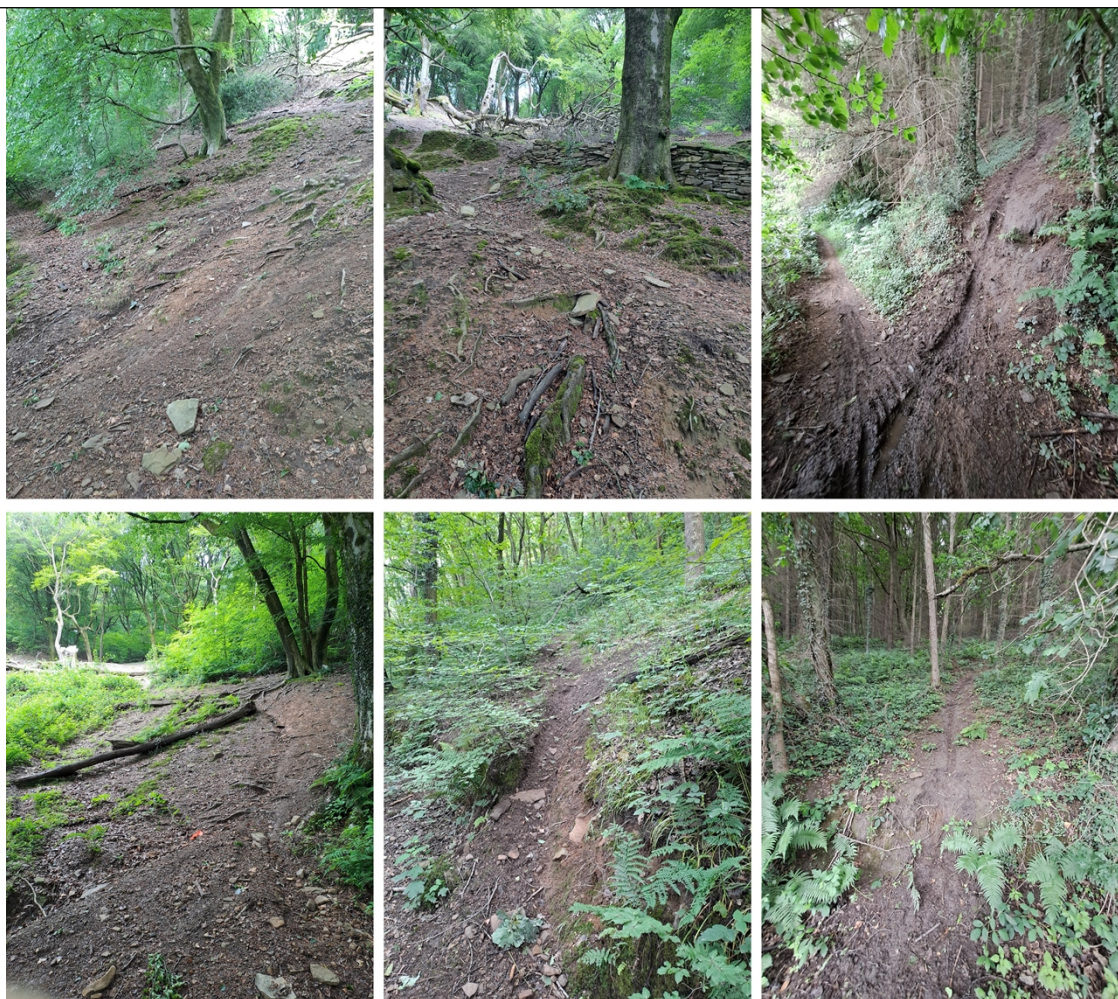
GS and I walked the footpath along the boundary of the site. While we observed numerous eroded paths (as seen in Figure 4) reported to have been created/caused by bikes, there was no active runoff of any kind observed at the time of the visit. We walked the footpath to the point where it joins Lower Brook Street at ST2201796052. No active runoff or flows of any kind were observed. We proceeded to check the permitted discharge point.

Figure 4 – An example of the areas of erosion reportedly acting as a conduit for polluted runoff.

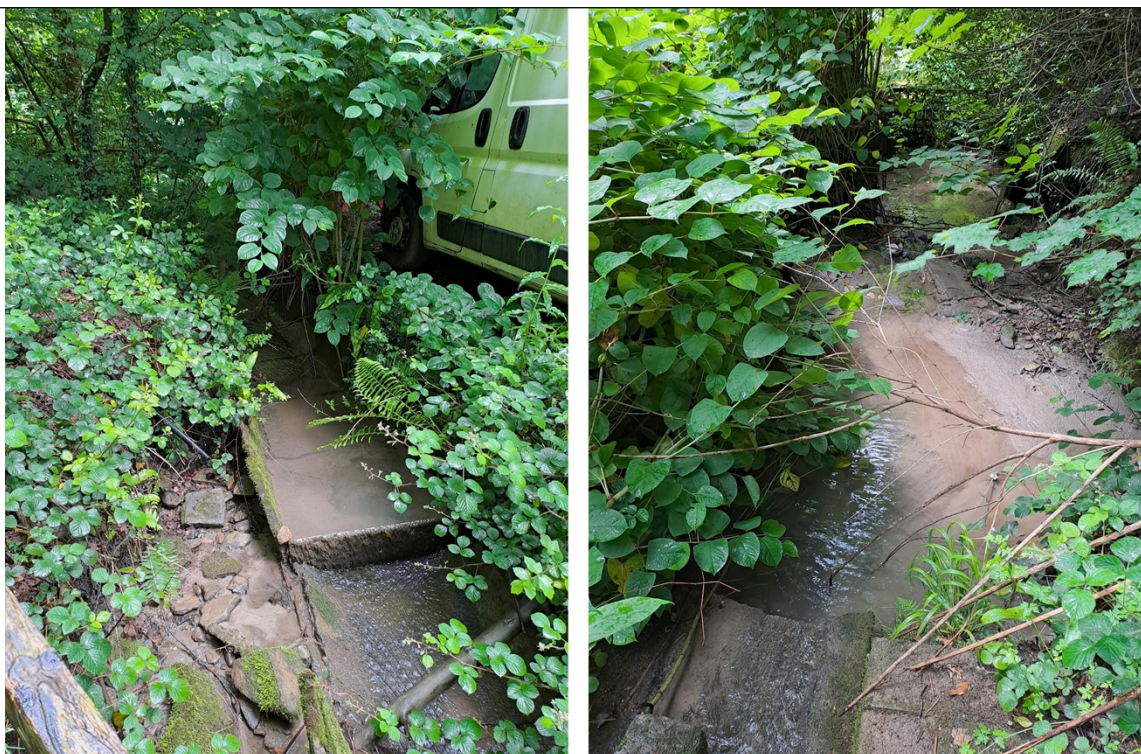
The sample point was observed. The water itself was running clear that the time of the visit although there was evidence of significant siltation on the bed of the leat both at the sample point and downstream. This is evidenced in Figure 5.

Figure 5 – The sample point, upstream (left) and downstream (right) as observed during the visit.

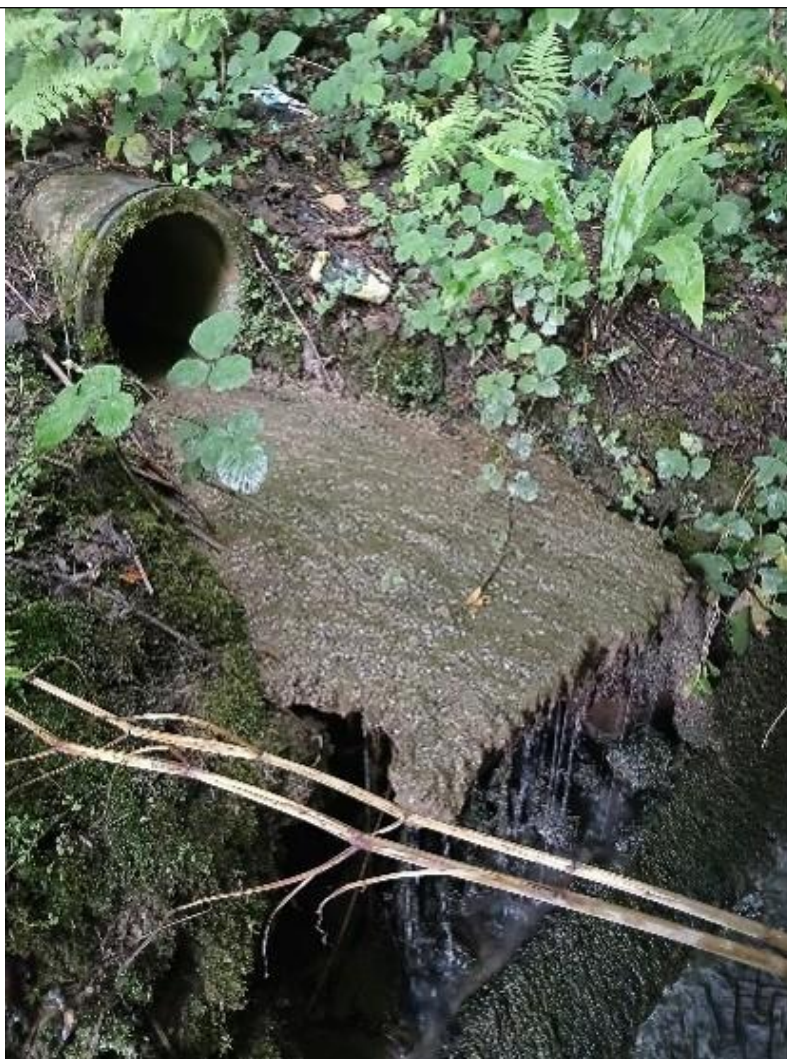
On investigating around the sample point, a lateral pipe previously identified by NRW sampling staff discharging polluted water was located ~4m upstream of the sample point. There was clear evidence of siltation around the outfall, as can be seen in Figure 6. At this time it was not clear where this lateral pipe was originating and what this discharge was. However it was known that the road leading up to the site is serviced by a closed drainage system which includes gullies, silt traps and interceptor chambers. It was decided that the leat would be walked and inspected back up to the site before officers retrieved drain lifting equipment from the incident vehicle to survey this drainage system. LJ rejoined us at this point to undertake upstream investigations.

Figure 6 – Lateral pipe discharging to the leat directly upstream from the sample point.

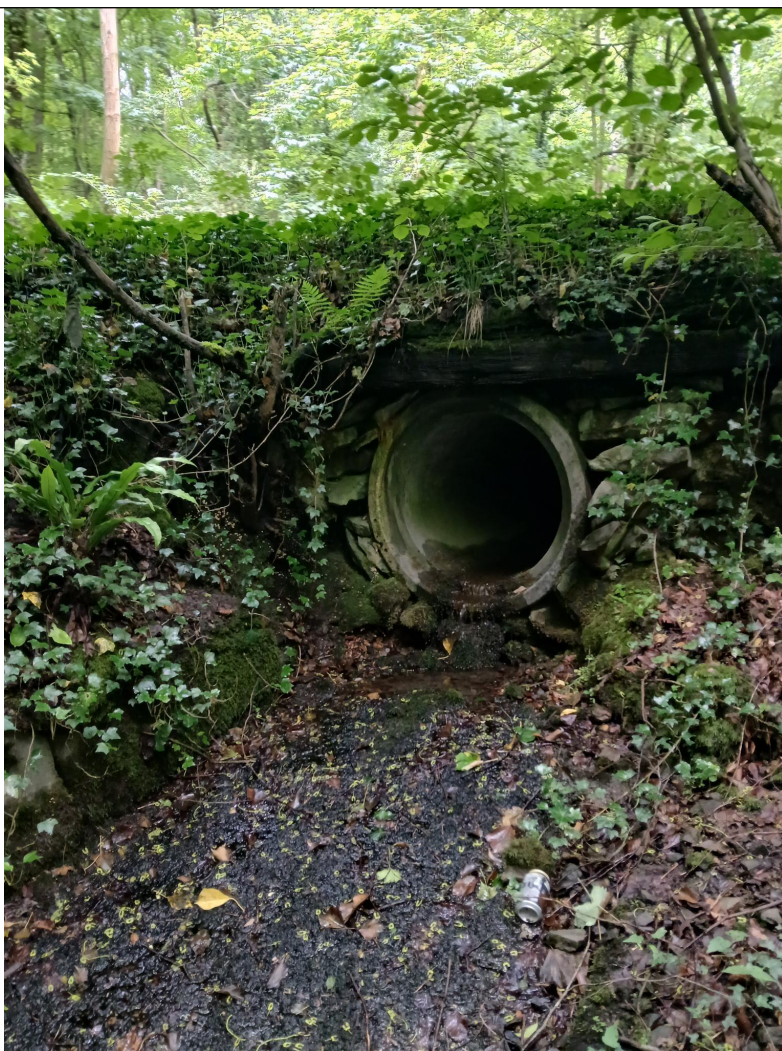
We walked the leat upstream to identify any additional inputs or issues which may be contributing to the ongoing siltation issues. A large 800mm pipe was found at ST2201296038 discharging clean water to the leat. From the drainage plan the pipe is listed as taking water from the public footpath and surface water via a soakaway on the opposite side of Lower Brook Street. Between the sample point and this pipe there was a clear flow in the leat, however directly upstream of the outfall of this pipe there was no flow. This pipe and the water quality can be seen in Figure 7. After making these observations we continued our investigations upstream.

Figure 7 – 800mm pipe discharging to the leat as observed during the visit.

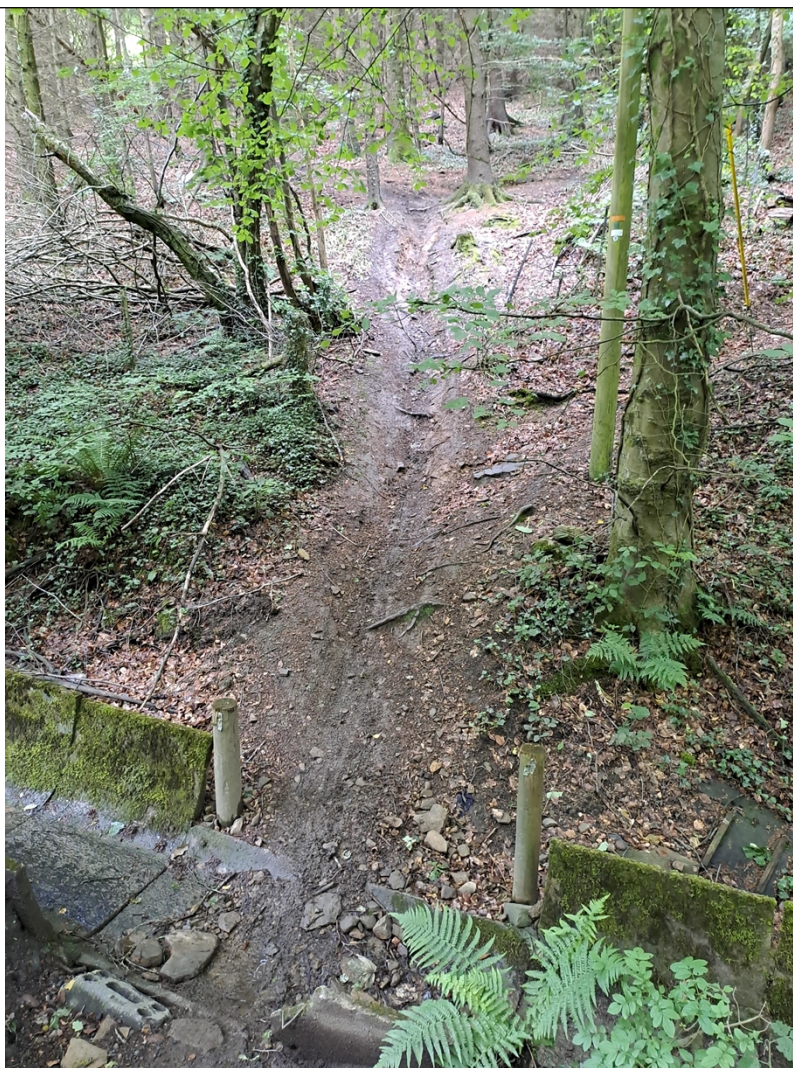
Further upstream at ST2205396069 another area of erosion caused by bikes was observed, as seen in Figure 8. LJ noted this as a major area of concern and that it becomes majorly silted during heavy rainfall with water clearly running over the eroded, exposed soil from off site. It is noted that there was no silty runoff observed at the time of the visit, however it is clear that the lack of vegetation as a result of the bike tracks pose a very high risk of erosion and silt mobilisation. It is also clear that a section of the concrete channel has been removed in order to accommodate this bike track.

Figure 8 – Exposed area of soil caused by bike tracks.

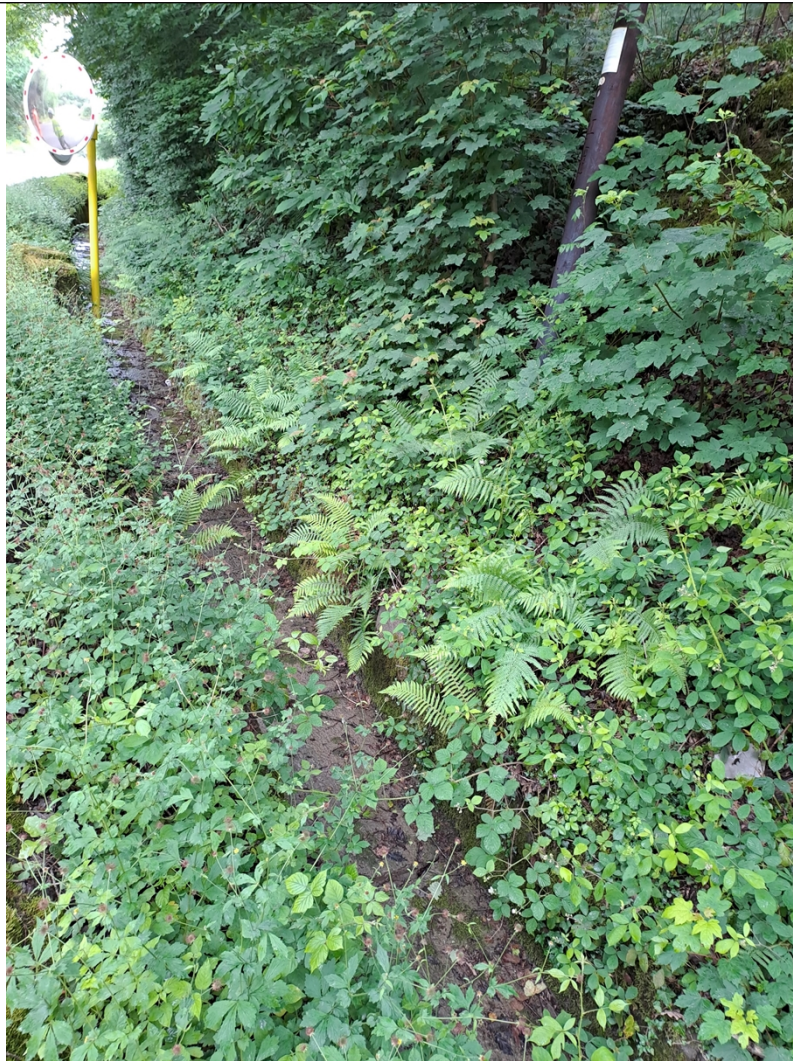
We walked the leat as far as ST2209496138 to where the new sample point will be located once the variation to the site's discharge permit comes into effect in October 2026. There was no flow from upstream present in the leat (as seen in Figure 9) so no further upstream investigations were undertaken. We returned to the vehicle in preparation to survey the road drainage system.

Figure 9 – The leat near the forthcoming new sample point as observed during the visit.

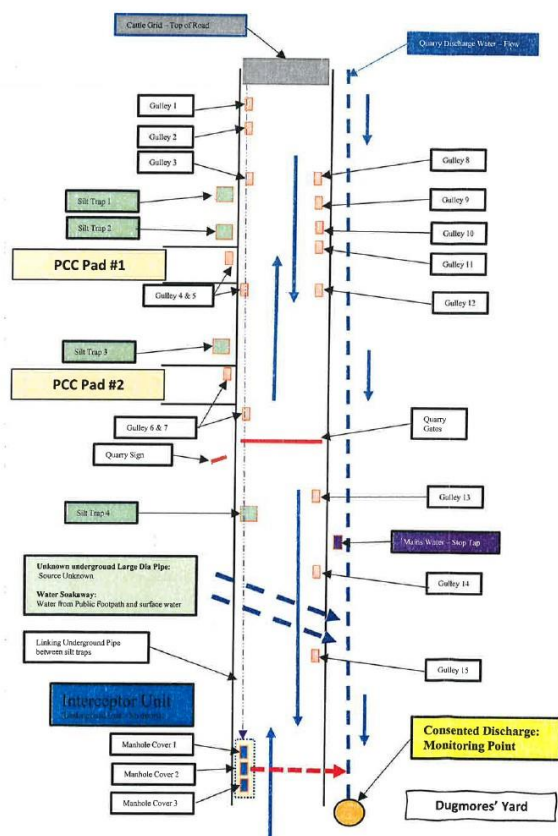
Figure 10 – Surface water discharge system on entrance/exit road (2022)

Drainage plans for the enclosed road drainage system were available and can be seen in Figure 10. It is noted that the plan is dated 2022 but LJ was not aware of any changes made since this plan was created.

7. Undertake a full survey and assessment of the road drainage system to form an updated plan and confirm how it works. Any issues/faults shall be identified and communicated with NRW to agree an acceptable deadline to complete remedial works.

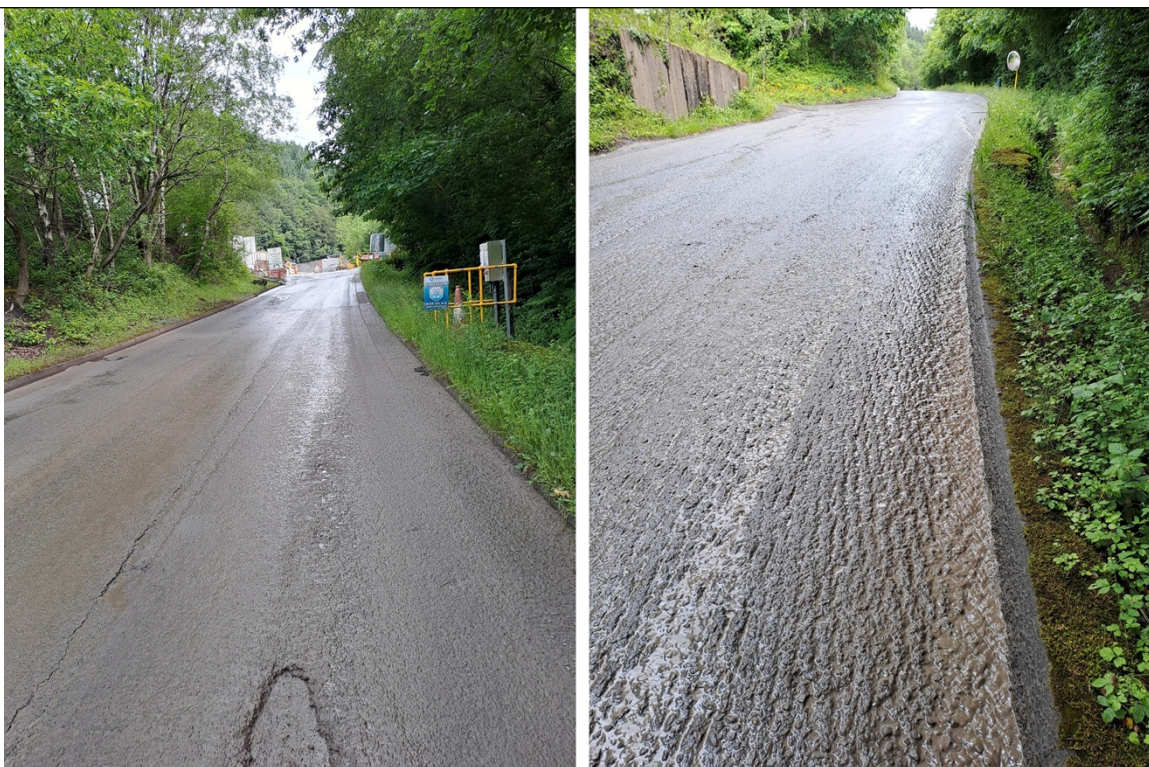
It was decided to survey the system in the direction of flow, checking the infrastructure stated to be in place as well as the conditions and water quality within the chambers where possible. It is key to note that the intensity of the rainfall increased before this section of the visit, visibly increasing the volume of surface water present on the road leading to site. The conditions of the road at the time of the visit can be seen in Figure 11, with residual silt/mud present being tracked on/off site by vehicles and increased runoff entering the road gullies. It is noted that there were road sweepers and tankers on site undertaking maintenance at the time of the visit.

Figure 11 – The conditions of the road as observed during the visit.

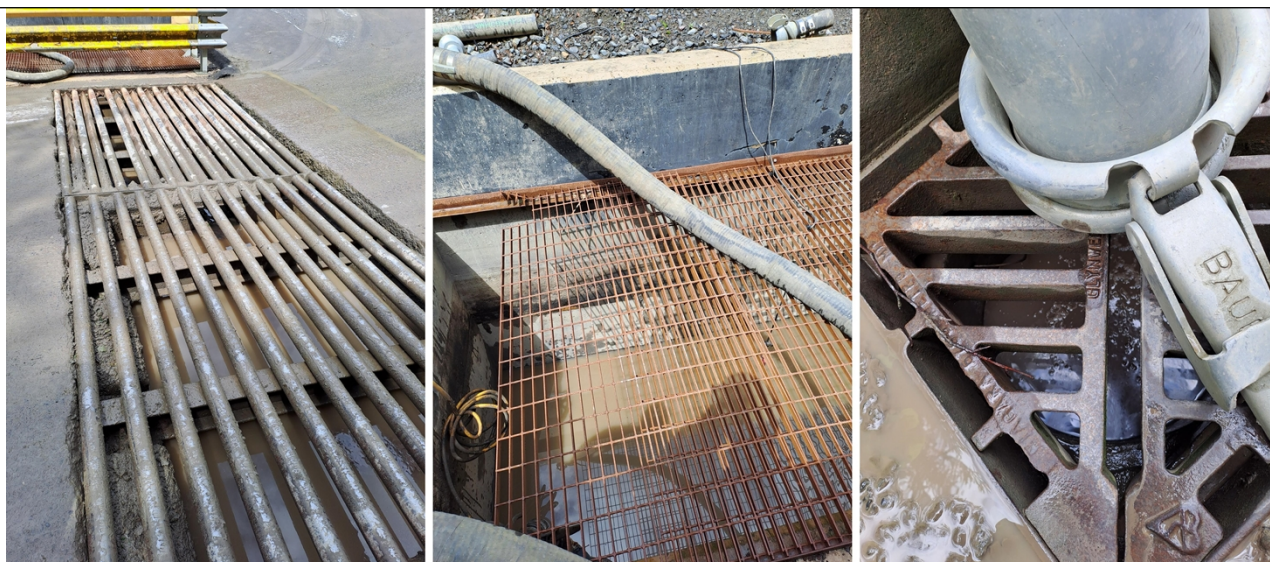
The cattle grid at the entrance to the site was seen to be heavily polluted with silty site runoff as expected. This flows into the adjacent catch pit. The site have installed a temporary Silt buster system which treats this catch pit effluent before discharging it back into a road gully, as seen in Figure 12. It is noted that the Silt buster was not in operation at the time of the visit.

Figure 12 – The cattle grid and catchpit as observed during the visit.

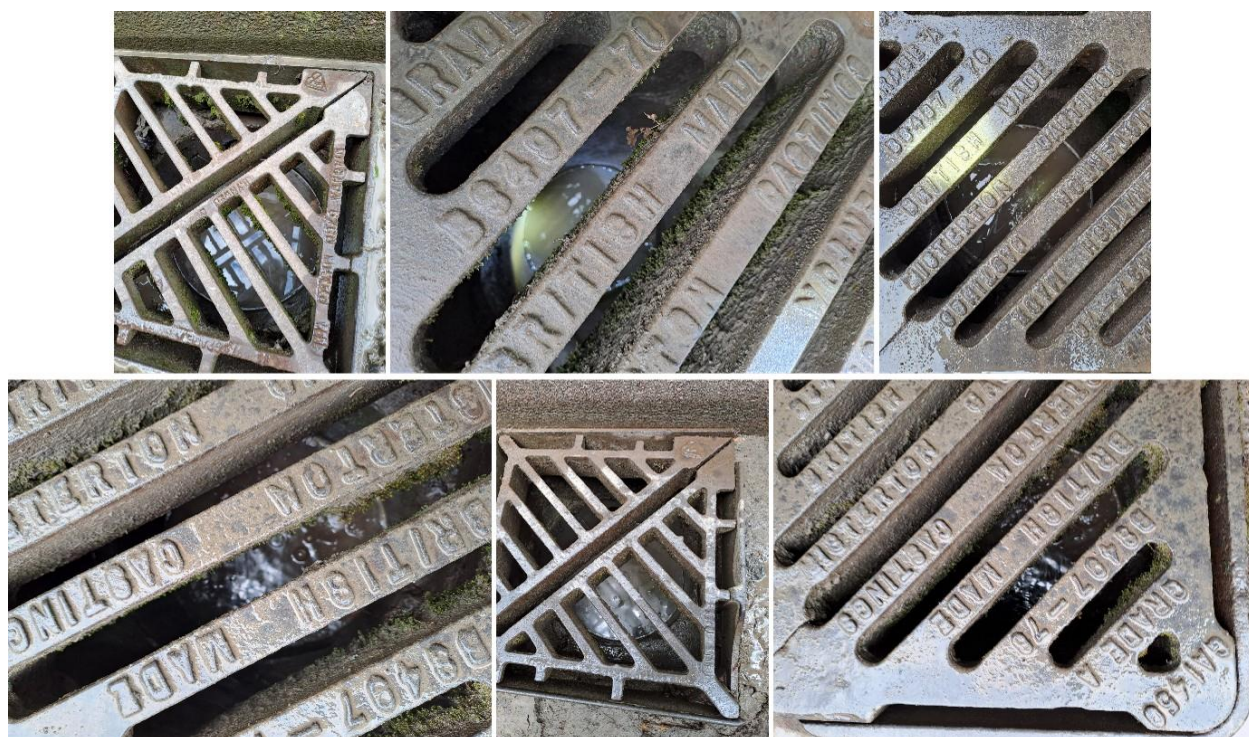
The gullies displayed significant signs of siltation, directing this effluent into the drainage system downstream of the site. It is assumed that these gullies discharge via the slit traps, into the interceptor and out into Nant Hafod Fach via the sample point. An example of the gully condition can be seen in Figure 13.

Figure 13 – The condition of the road gullies as observed during the visit.

5. Include cleaning and assessments of the road drainage system in the regular maintenance programme for the site going forward.

6. Provide evidence of regular maintenance and cleaning of the road drainage system via waste transfer notes and assessment records.

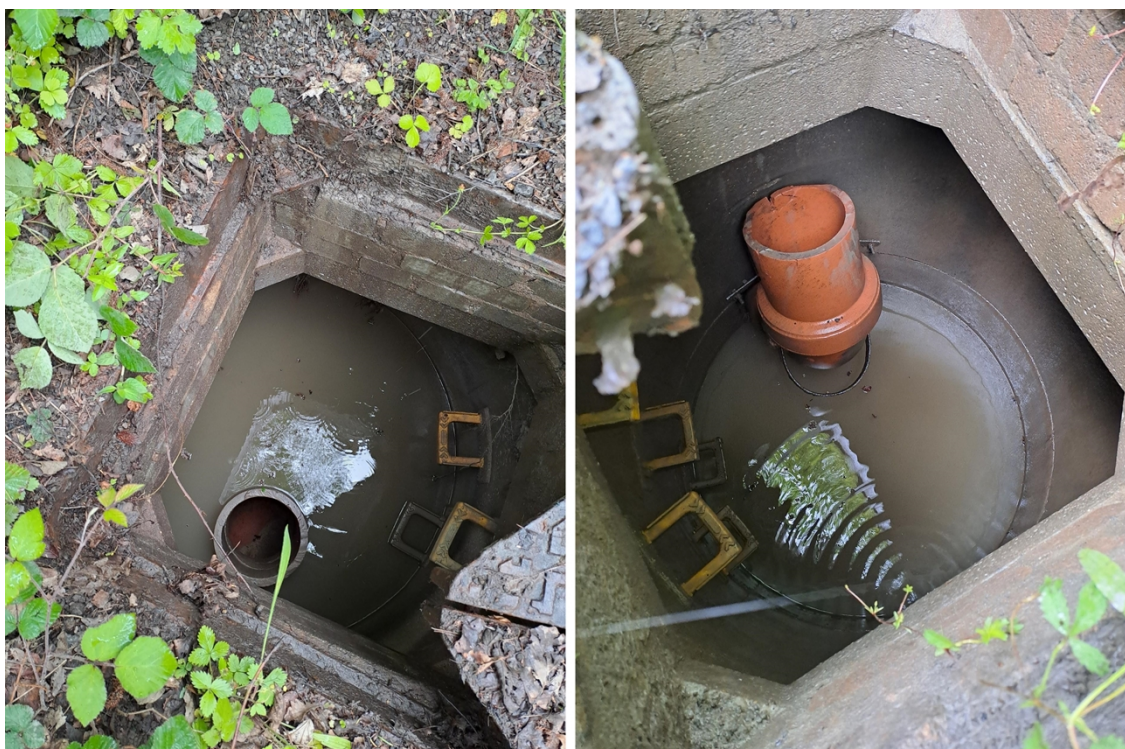
The system has 4 listed silt traps on the plan. These were all inspected in turn where possible. Silt traps 1 & 2 were lifted and appeared to be working as designed with silted effluent entering the settlement chamber and standpipes in place to allow for the settlement of solids prior to discharge. At the time of the visit the standpipe was not being overtopped and as such there was no discharge from either silt trap. These observations can be seen in Figure 14.

Figure 14 – Silt traps 1 and 2 (left and right respectively) as observed during the visit.

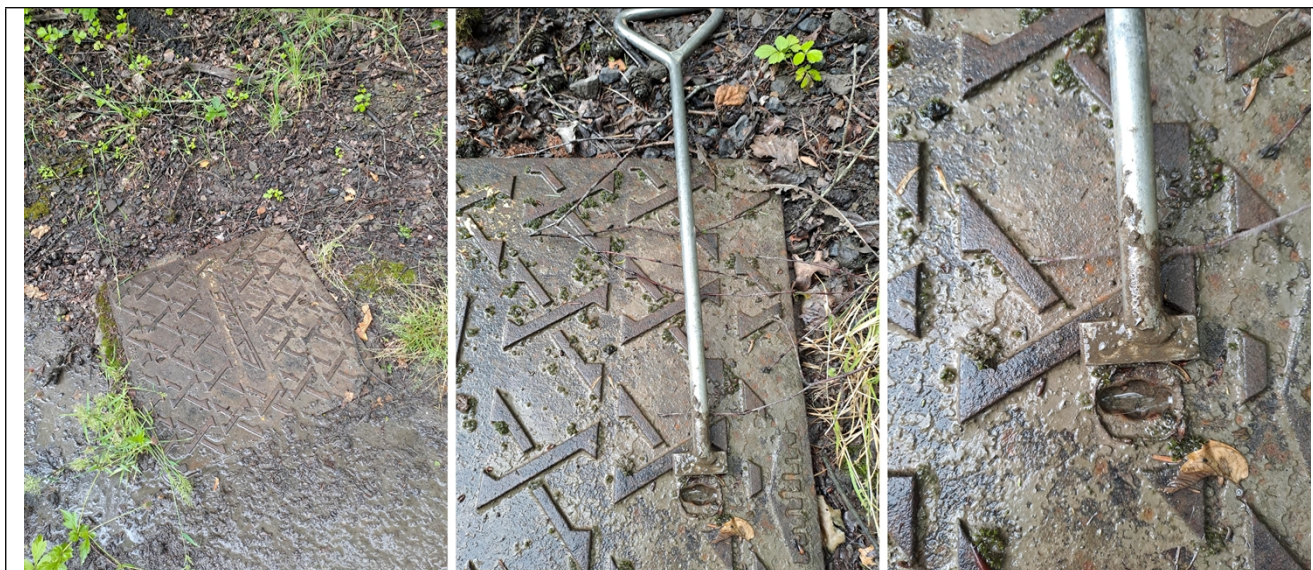
We attempted to lift the chamber listed to be Silt Trap 3 but due to us having the incorrect drain key sizes (as seen in Figure 15) we were unable to do so and check the infrastructure within. As such I have actioned that the site gain access to the chamber and provide photographic evidence of the internal infrastructure for assessment. Further details on this action can be seen below.

Figure 15 – The chamber identified as Silt Trap 3 which we were unable to be lifted during the visit.

1. Provide NRW with photographic evidence of the inside of silt trap 3 as evidence of its condition.

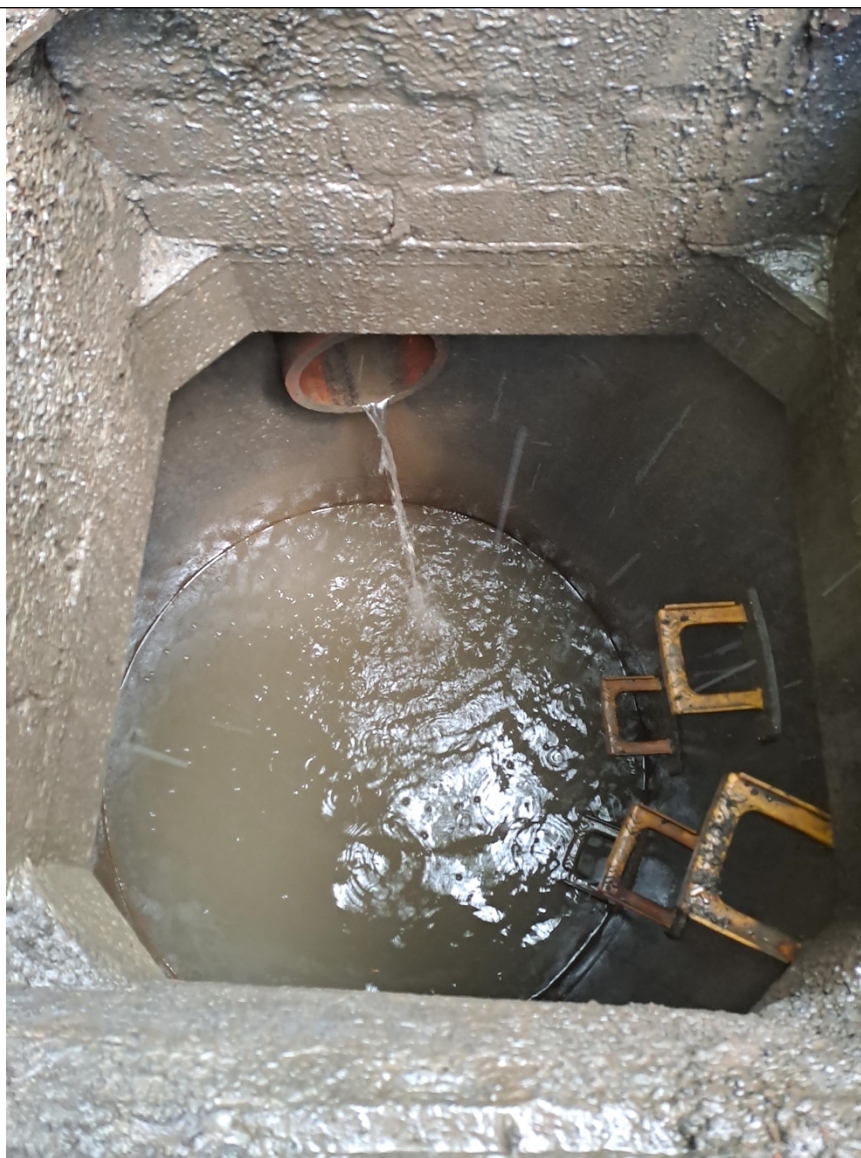
On lifting the chamber identified as Silt Trap 4, it was evident that there was no standpipe present. There was silty effluent being held within the chamber, as well as minimal, clear input from upstream, but it was unclear where and if there was a discharge being made from this chamber. This is evidenced in Figure 16. On discussing this with LJ, it was noted that they recall there being a reason for the omission of a standpipe in this chamber but could not remember the details and justifications at the time of the visit. As such I have added an action for the site to inform NRW why there is no infrastructure in place in this chamber for it to act effectively as a silt trap. Further details are seen below.

Figure 16 – The chamber identified as Silt Trap 4 as observed during the visit.

2. Inform NRW why there is no infrastructure in place in Silt Trap 4 for it to act effectively as a silt trap.

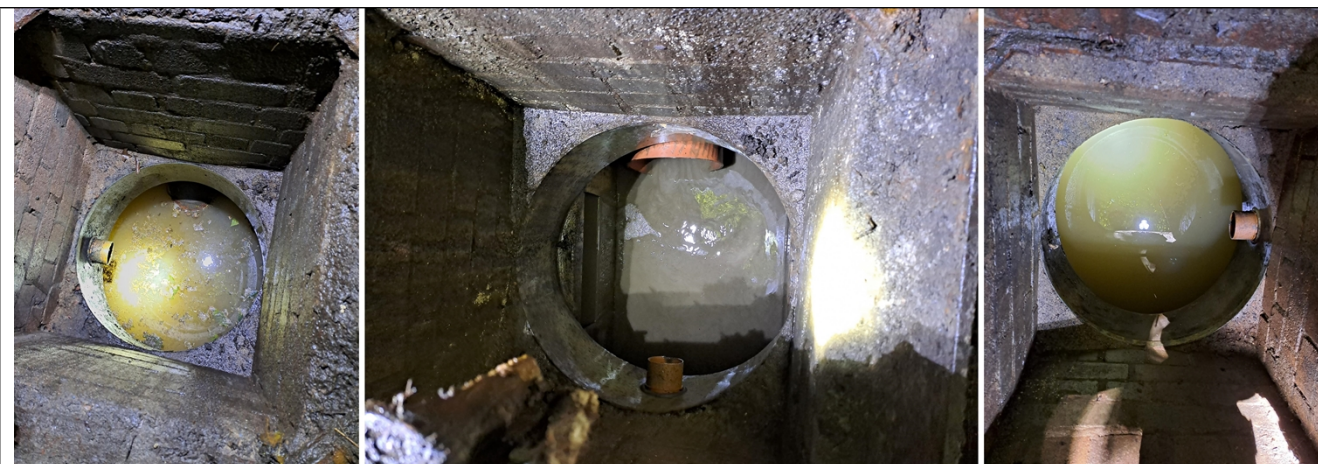
The interceptor system was inspected. It comprises 3 manholes and discharges to the leat via the lateral pipe observed in Figure 6. Manhole 1 was lifted and found to be relatively clear of silt with minimal flow in or out. Manhole 2 was very silty with a clear discharge in the direction of the leat, and it is unknown how this silty water is not present in Manhole 1 or 3. Manhole 3 was also mostly clear with no apparent flow present. These observations can be seen in Figure 17. When discussing with LJ it was agreed that the system should be cleared of effluent so that an assessment of how it operates can be made and corrective actions made where needed. This is detailed in the actions list below.

Figure 17 – Manholes 1-3 (left to right) of the drainage interceptor as observed during the visit.

3. Clear the interception chambers of effluent so that an assessment of how it operates can be made. Inform NRW of how the system operates once identified.

4. Undertake corrective actions on the interception chambers if/where needed.

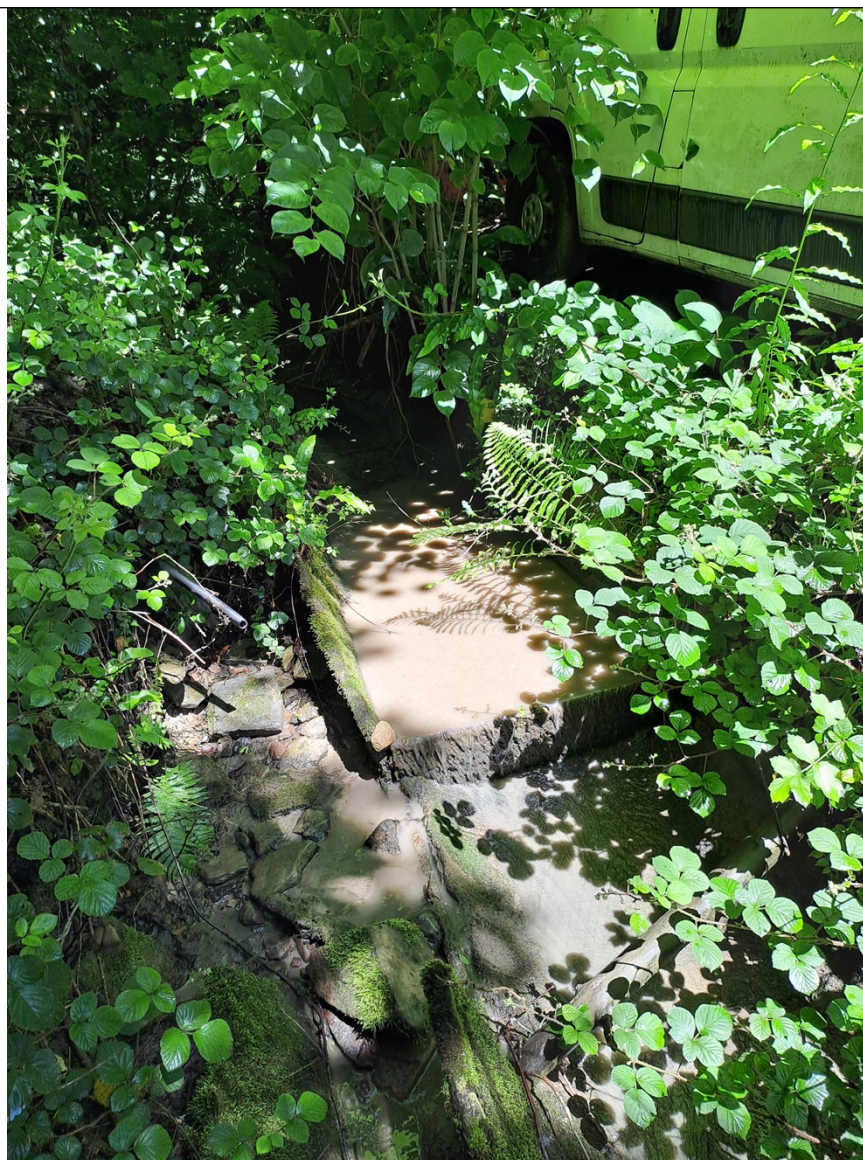
Due to the apparent significant volume of silty water discharging from Manhole 2, the discharge point was checked again and found to be considerably siltier than when it was observed earlier in the visit. As such it suggests that this is the primary reason that continued breaches of consented limits are being experienced. This can be seen in Figure 18. While visually it was apparent that this was breaching the site discharge limits, I did not sample the discharge at the time of the visit and I have not scored it as a breach on this occasion. I have noted it as an ongoing non-compliance that we are working towards resolving. This is reflected below.

Figure 18 – The permitted sample point on a subsequent check during the visit.

A visual assessment of the effluent clearly shows elevated suspended solids. No samples were taken at this time but regular exceedances have been recorded by NRW over the past several months. As such this has been recoded as an ongoing non-compliance and not a new/separate breach. See actions list below for corrective actions to resolve this issue.
