# **Ferry Road Landfill**

Hydrogeological Risk Assessment

December 2021

County Council of the City  
and County of Cardiff

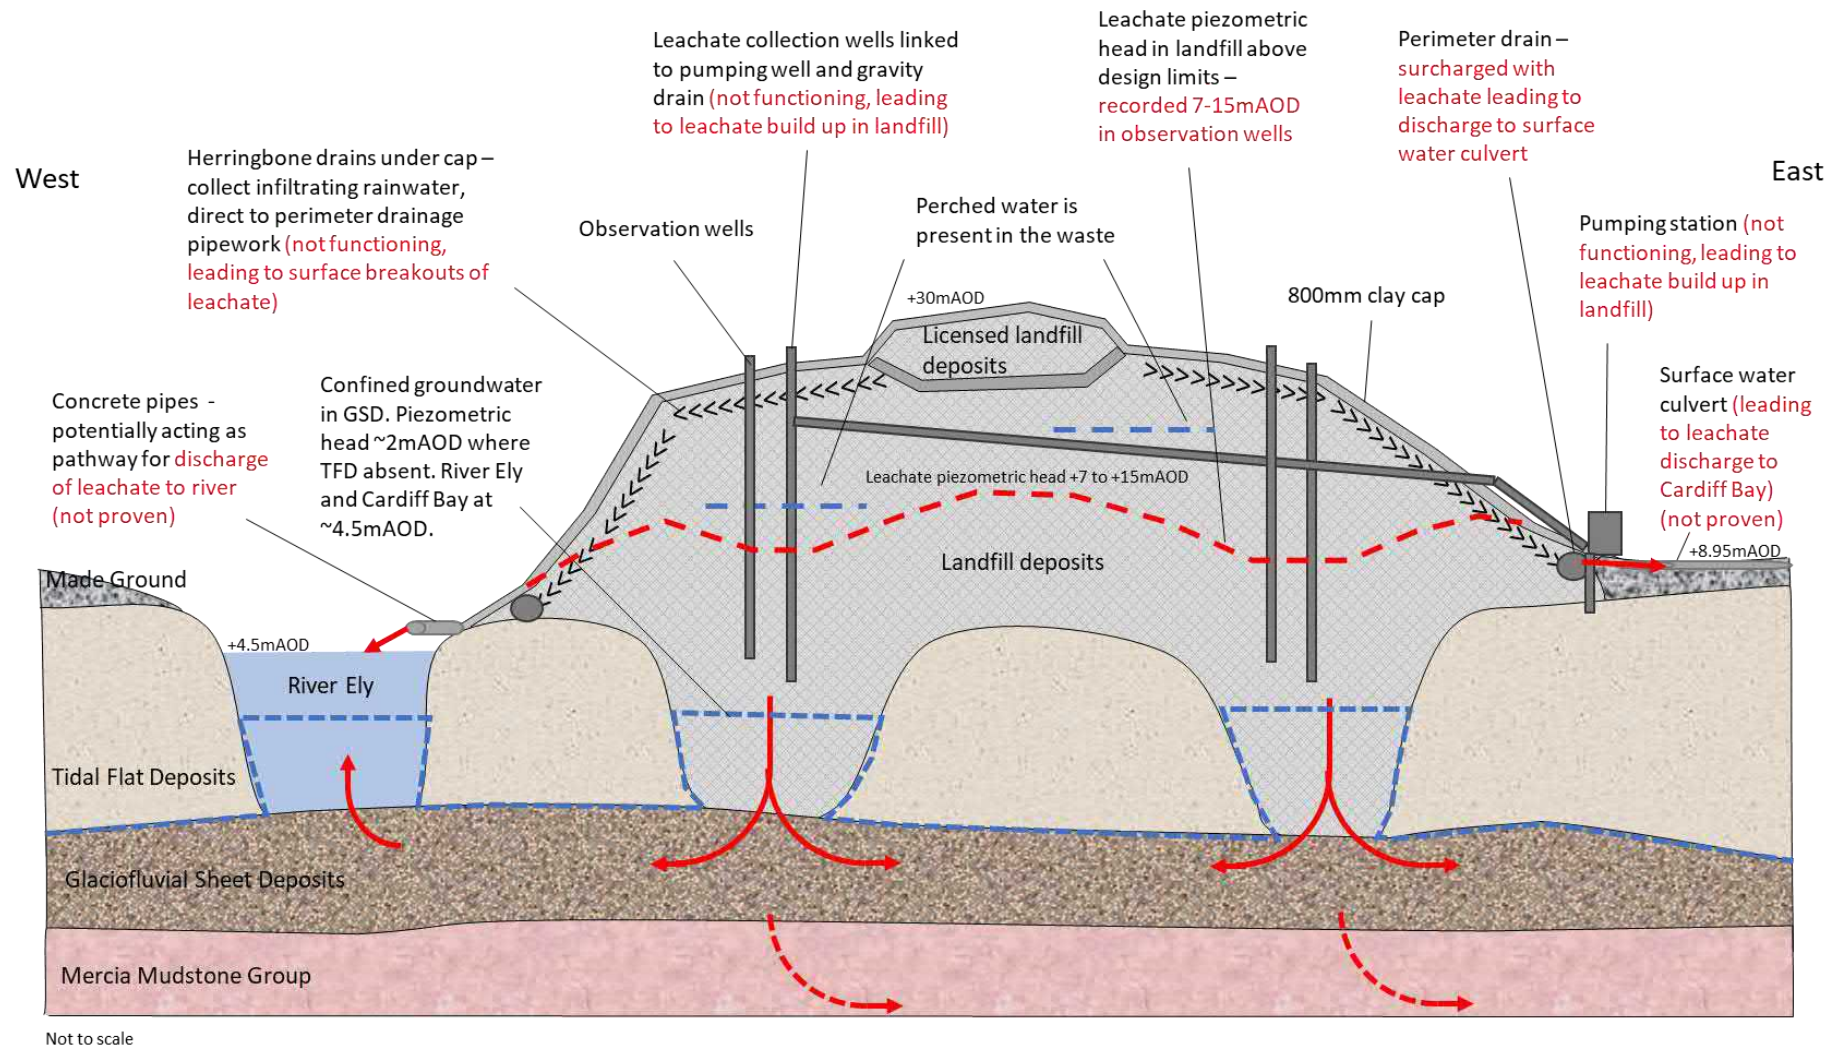
**Figure 3.1: Conceptual Site Model for Ferry Road Landfill site**

A diagrammatic hydrogeological CSM has been prepared to highlight key site details as shown in Figure 3.1. Note that this does not show human health or built environment receptors unless applicable to the hydrogeological assessment.
