## Compliance Assessment Report CAR\_NRW0052671

**For:** Cardiff Energy Recovery Facility, **held by:** Viridor Trident Park Limited

**At:** Trident Park, Glass Avenue, Cardiff, CF24 5EN.

**Reason:** Incident Response (Incident number 2501560).

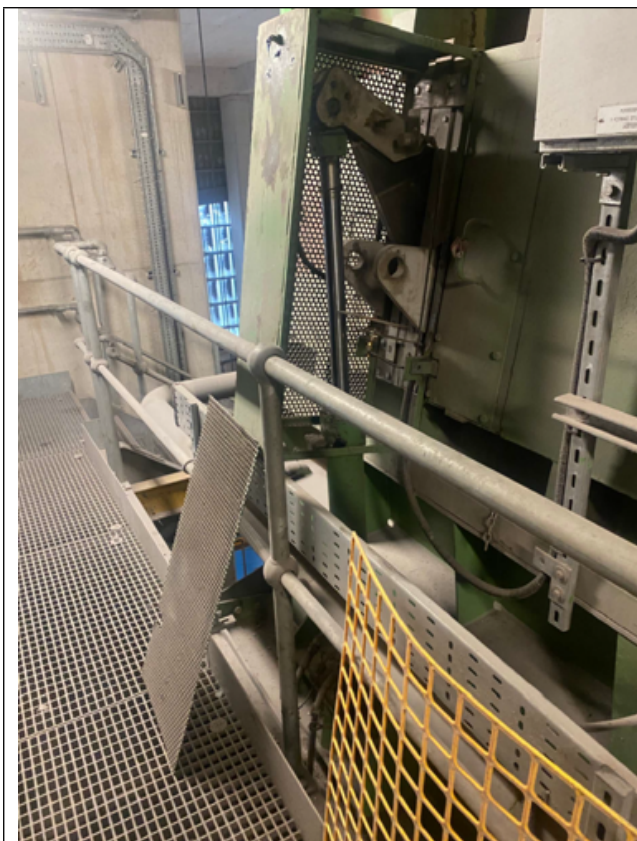
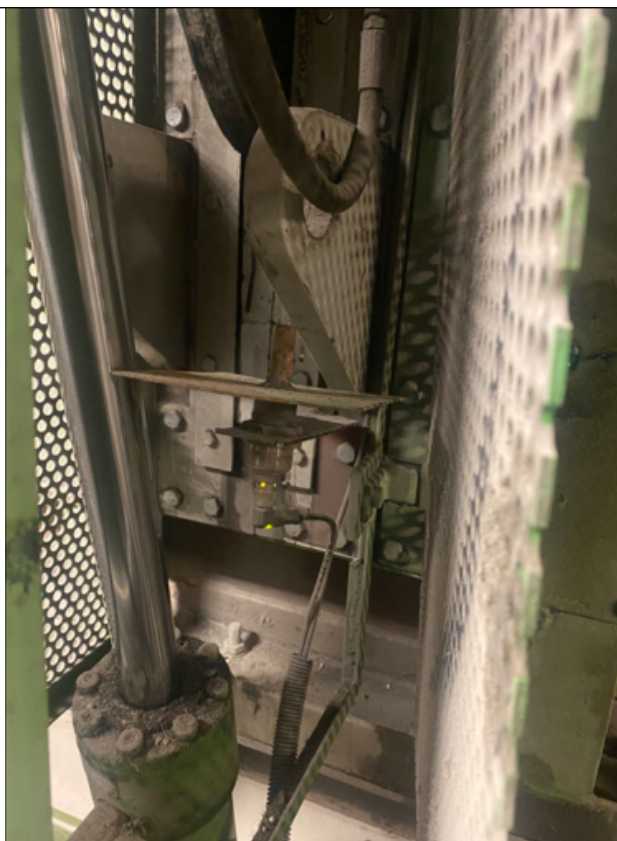
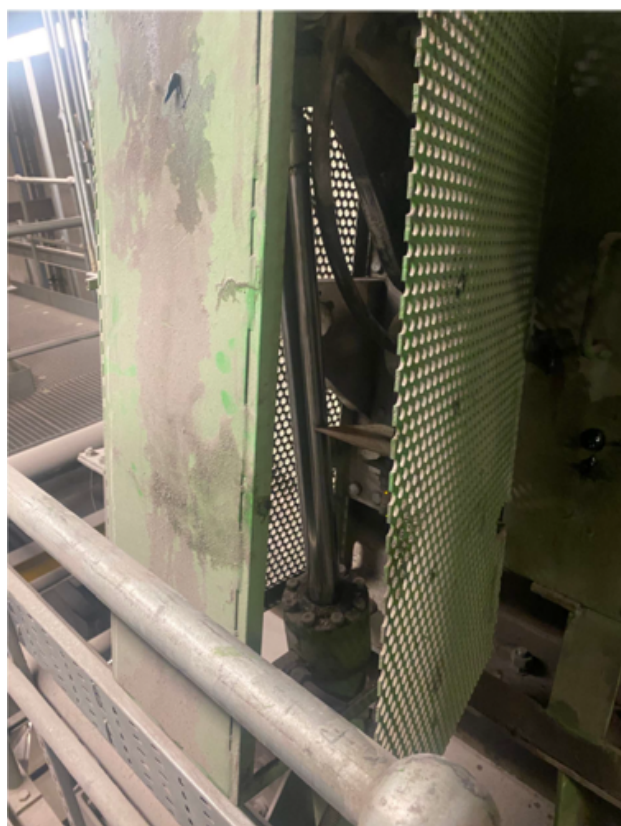
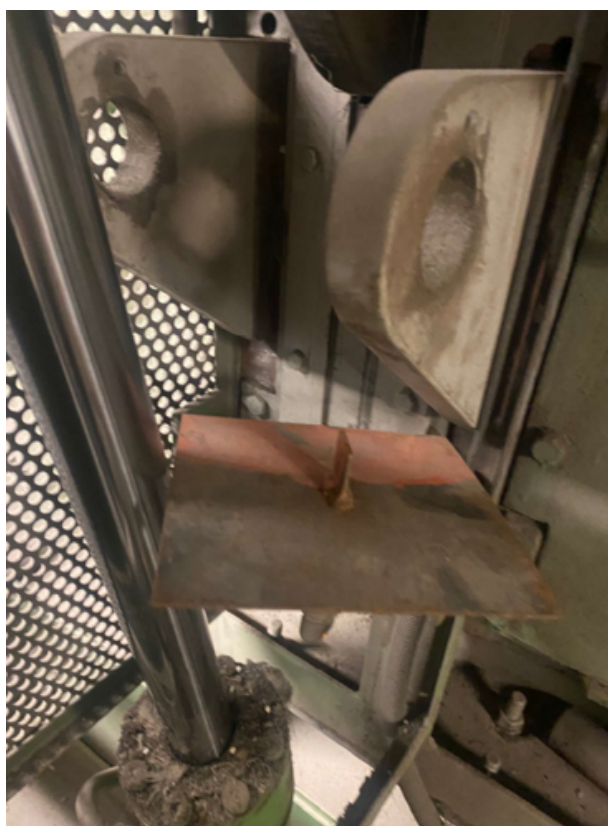
Photographic evidence (pictured below) did indeed show metallic scaffolding plates positioned over the limit switches associated with the waste feed chute dampers. On this basis, NRW considered it appropriate to investigate the circumstances surrounding these controls, their purpose at the time, and whether their use was consistent with normal operation and the requirements of the environmental permit. Viridor's subsequent internal investigation independently concluded that scaffold base plates had been used to simulate closed damper feedback, that this was not an approved operational or maintenance practice, and that the resulting signal behaviour was inconsistent with normal feed chute damper operation.

*“The objects (scaffolding plates) made contact with the closed proximity switches which resulted in a closed signal to the DCS when the open proximity switches were misaligned by bending the supporting bracket. The presence of the objects is not an approved practice. The feed chute damper guards are fitted to prevent access to the feed chute damper proximity switches; these guards should only be removed for defect rectification work or maintenance under a permit for work (SSoW). There is no operational or maintenance procedure requiring the placement of plates on the feed chute damper proximity switches.”*

Viridor's investigation concluded that the scaffold base plates were placed on the feed chute damper closed proximity switches to provide a false indication that the dampers were closed and that the open proximity switch feedback was defeated through misalignment of the switch bracket. Viridor further concluded that the DCS evidence supported the photographs and showed that the plates influenced the closed-position proximity switches, resulting in false position feedback being presented to the control system. The observed 1→0→2 and 2→0→1 transitions without corresponding opening or closing commands are therefore consistent with simulated damper position signals rather than normal damper movement.

Taken together, the DCS data, photographic evidence and Viridor's own investigation support the conclusion that the dampers were made to appear closed to the control system when they were not physically closed. Viridor concluded that the feed chute level trends observed during the period would have been physically impossible had the dampers genuinely been closed.

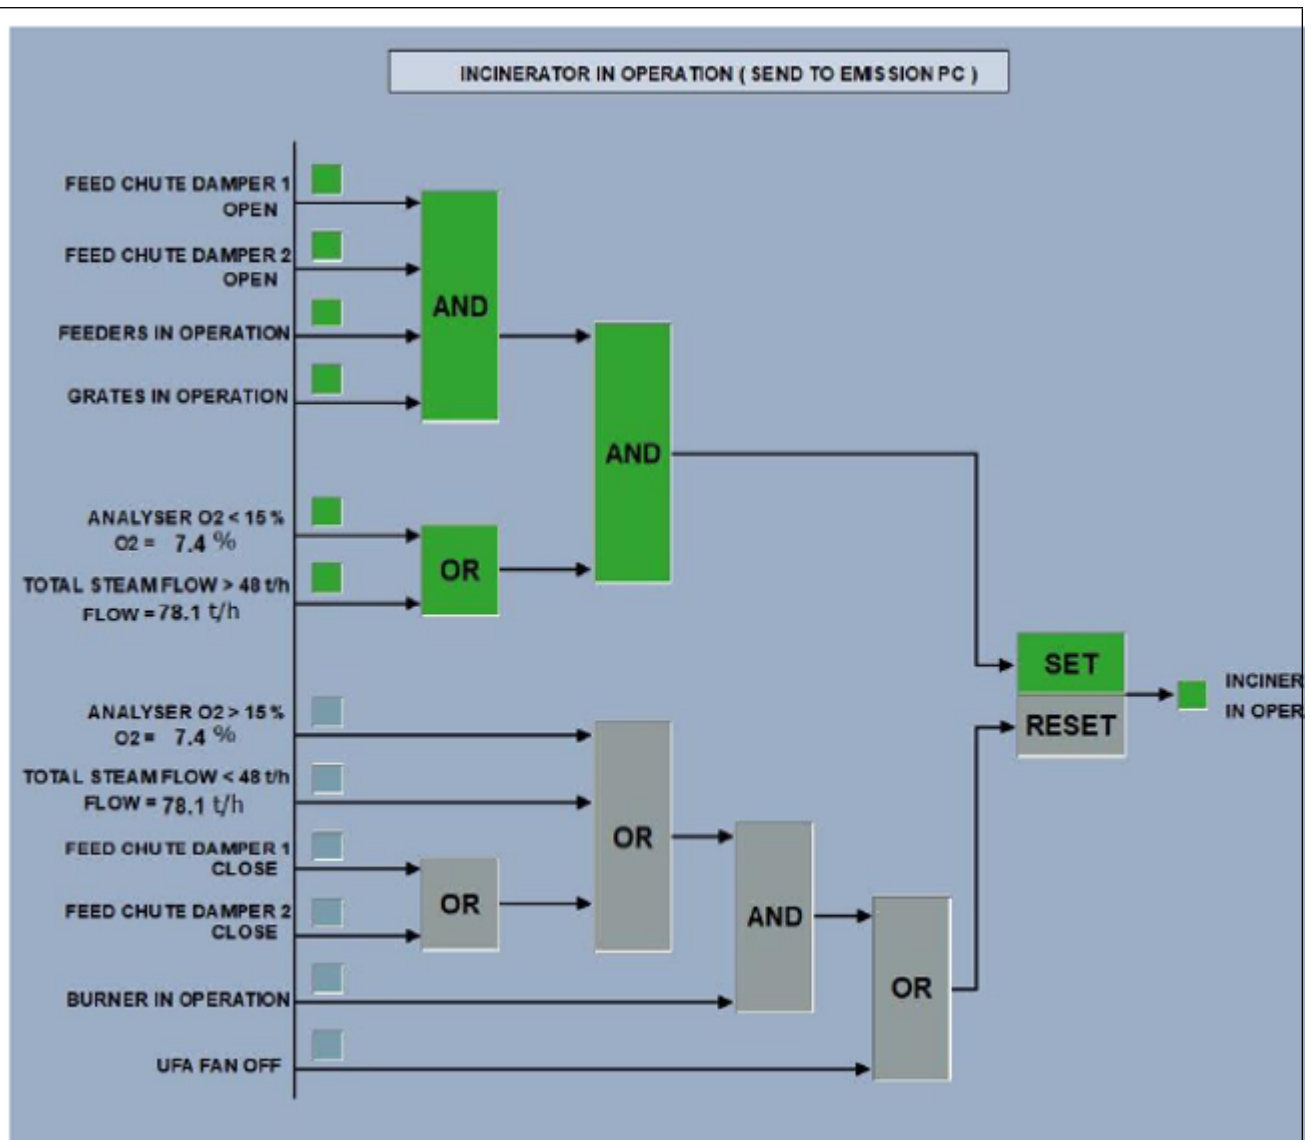
### Viridor OTNOC Management Plan Logic:

For completeness, in order for emissions to transition from CEMS reportable to non-reportable status, the predefined conditions set out in the lower (grey) section of the “incinerator in operation” logic must be satisfied (see logic above). Consequently, the timing of waste feed reduction, damper position and burner status should be assessed alongside the logic state transitions to determine whether the operational sequence was consistent with emissions reporting requirements.

When the control logic is compared directly with the process data, the following observations can be made. The burners remained in service until approximately 08:10, with burner output reducing to zero at 08:11, indicating that they were switched off at this point. Notably, at 08:10, while the burners were still operating, the conditions required to satisfy the lower (grey) section of the shutdown logic had already been met.

In relation to the upper section of the shutdown logic, only one additional condition was required for the CEMS to transition to non-reportable status. Between approximately 08:01 and 08:10, oxygen concentrations remained below 15%, steam flow was consistently above 48 t/h, and the feed chute dampers remained open until approximately 08:08. Therefore, from 08:01 onwards, within the

prevailing logic state, closure of the feed chute dampers alone would have been sufficient to cause the CEMS data to transition to a non-reportable state. This is significant because it isolates damper position as the sole remaining operational parameter capable of changing the emissions reporting status during this period. As such, the timing and manner of damper closure can be directly assessed against operational records and observed actions to determine whether the transition to non-reportable status accurately reflected the operational state of the line. This provides a clear basis for evaluating whether emissions reporting ceased as a result of a legitimate shutdown sequence or whether reporting status changed while conditions indicative of ongoing incineration remained present.

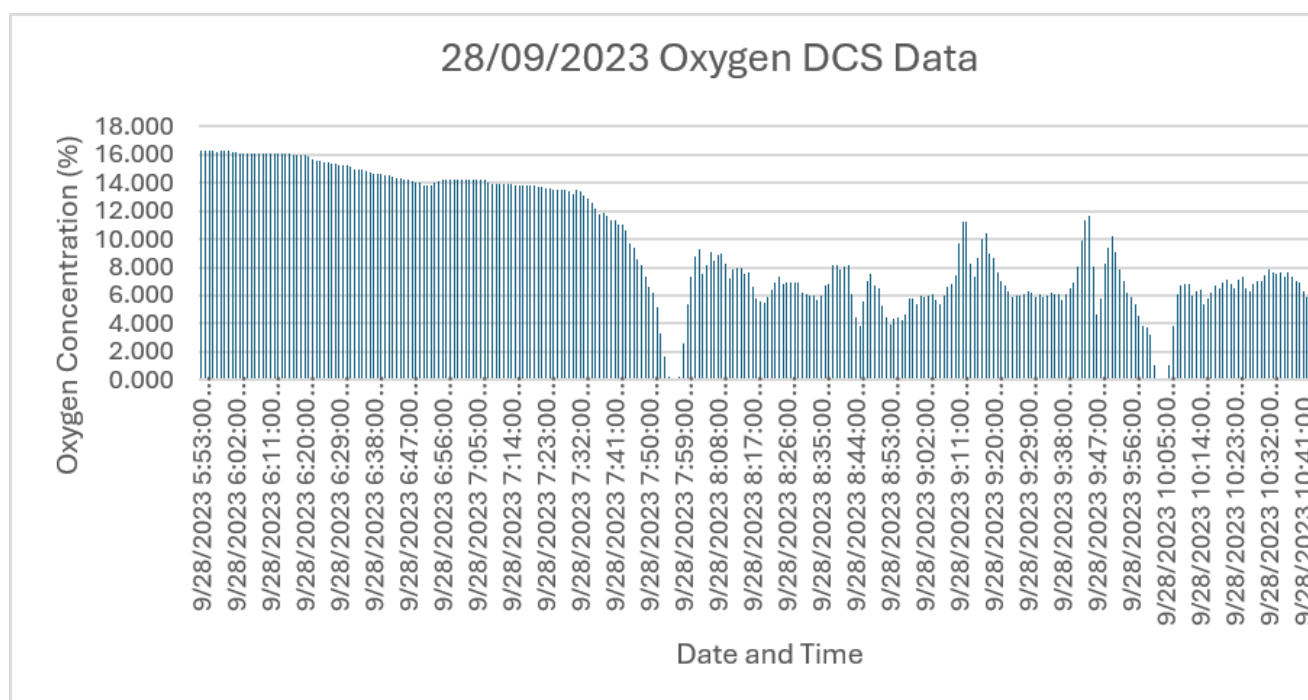
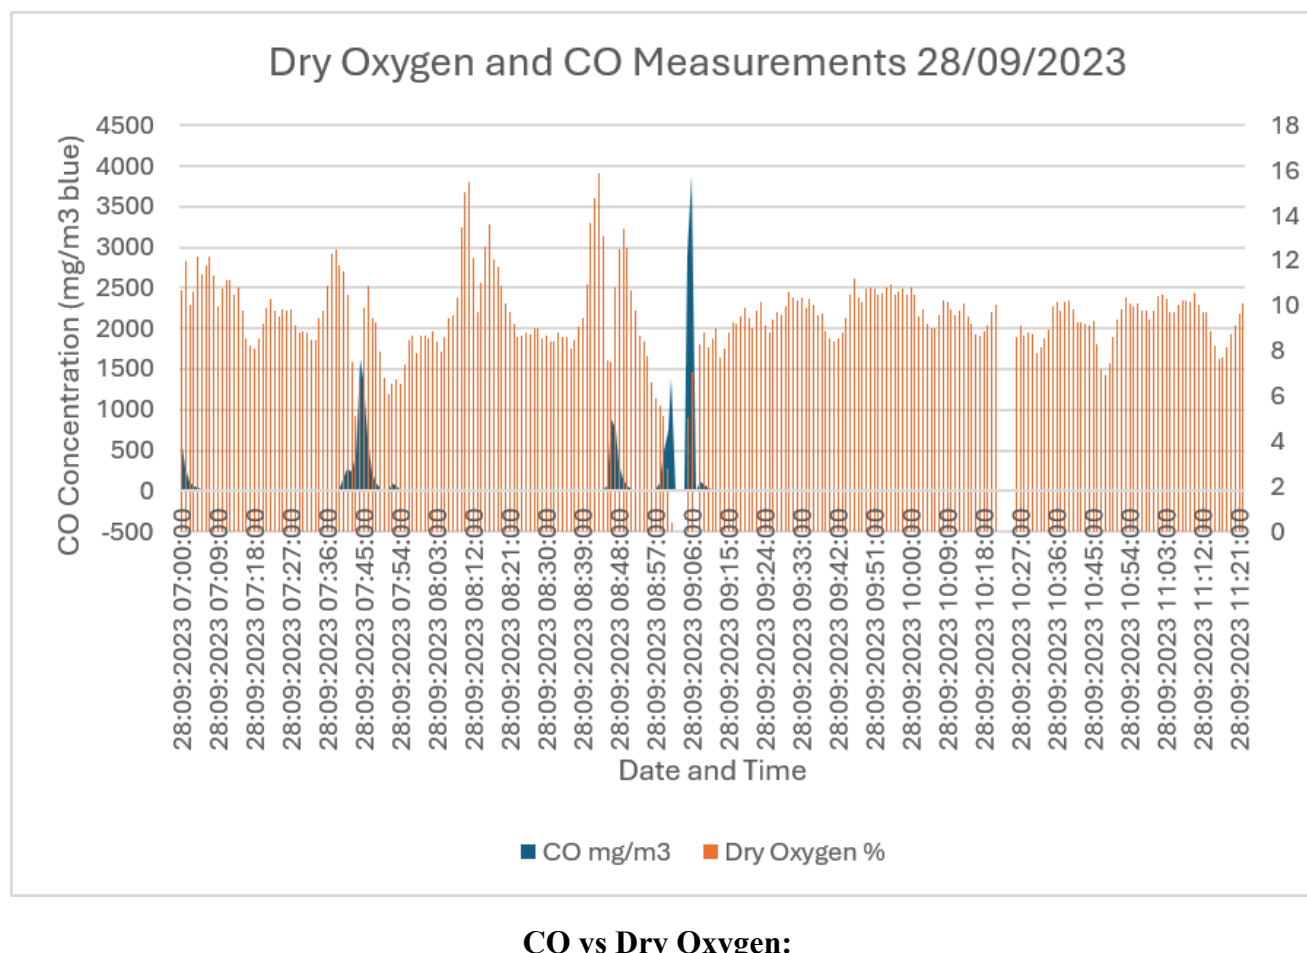
### Oxygen

On 28/09/2026, DCS oxygen gradually decreased from 05:53 as the boiler was ramped up on burners. At 07:37, both dampers were opened and waste feeding commenced. At approximately 07:50, the post-combustion oxygen measured by the DCS dropped sharply. This coincides with a pronounced increase in CO concentrations between 07:50 and 07:59, as recorded in the daily CO report (see table below). The incinerator “ON” signal was triggered at 07:53. At 08:00, waste feeding was stopped following a further potential 10-minute CO exceedance (a potential seventh within the rolling 24-hour

period), with the intention of running waste off the grate and stabilising boiler conditions. At approximately 08:10, the dampers were indicated as closed within the DCS and the incinerator 'OFF' signal was triggered. Viridor's subsequent investigation concluded that the damper position feedback did not reflect the physical position of the dampers and that they remained physically open. Consequently, the oxygen behaviour observed after 08:10 should be interpreted alongside the evidence of continued waste movement through the feed system, rather than on the basis that the dampers had physically closed and combustion had ceased.

In contrast, the dry oxygen concentration measured at the stack for compliance purposes remains relatively constant throughout this period (see table below). CO emissions data have been included alongside oxygen data for comparison; however, the relationship between the two is not immediately intuitive. The stack oxygen data appear to be already corrected and/or averaged, which may explain why short-term combustion instability evident in the DCS oxygen signal and CO emissions is not reflected in the compliance oxygen trends. This likely reflects differences in measurement location, time averaging, and data correction between the control (DCS) and compliance monitoring systems, rather than an absence of genuine combustion disturbance during the event.

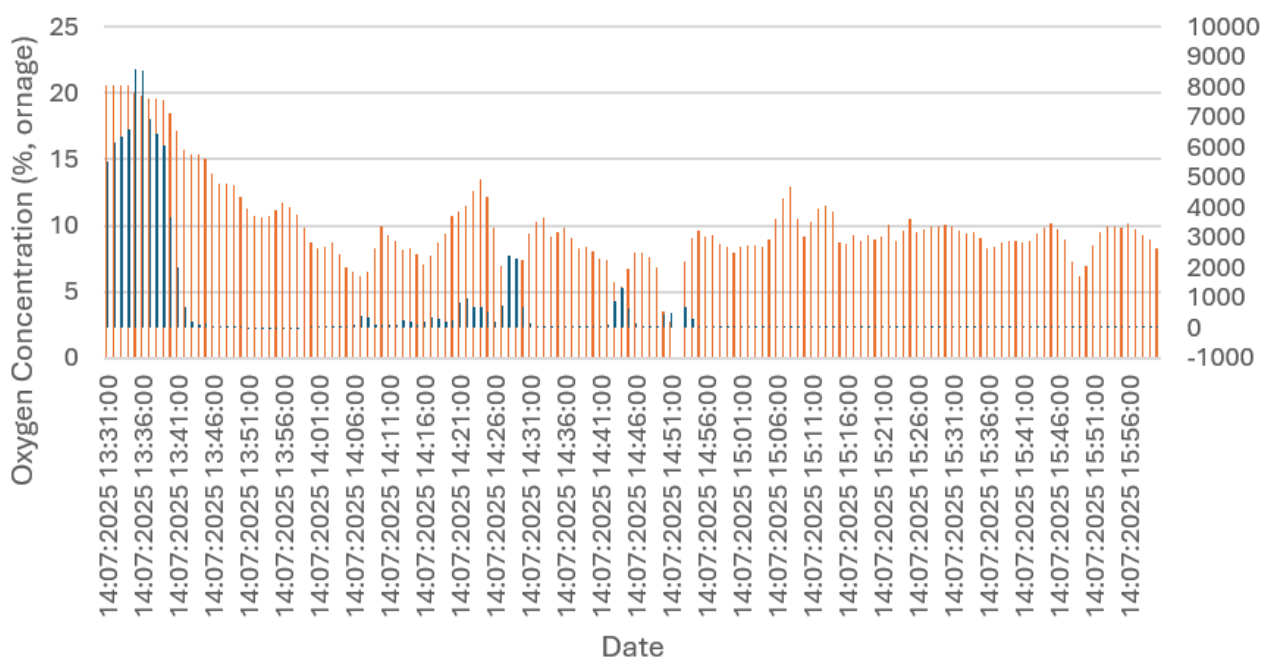
## 14/07/2026 Start Up Dry Oxygen Concentrations

Comparison with the only available startup dataset for reference (14/07/2025), using corrected (“CORR”) data, shows a broadly similar oxygen profile. During the 14/07/2025 startup, the waste dampers were opened at 13:54; however, the incineration “ON” signal did not switch to reportable status until 15:25. When compared, the corrected oxygen profiles for 28/09/2023 and 14/07/2025 appear broadly comparable, and no clear distinction can be drawn between the two events based on oxygen behaviour alone. As such, limited inference can be made from the corrected oxygen data regarding the cause of the observed CO exceedance on 28/09/2023.

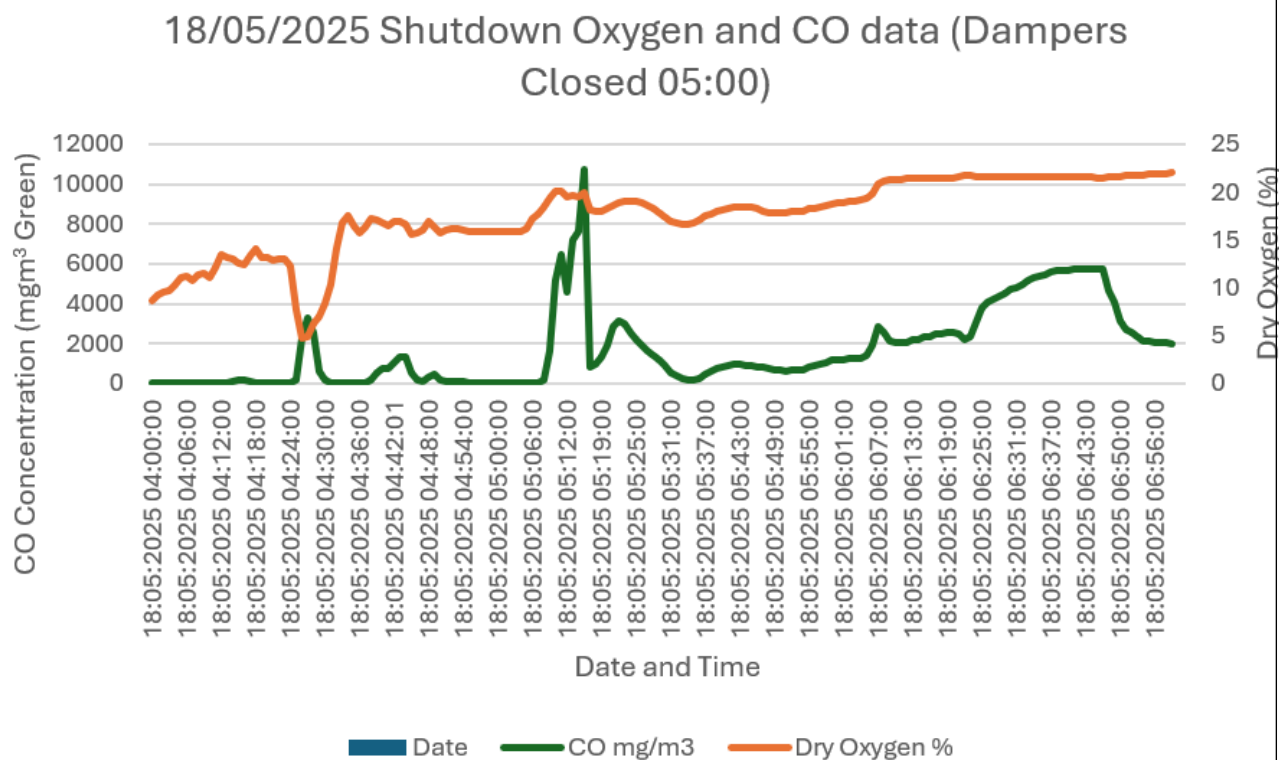
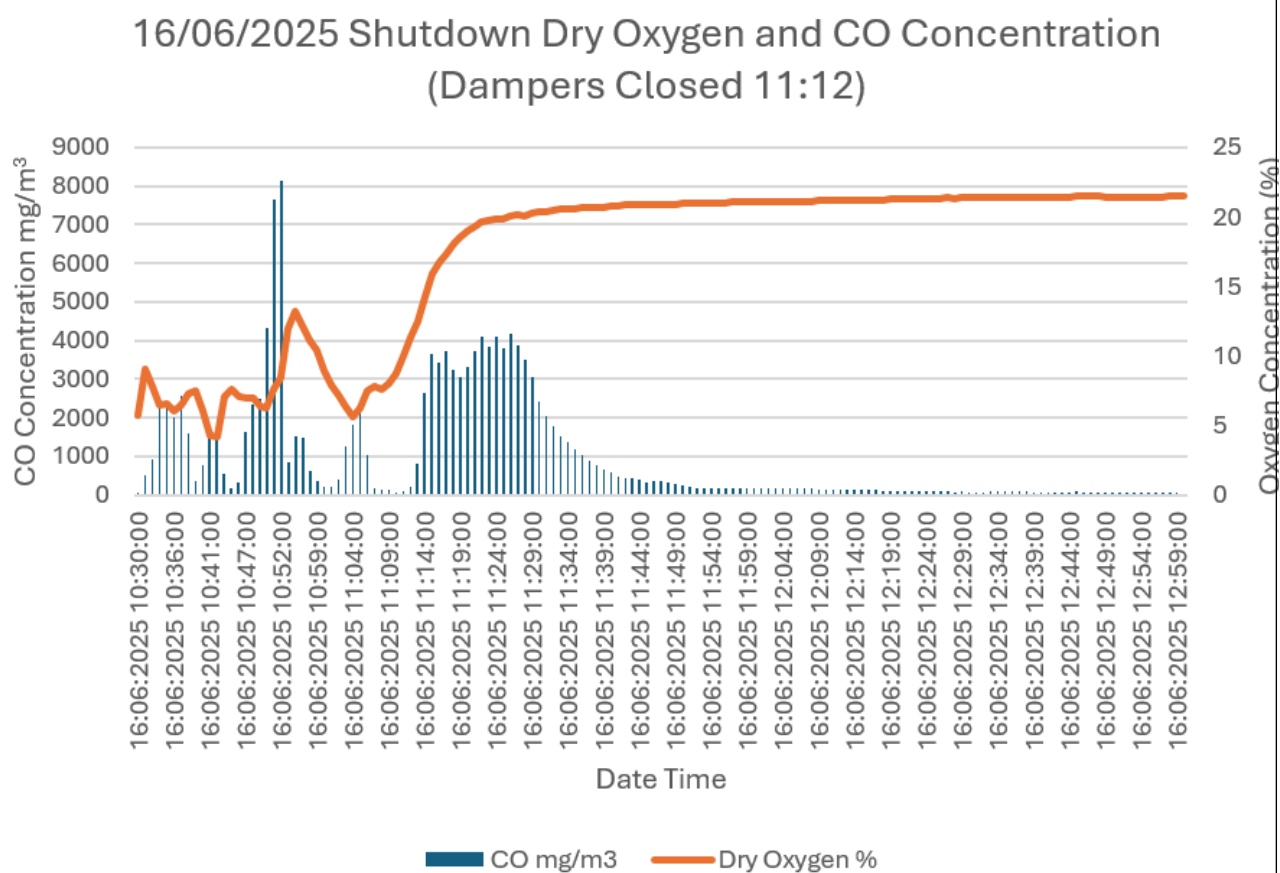
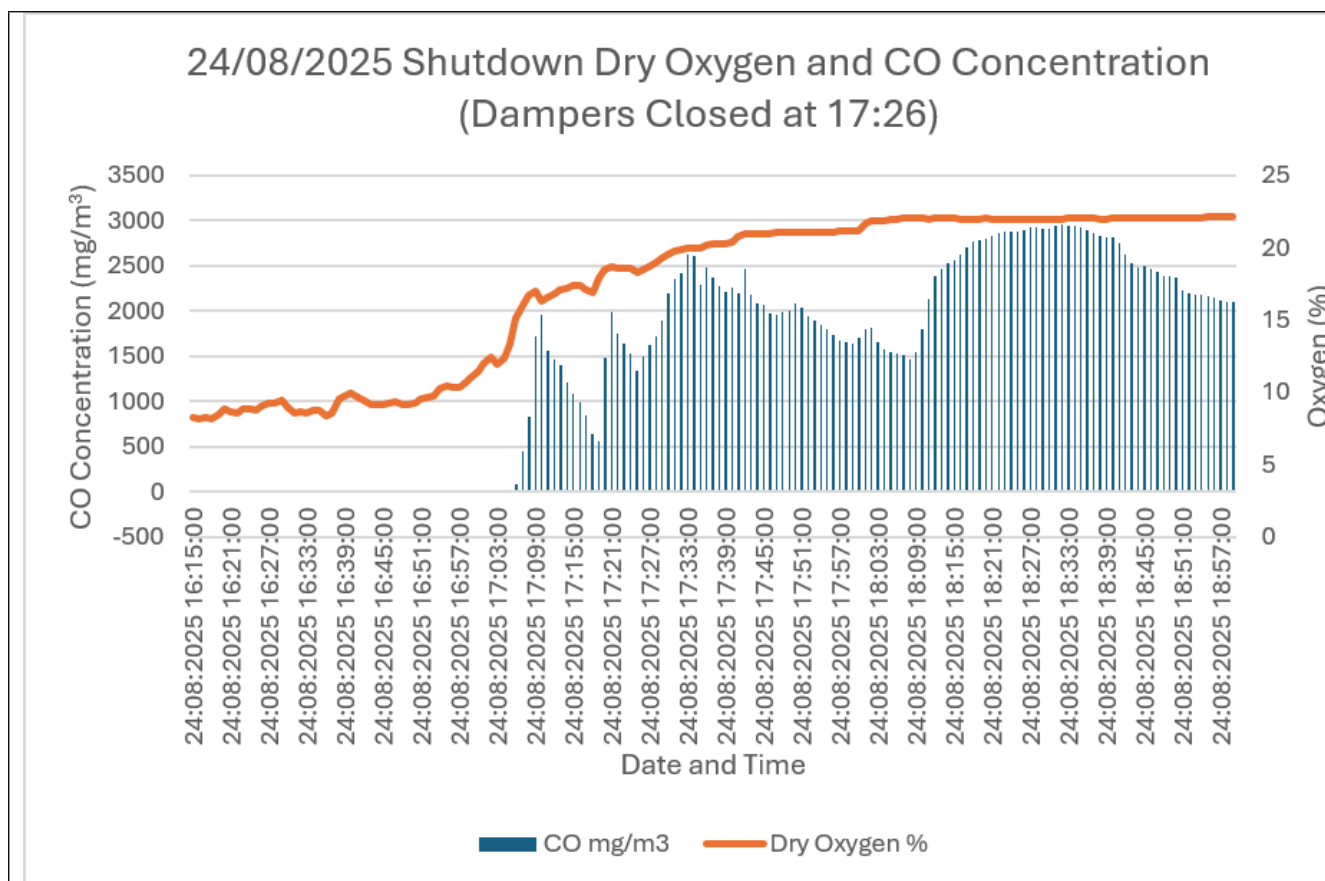
Attempts were also made to compare oxygen behaviour following damper closure with other shutdown scenarios. On 28/09/2023, oxygen concentrations remained consistently low (approximately 8-9%) between damper closure at 08:09 and reopening at 09:49. In contrast, during a planned shutdown on 18/05/2025, oxygen concentrations increased from approximately 10% at 04:00 to greater than 16% by 05:00, when the dampers were closed (see graph below). The refined second-by-second DCS data shows the CEMS switching to non-reportable at approximately 05:08 following the commencement of burner oil flow at approximately 05:07:25. At the time burner operation commenced, T2S remained approximately 987°C and steam generation approximately 75 t/h, indicating combustion conditions remained elevated. Oxygen concentrations continued to increase thereafter.

Similarly, on 16/06/2025, oxygen concentrations rose rapidly following damper closure at 11:12 (see graph below). The CEMS again switched to non-reportable when the burner was activated for approximately one minute. Whilst the available 1-minute average temperatures remained above 900°C, the instantaneous temperatures used to initiate burner operation were not available and therefore the precise trigger for burner activation could not be verified. On 24/08/2025, dampers were closed at 17:26 when oxygen concentrations were already elevated (approximately 18%). At 18:00, the CEMS switched to non-reportable when the burners came on and remained in operation.

Notwithstanding the limitations associated with comparing planned and unplanned shutdown events, Viridor's own investigation attached particular significance to the oxygen trends observed on the 28<sup>th</sup> September 2023. The investigation concluded that, during the period when the incineration signal remained OFF, stack oxygen concentrations remained consistently below 15%, which Viridor considered indicative of continuing combustion. This contrasts with the earlier shutdown event commencing at approximately 03:24, where oxygen concentrations gradually increased above 15% following cessation of combustion. Viridor therefore considered the oxygen behaviour during the 08:10-09:49 period to be consistent with ongoing waste combustion, notwithstanding the line's classification within the control system as being in an incineration-off state.
