SAB, Flood risk and Drainage Technical Note

Cog Road, Sully

Cleaning • Surveys • Lining • Civils  
Job - 20958 - 01 - 001

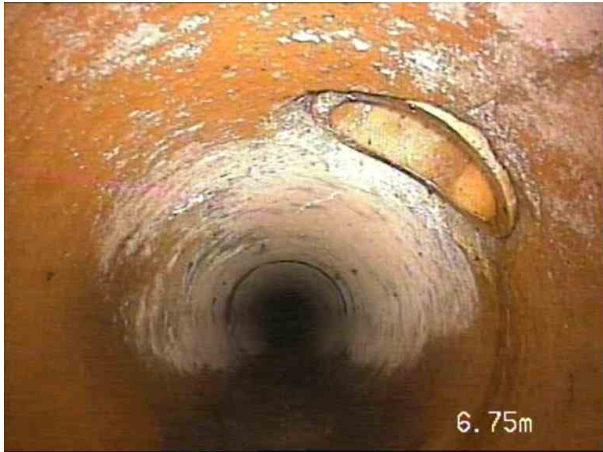
1, 00:01:11, 6.75 m  
Connection defective, connecting pipe is intruding at 1 o'clock,  
100mm dia, intrusion: 5%

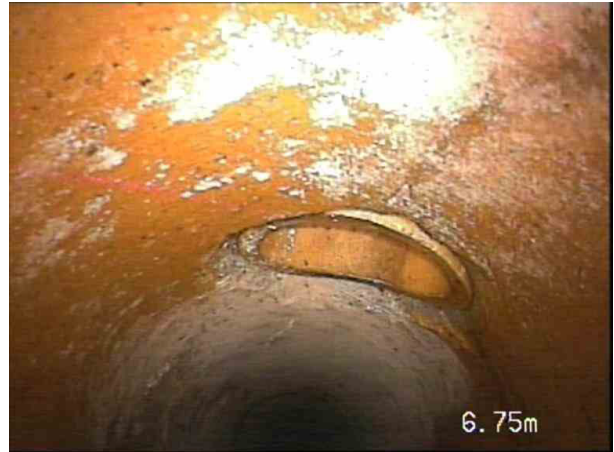
2, 00:01:16, 6.75 m  
Crack, longitudinal at 1 o'clock

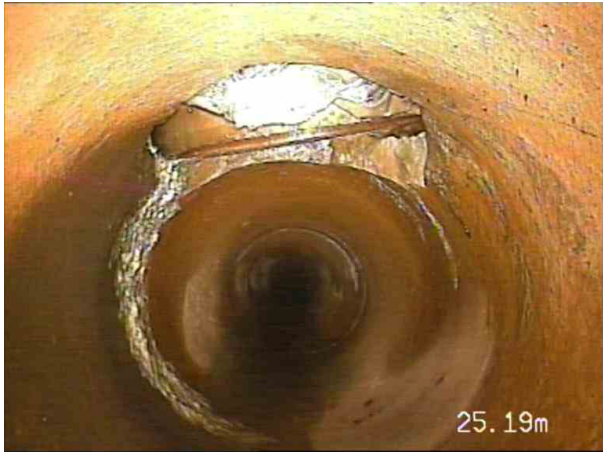
1, 00:02:42, 25.19 m

| Scale: 1:271 | Position [m] | Code | Observation | MPEG | Photo | Grade |
|---|---|---|---|---|---|---|
| | 25.19 | CXI | Connection defective, connecting pipe is intruding at 11 o'clock, 150mm dia, intrusion: 10% | 00:02:42 | 1 | 3 |

Connection defective, connecting pipe is intruding at 11 o'clock, 150mm dia, intrusion: 10%

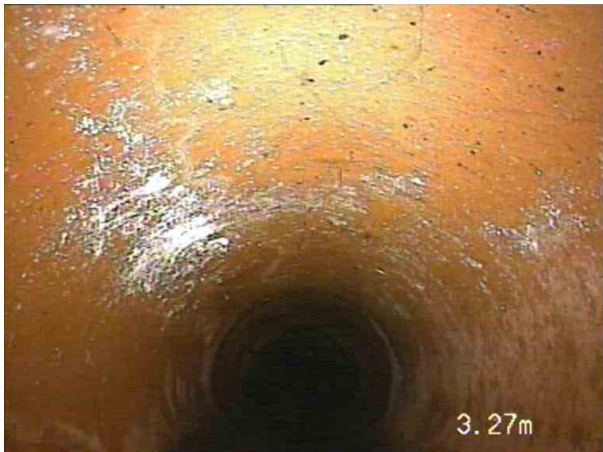
| Scale: | 1:50 | Position [m] | Code | Observation | MPEG | Photo | Grade |
|---|---|---|---|---|---|---|---|
| | | 3.27 | CL | Crack, longitudinal at 12 o'clock | 00:00:36 | 1 | 2 / 2 |

1, 00:00:36, 3.27 m  
Crack, longitudinal at 12 o'clock

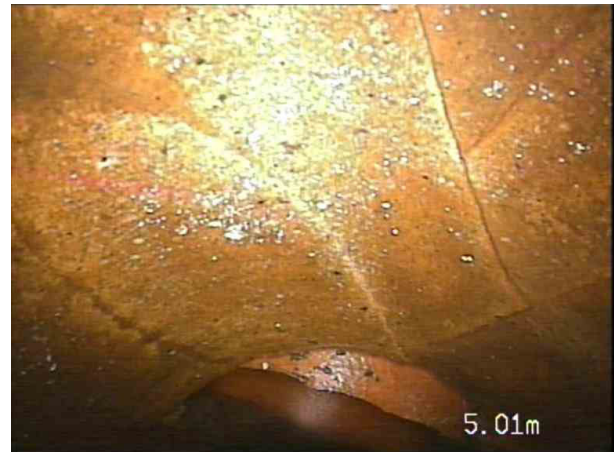
| Scale: | 1:50 | Position [m] | Code | Observation | MPEG | Photo | Grade |
|---|---|---|---|---|---|---|---|
| | | 5.01 | CM | Cracks, multiple from 1 o'clock to 4 o'clock | 00:01:04 | 2 | 3 / 2 |

2, 00:01:04, 5.01 m  
Cracks, multiple from 1 o'clock to 4 o'clock

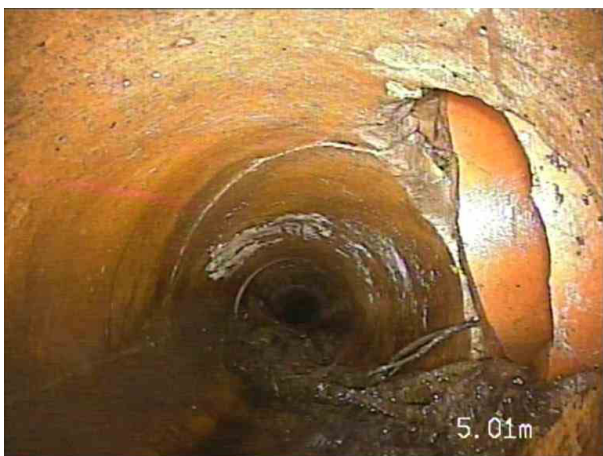
| Scale: | 1:50 | Position [m] | Code | Observation | MPEG | Photo | Grade |
|---|---|---|---|---|---|---|---|
| | | 5.01 | CXI | Connection defective, connecting pipe is intruding at 2 o'clock, 150mm dia, intrusion: 10% | 00:01:12 | 3 | 3 |

3, 00:01:12, 5.01 m  
Connection defective, connecting pipe is intruding at 2 o'clock,  
150mm dia, intrusion: 10%

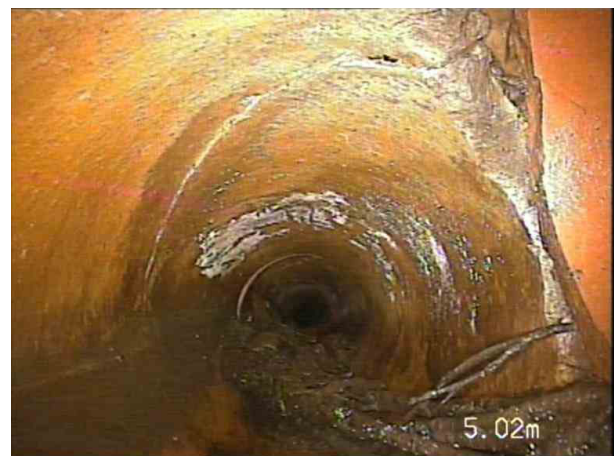
| Scale: | 1:50 | Position [m] | Code | Observation | MPEG | Photo | Grade |
|---|---|---|---|---|---|---|---|
| | | 5.02 | FS | Fracture, spiral from 8 o'clock to 1 o'clock | 00:01:18 | 4 | 4 / 2 |

4, 00:01:18, 5.02 m  
Fracture, spiral from 8 o'clock to 1 o'clock

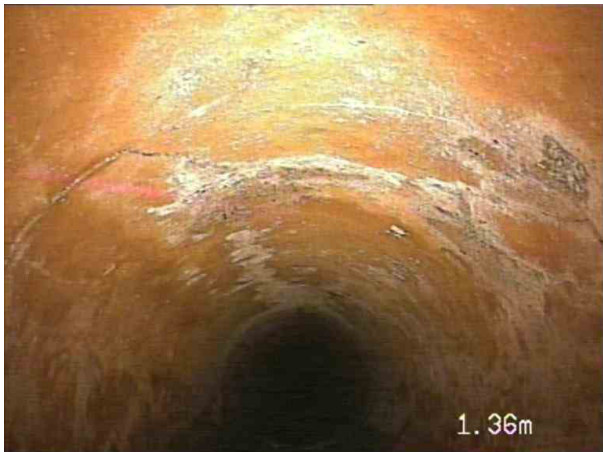
| Scale: 1:264 | Position [m] | Code | Observation | MPEG | Photo | Grade |
|---|---|---|---|---|---|---|
| | 1.36 | FSJ | Fracture, spiral at joint from 11 o'clock to 1 o'clock | 00:00:42 | 1 | 4 / 2 |

1, 00:00:42, 1.36 m  
Fracture, spiral at joint from 11 o'clock to 1 o'clock

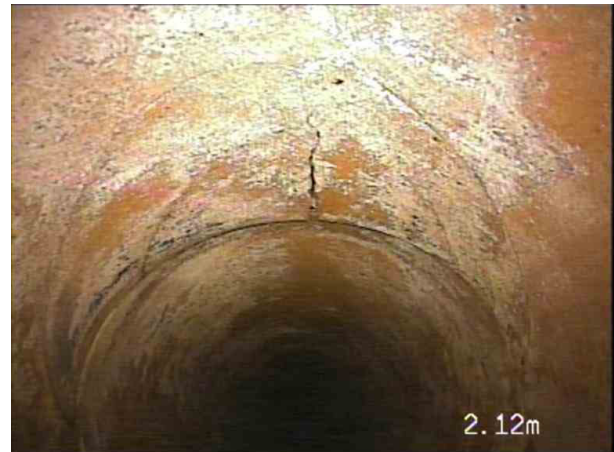
| Scale: 1:264 | Position [m] | Code | Observation | MPEG | Photo | Grade |
|---|---|---|---|---|---|---|
| | 2.12 | FSJ | Fracture, spiral at joint from 8 o'clock to 3 o'clock | 00:00:55 | 2 | 4 / 2 |

2, 00:00:55, 2.12 m  
Fracture, spiral at joint from 8 o'clock to 3 o'clock

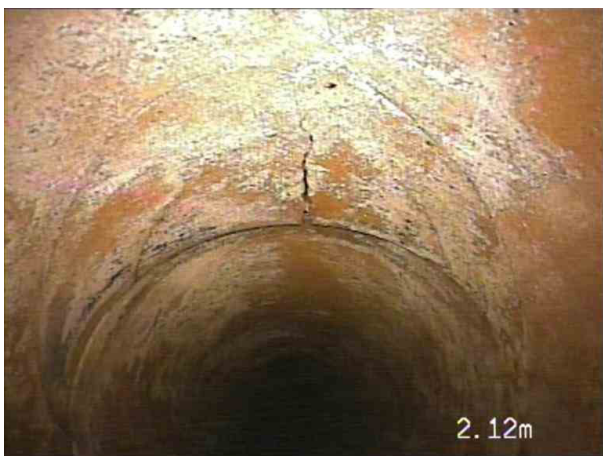
| Scale: 1:264 | Position [m] | Code | Observation | MPEG | Photo | Grade |
|---|---|---|---|---|---|---|
| | 2.12 | FLJ | Fracture, longitudinal at joint at 12 o'clock | 00:00:57 | 3 | 3 / 2 |

3, 00:00:57, 2.12 m  
Fracture, longitudinal at joint at 12 o'clock

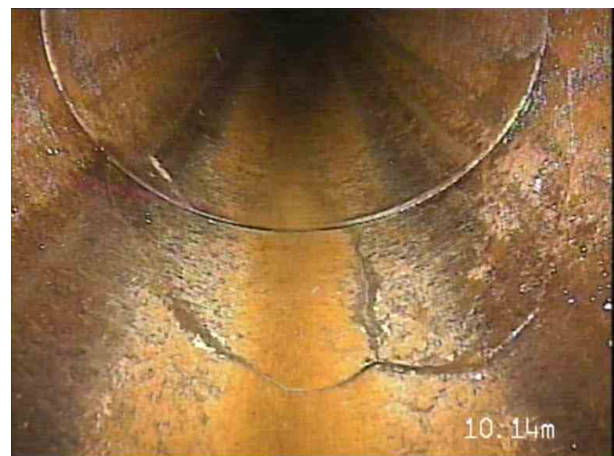
| Scale: 1:264 | Position [m] | Code | Observation | MPEG | Photo | Grade |
|---|---|---|---|---|---|---|
| | 10.14 | FSJ | Fracture, spiral at joint from 3 o'clock to 7 o'clock | 00:01:57 | 4 | 4 / 2 |

4, 00:01:57, 10.14 m  
Fracture, spiral at joint from 3 o'clock to 7 o'clock

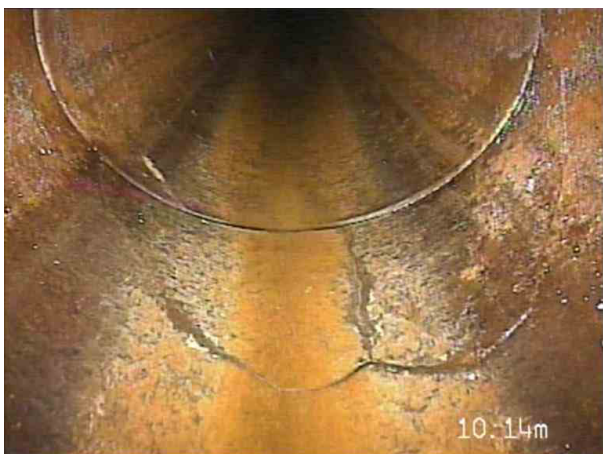
| Scale: 1:264 | Position [m] | Code | Observation | MPEG | Photo | Grade |
|---|---|---|---|---|---|---|
| | 10.14 | CLJ | Crack, longitudinal at joint at 5 o'clock | 00:02:00 | 5 | 2 / 2 |

5, 00:02:00, 10.14 m  
Crack, longitudinal at joint at 5 o'clock

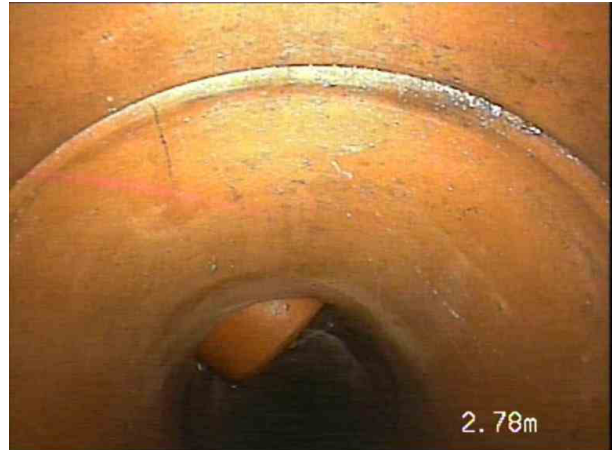
| Scale: 1:258 | Position [m] | Code | Observation | MPEG | Photo | Grade |
|---|---|---|---|---|---|---|
| | 2.78 | CLJ | Crack, longitudinal at joint at 11 o'clock | 00:00:38 | 2 | 2 / 2 |

2, 00:00:38, 2.78 m  
Crack, longitudinal at joint at 11 o'clock

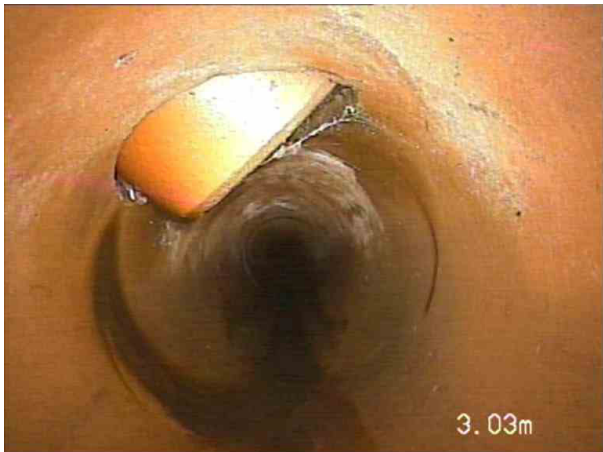
| Scale: 1:258 | Position [m] | Code | Observation | MPEG | Photo | Grade |
|---|---|---|---|---|---|---|
| | 3.03 | CXI | Connection defective, connecting pipe is intruding at 11 o'clock, 150mm dia, intrusion: 20% | 00:00:47 | 3 | 4 |

3, 00:00:47, 3.03 m  
Connection defective, connecting pipe is intruding at 11 o'clock, 150mm dia, intrusion: 20%

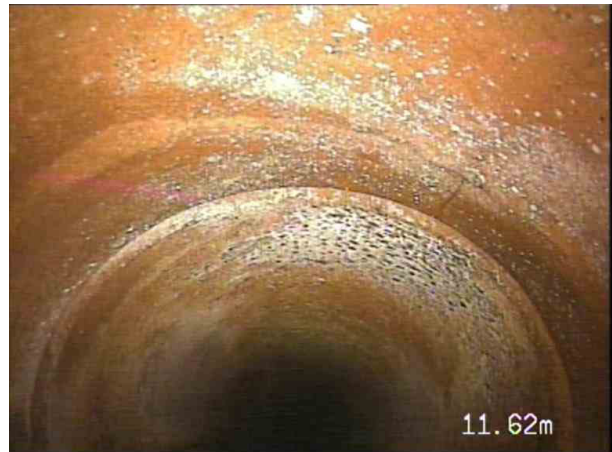
| Scale: 1:258 | Position [m] | Code | Observation | MPEG | Photo | Grade |
|---|---|---|---|---|---|---|
| | 11.62 | CLJ | Crack, longitudinal at joint at 1 o'clock | 00:01:52 | 4 | 2 / 2 |

4, 00:01:52, 11.62 m  
Crack, longitudinal at joint at 1 o'clock

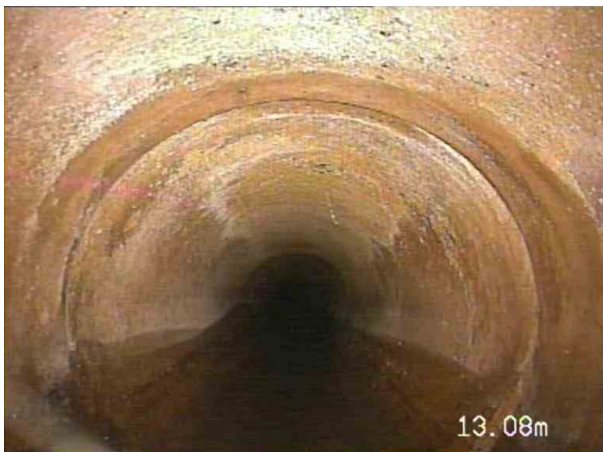
| Scale: 1:258 | Position [m] | Code | Observation | MPEG | Photo | Grade |
|---|---|---|---|---|---|---|
| | 13.08 | CCJ | Crack, circumferential at joint from 9 o'clock to 3 o'clock | 00:02:07 | 5 | 2 / 2 |

5, 00:02:07, 13.08 m  
Crack, circumferential at joint from 9 o'clock to 3 o'clock

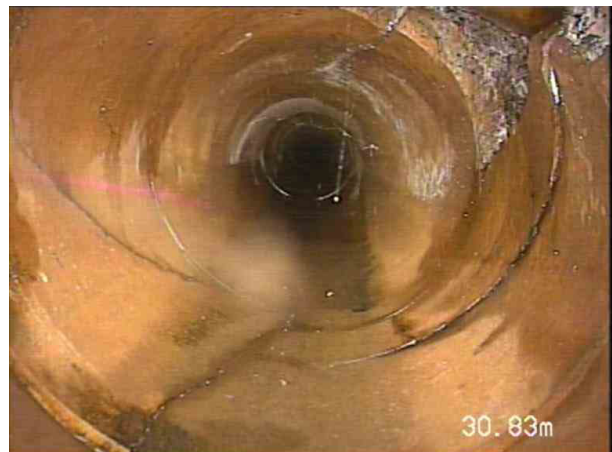
| Scale: | 1:258 | Position [m] | Code | Observation | MPEG | Photo | Grade | | |
|---|---|---|---|---|---|---|---|---|---|
| | | 30.83 | FM | Fractures, multiple from 2 o'clock to 12 o'clock | 00:04:46 | 6 | 4 / 2 | | |

6, 00:04:46, 30.83 m  
Fractures, multiple from 2 o'clock to 12 o'clock

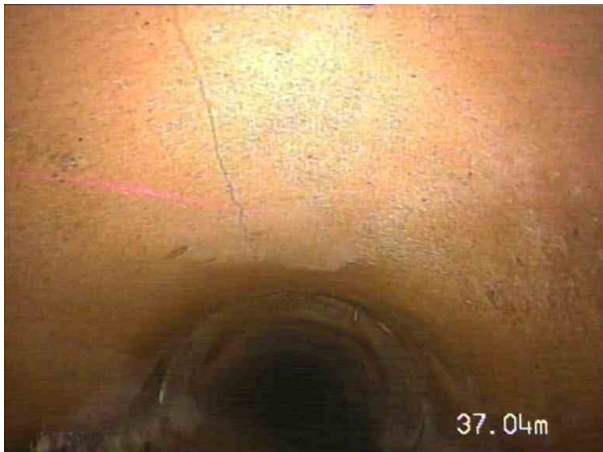
| Scale: | 1:258 | Position [m] | Code | Observation | MPEG | Photo | Grade | | |
|---|---|---|---|---|---|---|---|---|---|
| | | 37.04 | CL | Crack, longitudinal at 12 o'clock | 00:05:28 | 7 | 2 / 2 | | |

7, 00:05:28, 37.04 m  
Crack, longitudinal at 12 o'clock

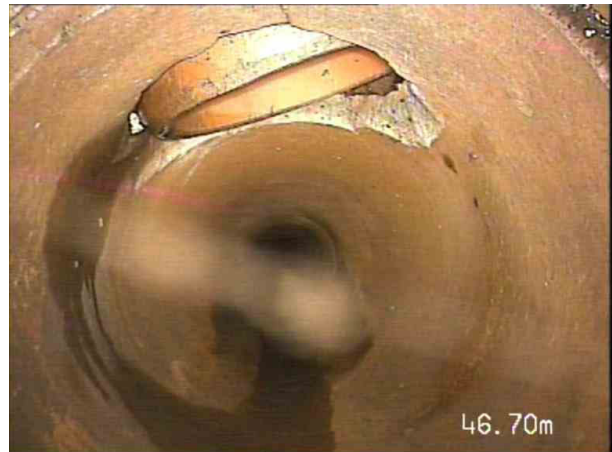
| Scale: | 1:258 | Position [m] | Code | Observation | MPEG | Photo | Grade | | |
|---|---|---|---|---|---|---|---|---|---|
| | | 46.70 | CXI | Connection defective, connecting pipe is intruding at 11 o'clock, 150mm dia, intrusion: 5% | 00:06:28 | 8 | 3 | | |

8, 00:06:28, 46.70 m  
Connection defective, connecting pipe is intruding at 11 o'clock, 150mm dia, intrusion: 5%

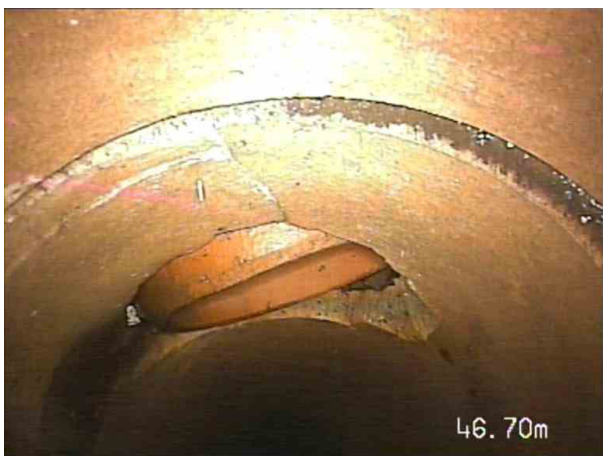
| Scale: | 1:258 | Position [m] | Code | Observation | MPEG | Photo | Grade | | |
|---|---|---|---|---|---|---|---|---|---|
| | | 46.70 | CLJ | Crack, longitudinal at joint at 12 o'clock | 00:06:33 | 9 | 2 / 2 | | |

9, 00:06:33, 46.70 m  
Crack, longitudinal at joint at 12 o'clock

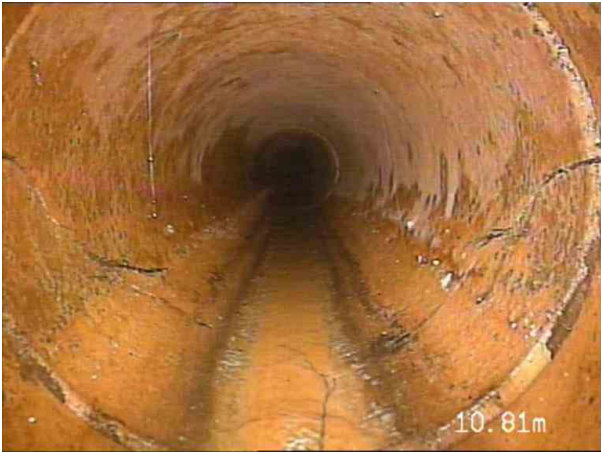
| Scale: 1:443 | Position [m] | Code | Observation | MPEG | Photo | Grade |
|---|---|---|---|---|---|---|
| | 10.81 | FSJ | Fracture, spiral at joint from 3 o'clock to 9 o'clock | 00:01:17 | 1 | 4 / 2 |

1, 00:01:17, 10.81 m  
Fracture, spiral at joint from 3 o'clock to 9 o'clock

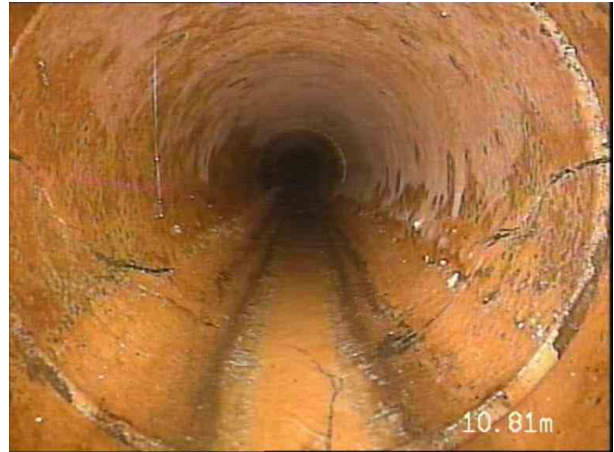
| Scale: 1:443 | Position [m] | Code | Observation | MPEG | Photo | Grade |
|---|---|---|---|---|---|---|
| | 10.81 | FLJ | Fracture, longitudinal at joint at 6 o'clock | 00:01:19 | 2 | 3 / 2 |

2, 00:01:19, 10.81 m  
Fracture, longitudinal at joint at 6 o'clock

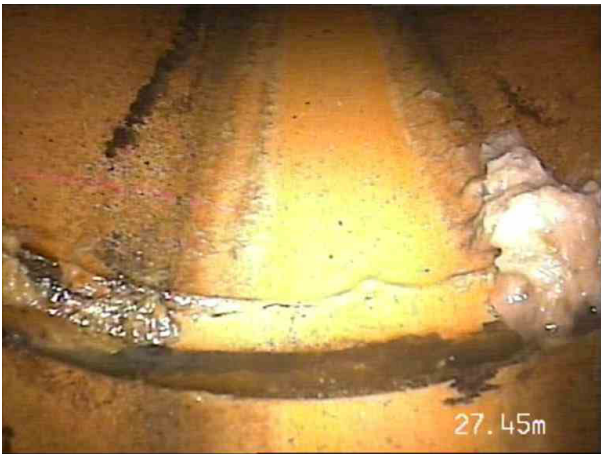
3, 00:03:07, 27.45 m  
Open joint, medium

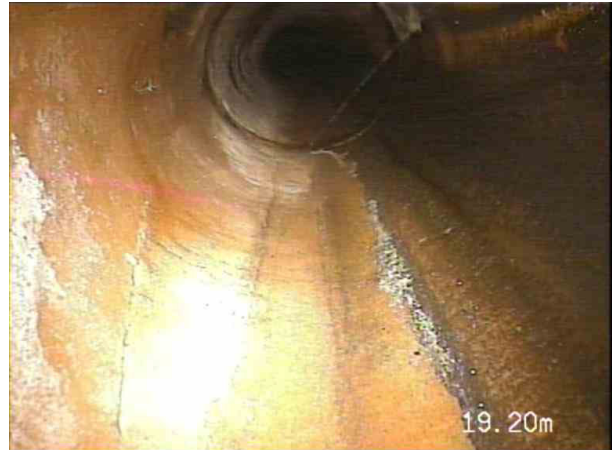
| Scale: 1:342 | Position [m] | Code | Observation | MPEG | Photo | Grade |
|---|---|---|---|---|---|---|
| | 19.20 | FL | Fracture, longitudinal at 9 o'clock | 00:02:46 | 2 | 3 / 2 |

2, 00:02:46, 19.20 m  
Fracture, longitudinal at 9 o'clock

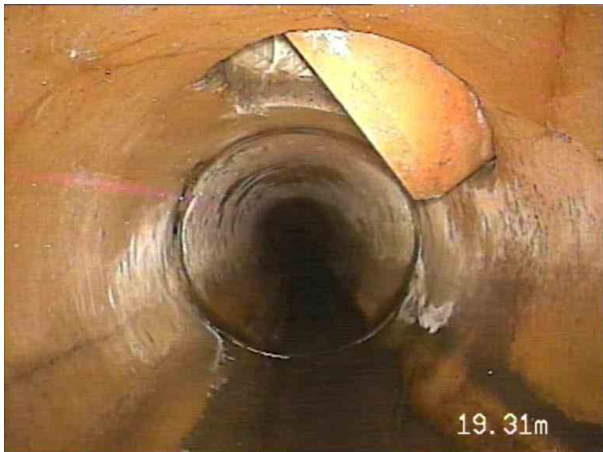
3, 00:02:53, 19.31 m  
Connection defective, connecting pipe is intruding at 1 o'clock,  
150mm dia, intrusion: 15%

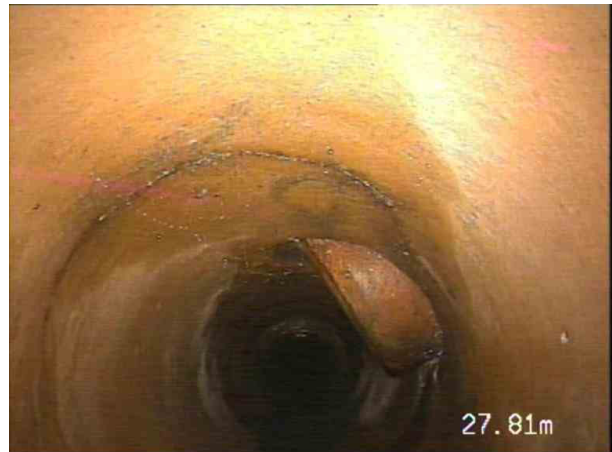
4, 00:03:49, 27.81 m  
Fracture, spiral from 8 o'clock to 2 o'clock

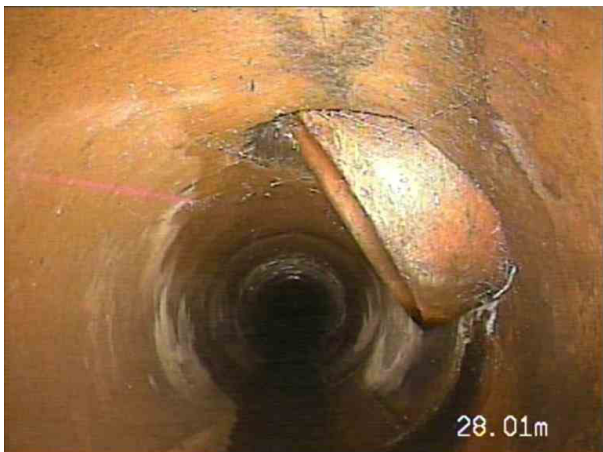
5, 00:03:54, 28.01 m  
Connection defective, connecting pipe is intruding at 2 o'clock,  
150mm dia, intrusion: 20%

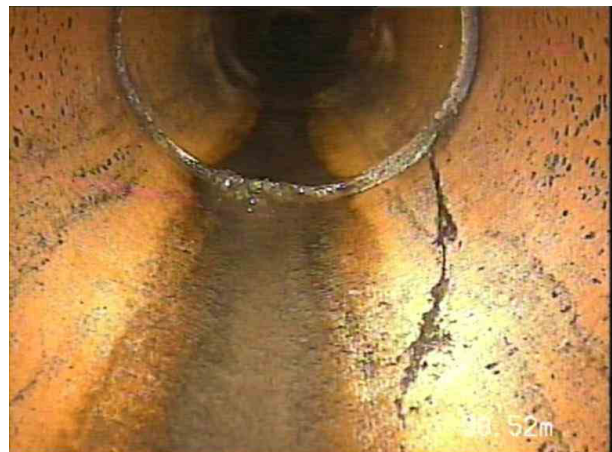
6, 00:05:03, 38.52 m  
Fracture, spiral at joint from 5 o'clock to 6 o'clock

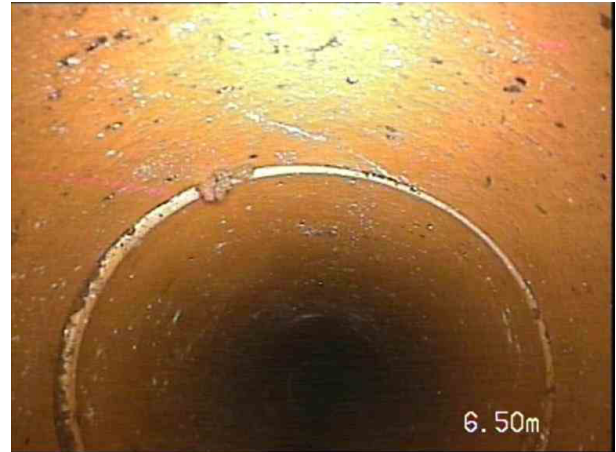
2, 00:01:07, 6.50 m  
Crack, longitudinal at joint at 12 o'clock

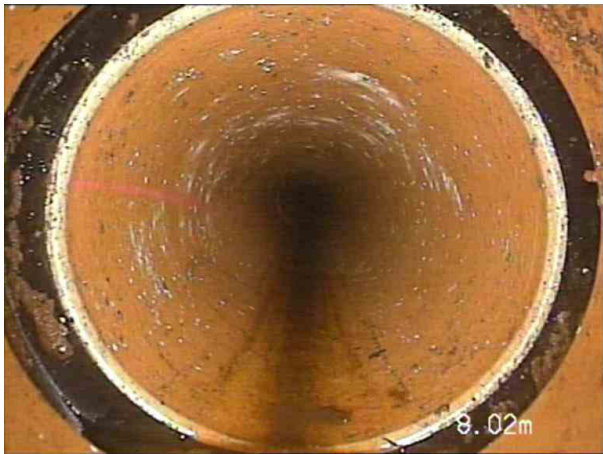
3, 00:01:22, 8.02 m  
Open joint, large

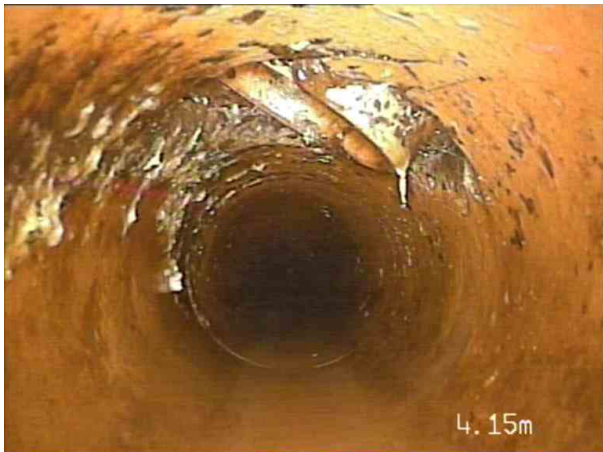
1, 00:01:09, 4.15 m  
Connection defective, connecting pipe is intruding at 12 o'clock, 100mm dia, intrusion: 5%

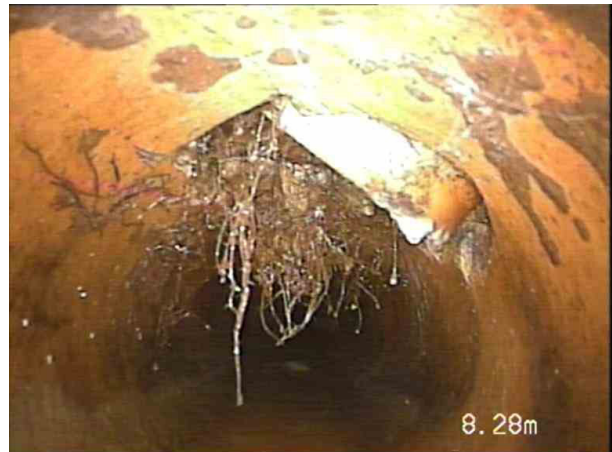
2, 00:02:00, 8.28 m  
Connection defective, connecting pipe is intruding at 1 o'clock, 100mm dia, intrusion: 10%

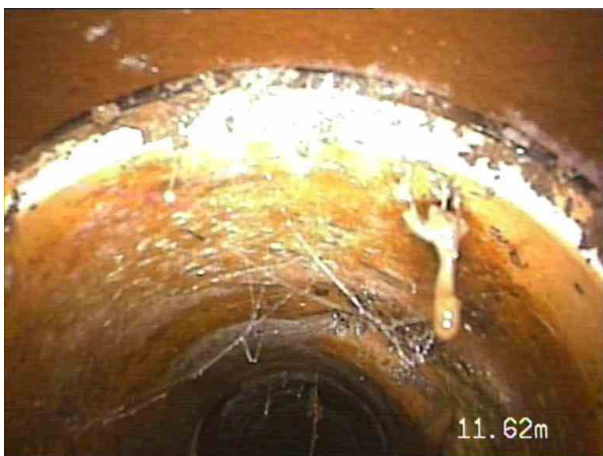
3, 00:02:57, 11.62 m  
Joint displaced, medium

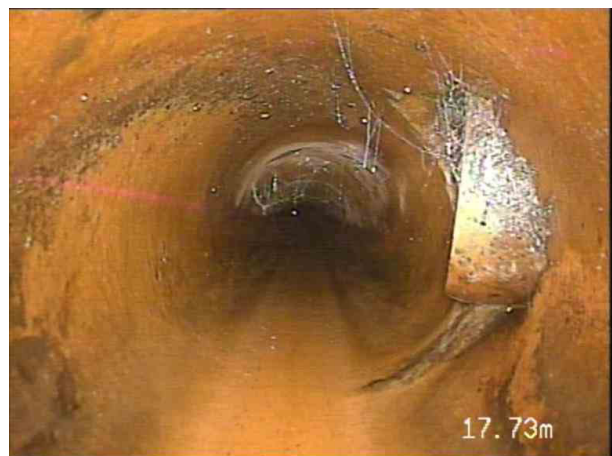
4, 00:04:06, 17.73 m  
Connection defective, connecting pipe is intruding at 3 o'clock, 100mm dia, intrusion: 10%

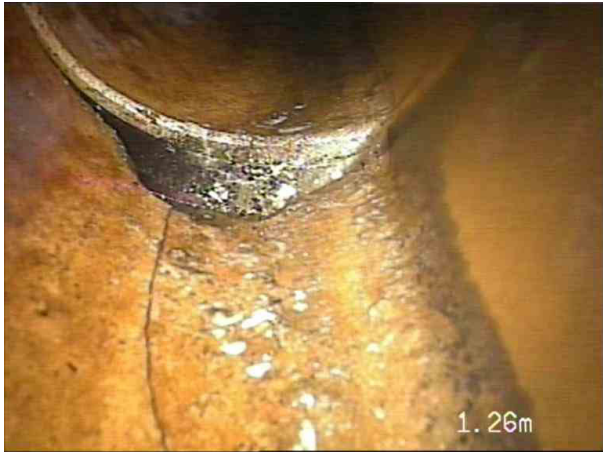
1, 00:00:28, 1.26 m  
Fracture, longitudinal at joint at 8 o'clock

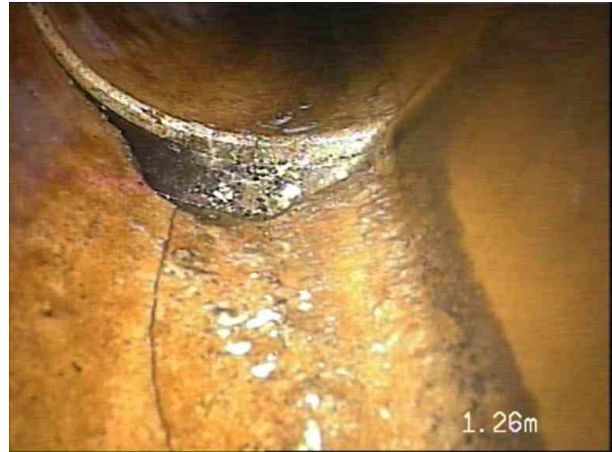
2, 00:00:31, 1.26 m  
Hole in drain or sewer from 7 o'clock to 8 o'clock

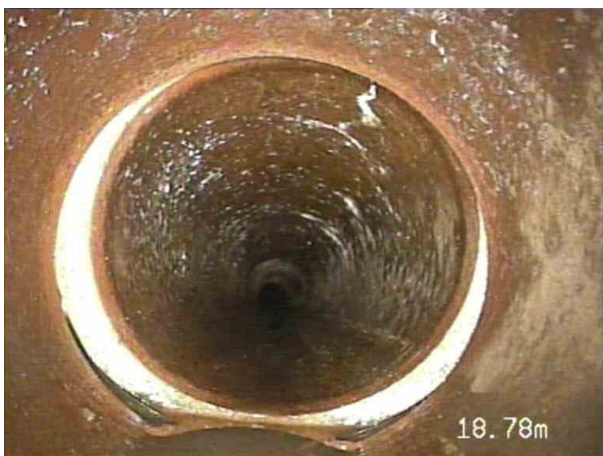
9, 00:03:26, 18.78 m  
Crack, longitudinal at joint at 1 o'clock

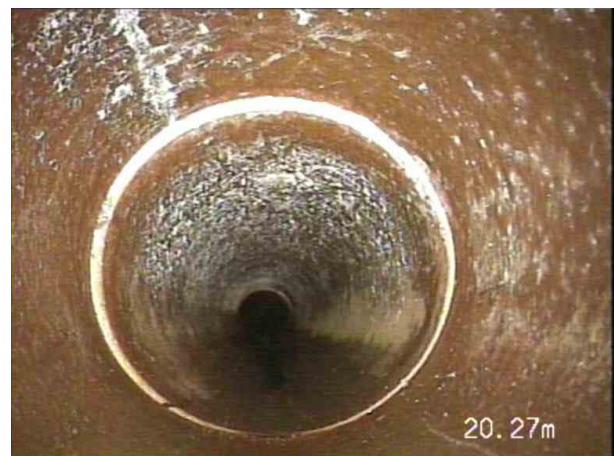
10, 00:03:46, 20.27 m  
Crack, longitudinal at joint at 5 o'clock

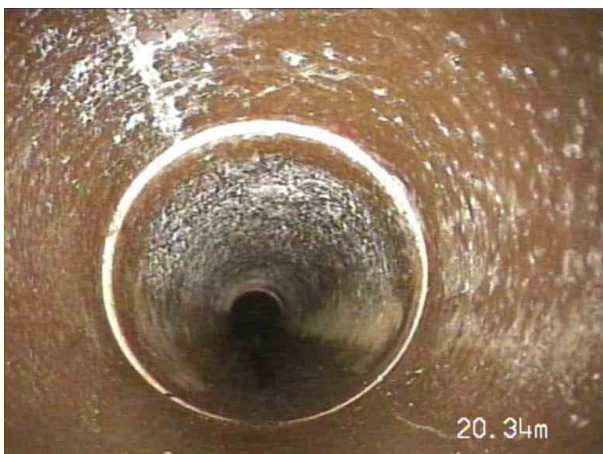
11, 00:03:39, 20.34 m  
Crack, longitudinal at joint at 11 o'clock

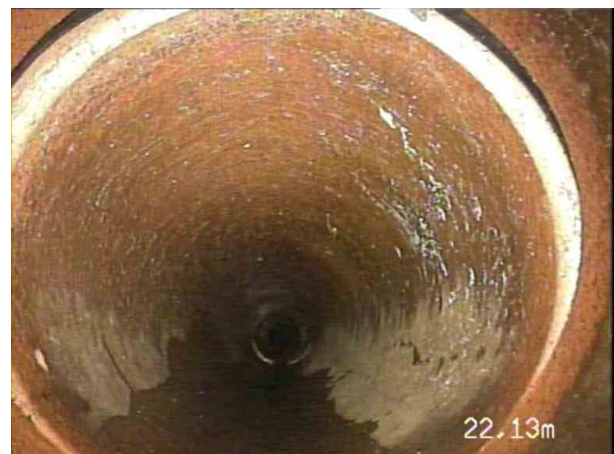
12, 00:04:06, 22.13 m  
Joint displaced, medium

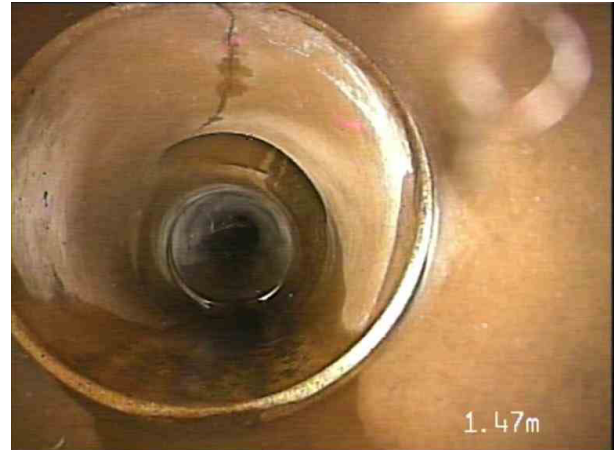
2, 00:00:27, 1.47 m  
Crack, longitudinal at joint at 12 o'clock

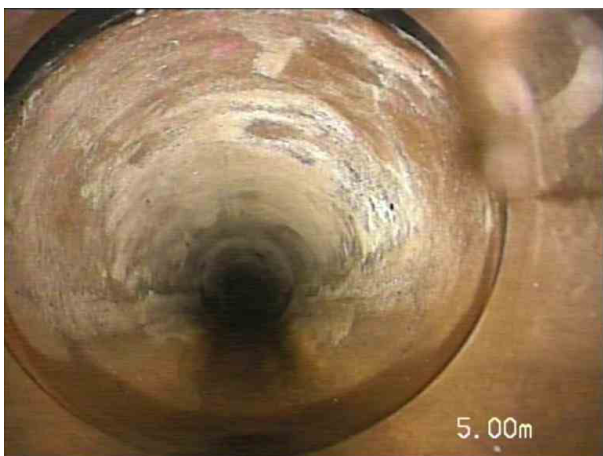
3, 00:00:55, 5.00 m  
Joint displaced, large

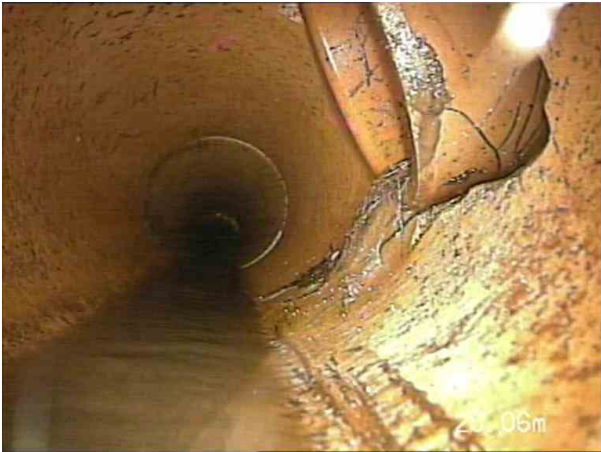
1, 00:03:09, 20.06 m

Connection defective, connecting pipe is intruding at 2 o'clock,  
100mm dia, intrusion: 15%

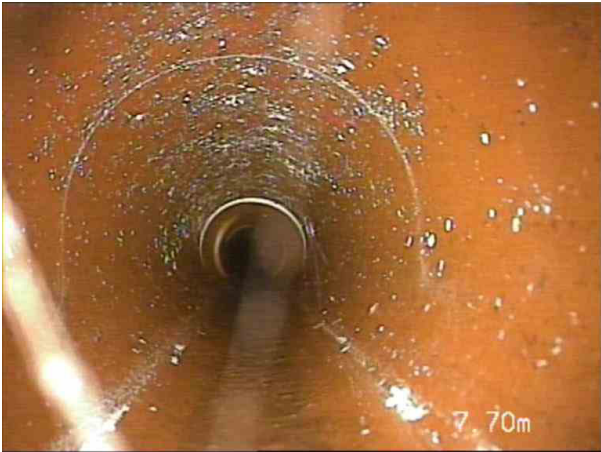
1, 00:01:18, 7.70 m

Crack, circumferential from 8 o'clock to 4 o'clock

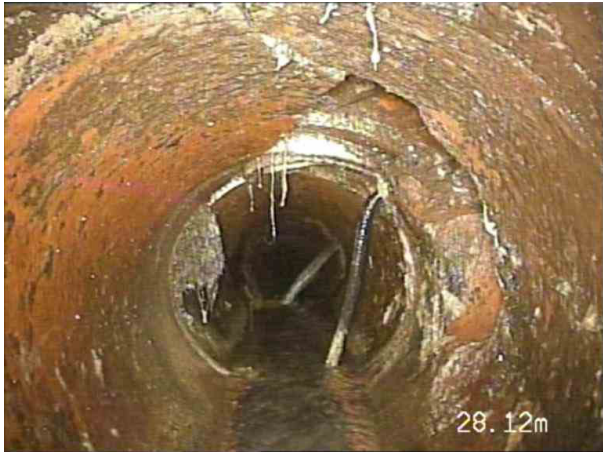
1, 00:03:28, 28.12 m  
Fracture, longitudinal at joint at 12 o'clock

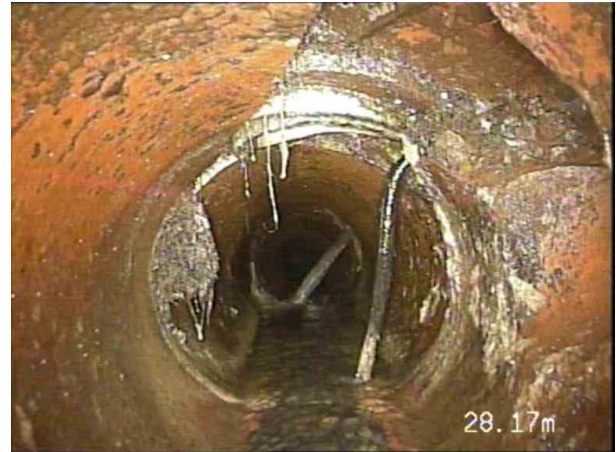
2, 00:03:41, 28.17 m  
Broken pipe from 11 o'clock to 1 o'clock

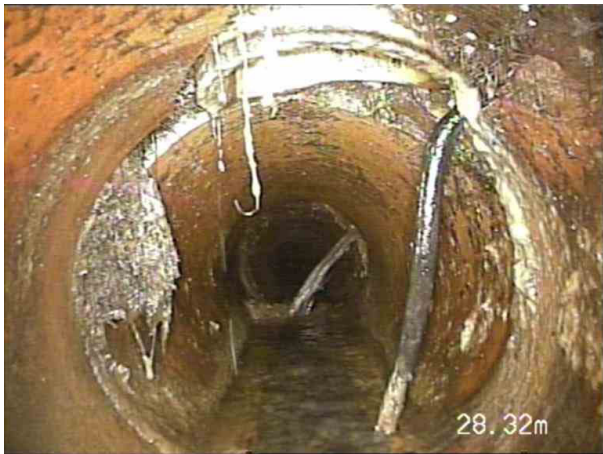
3, 00:03:51, 28.32 m  
Sealing ring intruding from 1 o'clock to 5 o'clock

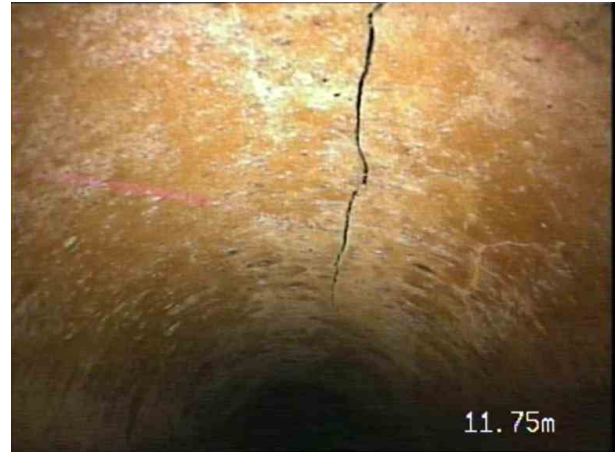
2, 00:02:19, 11.75 m  
Fracture, longitudinal at 1 o'clock

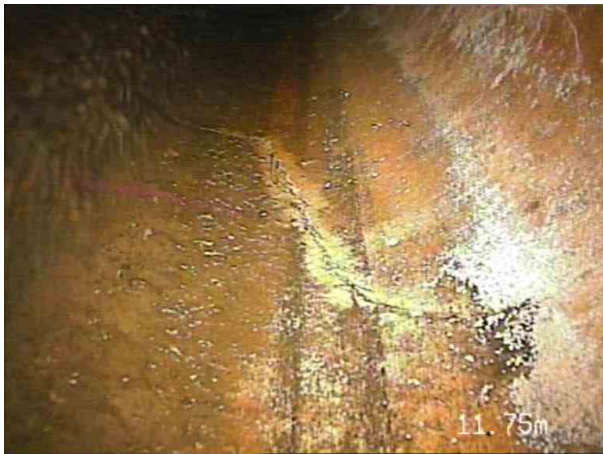
3, 00:02:32, 11.75 m  
Cracks, spiral from 3 o'clock to 6 o'clock

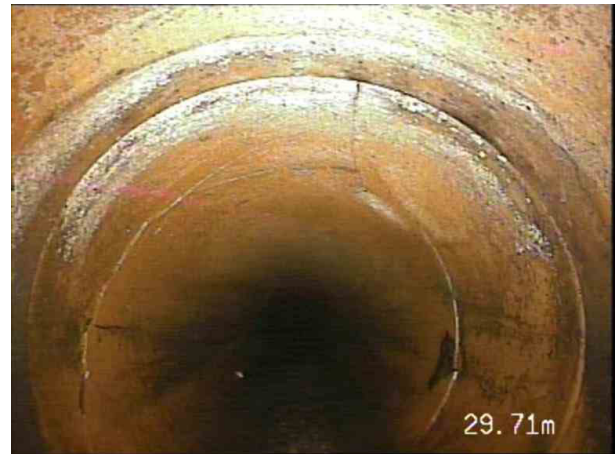
4, 00:04:41, 29.71 m  
Crack, longitudinal at joint at 12 o'clock

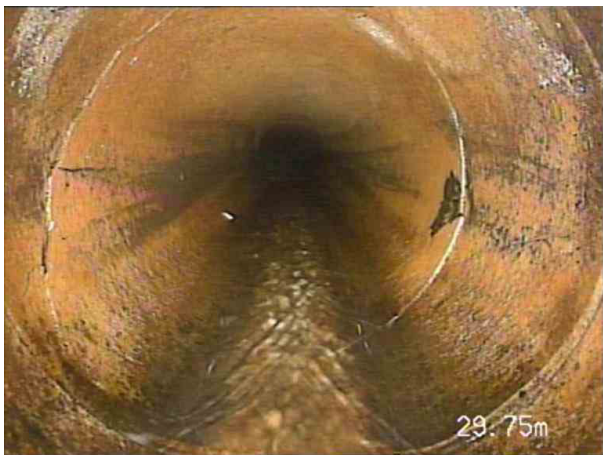
5, 00:04:48, 29.75 m  
Fracture, spiral at joint from 7 o'clock to 6 o'clock

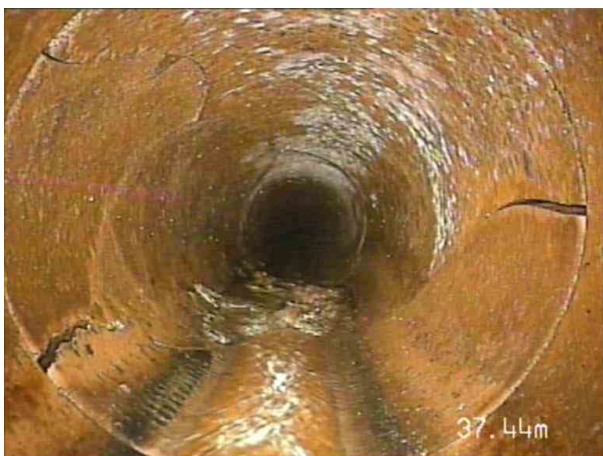
3, 00:03:57, 37.44 m  
Fracture, spiral at joint from 3 o'clock to 7 o'clock

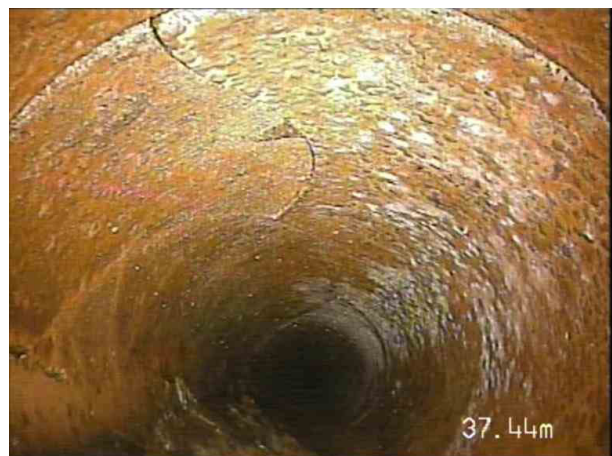
4, 00:04:04, 37.44 m  
Fracture, longitudinal at joint at 10 o'clock

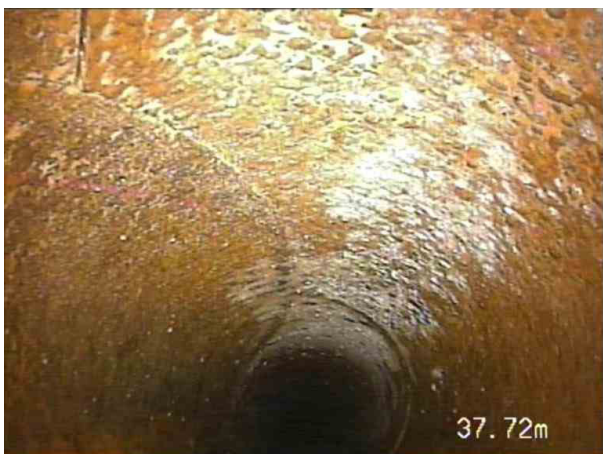
5, 00:04:18, 37.72 m  
Crack, longitudinal at joint at 11 o'clock

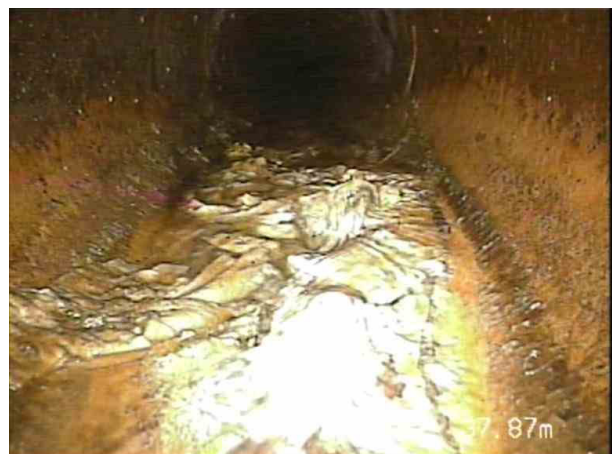
6, 00:04:31, 37.87 m  
Fracture, longitudinal at joint at 5 o'clock

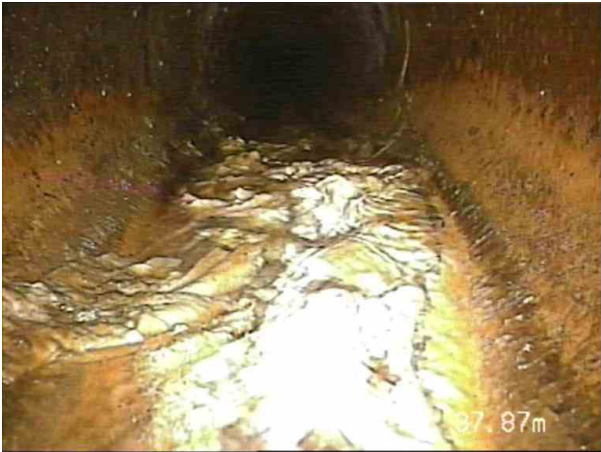
7, 00:04:33, 37.87 m  
Fracture, longitudinal at joint at 6 o'clock

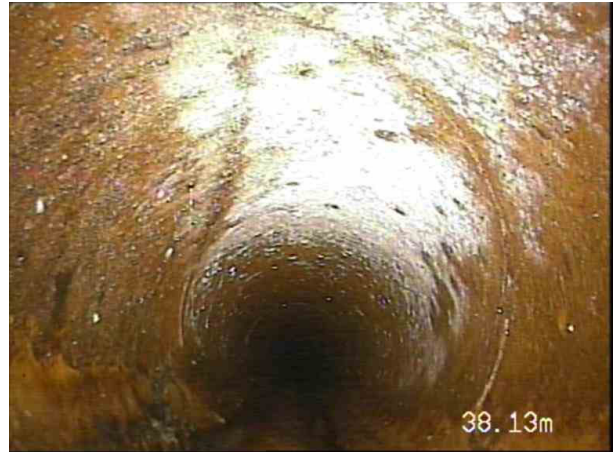
8, 00:04:48, 38.13 m  
Fracture, spiral from 11 o'clock to 5 o'clock

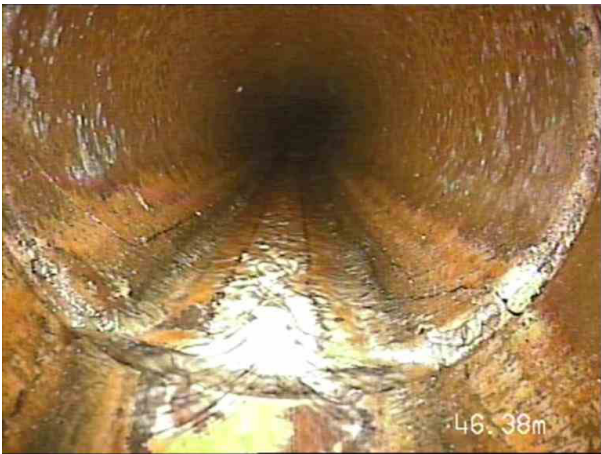
9, 00:05:40, 46.38 m  
Fracture, spiral at joint from 5 o'clock to 6 o'clock

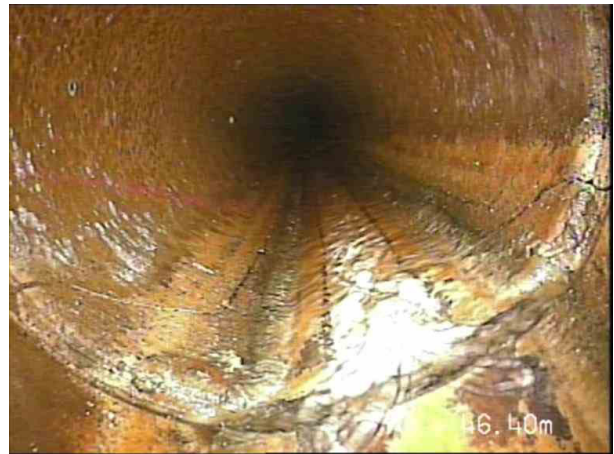
10, 00:05:47, 46.40 m  
Fracture, spiral at joint from 7 o'clock to 8 o'clock
