# **CARDIGAN TIDAL FLOOD RISK MANAGEMENT SCHEME**

## Appendix 11.2 – Land Contamination Risk Assessment

Land Contamination Risk Assessment

Project no. 4021883

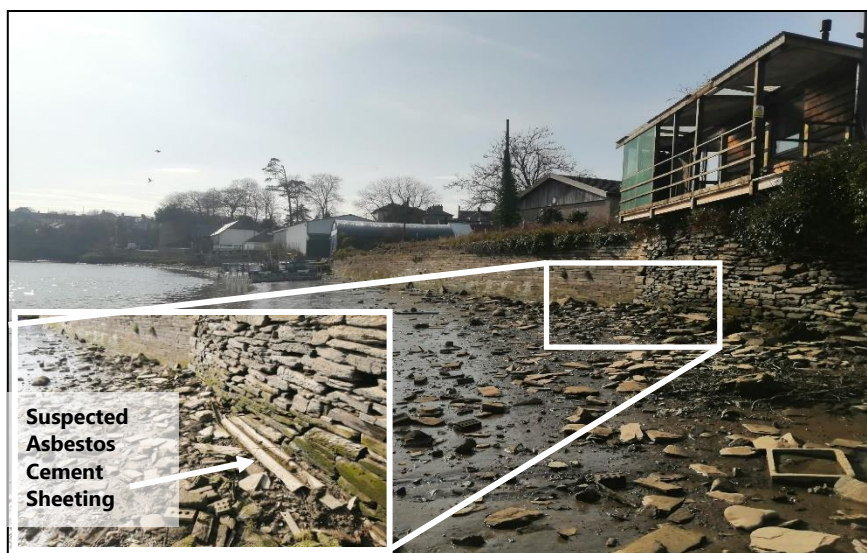
During the CJ Associates works (2022), suspected Asbestos Containing Materials (ACMs) were visually identified in borehole BH03 at 4.75m depth at the base of the Made Gound (black fibrous material); surface fragments of suspected cement-bound asbestos sheeting were also seen along the river foreshore by the investigation supervisor (Figure 4-1).

Figure 4-1 – Possible asbestos cement sheeting identified on foreshore in 2022.

Suspected asbestos containing materials (ACMs) were also observed in the Made Ground in BH03 at 4.75m bgl and at surface along the foreshore in the central-eastern area of the site, though samples were not tested from these materials to confirm the presence of asbestos. Contamination exceedance locations are indicated on Figure 5-1 below.

Due to the presence of asbestos in the area of works, it was recommended that a site-specific asbestos risk assessment be carried out prior to any works to assess the risk to construction workers and any residual risks associated with disturbing potentially asbestos contaminated ground.

Given the findings of the GQRA, remediation measures are likely to be required to protect site end-users where Made Ground is present and a potential contamination pathway exists (e.g. any proposed areas of soft landscaping). Site-specific construction work risk assessments will also be required to assess risks from contamination (including asbestos) prior to any works being carried out, so that appropriate mitigation can be undertaken accordingly, including removal of surface ACM fragments identified along the foreshore prior to construction; detailed recommendations are provided in Section 7.

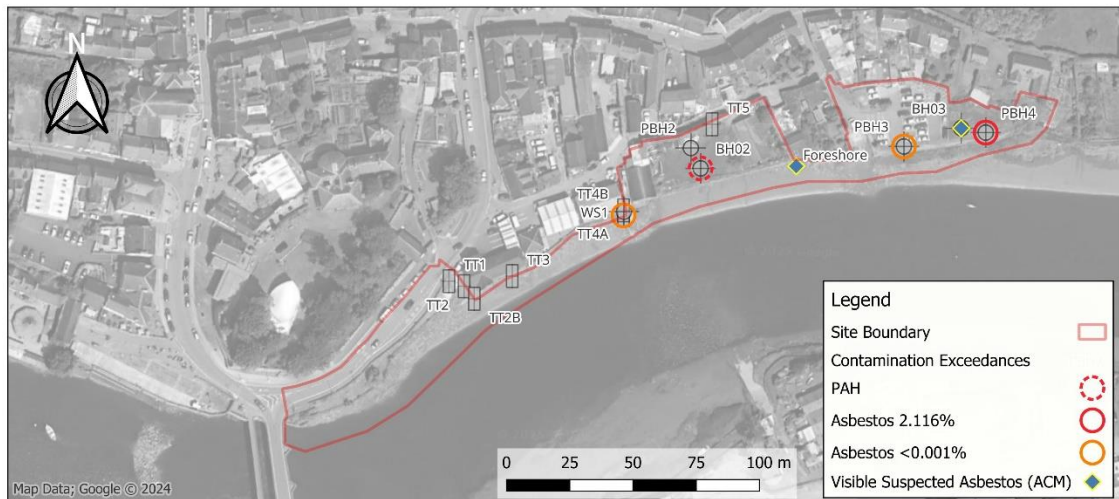
As shown by Table 5-1, slightly elevated concentrations of individual PAHs were recorded in one soil sample from borehole BH02 at 0.5m depth. In addition, a sample tested from borehole PBH4 at 0.5 - 1m bgl has recorded chrysotile asbestos cement debris with a quantification result of 2.116%. Chrysotile asbestos fibres were also recorded in two samples during the previous WYG investigation in 2015 (TT4 & PBH3), though the quantification results were both <0.001% which falls below the adopted POS(park) GAC. All exceedances were identified within the Made Ground.

**Figure 5-1: Contamination exceedance locations; WYG (2015) and CJ Associates (2022) data.**
