Project Reference: 191163

**Pencefn Drysgol
Tregaron
Ceredigion
SY23 6JW**

Assessment of the design and construction of a concrete bund

Pencefn Feeds Limited

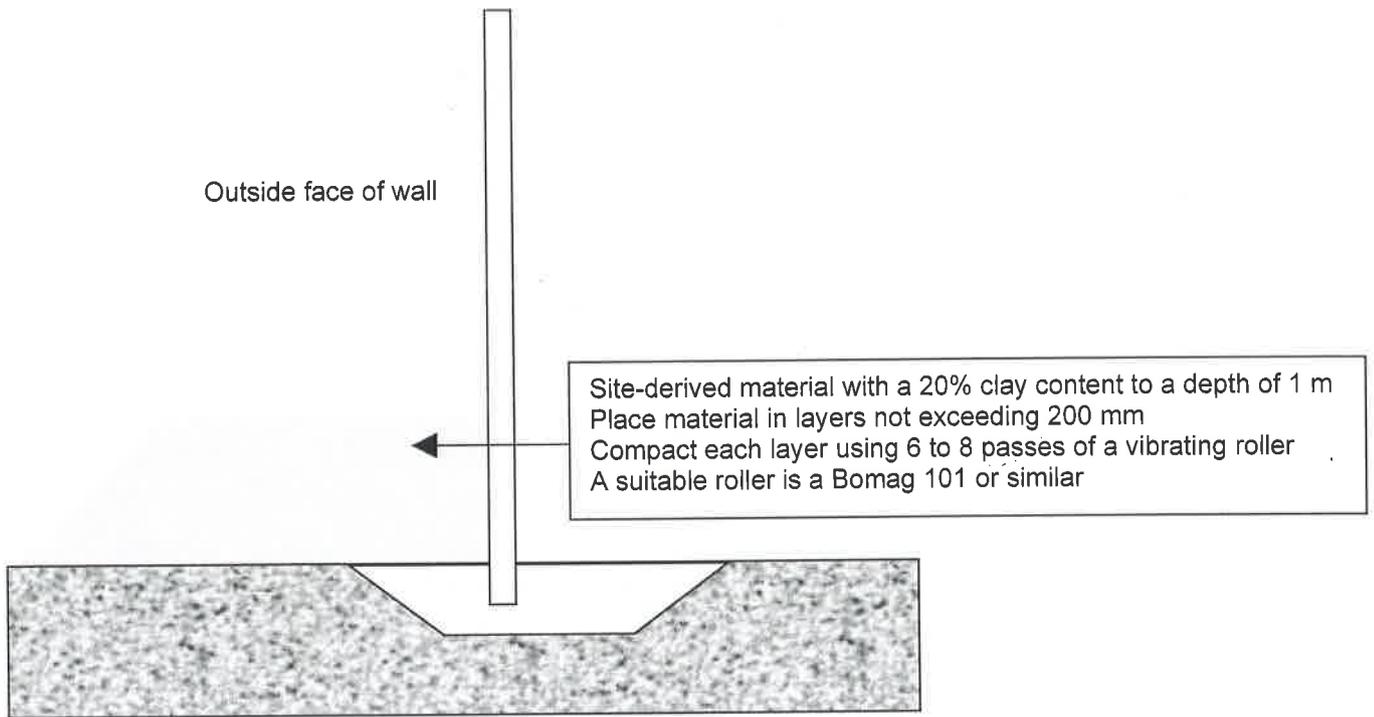
Secondary leak prevention around outside of wall

When the ground between the tank and the wall has been sealed with an adequate depth of concrete, the bund wall can then be regarded to be fully effective. Until such time, the loose surface area cannot be considered an effective leak-proof barrier and it was recommended to PFL that an impermeable plug of soil be created along the outer face of the wall to a depth of 1m. A schematic drawing with a specification of the requirements passed to PFL has been included at the end of this section. This backfill will also increase the stability of the wall by counterbalancing the overturning effect should any leakage occur.

It should be noted that at the time of the second visit to the site on Sunday the 10th of November 2019, the external backfilling had been satisfactorily completed and the bund adequately sealed.

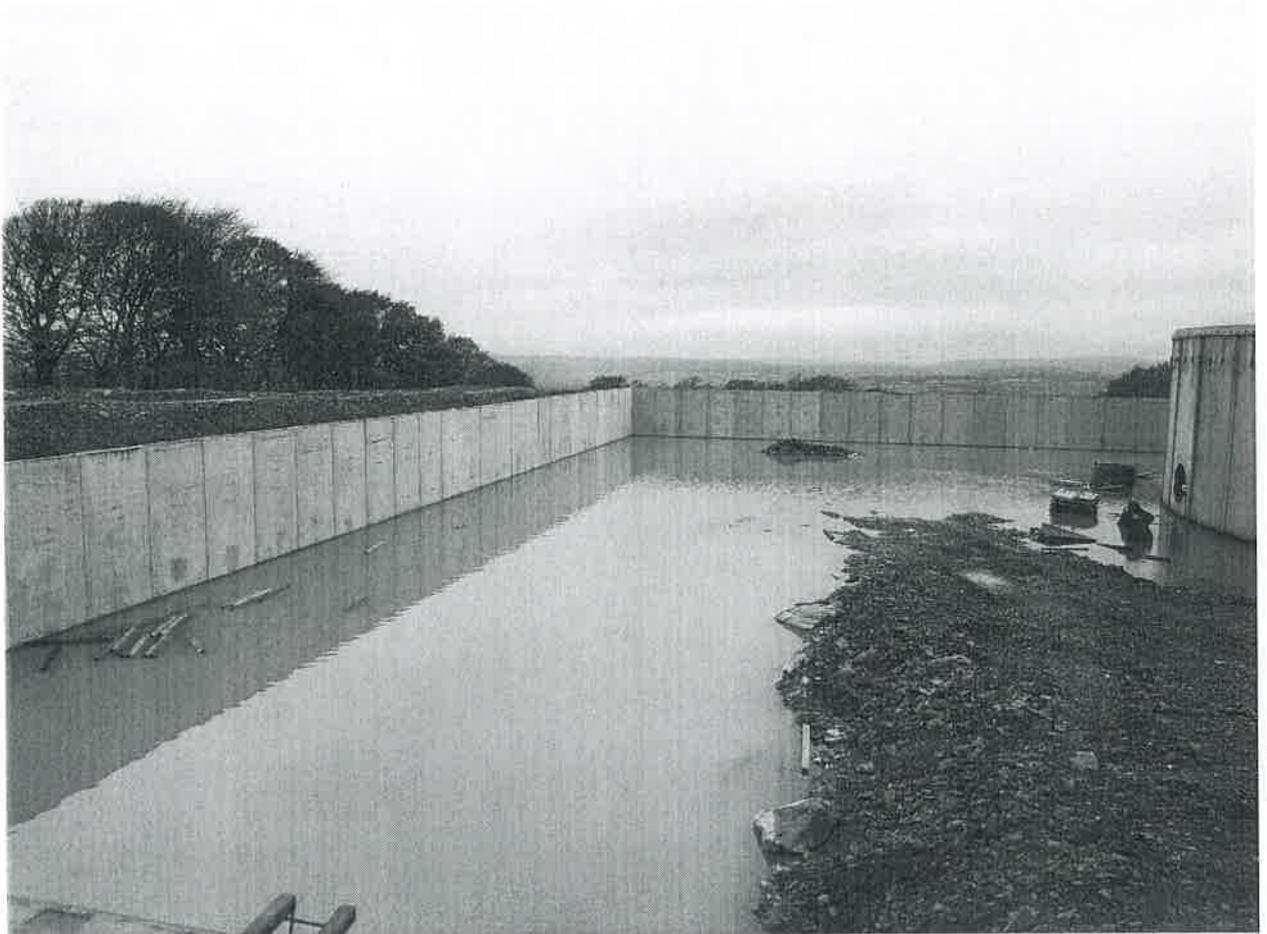
Photograph 1. The bund with tank on right. View looking west.

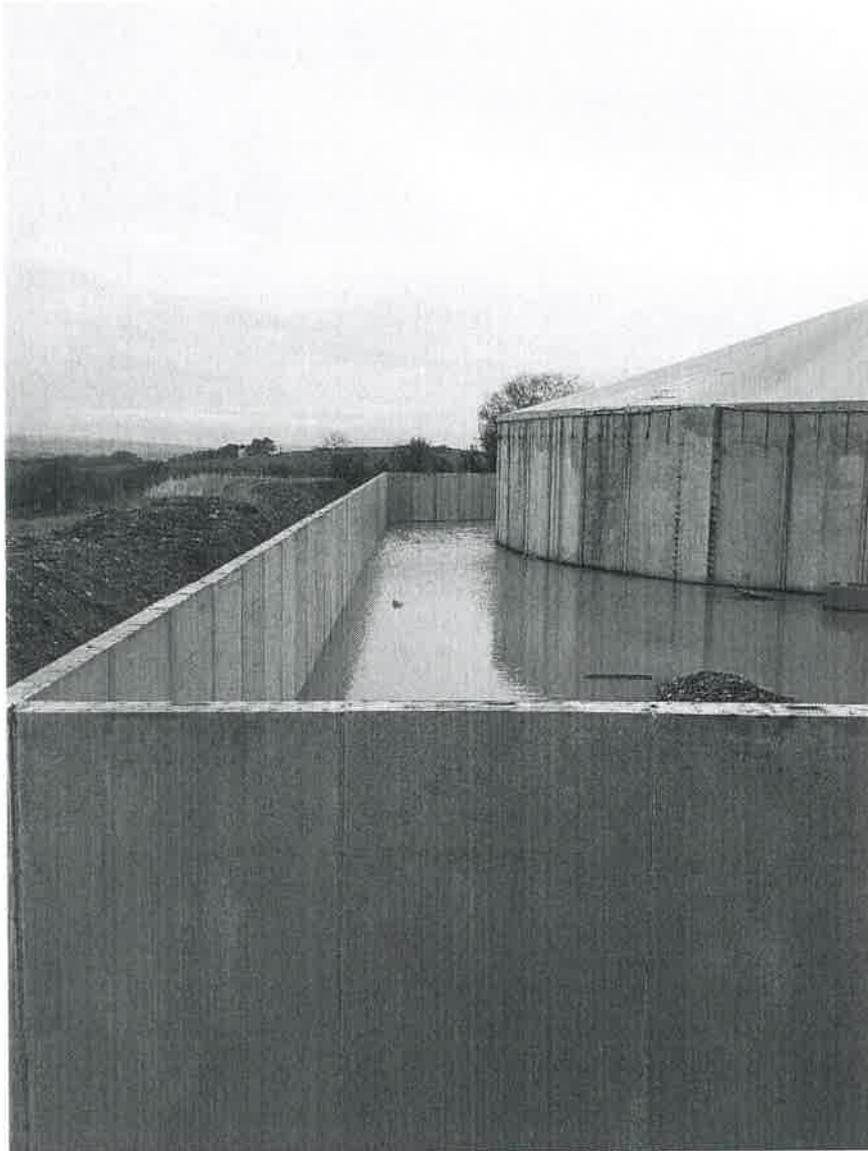
There is a bio-digester tank constructed from pre-formed concrete sections enclosed within a walled area (2900 m²), the wall of which is also constructed from pre-formed concrete sections. Outside the secondary wall there is an embankment of shale mixed with clay (see Photographs in Appendix).

Photograph 2. View along west wall looking north. The embankment can be seen on the left of photograph.

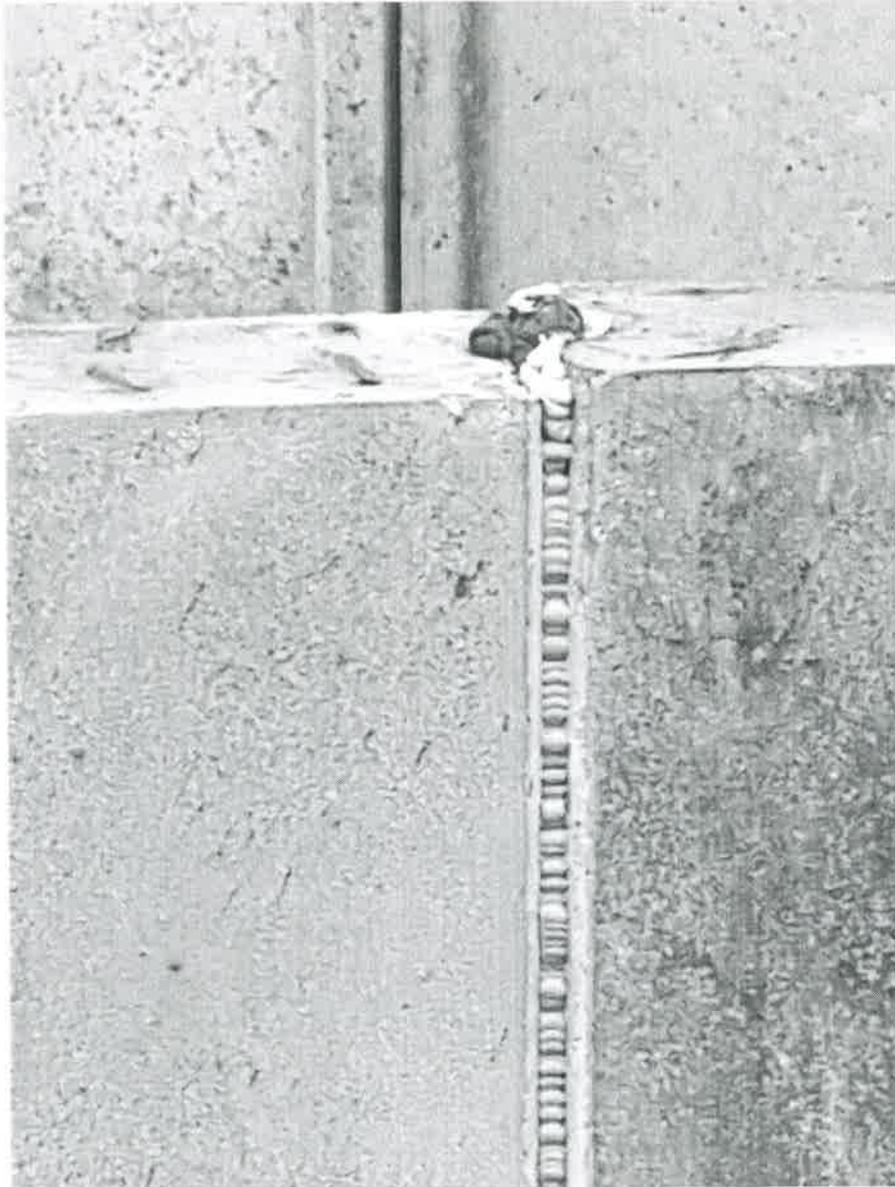
The panels for the bund wall are in pre-stressed concrete and are 180 mm thick. They are manufactured by ACP (Concrete) Limited and installed by Lloyds Brothers Construction Limited. The joints of the concrete slabs utilize a tongue and groove system with SikaSwell S-2 (red), swellable sealant applied to the central tongue and groove and Fosroc Supercast SW (grey), sealant applied to the flat outer edges of the joint.

As noted in Section 3 the wall has been built to a high standard with all joints being uniform and even. Close inspection of the joints shows that the sealant has been applied uniformly and evenly. The photographic archive of the various stages of construction, in addition to the visual inspection, show that the work has been carried out to a high standard in accordance with CIRIA C736 guidelines.

Photograph 3. Section of joint showing two types of swellable sealant

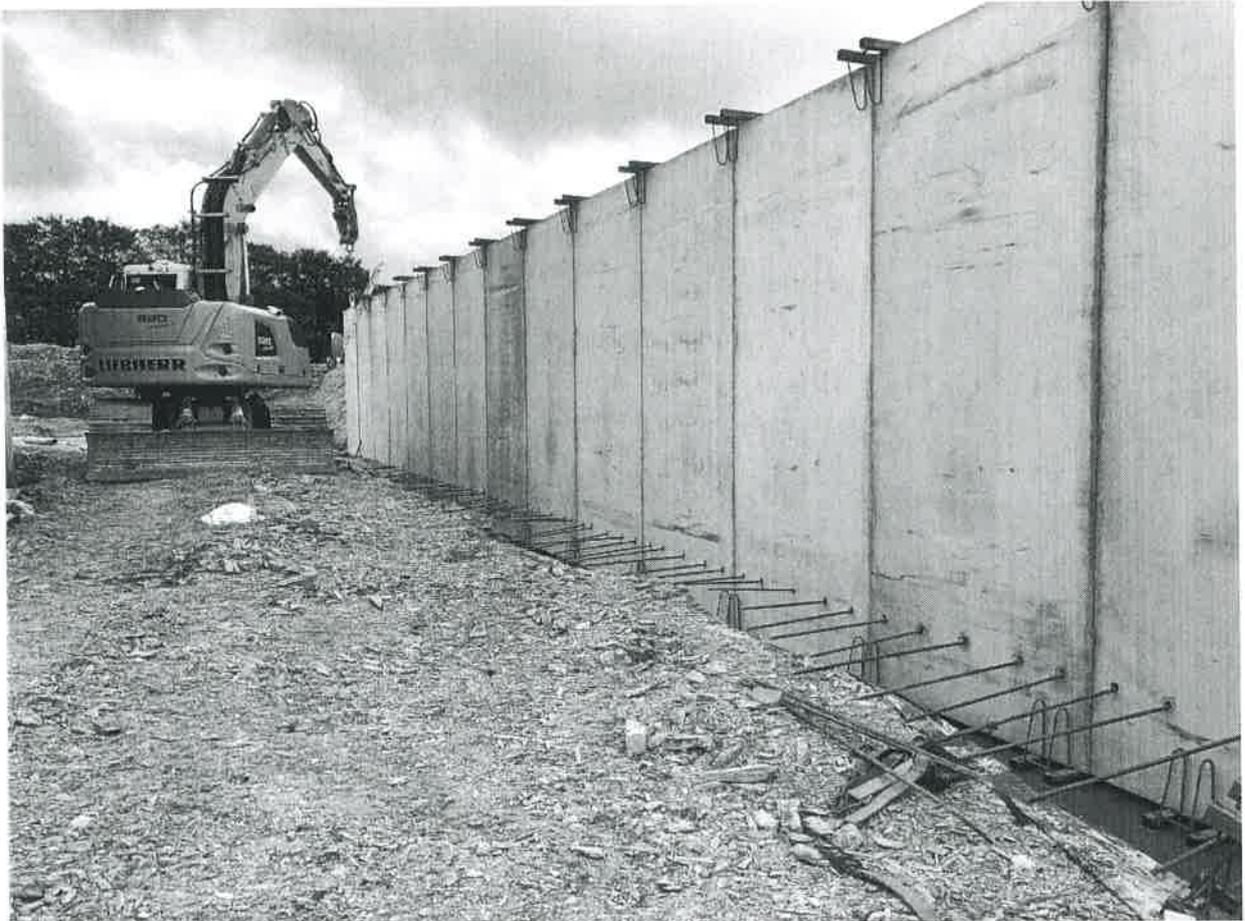
The ground within the enclosed area of the bund is presently of loose shale and photographic evidence shows bedrock close to the surface. The composition of the mudstone in this area is such that it is prone to fracturing and the likelihood of this occurring on a construction site with heavy machinery movements is high.

The ground condition in its present state is likely to be permeable and would therefore be ineffective as a containment medium. It is understood from PFL that there is a DPM membrane below the surface shale but conditions on the day of the site visit meant that it was not possible to confirm this. PFL have also advised that the ground between the tank and the wall will be concreted as part of Phase 2 of the project. Re-surfacing of the yard area with concrete close to the site has already commenced and it is understood that the entire yard including the bund will be concreted in due course.

Photograph 4. The bund during construction showing ground surface. Photo courtesy of Bill Lloyd, PFL.

It is recommended that a further inspection be made of the site when the Internal base of the bund has been concreted.
